U. S. NUCLEAR REGULATORY COMMISSION

Report No.: 999-90002/2003-003

Facility: Smith Iron & Metal Company, Inc.

Inspection Dates: August 4 and 7, 2003, and subsequent  
telephone conversations

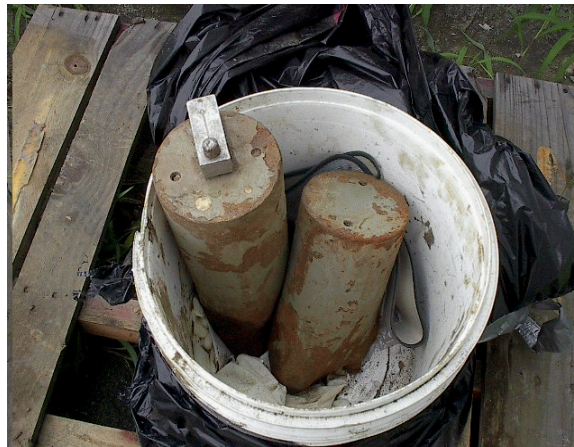
**Above:** Picture showing the two pieces of the device as found at Smith Iron & Metal. Note the silver shutter mechanism on the top of the left piece.

The VABRH representative conducted removable contamination and area radiation surveys of the device without removing it from the bucket, determining that it contained a cesium-137 (Cs-137) source. The VABRH representative reported exposure rates of

120 milliroentgen per hour (mR/hr) on contact and less than 2.6 mR/hr at three feet from the bucket. SI&M posted the bucket with a radiation sign and temporarily placed it in a secured location on site. A local company assisted SI&M in these efforts by hiring a health physics consultant to characterize the damage to the device and any resulting contamination.

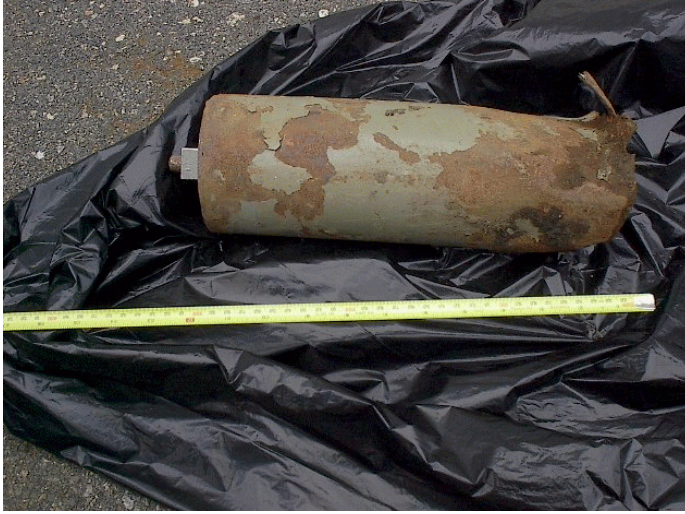
**Left:** Picture showing one half of the cylindrical device. The shutter mechanism is discernable on the left end of the device. The right end of the device shows where it was cut and deformed by the shear. In all, this section measured approximately 12 inches long.

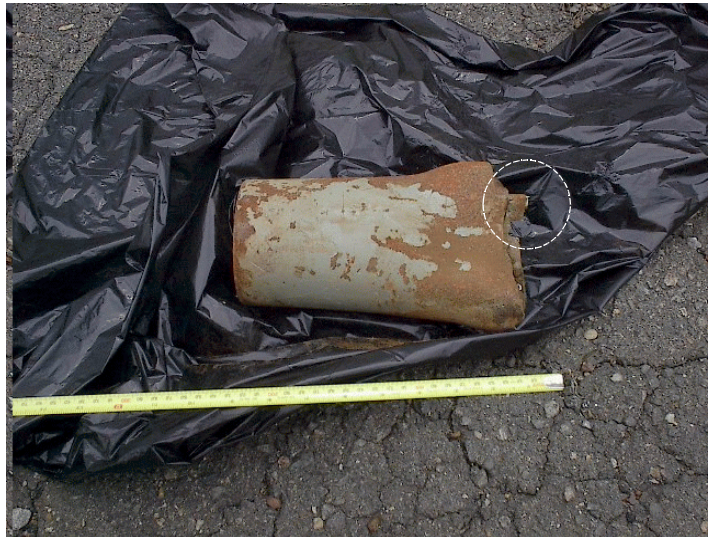
**Right:** This is the second section of the device. A portion of the exposed source rod is visible (centered within the dashed circle) at the location where the shear cut the device in two. This section of the device measured approximately 8 inches long. Neither section of the device was marked with identifying labels or markings.

of the device. The highest reading swipe was later quantified in the VABRH lab to be 381 picocuries of Cs-137. Area radiation surveys were also performed by the inspectors, and the highest readings on both pieces were detected near the cut ends of the device. The highest readings observed by the inspectors at these ends were approximately 650 mR/hr and 3.5 mR/hr at contact and three feet, respectively. After surveying, the pieces were returned to the bucket and placed in a locked and secured building at the SI&M facility.

On August 5, 2003, in coordination with a local company and a health physics consultant, SI&M packaged the device into a labeled shipping container, and locked the container in a secured building on site. On August 7, 2003, the inspectors met with a representative of the U. S. Environmental Protection Agency (EPA) at the SI&M facility to ensure that the licensed material was appropriately packaged and secured. From direct observations and independent confirmatory area radiation surveys, the inspectors did not identify any concerns with the shipping container or survey results. The inspectors found that the licensed material had been properly packaged and labeled for transport. The EPA representative informed the inspectors that EPA would coordinate the disposal of the device appropriately with SI&M.
