SUBJECT: SUMMARY OF AUGUST 25, 2003, MEETING FOR COMANCHE PEAK STEAM
ELECTRIC STATION

This refers to the meeting conducted in Arlington, Texas, on August 25, 2003. This purpose of this meeting was to discuss the Comanche Peak plant response to a grid disturbance on May 15, 2003.

Comanche Peak

Response to Grid Disturbance

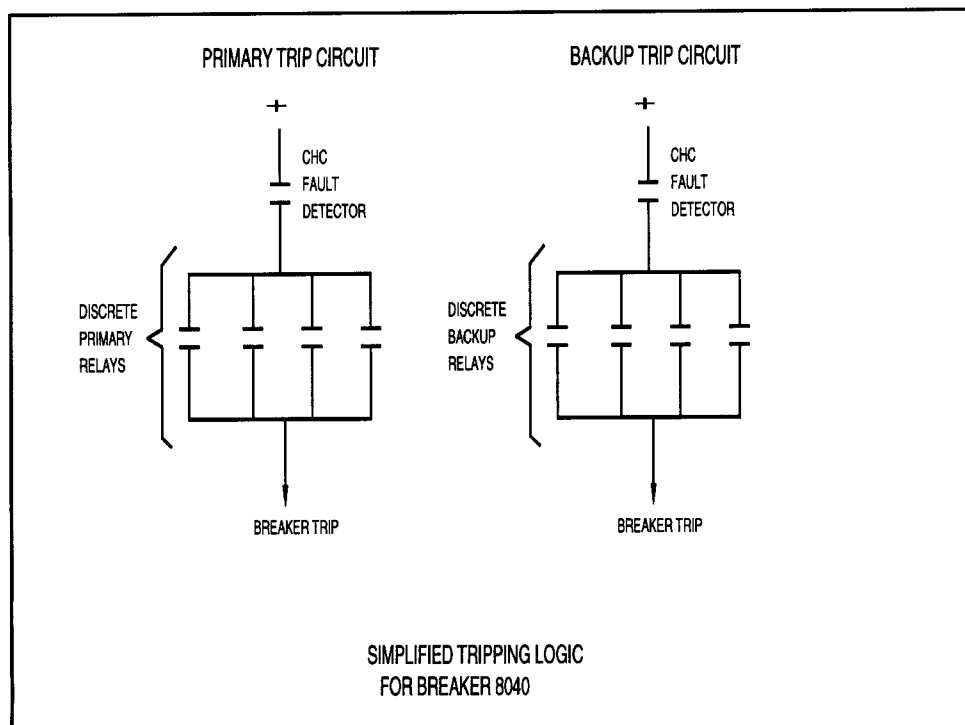
Causes for Undesirable Operations

Event root cause is the fault detector relays failed to operate on CPSES breaker 8040.

Contributing Factors for Failure of Relay Protection on Breaker 8040

- Fault detector relay failed to operate
 - Settings relative to load current on circuit
 - Maintenance practices
- Relay system design in CPSES switchyard

Improvement Actions for Maintenance Practices

- Revise Procedures
 - Maintenance
 - Relay testing
- Enhanced Training
 - Procedures
 - Reporting
- Enhanced qualification verification program for technicians to work in the Comanche Peak switchyard

Improvement Actions for CPSES 345 kV Switchyard Relaying

- Load flow and relay coordination optimization studies
- Revise settings
 - CHC fault detectors
- Modify design to increase dependability
- Consider recommendations from Third Party Review
