State of New Mexico
ENVIRONMENT DEPARTMENT

August 15, 2003

RE: New Mexico Environment Department inspection visit with Mr. Anton Allensworth-Cannaday, Milan, New Mexico

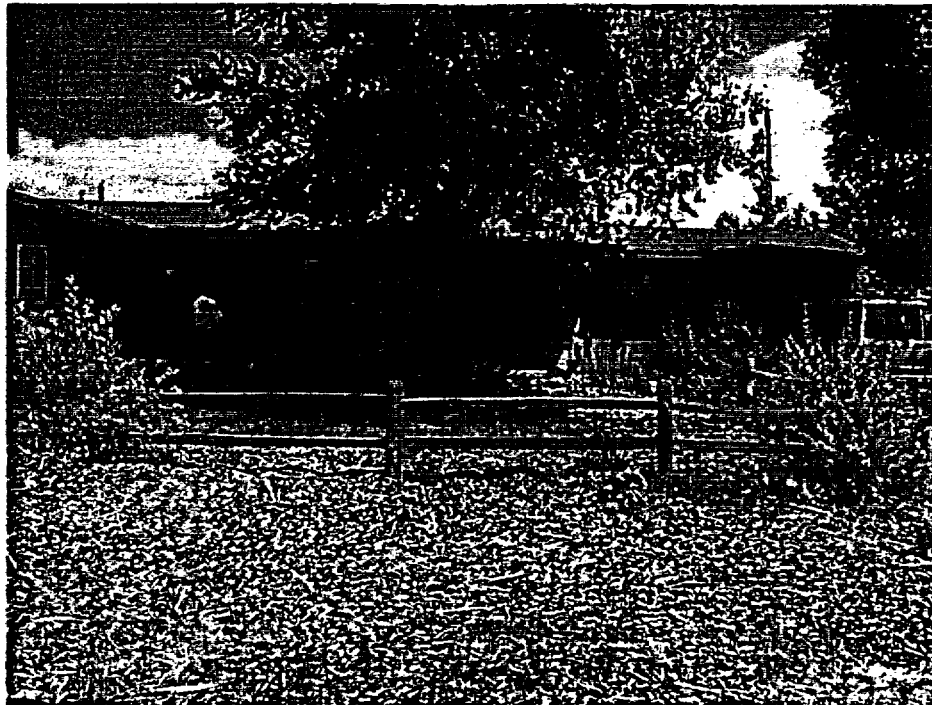
Figure 1: General view of front side (i.e., southern side) of Mr. Allensworth-Cannaday's house

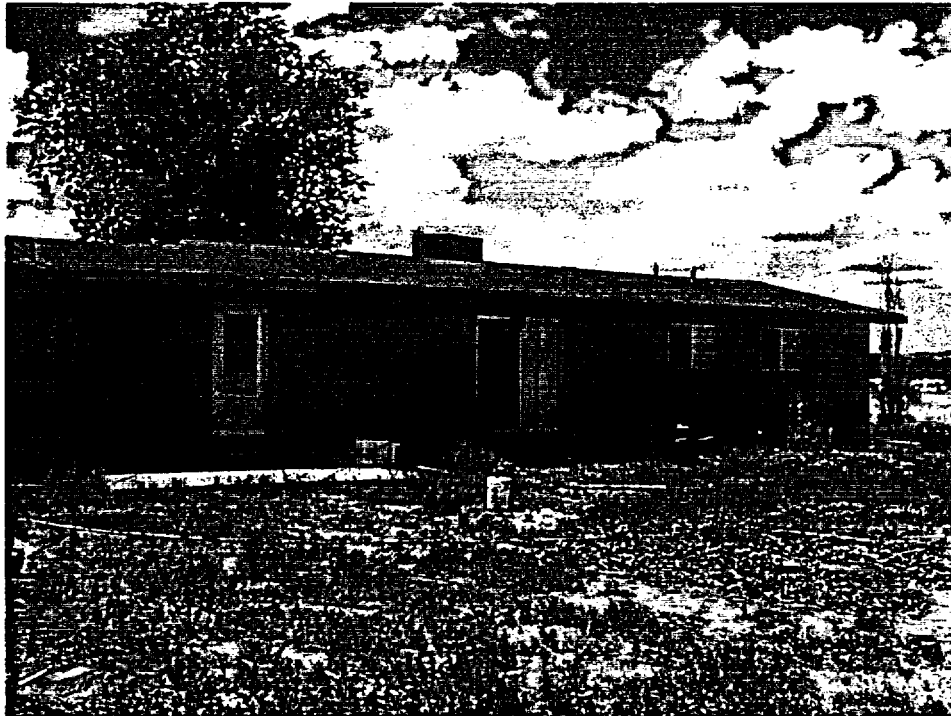
Figure 2: General view of back side (i.e., northern side) of Mr. Allensworth-Cannaday's house

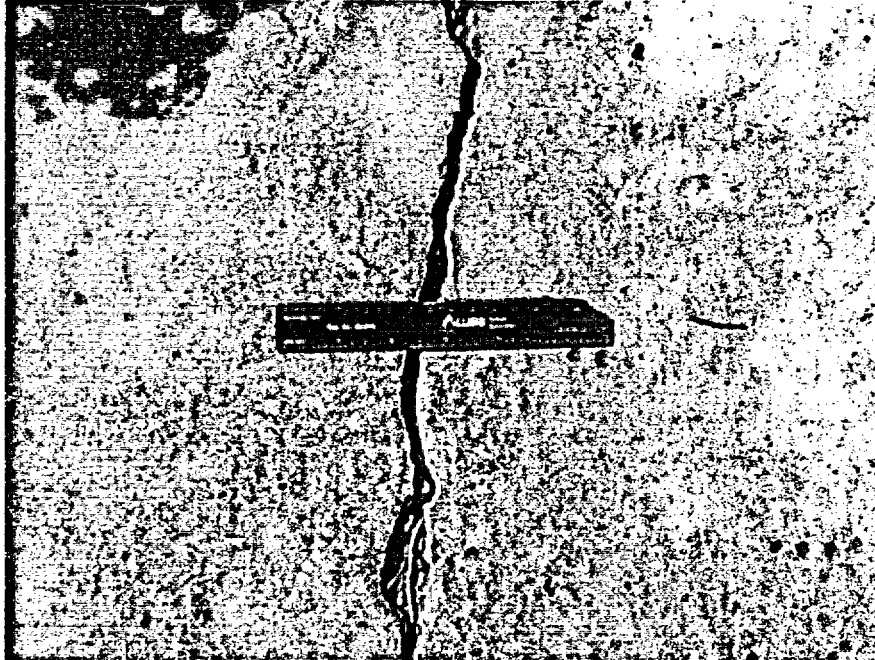
Mr. Allensworth-Cannaday showed NMED personnel a crack in the concrete apron on the back (i. e., north side) of the house (Figure 5). This crack is oriented approximately north/south, in approximate alignment with well ACW and is approximately ¼ inch in width. The crack is visible into the wall stucco up to the house's eave. This crack is located approximately 5 feet to the east of the inferred seam between the original house structure and the addition to the house. Some dislocation of the roof line was noted, but may be related to the seam of the house addition.

No evidence of the crack was noted on the interior of the house; however Mr. Allensworth-Cannaday stated that he had repaired interior cracks on several occasions.

Mr. Allensworth-Cannaday stated that all of these dislocations suddenly appeared shortly after HMC had discontinued injection into well ACW.

1. The area around well ACW, which is in relatively close proximity to the house, was elevated, damp and highly-vegetated at the time it was used for injection. These observations might indicate leakage to the surface of injected water. Such leakage, if it occurred, may have caused swelling of near-subsurface clays and/or soil liquefaction, contributing to foundation dislocation. The crack on the back side of the house aligns fairly closely to this well, and involves both the house itself as well as a concrete apron that appears to be unconnected to the structure.
2. The observed structural dislocations occurred subsequent to cessation of HMC's injection activities.

Figure 5: Crack in concrete apron on back (i. e., north) side of Mr. Allensworth-Cannaday's house

NMED has spoken to Mr. Al Cox (HMC) to request that he contact, and subsequently arrange to visit, Mr. Allensworth-Cannaday about his property concerns, and also to inform him about the status and process of HMC's ongoing remedial effort. NMED believes that the following assertions by the owner may be mitigating factors that could indicate the need for HMC to provide Mr. Allensworth-Cannaday with an independent structural engineering inspection of house to determine the cause of the observed structural dislocations:
