Edwin I. Hatch Nuclear Plant
Measurement Uncertainty Recapture Power Uprate (MURPU)
Post MURPU Steam Dryer Performance Monitoring and Inspections

Enclosure 1
Post MURPU Steam Dryer Performance Monitoring Inspections

BWR steam dryer integrity

SIL No. 644
Supplement 1
September 8, 2003

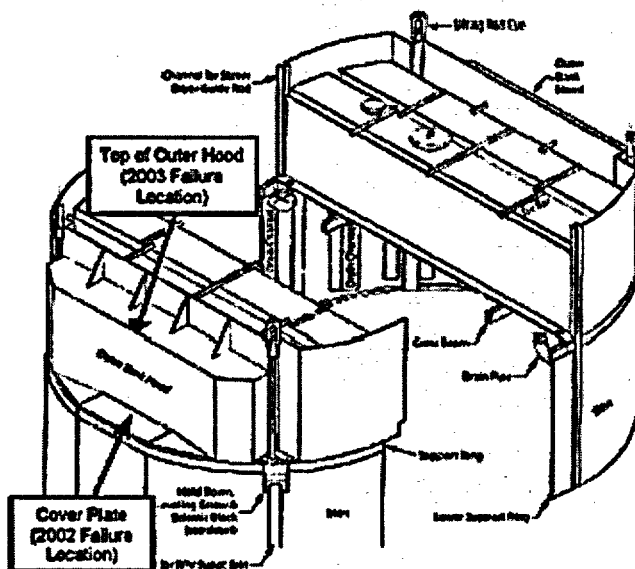
The purpose of this Supplement 1 to SIL No. 644 is to describe a second steam dryer failure that occurred at the same BWR/3 approximately one year following the initial steam dryer failure. The location of the failure (refer to Figure 1) and the root cause are different than the earlier failure. As a result, additional monitoring and inspections are recommended for all BWR plants that are operating, or plan to operate, at power levels greater than the OLTP. SIL 644 applied to BWR/3-style steam dryer design plants. This Supplement 1 to SIL No. 644 presents revised recommendations for plants with BWR/3-style steam dryers and provides recommendations applicable to plants with BWR/4 and later steam dryer designs.

Detailed visual inspection of the accessible external and internal areas of the steam dryer revealed significant steam dryer damage. The damage was most severe on the 90-degree side of the steam dryer, the side that was closest to the PORV that had opened. On the 90-degree side, a through-wall crack approximately 90 inches long and up to three inches wide was observed in the top of the outer hood cover plate and the top of the vertical hood plate (refer to Figure 2). Three internal braces in the outer hood were detached and one internal brace in the outer hood was severed. The detached braces were found on top of the steam separator. All detached parts were accounted for and retrieved. On the opposite side of the steam dryer (270-degree side), incipient cracking was observed on the inside of the outer hood cover

plate and one vertical brace in the outer hood was cracked. No damage was found in the cover plates that had been replaced following the first steam dryer failure in 2002.

Figure 1 — Steam Dryer Failure Locations, 2002 and 2003

The following repairs and pre-emptive modifications were made to both the 90 and 270-degree sides of the steam dryer:

1. replaced damaged ½ inch outer hood plates with 1 inch plates
2. removed the internal brackets that attached the internal braces to the outer hood
3. added gussets at the outer vertical hood plate and cover plate junction
4. added stiffeners to the vertical welds and horizontal welds on the outer hood
