Donald C. Cook Nuclear Plant Units 1 and 2
STEAM GENERATOR INSPECTION – REQUEST FOR ADDITIONAL
INFORMATION (TAC NOS. MB8121 and MB8122)

ATTACHMENT TO AEP:NRC:3691-05

Steam Generator Inspections Request for Additional Information

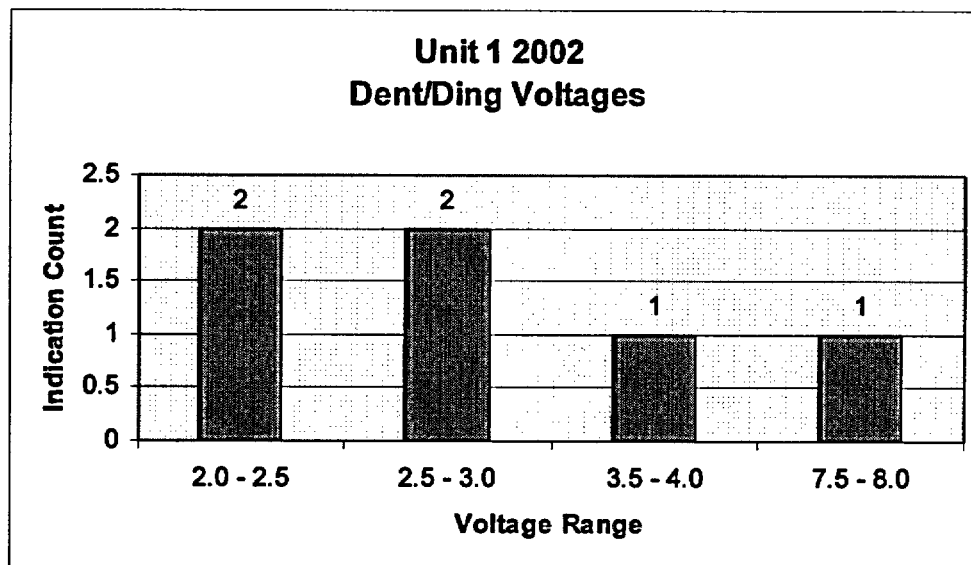
Figure 5
Unit 1 Bobbin Voltage Amplitude Distribution

The bobbin voltage amplitude distributions for the dent/ding signals reported during the 2002 inspection are presented in Figure 5.

A review of the Unit 1 data noted that of the six indications, five were present in the baseline examination record and had not changed. The sixth tube, SG 14, R34/C26, was found to have a small ding indication (2.15 volts) in the U-bend region that was not present in the baseline data. This indication was most likely caused by either probe interaction when traversing the U-bend region or by steam generator movement during shipping (Note: The baseline examination was performed in the factory and no additional inspections were performed until 2002).

The planned 2002 Unit 1 rotating coil inspection for dents and dings consisted of a random 20 percent sample of all dent/ding indications above two volts. When the inspection results were obtained, it was noted that of the six dents/dings reported, five of the indications were in the U-bend area. However, due to an oversight, a U-bend rotating probe was not available to perform the one additional indication inspection necessary to comply with the 20 percent sample. A decision was made to inspect the accessible freespan indication and to defer the U-bend inspection of the one additional indication until the next scheduled inspection, the Unit 1, Cycle 19 refueling outage. This decision was judged to have no adverse impact on tube integrity due to the small signal amplitudes of the U-bend indications, the limited operating time of the Unit 1 steam generators, the enhanced design features and the degradation resistant properties and operating experience with the alloy 690 thermally treated tubing material. I&M plans to inspect a

sample (inclusive of SG 14, tube R34/C26 discussed above) of U-bend dent/ding indications with a rotating coil during the Unit 1 Cycle 19 refueling outage.

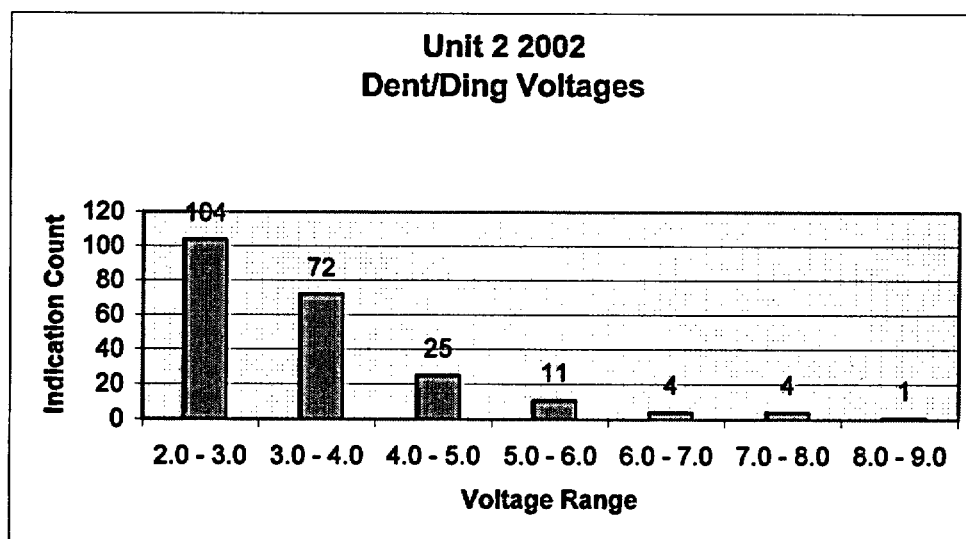
Figure 6
Unit 2 Bobbin Voltage Amplitude Distribution

The bobbin voltage amplitude distributions for the dent/ding signals reported during the 2002 inspection are presented in Figure 6.

A review of the Unit 2 data provided reasonable assurance that all of the dent/ding indications reported during the 2002 inspection were present in the baseline examination and had not changed. A portion of the baseline data, which was originally recorded on cartridge tape, is unavailable for review because of problems encountered when duplicating the data from the obsolete cartridge tapes to the current industry standard data media (optical discs). Therefore, a review of 100 percent of the indications could not be performed. Over ninety eight percent of the indications were reviewed, and no signal changes were identified. The results of the data review provide confidence that the dents/dings are not service induced. Of the 221 reported dent/ding signals from the 2002 inspection, 217 were confirmed in the baseline data and indicated no change. The traceability of these signals to the baseline data coupled with design features such as the quatrefoil stainless steel support structures and full depth expanded tubesheet are felt to provide reasonable assurance that service induced dents/dings are not occurring in these steam generators.

The Unit 2 rotating coil inspection for dents and dings was based upon a 20 percent random sample of all dent/ding indications above two volts in the freespan region. The inspection consisted of tubes with both single indications and tubes with multiple indications. No U-bend indications were tested. While no degradation is expected in any of the U-bend dent/ding indications due to the service time of the Unit 2 steam generators and the enhanced design features/degradation resistance offered by the alloy 690 thermally treated tubes, I&M plans to inspect a sample of U-bend dent/ding indications with a rotating coil during the Unit 2 Cycle 15 refueling outage.

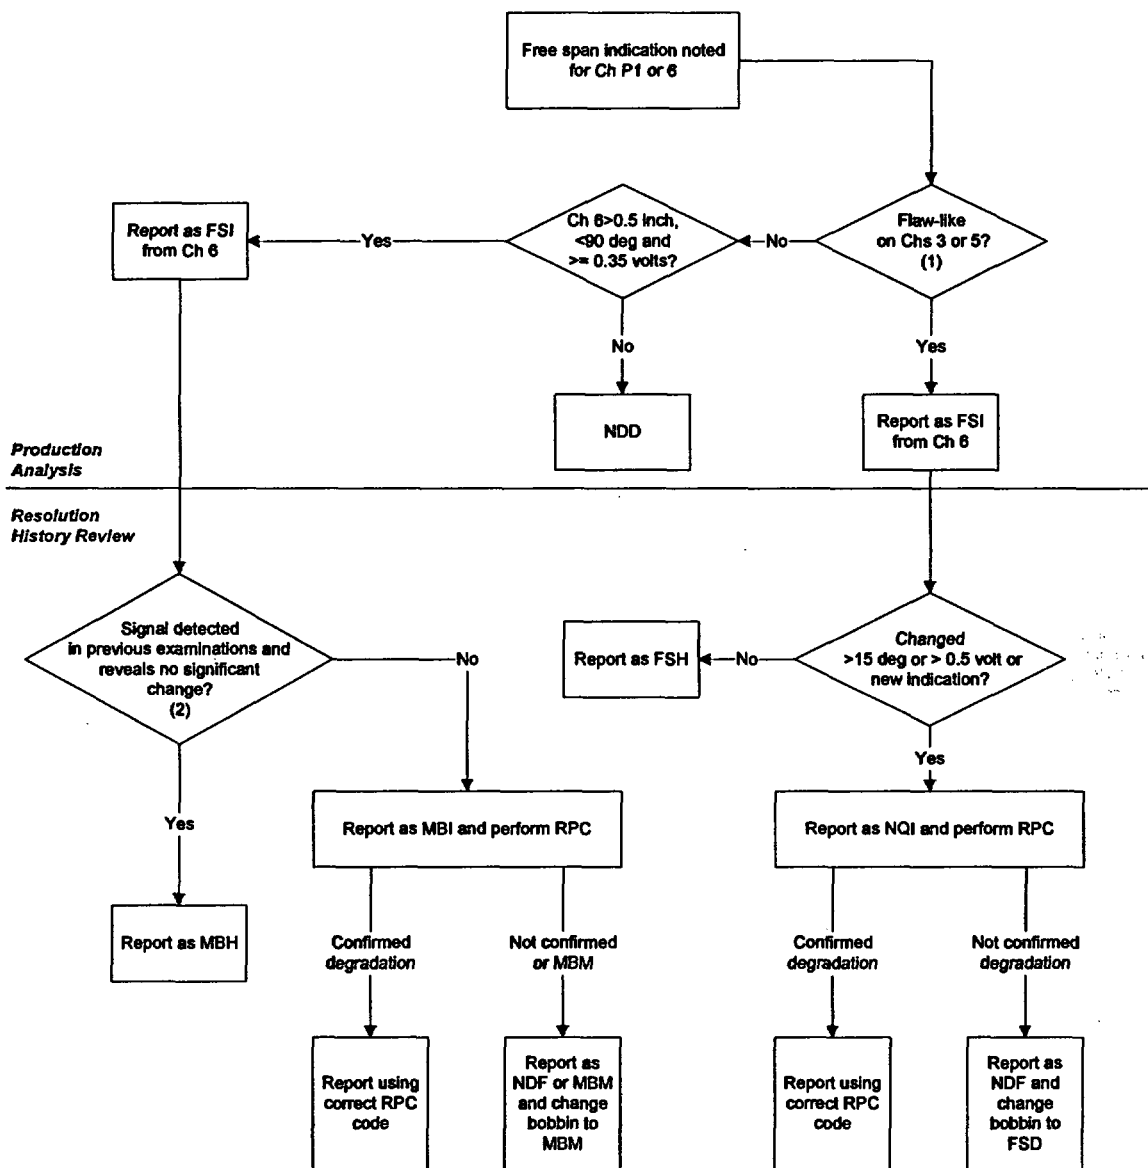
Figure 7
Decision Flowchart

The criteria for determining whether a signal had changed was developed by the lead level III analyst and concurred with by an independent level III analyst. The criteria, which are based upon industry experience, are illustrated in Figure 7.

(1) Flaw-like: reads above 0%

(2) Significant change: >15 degree positive phase shift. All MBH calls require review by both resolution analysts.
