L-2003-234

NRC Bulletin 2003-02
Leakage From Reactor Pressure Vessel Lower Head Penetrations
And Reactor Coolant Pressure Boundary Integrity

Turkey Point Plant Units 3 and 4 Response NRC Bulletin 2003-02

Seabrook Station Response NRC Bulletin 2003-02

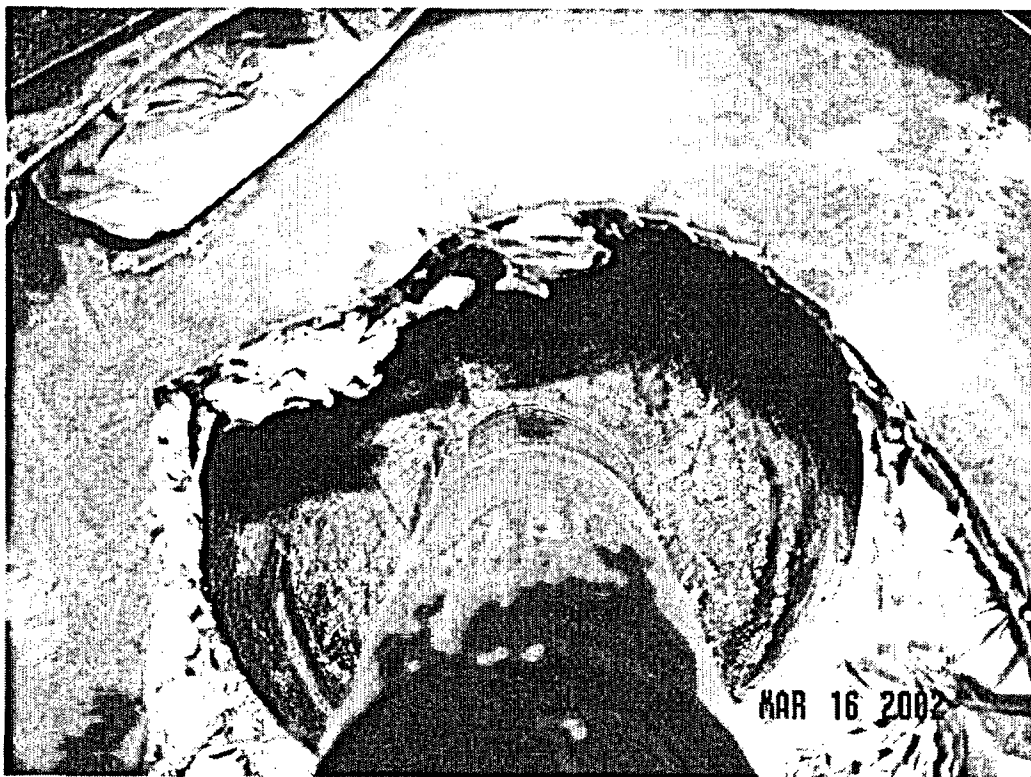
pressure tests and boric acid program walkdowns have never identified any BMI leakage. However, minor discoloration was noted at the last Turkey Point Unit 3 RFO that was dispositioned as cavity seal ring leakage as discussed below:

During the Turkey Point Unit 3 spring 2003 RFO, the leak inspection walkdown of the BMIs revealed a minor discoloration on BMI # 35. A condition report was written as required by our corrective action program. As part of the disposition, insulation cover plates were removed around BMI penetration # 35 to reveal the interface where the nozzle enters the reactor vessel lower head. A direct visual examination was performed by a qualified VT-2 examiner and documented as part of the corrective action program. Digital images of the examination area were also recorded as shown in the figure below. The stain on both the nozzle and the RV surface was described as a dry rust film of no discernible thickness. The stain trail was observed coming from above this outer periphery nozzle (#35) on the vessel surface. No white boron deposits or accumulation was noted on the vessel surface or around the circumference of the nozzle as it penetrated the RV surface (see figure below). The source of the rust stain on the RV lower head surface and BMI penetration #35 was determined to be coming from above, most likely cavity seal ring leakage during refueling and not relevant as a BMI leak since there is no heat source to concentrate boric acid. Similar staining was also noted on the RV cavity walls below the refueling cavity seal ring. A smear sample was taken of the rust stain to analyze the activation products to determine the age of the stain/leak source. However, due to the stain having no discernable thickness (small sample size) the results were inconclusive.

Figure 1: Turkey Point Unit 3 BMI penetration # 35 at the vessel interface during 2003 RFO. Note clean insulation surrounding the penetration and no boron deposits or accumulation.
