Subject: Inspection of Embedded Flaw Repair of a J-groove Weld

WDL-TJ-013-03 Rev. 1

NDE Process for CRDM Embedded Flaw Repairs

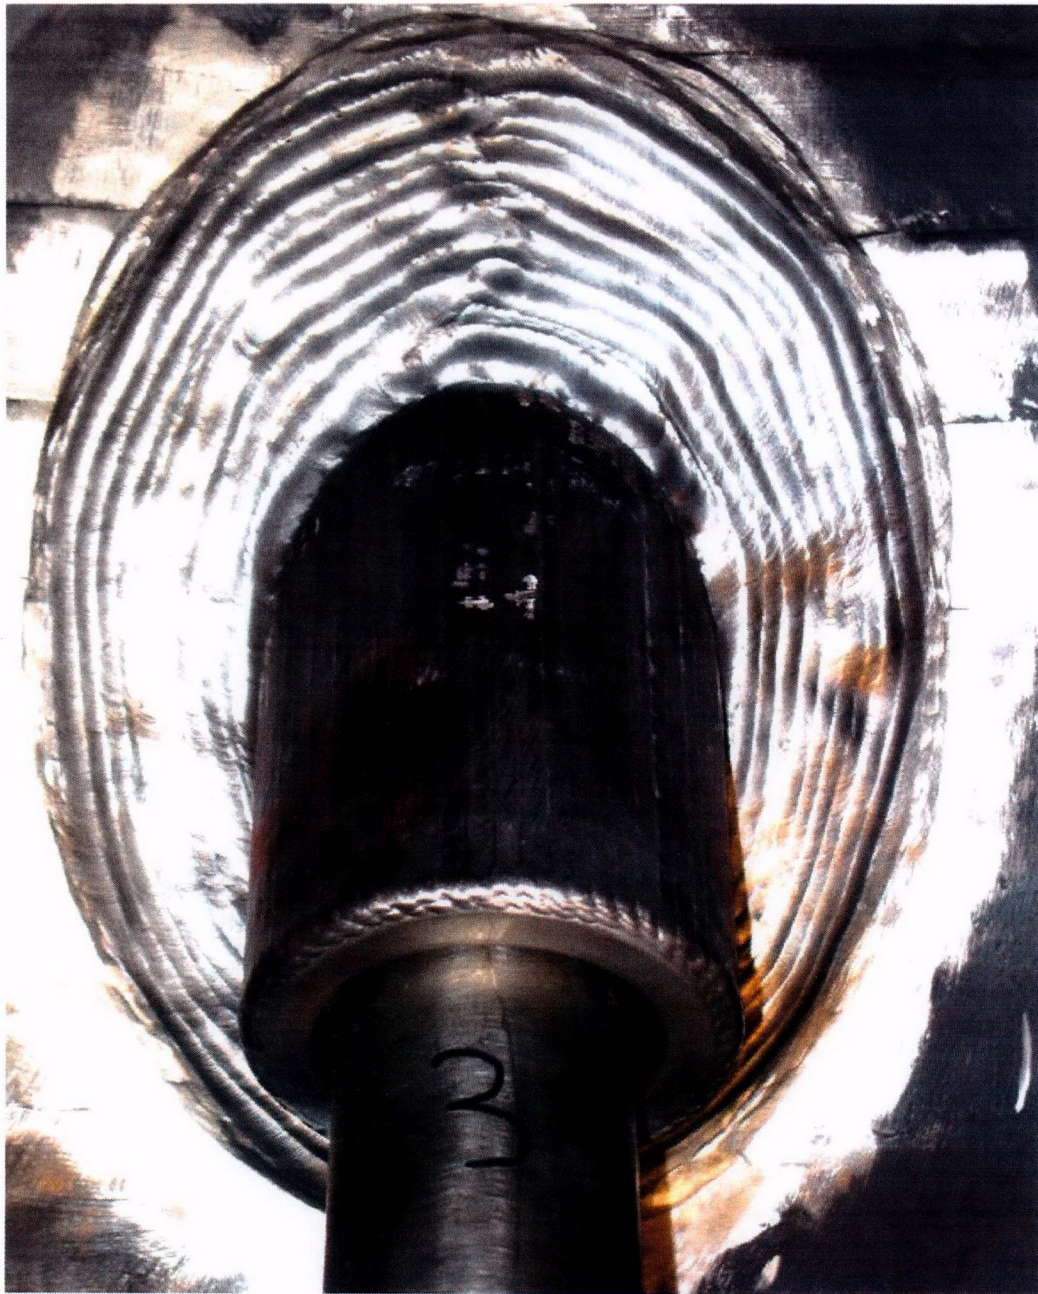
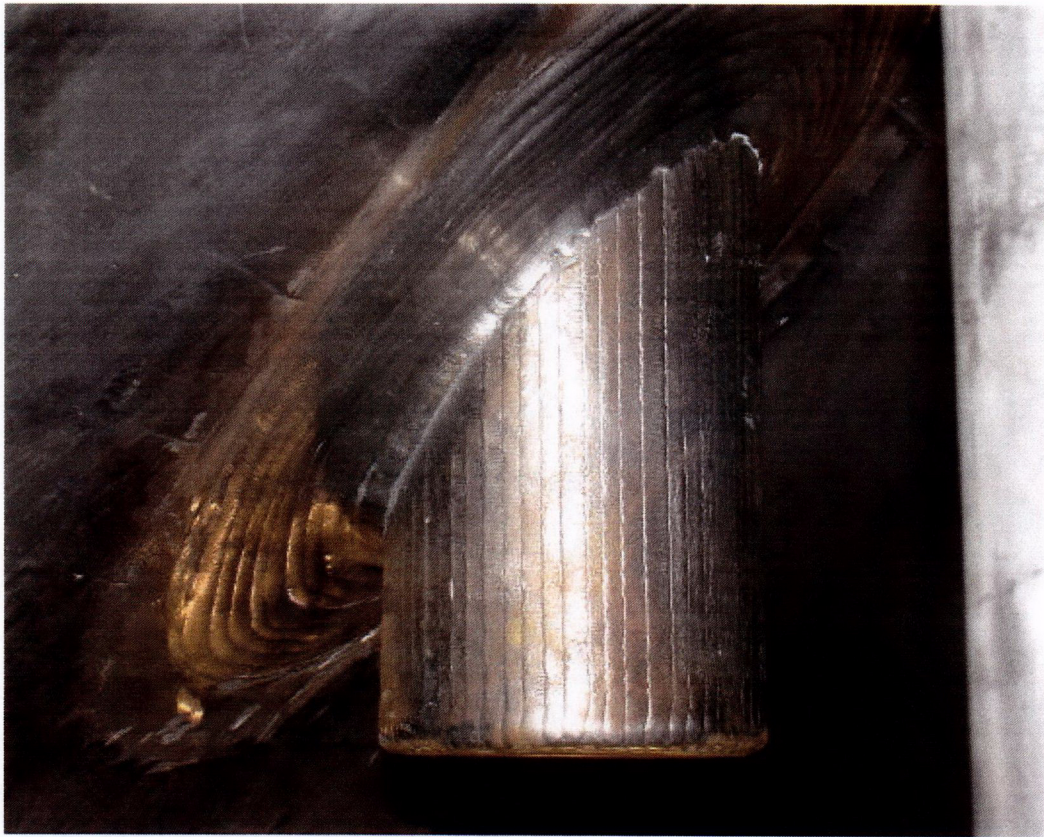
Figures 1 and 2 show the typical resultant surface condition obtained from the automated welding process of the embedded flaw repair. These photographs are from practice repair overlays that were performed on a spare reactor vessel head (Jamesport vessel) located in the Westinghouse Waltz Mill facility. They show the overlay repair as applied over the J-groove weld and over a part of the adjacent penetration nozzle OD surface.

The surface is very rough and it consists of a series of 'hills and valleys'. Machining to eliminate the surface roughness has been considered impractical given the dose rates under the head, the access restrictions, the time constraints, and the irregular geometry about the penetration nozzle. This roughness, however, does not impair the primary role of the weld repair, which is to isolate any cracks from the environment.

Figure 1: Weld Overlay Repair on J-Groove Weld and Nozzle OD in the Jamesport Head Depicting the Rough As Welded Surface Condition over the J-Groove Weld

Figure 2: Weld Overlay Repair on another J-Groove Weld and Nozzle OD in the Jamesport Head Depicting the Rough As Welded Surface Condition over the J Groove Weld

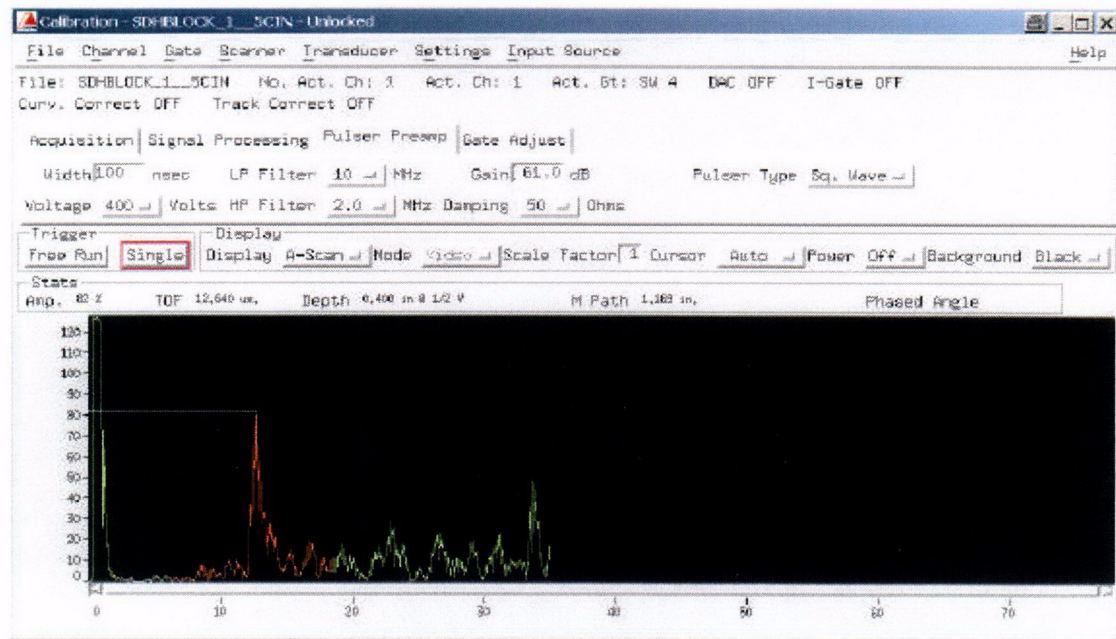
For the investigation on the weld overlays, the UT system was calibrated using a 1/32" diameter side-drilled hole at 0.4" below the surface in a smooth-surfaced IIW block. This reflector is at approximately 25% of the J-groove weld thickness; the calibrated A-scan display is shown in Figure 3 with the side-drilled response at 82% FSH. The signal-to-noise ratio is about 9:1. The probe was then manipulated manually on various J-groove weld surfaces in the Jamesport head using a scanning sensitivity +6dB above the calibration gain.

Figure 3: Calibration Response for the 2.25 MHz, Dual Element 70-degree Refracted Longitudinal Wave Transducer (1/32" diameter side drilled hole set to 82% FSH response)

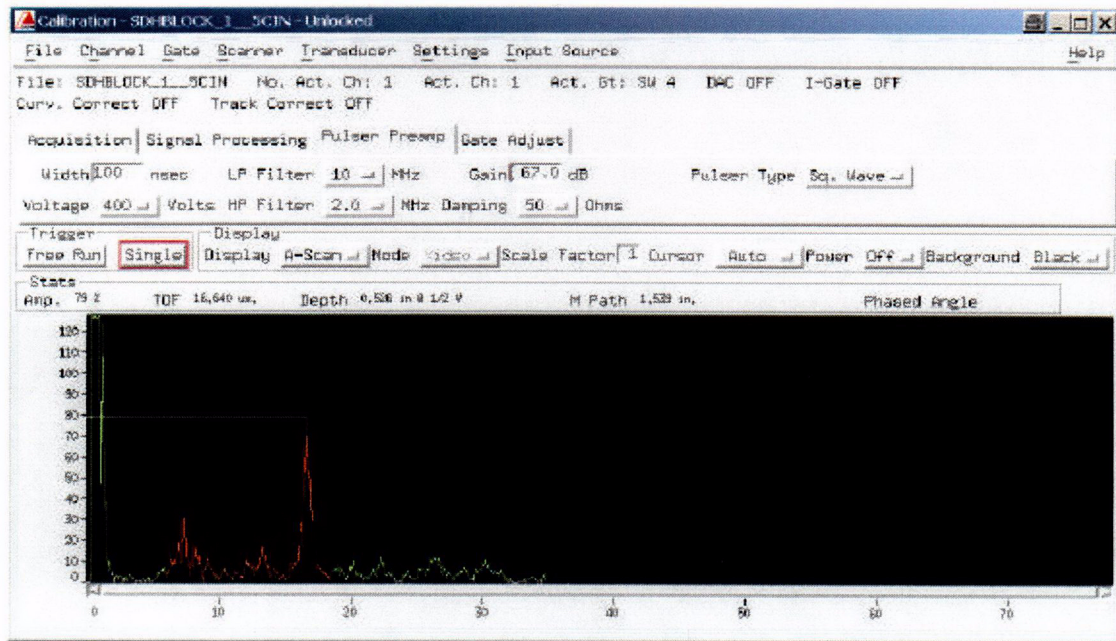
Figure 4 shows results from a non-repaired J-groove weld inspection which indicates the presence of a distinct 79% response that would be comparable to a 40% response at the calibration gain (note that the instrument gain is at +6 dB above the calibration gain). This signal could be associated with metallurgical reflector or a weld discontinuity. Such signals are to be expected in the coarse dendritic grain structure of the weld and from welds that were inspected in fabrication using ASME Code Section III criteria (PT at defined intervals). If the region were examined after the weld overlay repair and such a signal was observed it may have to be incorrectly interpreted as emanating from PWSCC or a flaw initiated as a result of the repair process. This misinterpretation would result in unnecessary repairs (which could only be done manually) and an increased dose exposure to repair personnel.

Figure 4: Axial Scan Results from a Non-Repaired J-Groove Weld Depicting Distinct Reflector in the Weld (79% FSH response, approx. 40% FSH response at calibration gain)

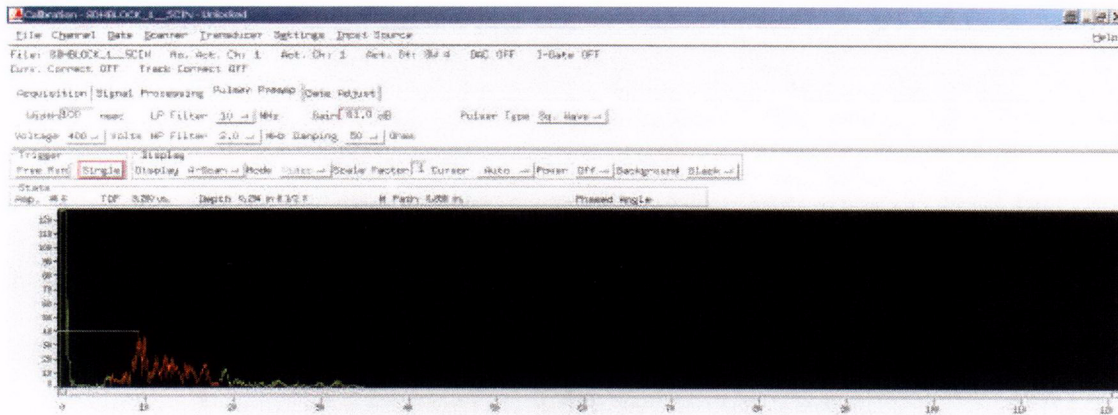
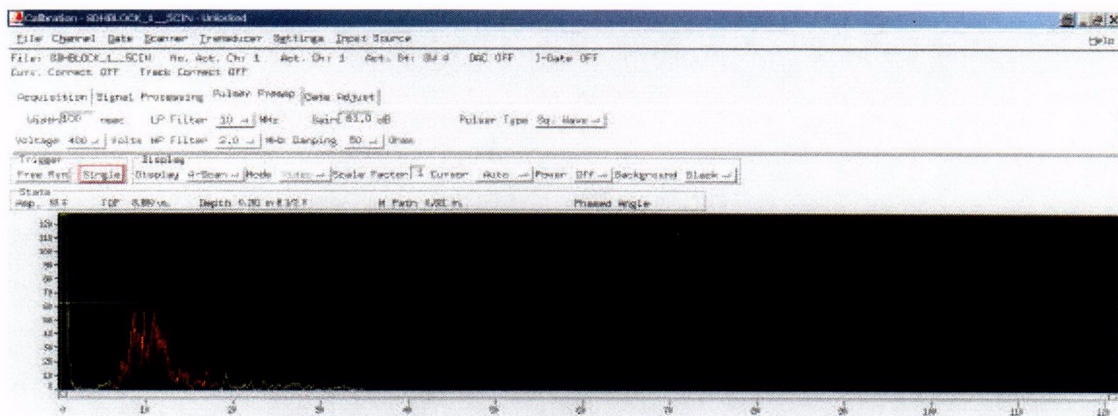
Figures 5 and 6 depict representative results from scans (axial and circumferential, respectively) on overlay repairs covering the J-groove weld. In these examples, the noise associated with the rough surface ranges from 40% to 63% at the calibration gain level. Such responses could mask signals from planar flaws.

Figure 5: Axial Scan on a Weld Overlay Surface Depicting the High Noise Background from the Irregular Surface (background noise from the irregular coupling surface is nominally 50% of the calibration response)

Figure 6: Circumferential Scan On a Weld Overlay Surface Depicting High Noise Level from the Irregular Surface (background noise from the irregular coupling surface exceeds 50% of calibration response)

Thus the use of ultrasonic inspection techniques for the J-groove weld overlay repair process is considered not practical for the following reasons:

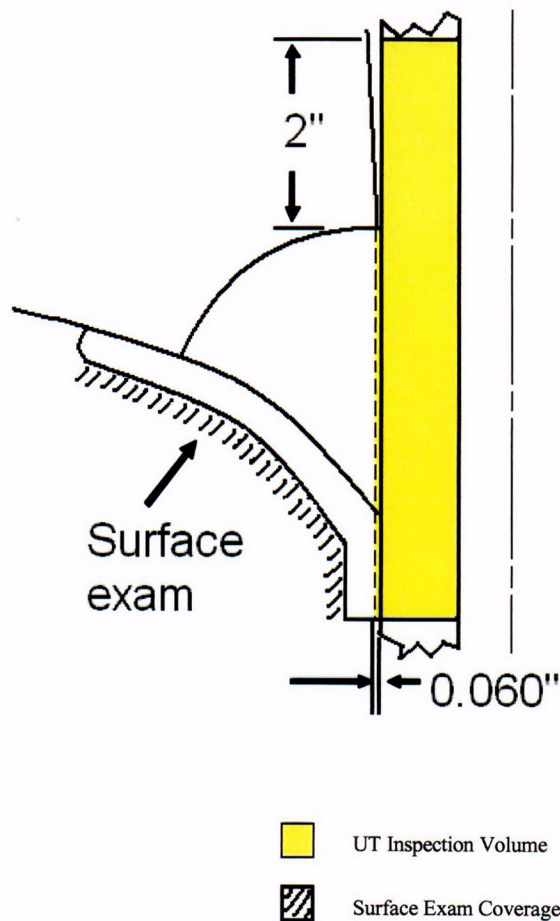
Figure 7: NDE Examinations and Coverage Associated with the J-Groove Weld and Adjacent Penetration Outside Diameter Surface Embedded Flaw Repair

Given these limitations to the use of ultrasonic inspection techniques on the weld overlay surface, the following nondestructive test methods are to be implemented for the embedded flaw repair on J-groove welds (Figure 7):

- Surface examination (PT) of the weld overlay surface consistent with ASME Code requirements.
- Ultrasonic examination (UT) from the penetration nozzle inside diameter surface using techniques demonstrated to the MRP. Such techniques would examine the volume of the penetration plus 0.06" inside the J-groove weld adjacent to the penetration for flaw growth and leak paths.

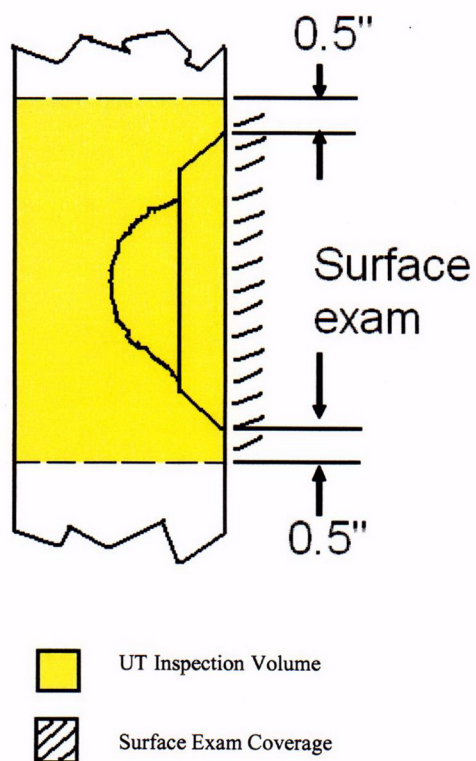
Figure 8: NDE Examinations and Coverage Associated with Penetration Inside Diameter Surface and Penetration Outside Diameter Surface Embedded Flaw Repair (surface examination is PT for OD repair and ET for ID repair)

The inspection coverage for the penetration ID and OD surface embedded flaw weld repairs is shown in Figure 8.
