Palo Verde Nuclear
Generating Station

Subject: Palo Verde Nuclear Generating Station (PVNGS)
Unit 3
Docket No. STN 50-530
Special Report 3-SR-2003-004
Report of Boron Deposit at Control Element Drive Mechanism
Vents

Attachment
Palo Verde Nuclear Generating Station Unit 3
Special Report No. 3-SR-2003-004
Boron Deposit Found at Control Element Drive Mechanism Vent
Docket No. STN 50-530

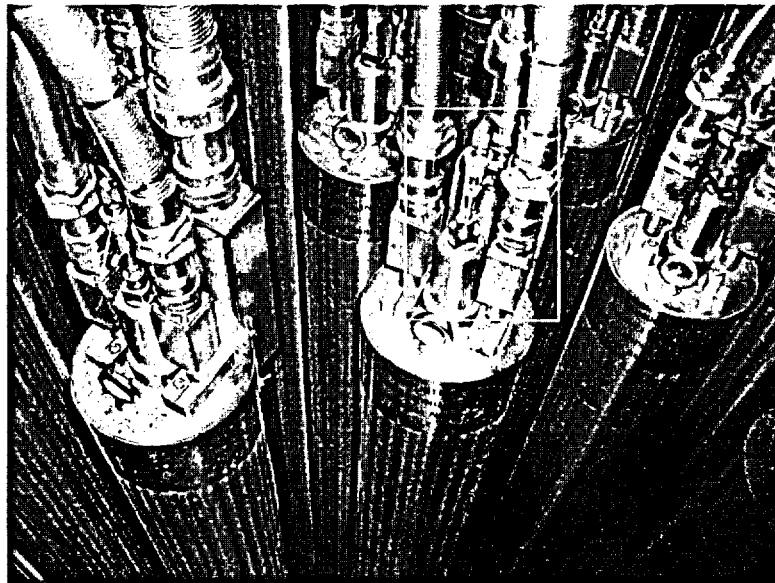
(CEDM Vent 73 As-Left Condition)

Versa-Vents for CEDMs 51 and 73 were cleaned and reworked during the outage following the Unit 3 trip.

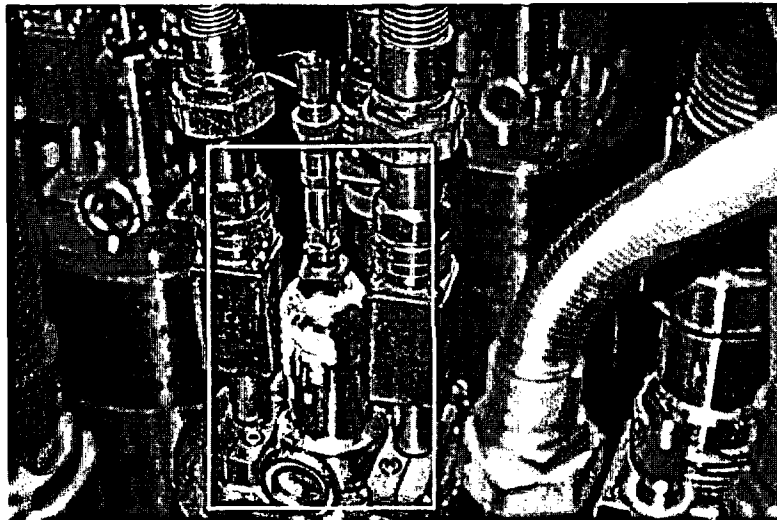
During boric acid walk-downs on July 29, 2003, two Unit 3 boric acid residue sites were identified above the RPV head. The sites were located on the Versa-Vents for control element drive mechanisms (CEDM) nos. 51 and 73. These sites exhibited no evidence of being active leaks and the boric acid residue did not contact the RPV head or related insulation. The source of the boric acid residue was most likely the vent ball / seating surface interface of the Versa-Vents.

(CEDM Vent 51 As-Found Condition)

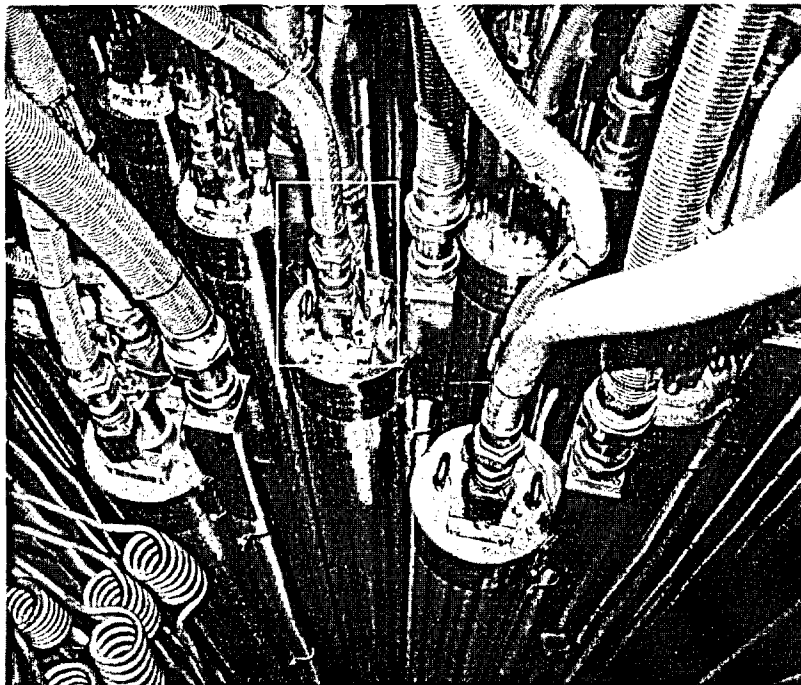
(CEDM Vent 51 As-Left Condition)
