**Pacific Gas and
Electric Company**

PG&E Letter DCL-03-125

Docket No. 50-275, OL-DPR-80
Docket No. 50-323, OL-DPR-82
Diablo Canyon Units 1 and 2
Licensee Event Report 2-2003-007-01
Technical Specification 3.8.4 Violation Due To Common Mode Battery
Charger Failures

LICENSEE EVENT REPORT (LER)

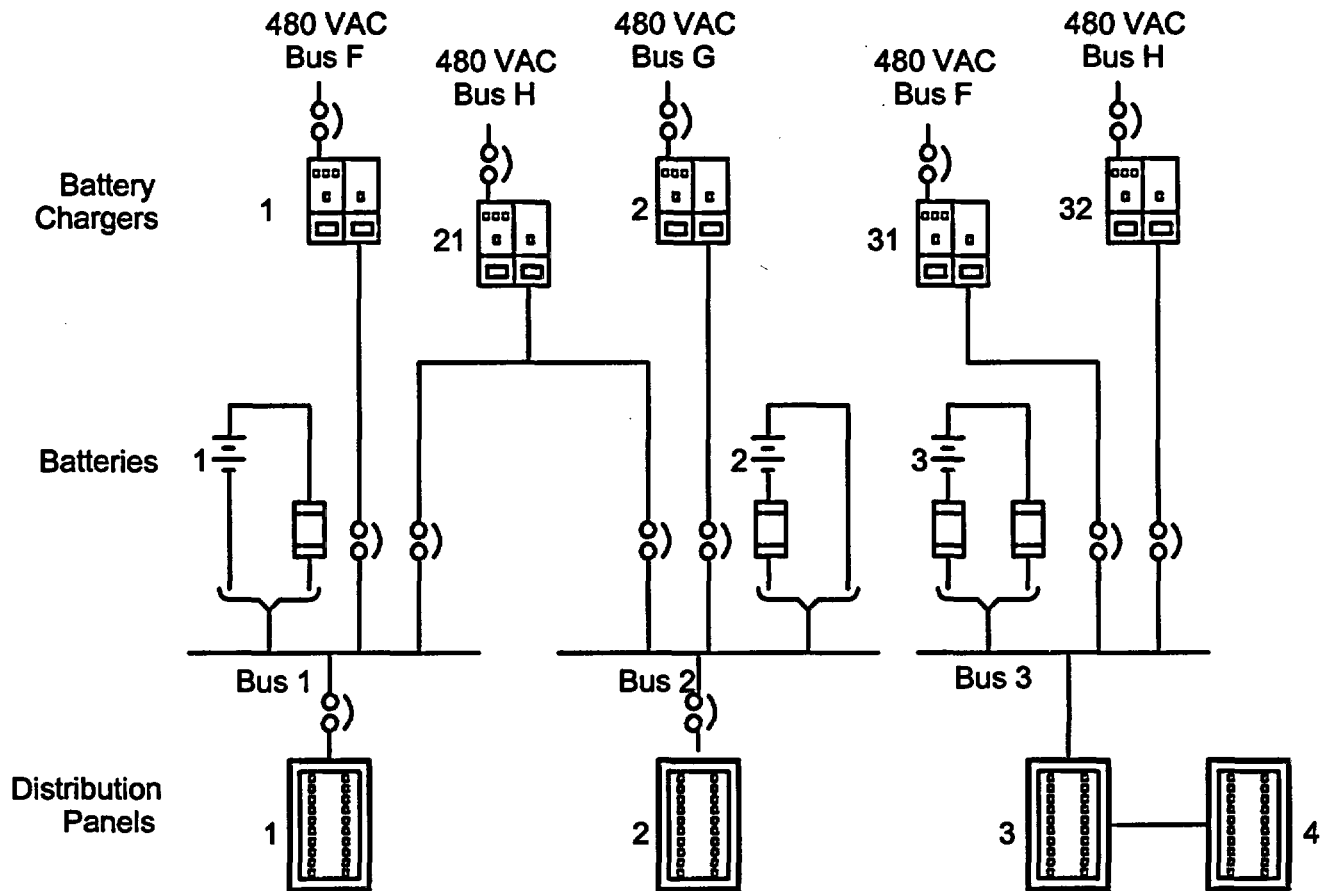
Figure 1 – Single Line Diagram of the 125 Volt DC Vital Power Supply System

Each Diablo Canyon Power Plant (DCPP) Unit has three 60-cell, 125 Volt DC (VDC) vital batteries and 5 full capacity battery chargers (BTCs)[BYC]. Each of the three vital 125 VDC busses has a dedicated battery and charger. The design of the vital 125 VDC system is such that a battery may be supplied by two full capacity chargers: one supplied from its associated 480 volt alternating current (480 VAC) vital bus, or an alternate charger supplied by another 480 VAC vital bus. The first additional charger can be switched to either of two of the batteries. The second charger is a dedicated backup charger for the third vital battery. See Figure 1 – "Single Line Diagram of the 125 Volt DC Vital Power Supply System."
