**TENNESSEE VALLEY AUTHORITY - BROWNS FERRY NUCLEAR PLANT (BFN) -
UNIT 2 - DOCKET 50-260 - FACILITY OPERATING LICENSE DPR - 52 -
LICENSEE EVENT REPORT (LER) 50-260/2003-005-00**

1. FACILITY NAME Browns Ferry Nuclear Plant Unit 2						2. DOCKET NUMBER 05000260			3. PAGE 1 OF 7			
4. TITLE Unplanned Start of DG A and DG B from Momentary Board Undervoltage

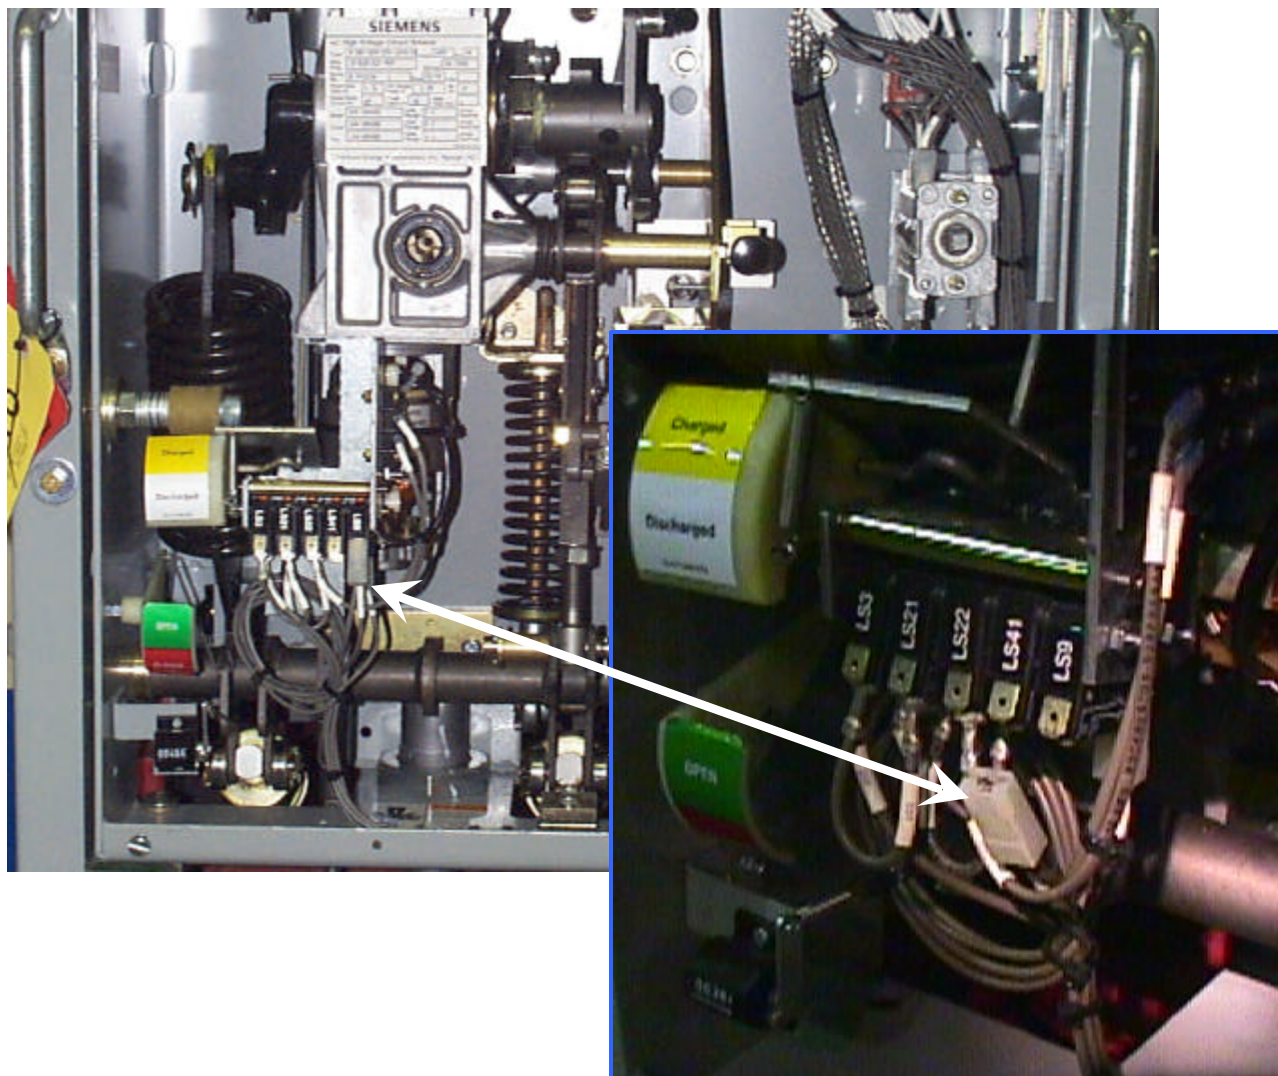
1. The connection at switch 52 SMLS, LS-9, internal to breaker 1622 came loose. This breaker is a Siemens model 5-3AF.

Post-event troubleshooting identified that a connector internal to breaker 1622 had come off its termination point (see section VII.A below for additional details on this component). On these type Siemens breakers, the amber light on the breaker front panel is used to indicate that the breaker closing spring is properly charged, but this open connection in the breaker internal electrical circuitry prevented it from illuminating. The extinguished amber light on breaker 1622 had been identified by plant staff, and an open work document existed to address it. It had not been recognized, however, that this same open connection also prevented current flow through the breaker closing coil, thus preventing closure of the breaker.

Shutdown Bus 1 alternate supply breaker 1622 is a Siemens model 5-3AF. In the larger picture below, a Siemens breaker identical to 1622 is shown. The inset picture shows the as-found condition of breaker 1622 when it was inspected following this event. The white arrow points to the example of the properly connected lug in the larger picture and to the same lug, found disconnected from LS-9, on breaker 1622 during post-event troubleshooting. Breaker 1622 was initially placed in service at BFN in March 1999.

1. The vendor has been notified of the condition and will be consulted for possible actions to be taken to improve the reliability of the SMLS terminal connections.
2. All plant 4 kV boards were walked down to verify that the amber light was illuminated on all breakers racked into the connect position.
3. Applicable Operations and Electrical Maintenance procedures and training materials will be revised to address the relationship between the amber light circuit current path and the breaker closing coil circuit current path.
