South Texas Project Electric Generating Station P.O. Box 289 Wadsworth, Texas 77483

October 15, 2003  
NOC-AE-03001610  
10CFR50.73

South Texas Project  
Unit 1  
Docket Nos. STN 50-498, STN 50-499  
Supplement to Licensee Event Report 03-003  
Bottom Mounted Instrumentation Penetration Indications

Bottom Mounted Instrumentation Penetrations Indications – Supplement to LER dated 6/11/2003

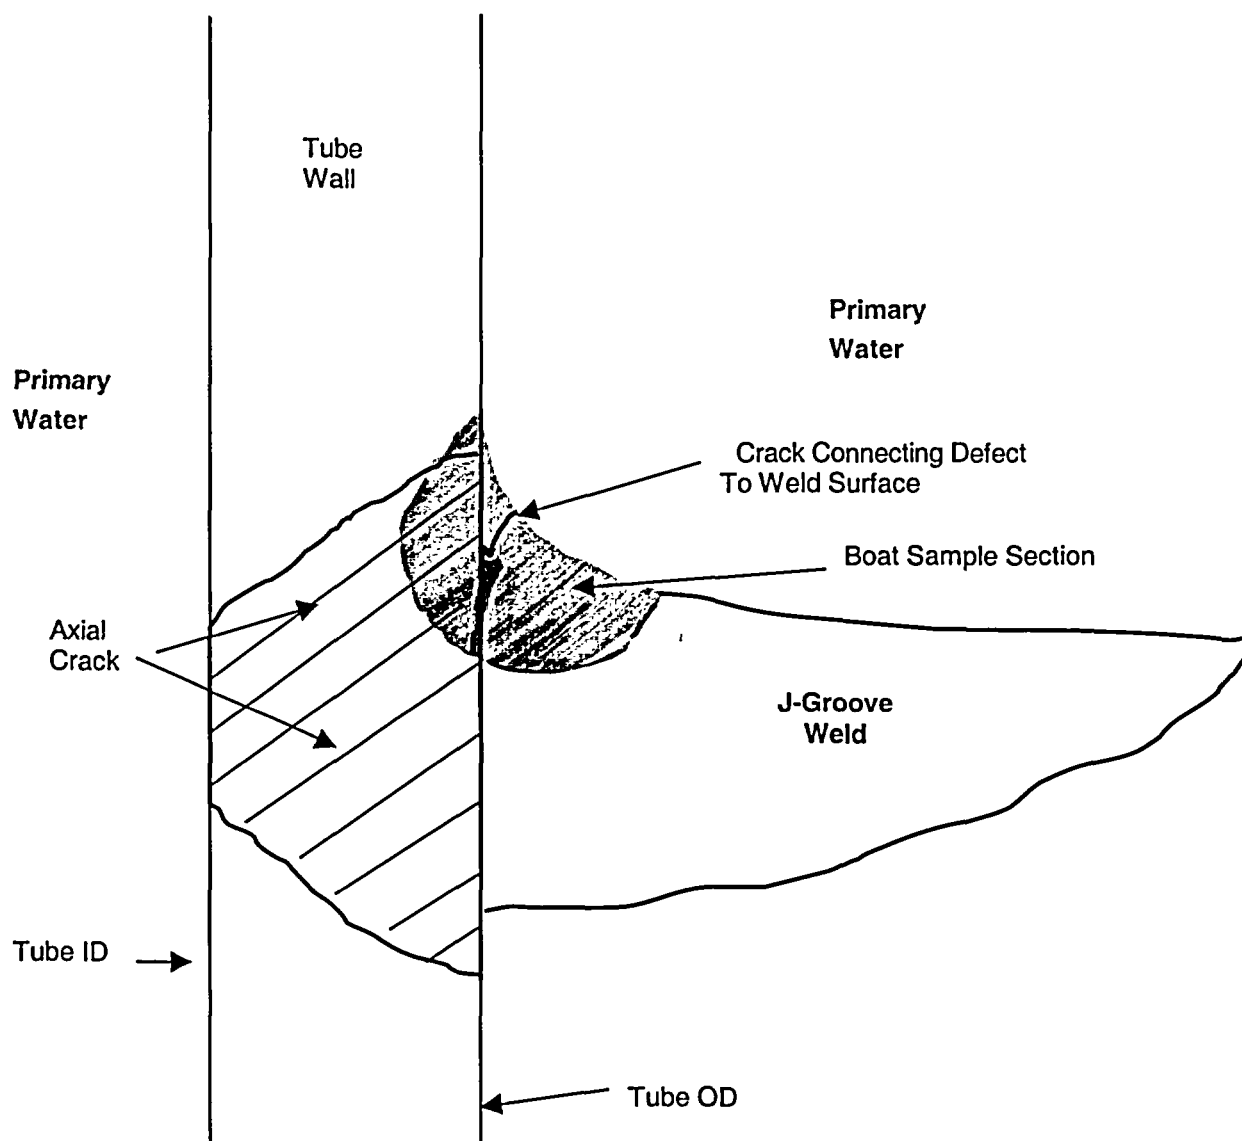
## Composite Drawing Showing Axial Crack, Weld Flaw, and Weld Crack

The boat sample from Penetration #46 was designed to capture as much tube material as possible in an attempt to harvest a portion of a crack not connected to the ID of the nozzle. The margins for error associated with positioning the EDM equipment through 70 feet of water resulted in a shallow cut in Penetration #46. The resulting undersized sample was either inadvertently discarded or completely consumed in the margins of the EDM cutting tool. The boat sample from Penetration #1 captured material and defects from the J-groove weld and J-groove/tube interface, as designed. A composite drawing showing the axial crack, weld flaw and weld crack is attached.

The boat sample from Penetration #1 contained a portion of the large through-wall axial crack in the tube, three "discontinuities" which were confirmed to be lack of fusion resulting from slag inclusions, and one crack at the helium bubble location which connects the surface of the J-groove weld to the largest area of lack of fusion.

The crack in the weld that connects the surface of the J-groove weld to the largest area of lack of fusion is singular and unique. The 0.2-inch long crack spans an 80 mil ligament separating the lack of fusion void from the surface of the J-groove weld in the ground fillet transition at the tube/J-groove weld interface. The length of the crack spans and is limited to the width of the lack of fusion void. The section of the boat sample containing this crack was broken in the laboratory to expose the crack face for examination. Tenacious deposits obscured the crack face, and gradually more aggressive attempts to remove the deposits also attacked and distressed the metal surface. The crack exhibits some intergranular characteristics. To some reviewers, the nature of the oxide deposits suggests hot cracking. Fatigue could also be a factor in the development of this crack. However, the precise mechanism responsible for initiating and propagating this crack could not be determined.

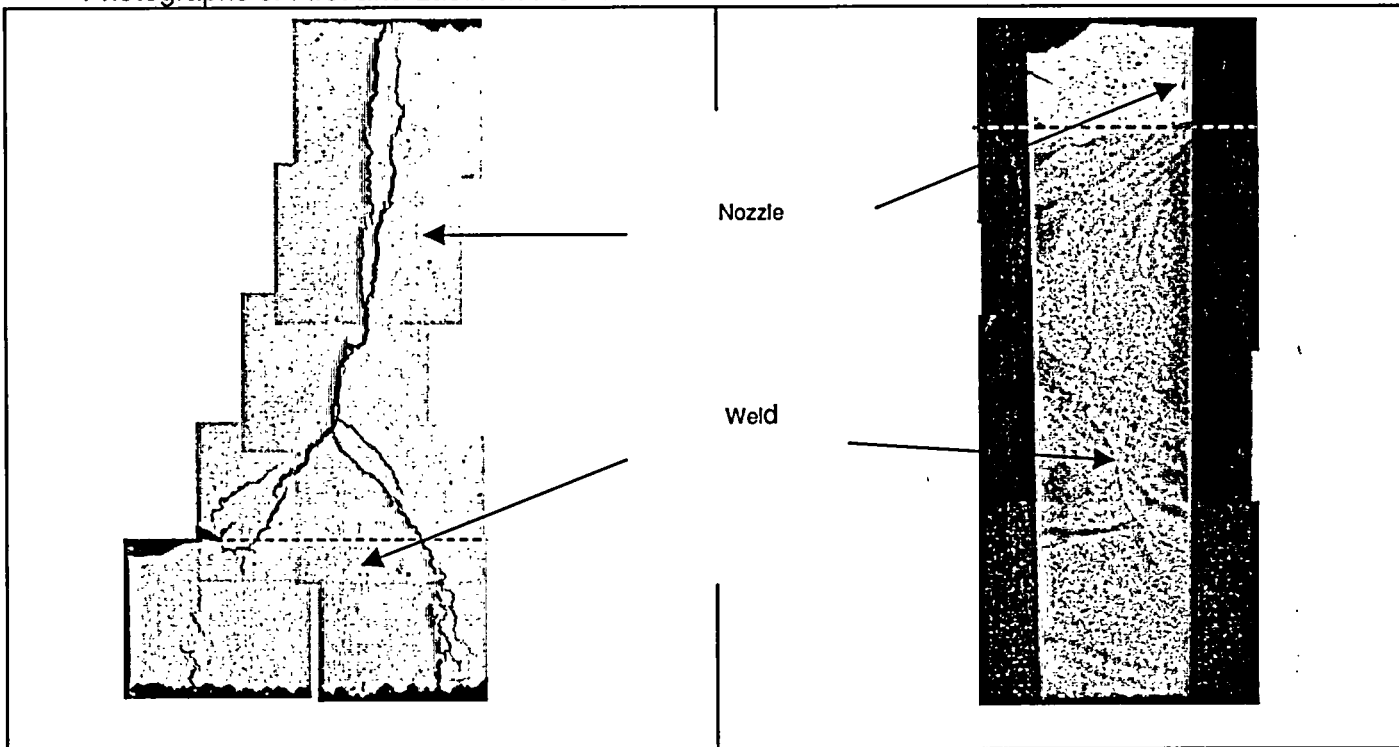
Photographs of First and Last Face Grind

Earlier UT results identified an axial crack in Penetration #1 which penetrated the ID of the nozzle and extended from just above to just below the J-groove weld. The boat sample from Penetration #1 successfully captured a part of the upper portion of this crack in the region of the tube/J-groove weld interface. The intergranular nature of this crack exhibits classic primary water stress corrosion cracking (PWSCC) characteristics. The extent of the crack was examined by progressively grinding away thin layers of the section of the boat sample. The orientation of the ground surface was such that more weld material and less

tube material was exposed at each successive grind. The initial exposed surface consisting of nearly all tube material contains a crack that extends into the weld material then stops. As successive layers are ground away, exposing more weld and less tube, the extent of the crack becomes smaller and smaller. The final ground surface, which consists almost entirely of weld material, reveals no crack at all in the weld and a small vestige of crack in the remaining small bit of tube. Photographs of the grinds of the first face and the last face are attached.

The axial crack in the tube appears to grow from the EDM surface out to the tube/J-groove interface since it branches and connects two of the three voids, at least at this location in the boat sample. This fact might suggest ID initiated PWSCC. However, neither of the two cracks in Penetration #46, the other leaking BMI penetration, connects to the ID of the tube. A supplemental ET examination of the ID surface was performed specifically to confirm the UT results that the flaws did not penetrate the ID. ET established that the cracks did not connect to the ID. Based on this fact STPNOC has concluded that the PWSCC axial crack in the tube is OD initiated. The crack most likely originated on the OD of the tube in the highly stressed region of the flooded weld defects.

The boat sample also contained numerous small cracks around the periphery of the LOF flaws to a depth of 1 or 2 grains. Although hot cracking in the weld material is a possibility, this intergranular cracking also appears in the nozzle, where hot cracking is not possible. Therefore, STPNOC has concluded that this cracking is PWSCC resulting from flooding of the LOF voids.
