W3F1-2003-0083

Subject: Waterford 3 SES  
Docket No. 50-382  
License No. NPF-38  
Reporting of Licensee Event Report (LER 2003-001-00)

<b>1. FACILITY NAME</b> <b>Waterford Steam Electric Station, Unit 3</b>				<b>2. DOCKET NUMBER</b> <b>05000 382</b>		<b>3. PAGE</b> <b>1 OF 5</b>			
<b>4. TITLE</b> <b>Loose Breaker Fuse Rendered One Bank of Pressurizer Proportional Heaters Inoperable</b>									
<b>5. EVENT DATE</b>			<b>6. LER NUMBER</b>			<b>7. REPORT DATE</b>		<b>8. OTHER FACILITIES INVOLVED</b>	
MO	DAY	YEAR	YEAR	SEQUENTIAL NUMBER	REV NO	MO	DAY	YEAR	FACILITY NAME
08	26	2003	2003	001	00	10	22	2003	N/A
								DOCKET NUMBER	
								N/A	
<b>9. OPERATING MODE</b>		<b>10. POWER LEVEL</b>		<b>11. THIS REPORT IS SUBMITTED PURSUANT TO THE REQUIREMENTS OF 10 CFR §: (Check all that apply)</b>					
1		100		20.2201(b)		20.2203(a)(3)(ii)		50.73(a)(2)(ii)(B)

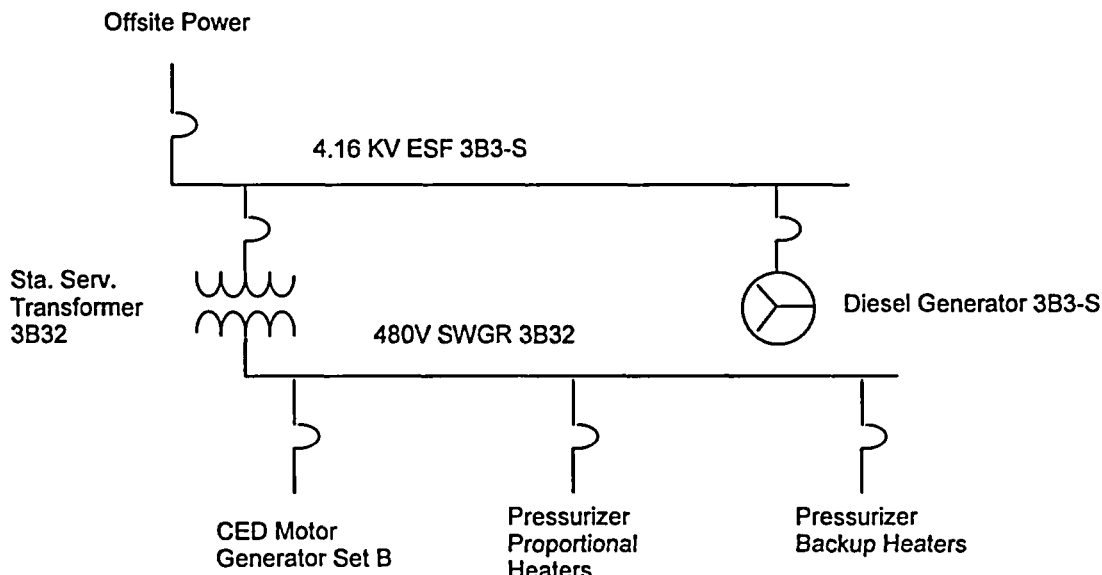
The pressurizer heater power supply design provides the capability to supply, from either the offsite power source or the emergency power source (when offsite power is not available), two groups of pressurizer proportional heaters and associated controls necessary to establish and maintain natural circulation at hot standby conditions. The two groups of proportional heaters, along with other loads, are powered from the 480 volt non-safety switchgear buses 3A32 and 3B32 [EC]. These non-safety related buses are fed from the Class 1E buses [ED] protected by safety grade circuit breakers [BKR]. Upon loss of offsite power, the safety related Class 1E feeder breakers providing power to these buses will trip. The Class 1E feeder breakers reclose on the diesel generator sequencer [JE] after 0.5 seconds as long as no Safety Injection Actuation Signal (SIAS) is present and all of the load breakers on the 3A32 or 3B32 bus are open. The diagram below shows the power supply arrangement:
