Re: Turkey Point Unit 4
Docket No. 50-251
Order (EA-03-009) Relaxation Request
Examination Coverage of Reactor Pressure Vessel Head
Penetration Nozzles

**TURKEY POINT UNIT 4 RELAXATION REQUEST
FROM US NRC Order EA-03-009**

**“Hardship or Unusual Difficulty without Compensating Increase in
Level of Quality or Safety”**

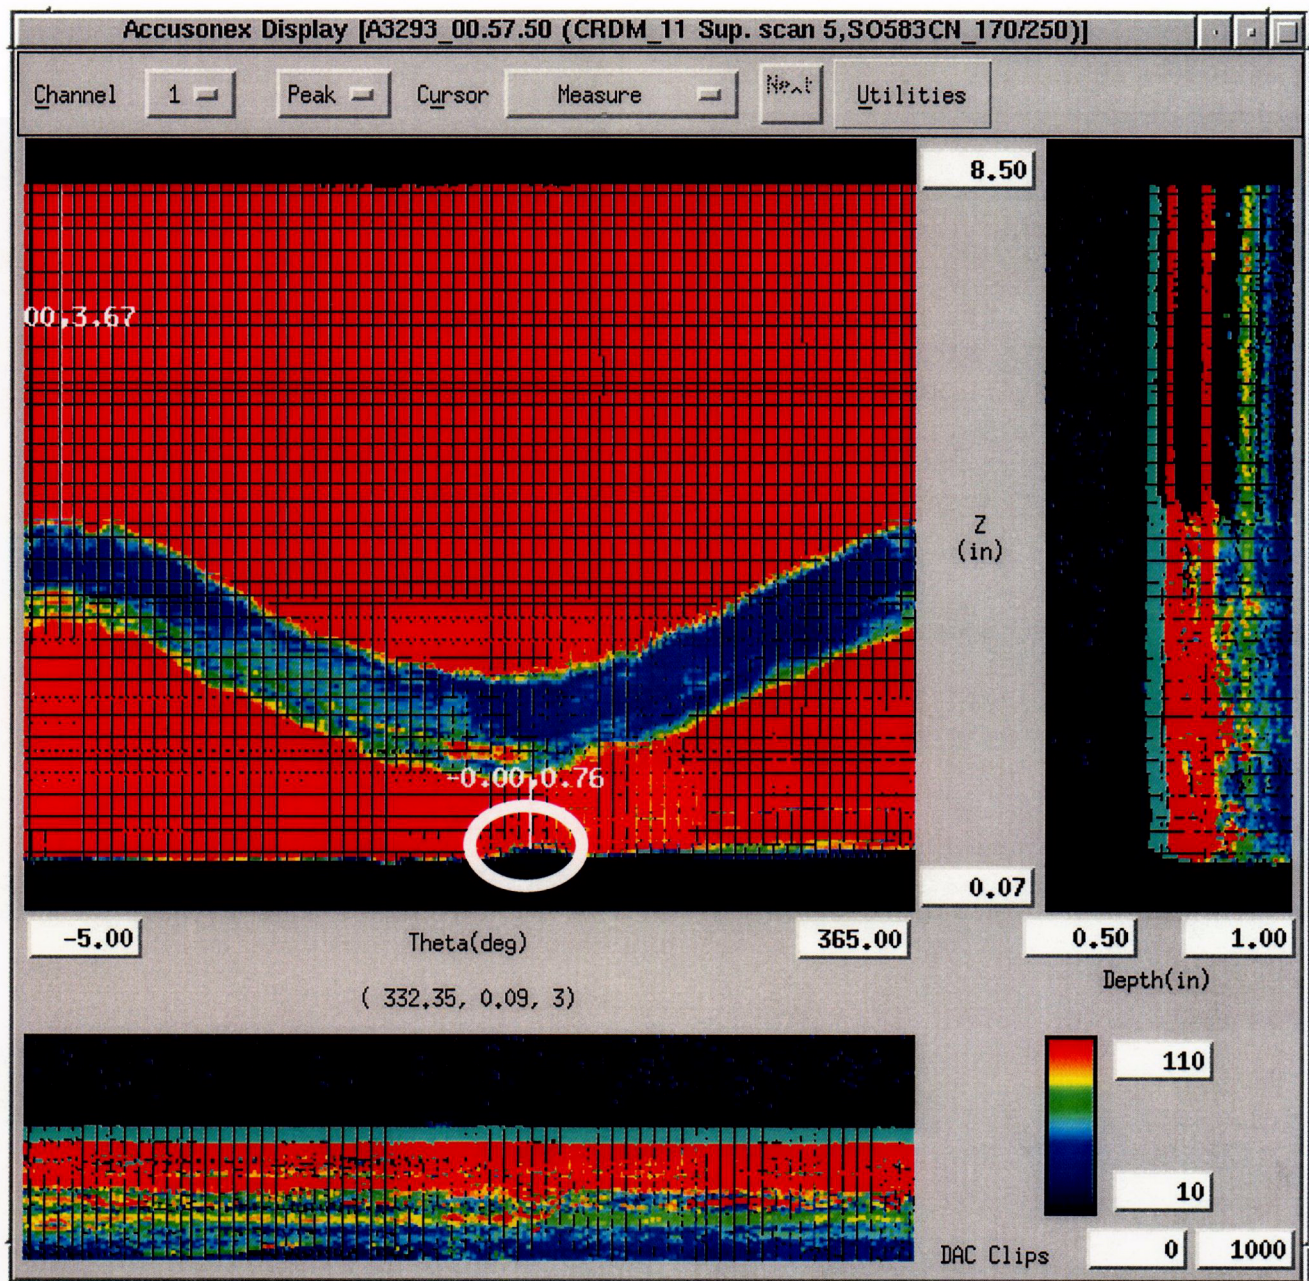
RPV head penetration # 11 contains an area of coverage less than that required by the NRC Order. The Order requires examination from 2 inches above the J-groove weld to the "bottom of the nozzle." The coverage below the weld, in the non-pressure boundary portion of the RPV head penetration nozzle, did not extend to the "bottom of the nozzle" for the full circumference. The actual area of missed coverage is a 32° arc, starting 0.76 inches below the bottom of the weld. A presentation of the UT coverage area, with the area of missed coverage identified, is shown in Figure 1.

inspected approximately 0.39 inches farther at the downhill location (half the distance of the transducer separation) in all blade probe inspections. This is due to the 50° angle of the UT signal and performance of the examination from the ID surface. Only in nozzle # 11 is the minimum distance below the weld a function of both UT probe design and the small region of missed coverage shown in Figure 1. However, the minimum distance below the weld for nozzle #11, identified in Table 1, is bounded by the minimum distance below the weld for other nozzles affected by the blade probe design issue. It is also noted that no recordable indications were identified in any of the UT examinations performed.

Figure 1: RPV Nozzle # 11 UT Inspection "C" Scan with area of missed coverage identified the white oval at the low point of the weld.

The proposed alternative is to perform the UT examination to the lowest elevation that can be practically inspected. This is defined as "the examination shall be performed to include 2 inches above the weld to the lowest elevation possible or ≥ 0.62 inches below the weld, whichever is greater." This relaxation request documents and submits to the NRC, deviations from the NRC Order required inspection coverage area along with a justification as to their acceptability.

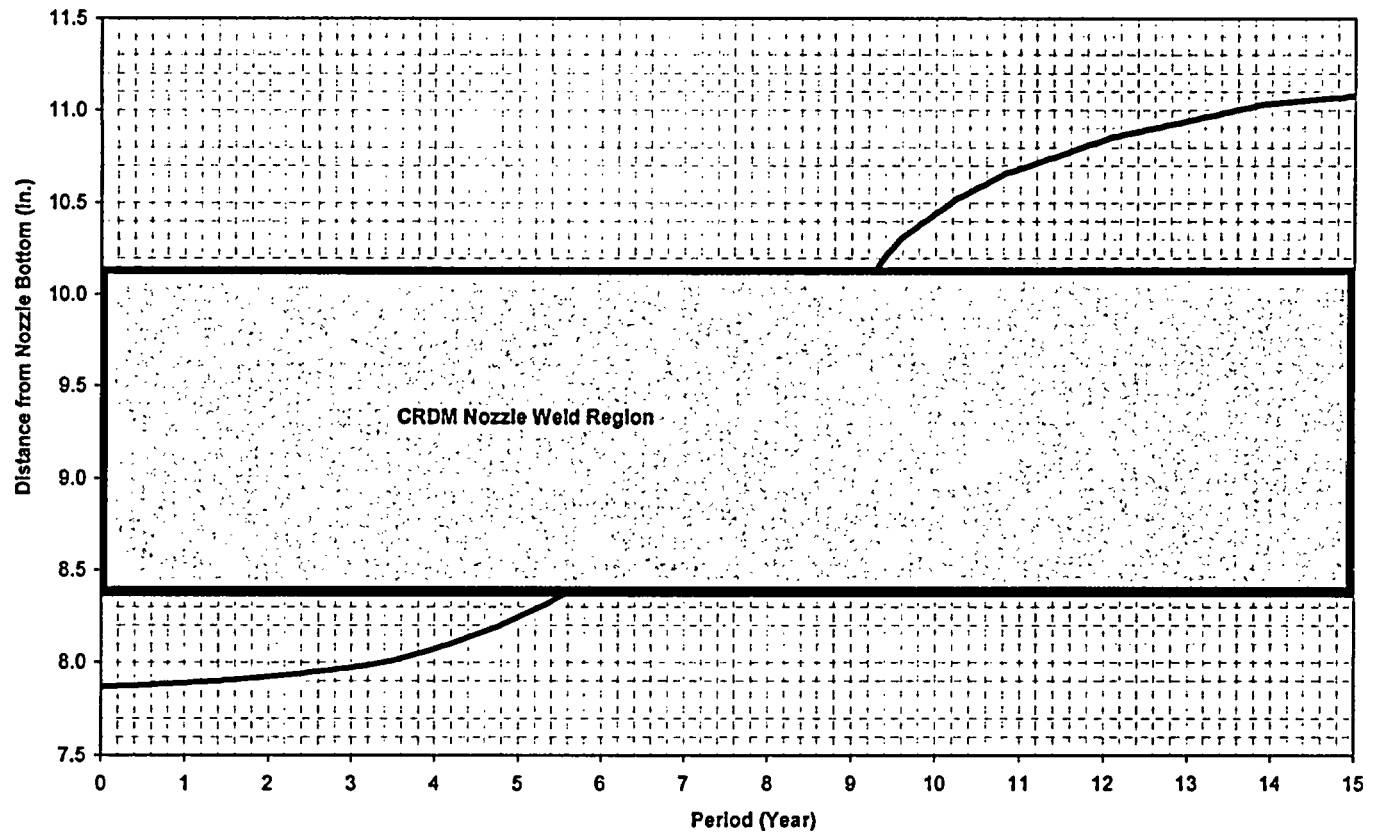
To determine the significance of an axial flaw that is contained in the non-pressure boundary nozzle material in the un-inspected region greater than 0.62 inches below the weld, a flaw tolerance approach is used. A flaw evaluation was performed postulating an axial flaw in the area of missed coverage below the weld using WCAP-16027-P.³ A through wall flaw is postulated in the nozzle material from the bottom of the penetration to 0.62 inches from the bottom of the weld. This is a conservative assumption since the inspected region extends 0.39 inches farther below the weld on the ID surface of the nozzle. The flaw evaluation in WCAP-16027-P is based on Turkey Point Unit 3 and 4 specific stresses in the nozzle penetrations. Since the stresses in the region greater than 0.62 inches below the weld are too low to propagate an axial flaw, the WCAP-16027-P flaw evaluations start at ½ inch below the weld, and evaluate the time to propagate the flaw in the nozzle to the bottom of the weld (start of the pressure boundary portion of the nozzle material or toe of the J-groove weld). Assuming a through wall flaw below the weld, with the flaw end located at ½ inch below the weld (which is in the area of complete UT examination coverage), an axial flaw would take greater than 5 years of operation (Figures 6-12 through 6-20 in WCAP-16027-P) in any nozzle location to grow to the point of contact with the weld. This time period is significantly greater than the current inspection frequency of every refueling cycle (18 months for Turkey Point Unit 4) identified in NRC Order EA-03-009. As an added conservatism, this evaluation does not attempt to evaluate the time for the axial flaw to grow from the bottom of the weld through the pressure boundary. Figure 2 provides a graphical presentation of the

above flaw evaluation discussion for the outer most penetration location (most limiting case).

Therefore, there are no concerns with the structural integrity of the Turkey Point Unit 4 RPV penetration nozzles that could be caused by axial cracking in the missed coverage areas in the non-pressure boundary portion of the nozzle material greater than 0.62 inches below the weld for a period of greater than 5 years of operation.

Figure 2: Through-Wall Axial Flaws Located in the 42.6 Degree Row of Penetrations, Uphill Side - Crack Growth Predictions (From Figure 6-19, WCAP-16027-P)
