FirstEnergy Nuclear Operating Company

Subject: Request for Additional Information Regarding the 2002 Steam Generator Tube
Inspections (TAC No. MB9541)

Request for Additional Information
Davis-Besse Nuclear Power Station 2002 Steam Generator Inspection
TAC No. MB9541

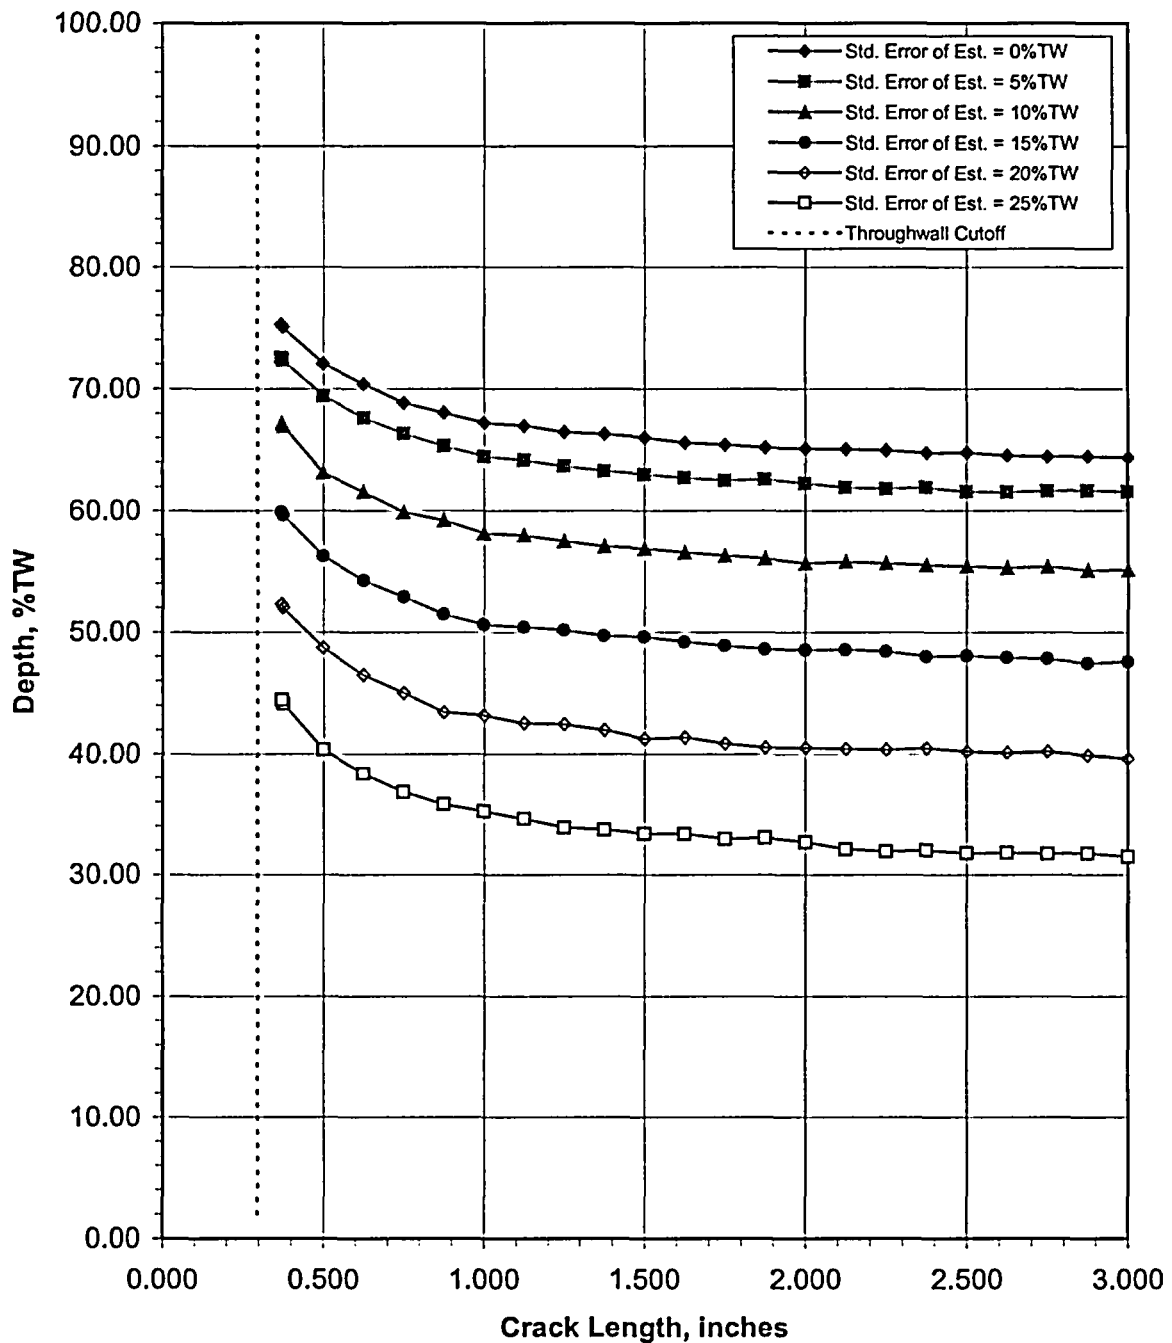
Axial Partial Throughwall OD Crack at 4050 psi

The plus point depths recorded in the indication list is a flaw maximum depth whereas the condition monitoring curves for in-situ screening are based on structural controlling depth which has been demonstrated to be approximately 0.8 times the maximum flaw depth. The following curve is from the in-situ selection criteria for partial wall penetration axial flaws. For ODIGA/SCC, the worst depth standard error of 25 % was used.

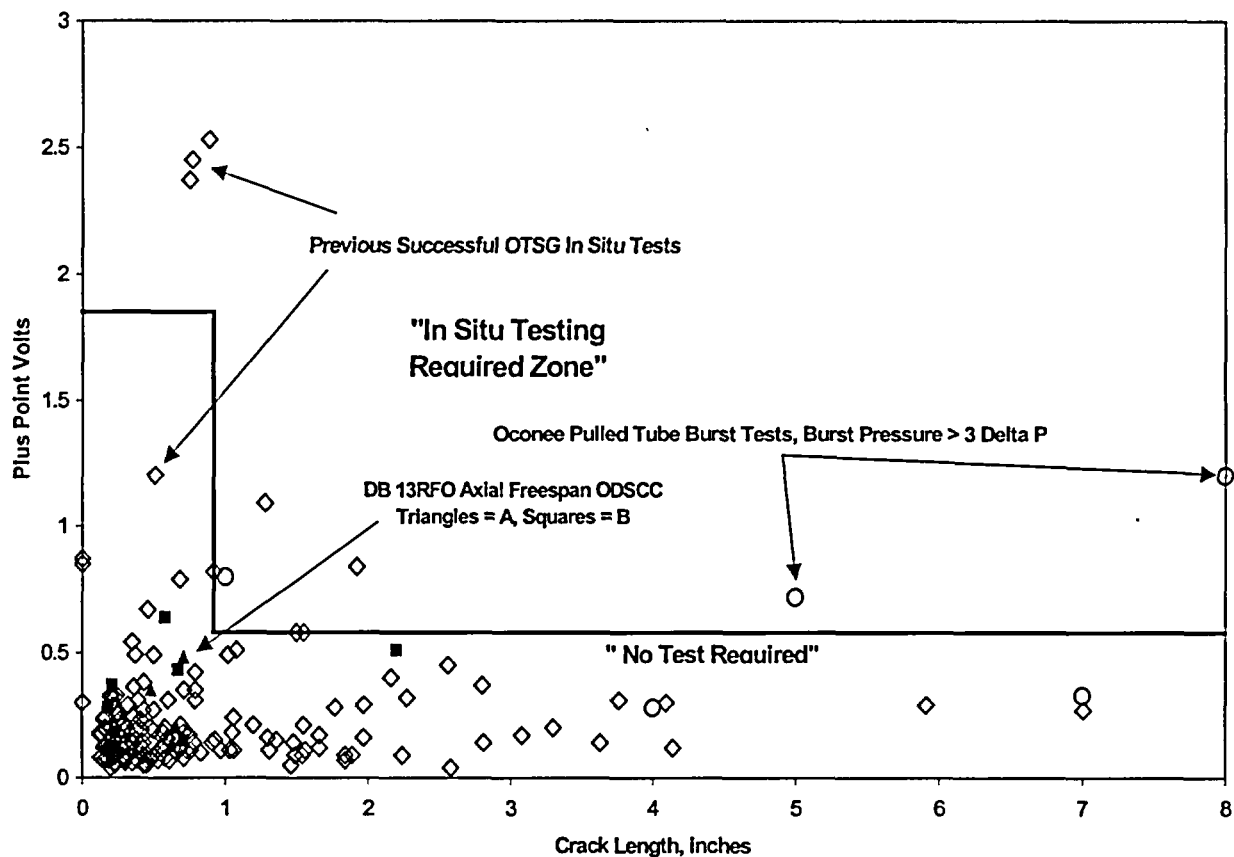
Plus point voltage screening was also used as a consideration for the in-situ selection based on historical in-situ and pulled tube burst results. The graph below compares plus point voltages and lengths of the freespan axial ODSCC degradation observed at the DBNPS with a database of previous successful in-situ tests for this type of degradation in other OTSG plants. By this measure it is seen that the severity of degradation at the DBNPS did not pose a threat to structural or leakage integrity. As a conservative measure, in-situ tests to the 3 delta-P limit with allowances for temperature differences and pressure gauge uncertainty were performed for 4 freespan axial ODSCC indications.

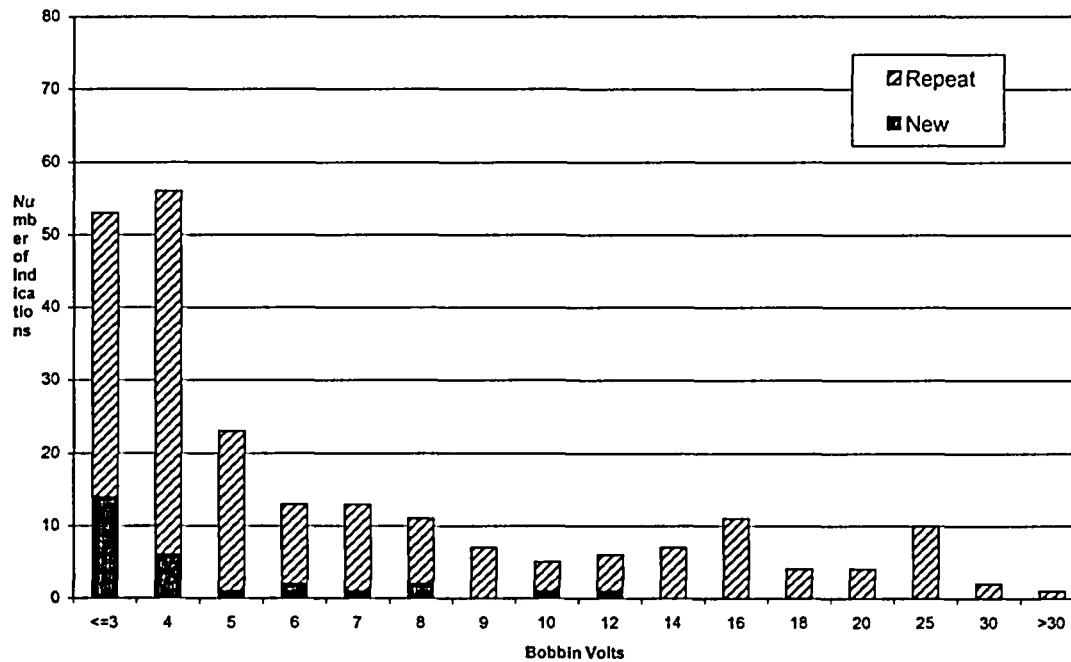
Voltage Distribution for Dents
DBNPS SG 2-A 02/02 13RFO

The voltage distribution for dents during 13RFO was as indicated on the attached figures:

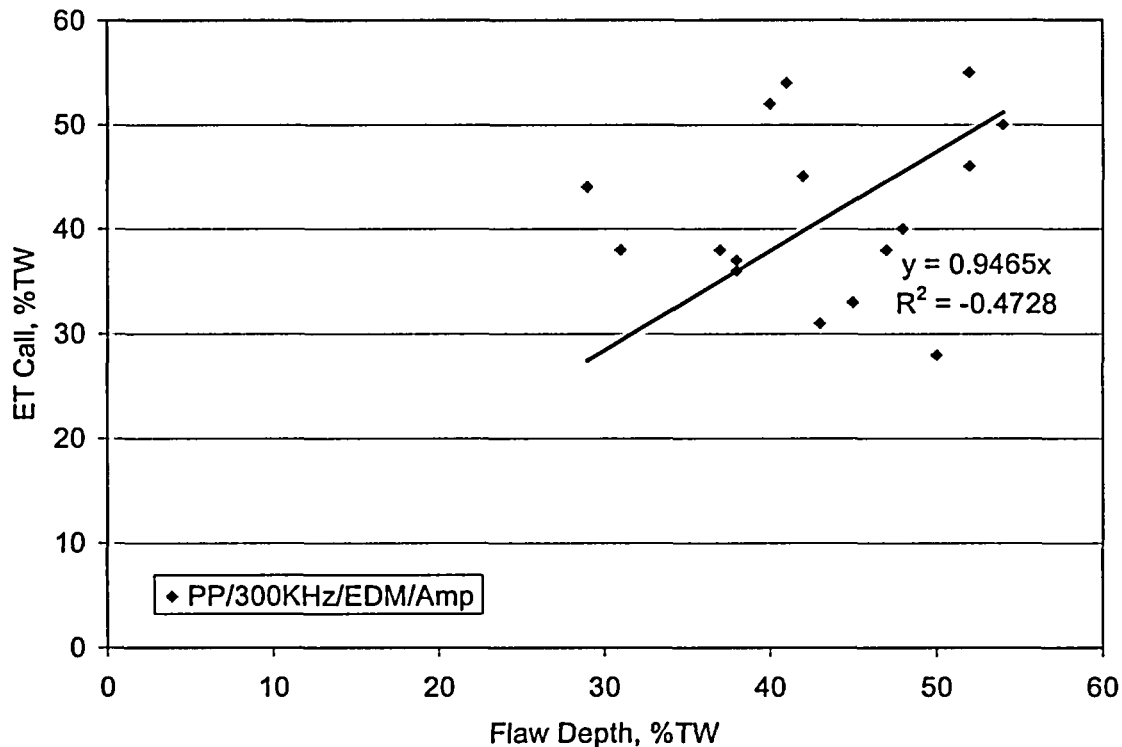
Based on the type of defects (patch IGA) present on the OD of the pulled tube, an effort to develop an approved eddy current sizing technique was attempted with the use of the pulled tube data. However, that ability to provide repeatable and accurate depth measurement of this damage prevented the successful development of a sizing qualification for this damage. Low flaw voltage signals were especially problematic in the ability to accurately size this damage.

It was concluded that the low voltage volumetric indication depth measurements were not reliable and that the plus point voltage values were a more reliable indicator of tube integrity. The center bundle volumetric indications that are being detected have much smaller voltage amplitudes than that of the pulled tube study. The typical voltage range for the volumetric flaws identified during 13 RFO were typically less than 0.3 volts. Whereas the pulled tube study voltages ranged from 0.95 volts to 0.26 volts.
