Subject: Routine Inspection No. 88-001

Report Nos. 030-05982/88-001
030-05980/88-001

Licensee: Safety Light Corporation
4150-A Old Berwick Road
Bloomsburg, Pennsylvania 17815

Inspection Conducted: July 8, 1988

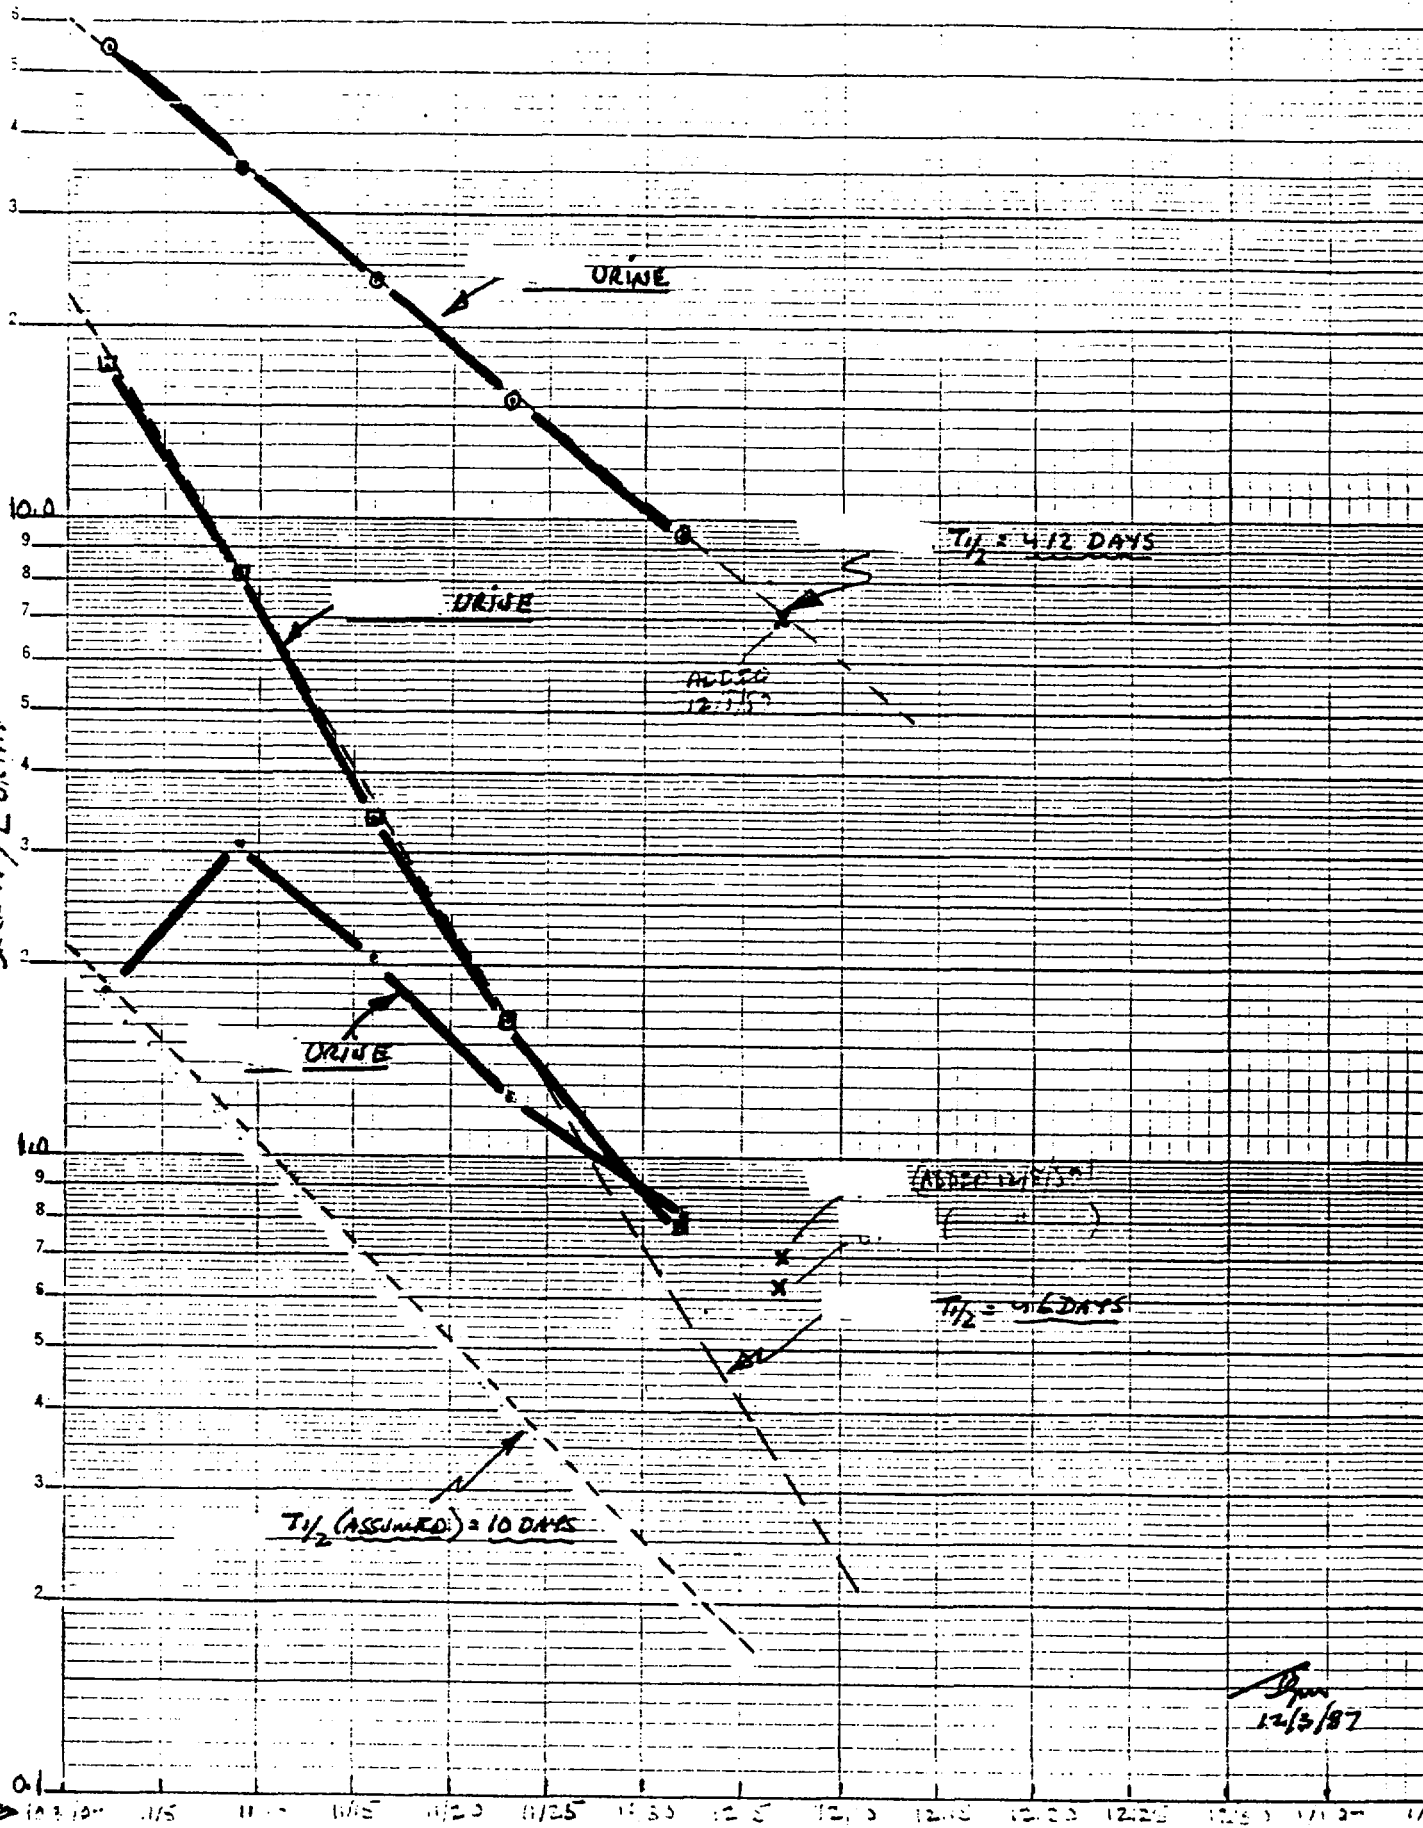
BIOASSAY DATA

The above estimates were based on the $\mu\text{Ci H}^3/\text{L}$ urine data obtained as of 11/2/87 (Monday) a.m., whereas the actual uptakes of H occurred two (2) days previously on 10/31/87 (Saturday) a.m. The previously reported values must therefore be corrected to include dosage from the estimated amount of H³ excreted between Saturday and the following Monday a.m. Also, because of the above-normal tritium uptakes which occurred in this instance with CB and GM, the SLC customarily-assumed 10 day average biological half-life for excretion of tritium was not used in estimating their respective whole body dose commitments; rather, use was made of their actual elimination rates determined experimentally after the incident occurred (See Fig. I attached). The whole body water volume assumed was that for "Standard Man", i.e. 43 L. The 'corrected' whole body doses, determined in accordance with the above (except in the case of AS), are shown in Table I.

NOTES: (1) & (2): From Fig. I
