**Entergy Nuclear Operations, Inc.**  
Pilgrim Nuclear Power Station  
600 Rocky Hill Road  
Plymouth, MA 02360

Licensee Event Report 2003-005-00

**TITLE (4)**  
 HPCI and RCIC Systems Inoperable due to De-energized Train 'A' Electrical Loads Caused by Circuit Breaker Current Transformer Malfunction

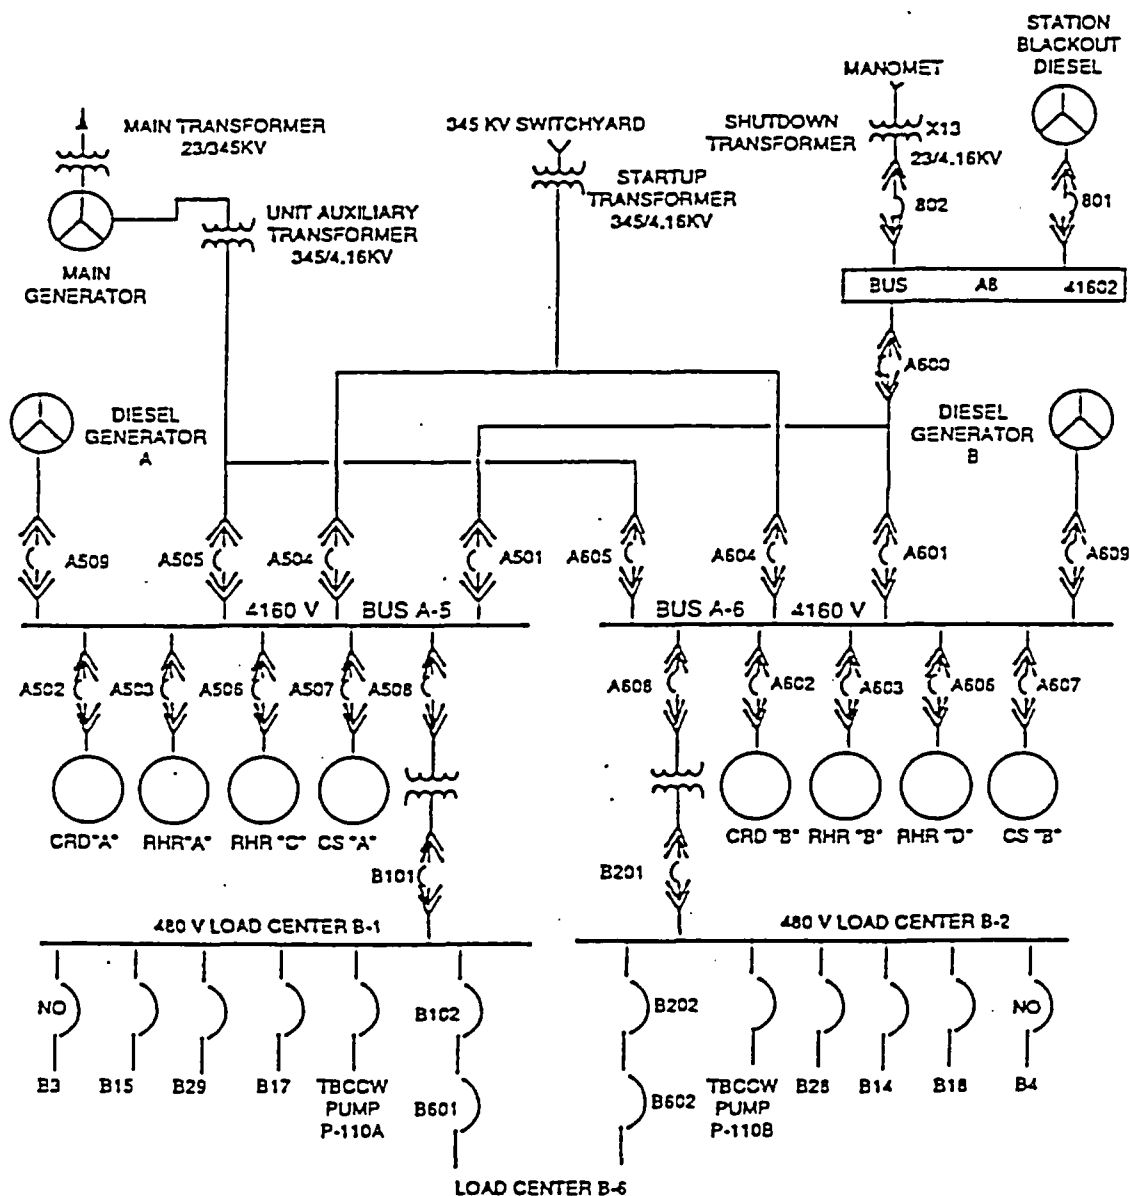
Figure of APDS

Safety-related 480-volt train 'A' load center B1 is powered from 4.16 kV Bus A5 via a step-down transformer (X-21) and circuit breaker (B101). Safety-related 480-volt train 'B' load center B2 is powered from 4.16 kV Bus A6. Safety-related 480-volt swing load center B6 is normally powered from B1 and is designed to automatically transfer from B1 to B2 if B1 becomes de-energized. Located at the end of this report is a figure that depicts a simplified single-line diagram of the APDS including load centers B1, B2, and B6.
