Subject: LER 2003-003, Containment Sump As-found Condition not in Accordance
With Design Requirements
R.E. Ginna Nuclear Power Plant
Docket No. 50-244

1. FACILITY NAME R. E. Ginna Nuclear Power Plant				2. DOCKET NUMBER 05000244		3. PAGE 1 OF 12								
4. TITLE Containment Sump As-found Condition not in Accordance with Design Requirements

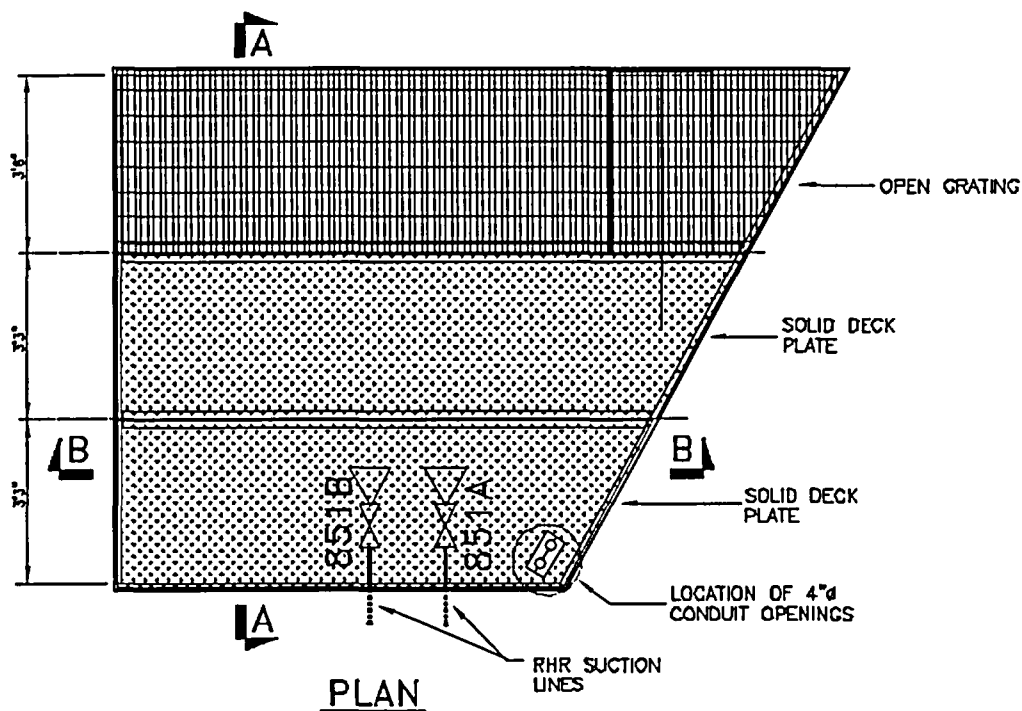
Figure 1

On September 18, 2003, engineering was performing inspections of the Containment Sump B (see Figures 1, 2, and 3). Specifically, the RFO examinations were to confirm that no by-pass flow areas existed around the Sump B inner screen. As a result of this initial external inspection, it was identified that a bypass area existed. This area consisted of three holes through the steel deck plate over the sump. Two holes were approximately 4 inches in diameter with 1.25 inch electrical conduit running through them. The third hole was approximately 2 inches in diameter. The total surface area of the bypass holes was approximately 26 square inches.

- The Sump B bypass flow paths were corrected by a modification during the 2003 RFO to return the sump to original design conditions.
- The solid material and embedded foreign material that was found on the floor of Sump B were removed during the Fall 2003 RFO.

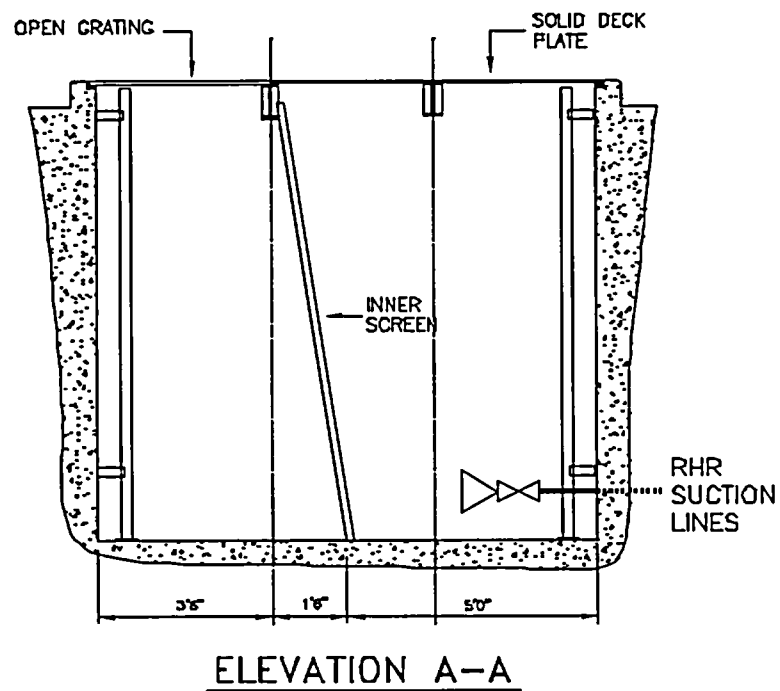
Figure 2

Initial attempts to enter Sump B to perform the internal by-pass area inspection were delayed due to the presence of standing water in Sump B. After plant personnel entered the sump to remove the water, it was discovered that the sump floor was completely covered by a solid mass of material approximately 1 inch thick. Additionally, during the clean-up of the sump to remove the solid material, miscellaneous foreign objects were found embedded within the solid material. The solid material on the sump floor and the embedded foreign material were discovered on both sides of the Sump B inner screen (see Figure 2).

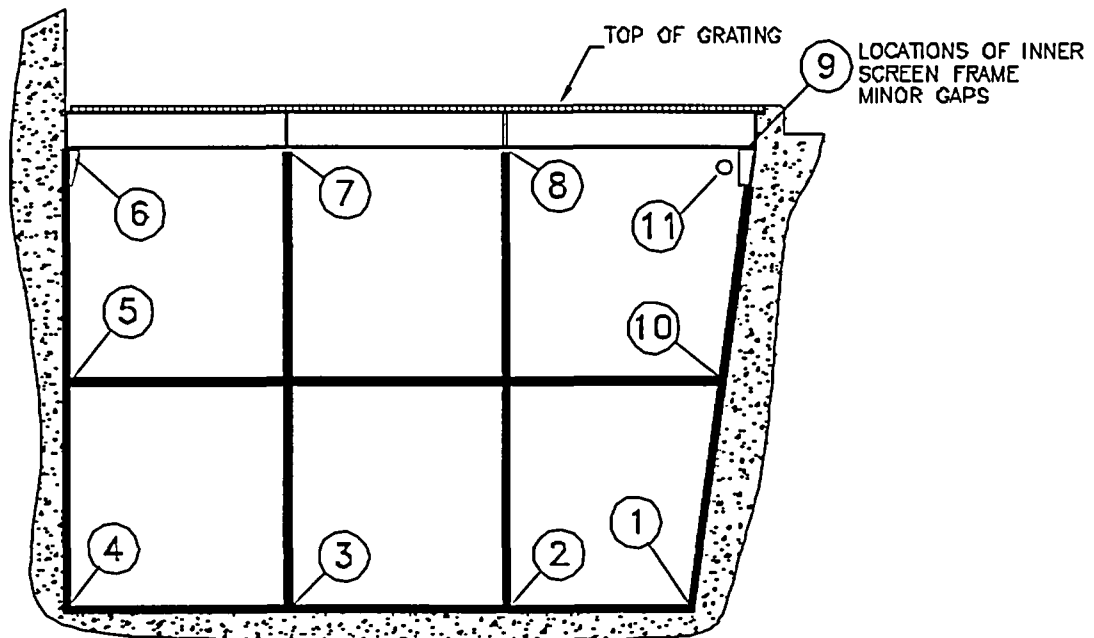
Figure 3

Supplemental inspections identified several other small gaps in the inner screen frame located within Containment Sump B and the steel deck plate. The total sum of these gaps is estimated at < 60 square inches. In addition, the dimensions of the mesh of the Sump B inner screen were confirmed to be approximately 3/16 inch wide by 9/16 inch tall. The Ginna UFSAR description implies a 0.25 inch mesh.
