Re: St. Lucie Unit 1  
Docket No. 50-335  
Order (EA-03-009) Relaxation Requests 1 and 2  
Examination Coverage of Reactor  
Pressure Vessel Head Penetration Nozzles

**ST. LUCIE UNIT 1 RELAXATION REQUEST NO. 1 Revision 0  
FROM US NRC Order EA-03-009**

**ST. LUCIE UNIT 1 RELAXATION REQUEST NO. 2  
FROM US NRC Order EA-03-009**

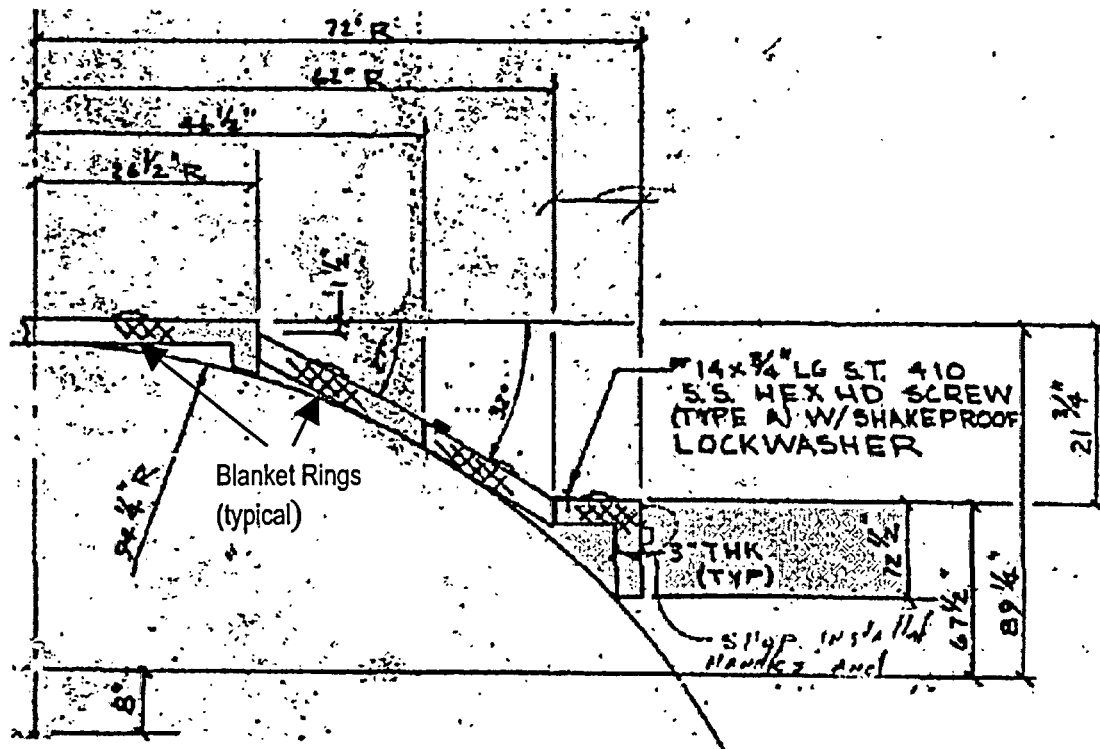
The insulation covering the RPV head at St. Lucie Unit 1 is metal reflective encapsulated mineral wool. The insulation conforms to the head as do the lower CEDM pressure housings. The insulation is made up of 33 panels, 21 of which encircle the 1 (1.050-inch OD) vent, 69 (3.85-inch OD) CEDM, and 8 (5.563-inch) ICI nozzles. Holes of 8.125-inch diameter for CEDM penetrations, 16.625-inch diameter for the ICI penetrations, and a 2-inch square hole for the vent line are cut in the insulation panels. The encircling panels were installed over the lower CEDM pressure housing flanges during initial construction. The gap between the insulation panels and the CEDM/ICI penetrations is filled with blanketed plug rings (4-inch ID and 8-inch OD for CEDM and 5.625-inch ID and 16.5-inch OD for ICI) made up of calcium-silicate wrapped in asbestos cloth. These rings were installed prior to the panels and secured with a metal band. A side view of the RPV head showing the blanket rings and the close conforming insulation panels (Figure 1) is included below.

inaccessible areas are a result of the blanket rings that fill the gap between the insulation panels and the penetrations. Some of these blanket rings have partially dropped and are in contact with the head base material in areas between the penetrations that will be inspected for evidence of leakage. The lack of access to these small areas (less than 1% of the total surface area) does not preclude performance of an effective bare metal visual examination of the nozzle-to-top-of-head interface region or the RPV head to identify evidence of wastage and/or leakage.

Figure 1: RPV Head Side View showing close conforming Insulation Panel Layout

FPL will achieve substantial compliance with the 100% Order requirement by conducting a bare metal visual examination of the RPV head surface to the maximum extent practical, excluding the inside of the 54 RPV stud holes, under the cooling shroud ring, the underside of the head, or the inside of the RVH lifting lug bolt holes. Specifically, the examination will include a visual examination of 100% of the nozzle-to-top-of-head interface region (360°) of at least 77 of the RPV head penetration nozzles for evidence of leakage and the maximum extent possible of penetration #2 (expected to be approximately 315 degrees). Additionally, the examination will include all base material uphill and downhill of any of the limitation areas encountered for evidence of wastage, or corrosive products entering or exiting the area.
