Subject: Waterford 3 SES
Docket No. 50-382
License No. NPF-38
Combined Category C-3 and 15-Day Special Report SR-03-002-00 on the
12th Refueling Outage Steam Generator Tube Inservice Inspection

**Special Report SR-03-002-00
W3F1-2003-0089**

RF12 Combined Category C-3 and 15-Day Special Report

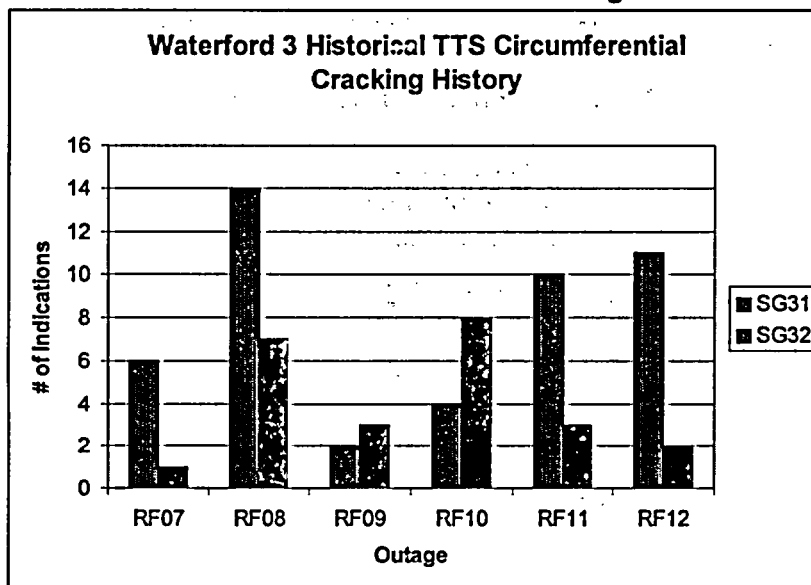
Figure 3.1.1
TTS Circumferential-Cracking

The number of circumferential indications found per SG in each inspection is shown in Figure 3.1.1.

Screening of the indications was performed for in-situ testing. One indication in SG32 exceeded the criteria for leakage at main steam line break (MSLB) pressure. It did not exceed the criteria for proof testing. The tube was 75-91. Details of the indication is listed in Table 3.1.2:

Based on CEOG Task 1154, stabilization was performed on all circumferential indications above -3 inches. Several tubes had multiple indications. None of the indications exceed the in-situ selection criteria.

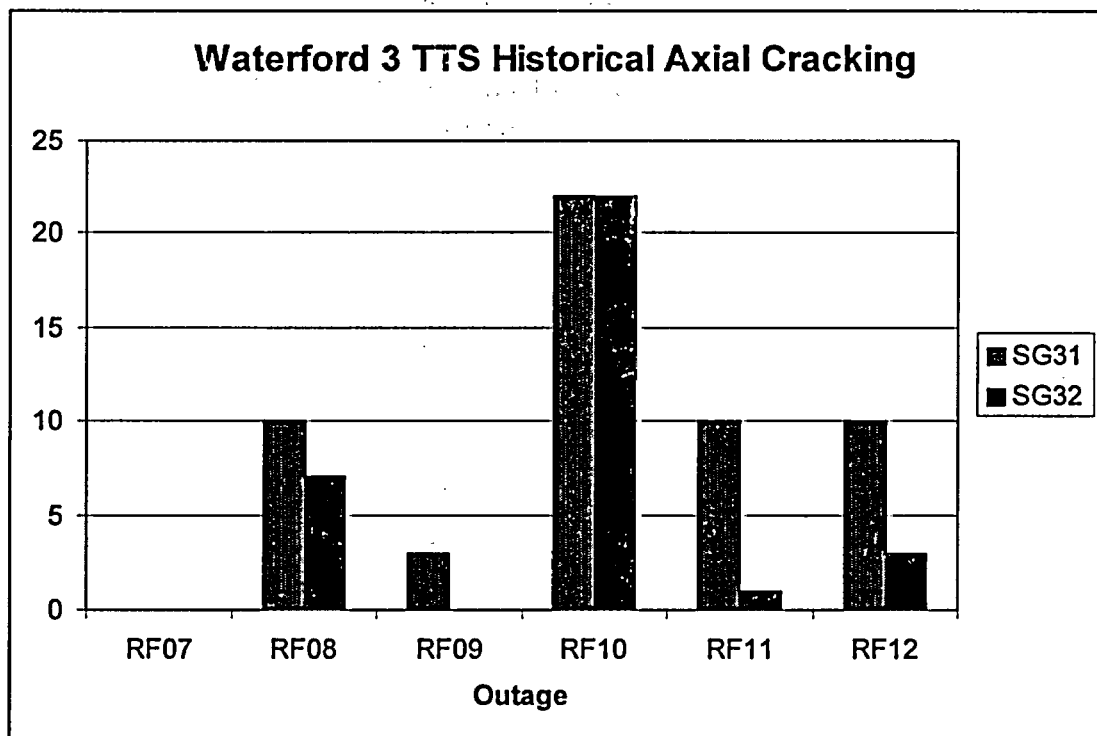
Figure 3.3.1
TTS Axial Cracking

Historically, axial cracking at the top of the tubesheet has been the predominant damage mechanism at Waterford 3, excluding mechanical wear. The historical summary for this mechanism is listed in Table 3.3.1:

This is displayed graphically below in Figure 3.3.1:

None of the TTS axial cracks exceeded the in-situ screening criteria for burst or leakage.

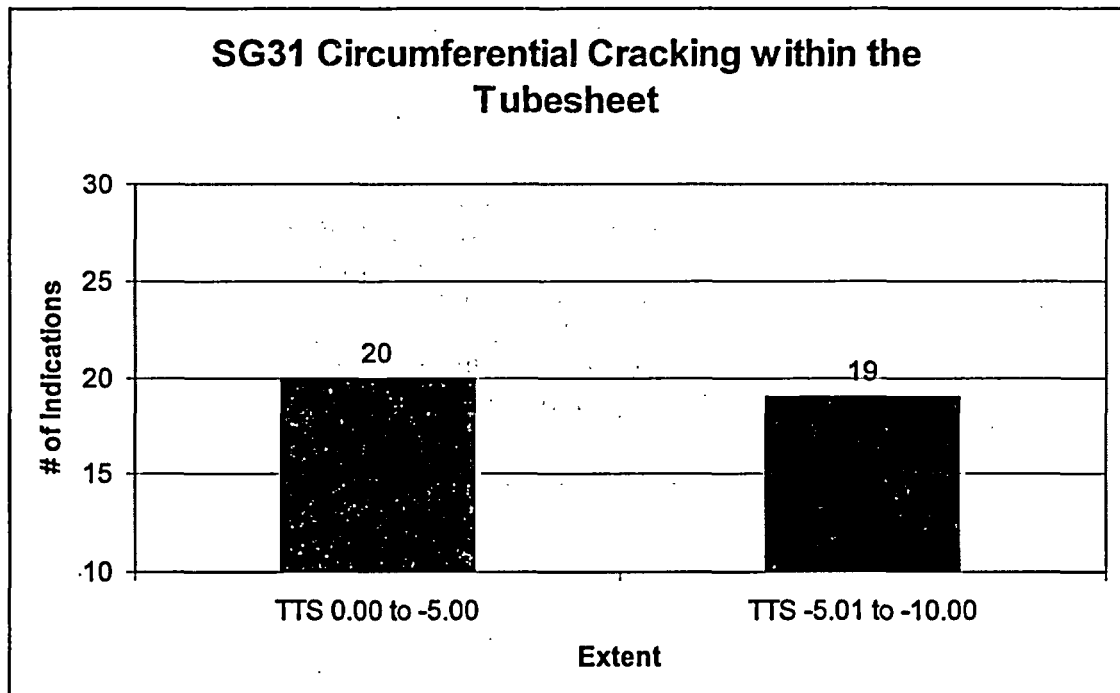
Figure 3.2.2
Circumferential Cracking within the Tubesheet

Circumferential cracking within the tubesheet has been identified as primary water stress corrosion cracking (PWSCC) or originating from the inside diameter of the tube. In an attempt to quantify this, the inspection extent was increased this outage to eight inches below the secondary face or top of the tubesheet. The following results were obtained in table 3.2.1:

20 of the 39 total circumferential indications were previously identified within the inspected level. Below -5 inches, 19 additional indications were found. There were no circumferential indications identified within the SG32 tubesheet. A breakdown by location of the cracking within the tubesheet is listed in Figure 3.2.2:

The increased number of indications identified within the tubesheet is due to primary water stress corrosion (PWSCC). This is a common mechanism seen in steam generators of this design. The indications identified in the previously tested zone were consistent with what was expected.

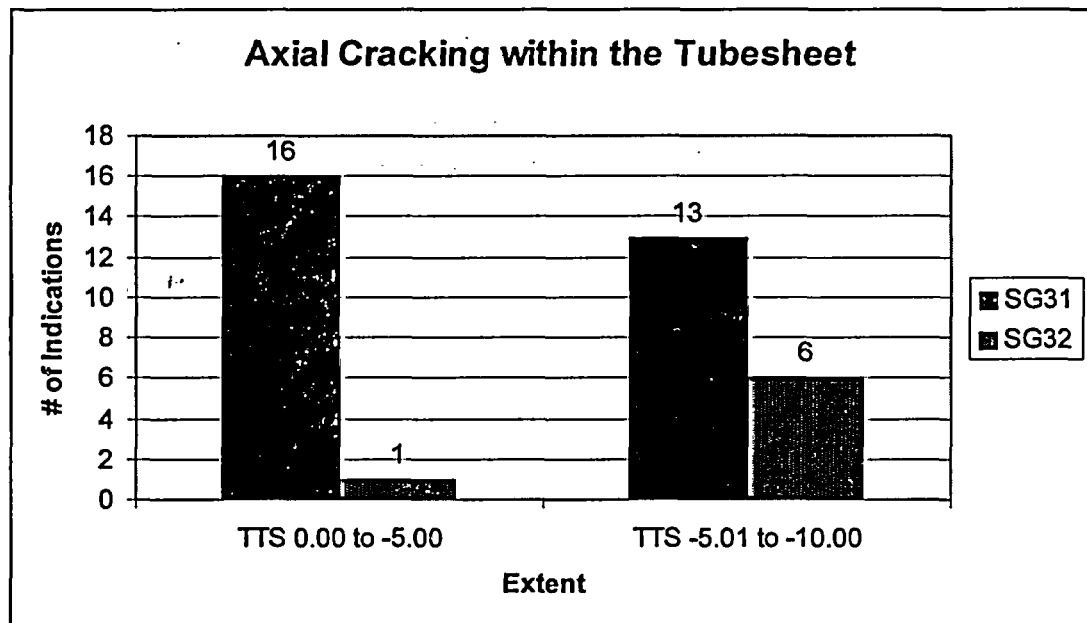
Figure 3.3.2
Axial Cracking within the Tubesheet

There were a total of 29 axial indications in SG31 and 7 indications in SG32 within the tubesheet. As discussed before, the added extent of testing resulted in additional indications being found. 17 of the 36 indications were located in the previously tested extent while the remaining 19 indications were identified below - 5 inches. This data is graphically displayed in Figure 3.3.2:

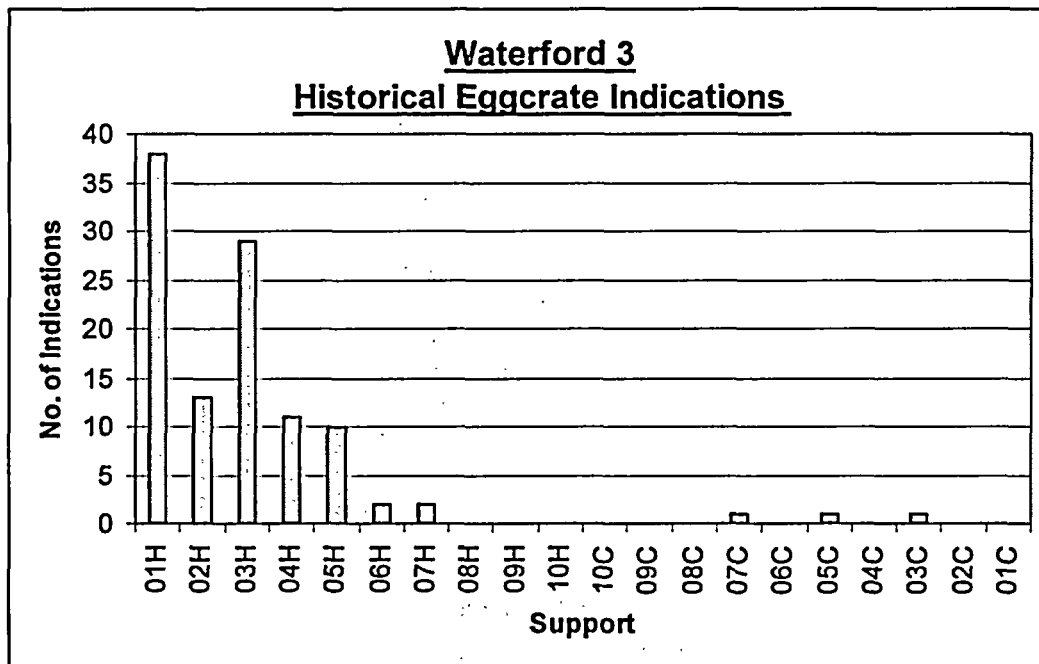
Figure 3.5.1
Eggcrate Flaw Distribution

Cracking at eggcrates was first detected at Waterford 3 in 1999 (RF09). Based on the examination results of tubes removed during the ANO-2 outages in 1992 and 1996, the eggcrate support flaws at Waterford 3 are classified as axially oriented outside diameter stress corrosion cracking. The cracking can be a single crack or multiple cracks interconnected in the tube within the eggcrate support. As noted in Figure 3.5.1, the largest number of flaws occurs at the hottest support plate (01 Hot) and generally decreases as the temperature decreases. Figure 3.5.2 depicts the number of indications by outage.

None of the eggcrate flaws detected during RF12 inspection met the in-situ pressure test criteria. As mentioned previously in this report, the detection capability of the eddy current inspection was enhanced during RF12 due to the chemical cleaning; therefore, an increase in eggcrate indications was not only predicted in the degradation assessment but was also found during the subject outage.
