Subject: 2003 Annual Site Inspection and Monitoring Compliance Report for UMTRCA Title II
Disposal Sites

2003 Annual Site Inspection and Monitoring Compliance Report for Uranium Mill Tailings Radiation Control Act Title II Disposal Sites

**Bluewater, New Mexico
Edgemont, South Dakota
Sherwood, Washington**

November 2003

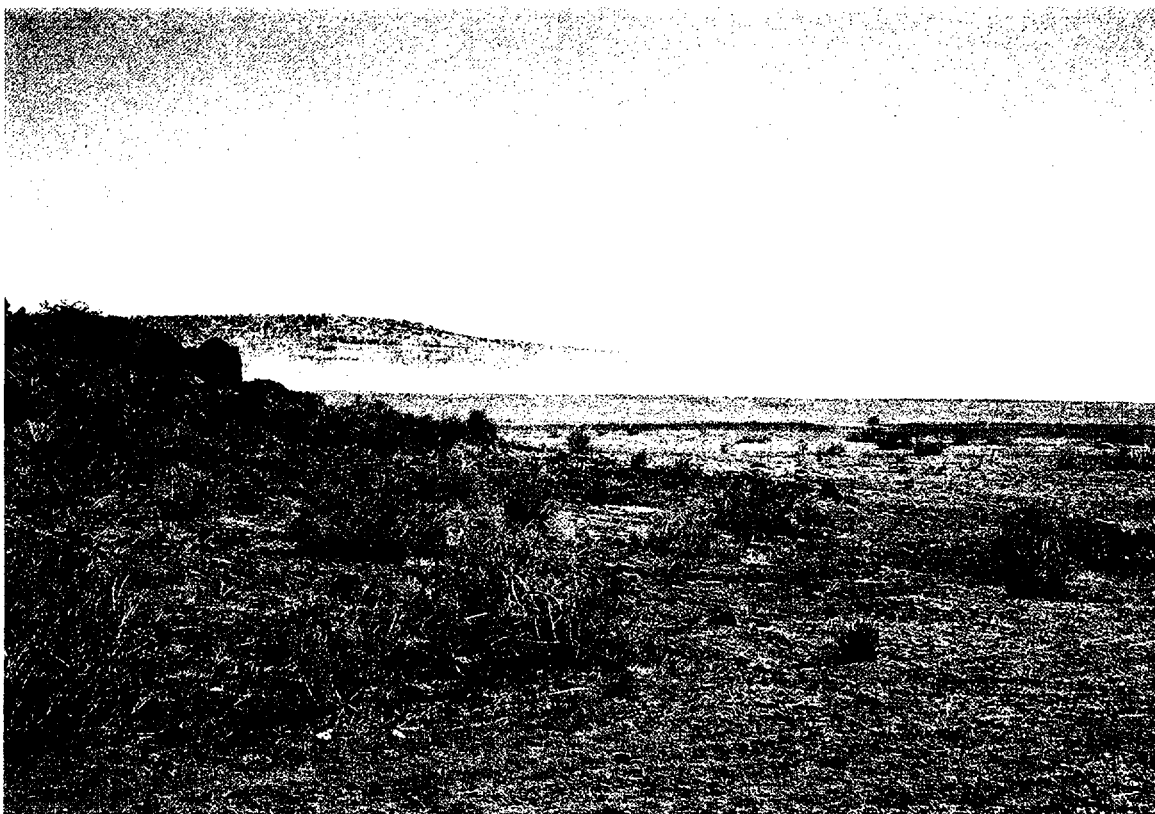
High winds occurring during the inspection were blowing a significant amount of sand and causing dust clouds (PL-1 and PL-2). Consequently the features shown in some of the photographs included in this report are less distinct than they would be under better weather conditions.

BLU 5/2003. PL-1. Blowing sand and dust, view north from north end of main tailings pile.

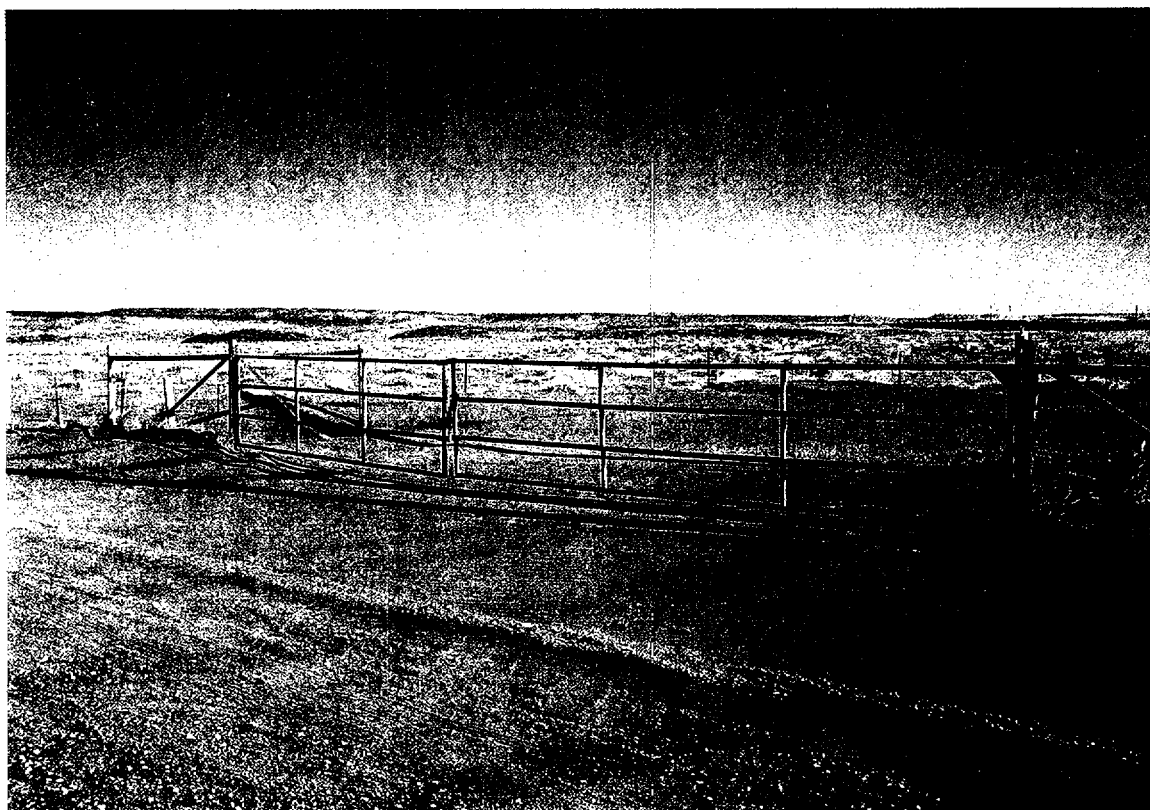
The entrance gate (at County Road 334) is a steel, double-swing stock gate. A chain and padlocks belonging to DOE and various utility companies that have rights-of-way across the site secure the gate. The access road leads from the entrance gate to the access gate. The access road is an all-weather road surfaced with crushed basalt and extends northward, along a narrow strip of DOE property, for approximately 1,700 feet to the site access gate. The access gate also is a steel, double-swing stock gate secured by padlocks keyed the same as the entrance gate. The entrance gate, access road, and access gate are in excellent condition. A significant amount of windblown sand had accumulated at the entrance gate (PL-3) and to open the gate, the inspectors had to force it through a small sand dune.

BLU 5/2003. PL-3. Entrance gate and windblown sand at County Road 334.

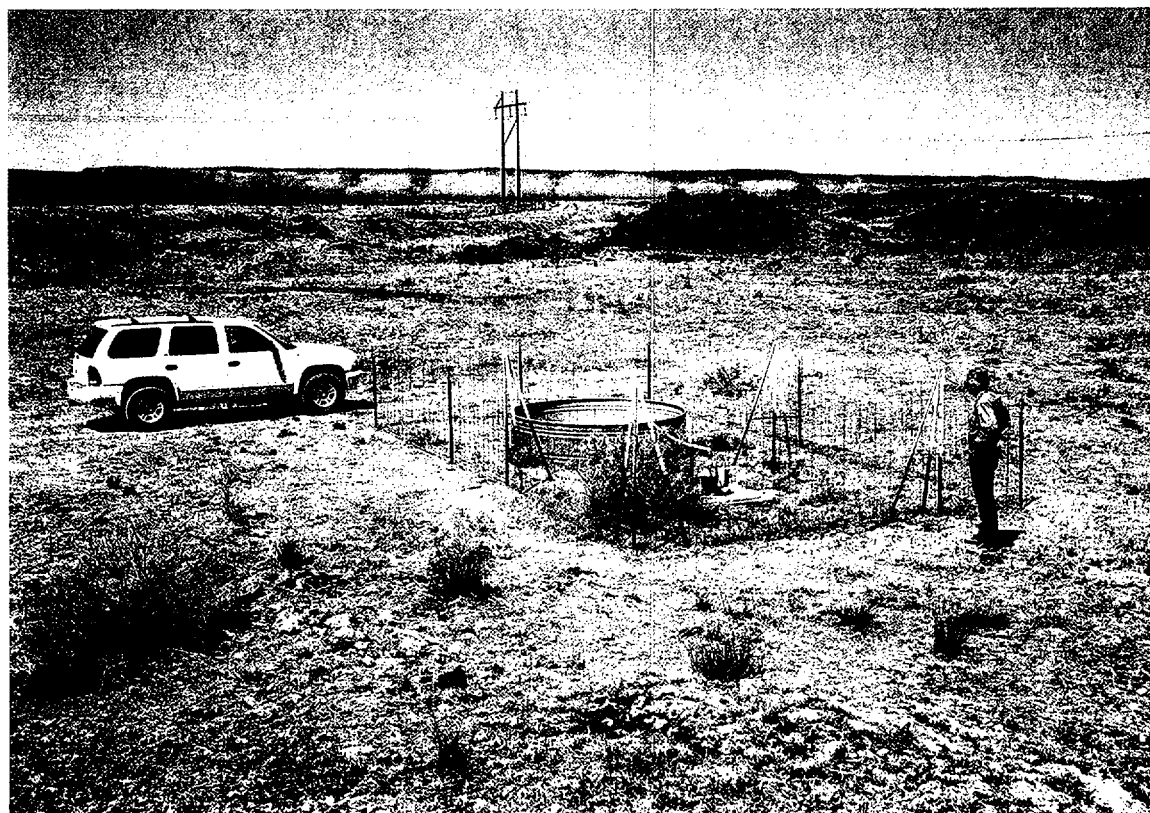
Wells previously had dedicated pumps, flow tubes, and stock tanks to contain purge water. Protective fencing placed around each well in 2001 to mitigate livestock damage was in good condition (PL-4). Tanks were missing from E(M) and Y2(M). Surface support equipment for the monitor wells (wiring and PVC pipes) is weathered and in poor condition but does not impact sampling activities.

BLU 5/2003. PL-4. Monitor well L(SG) and protective fencing.

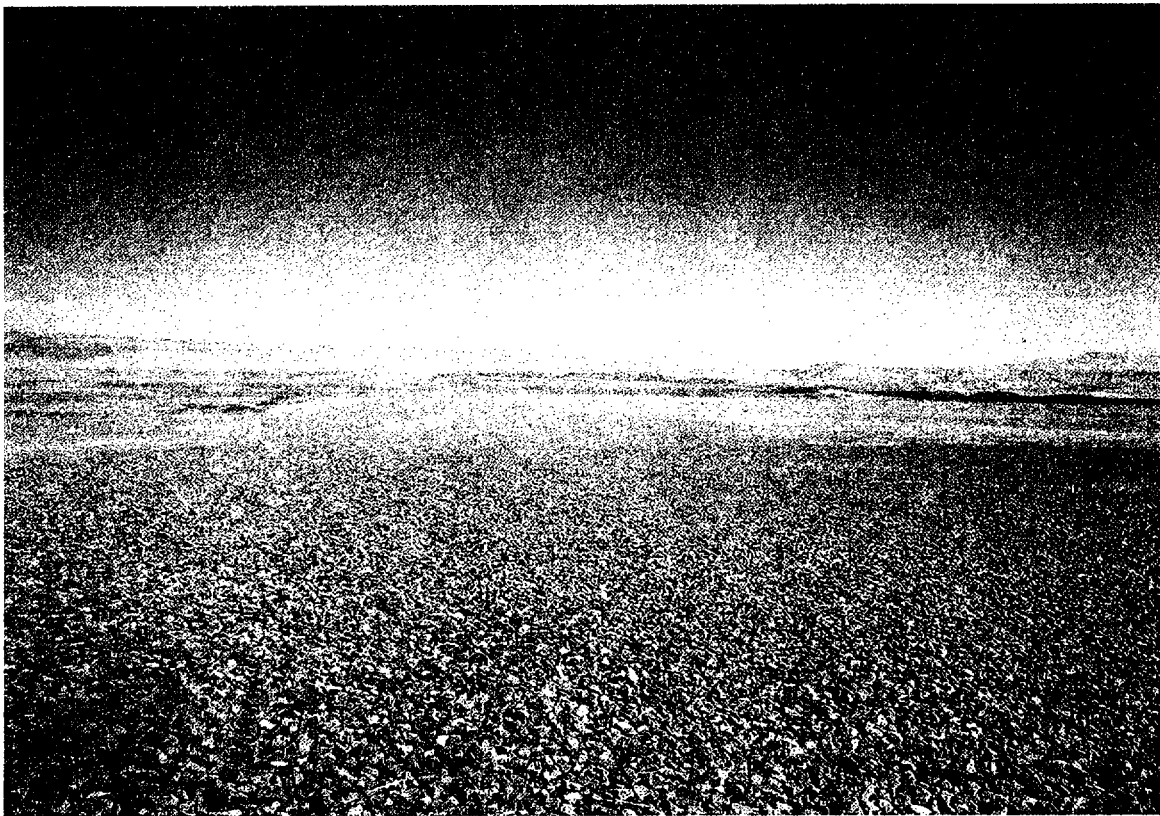
BLU 5/2003. PL-5. Top of main tailings pile along southwest edge.

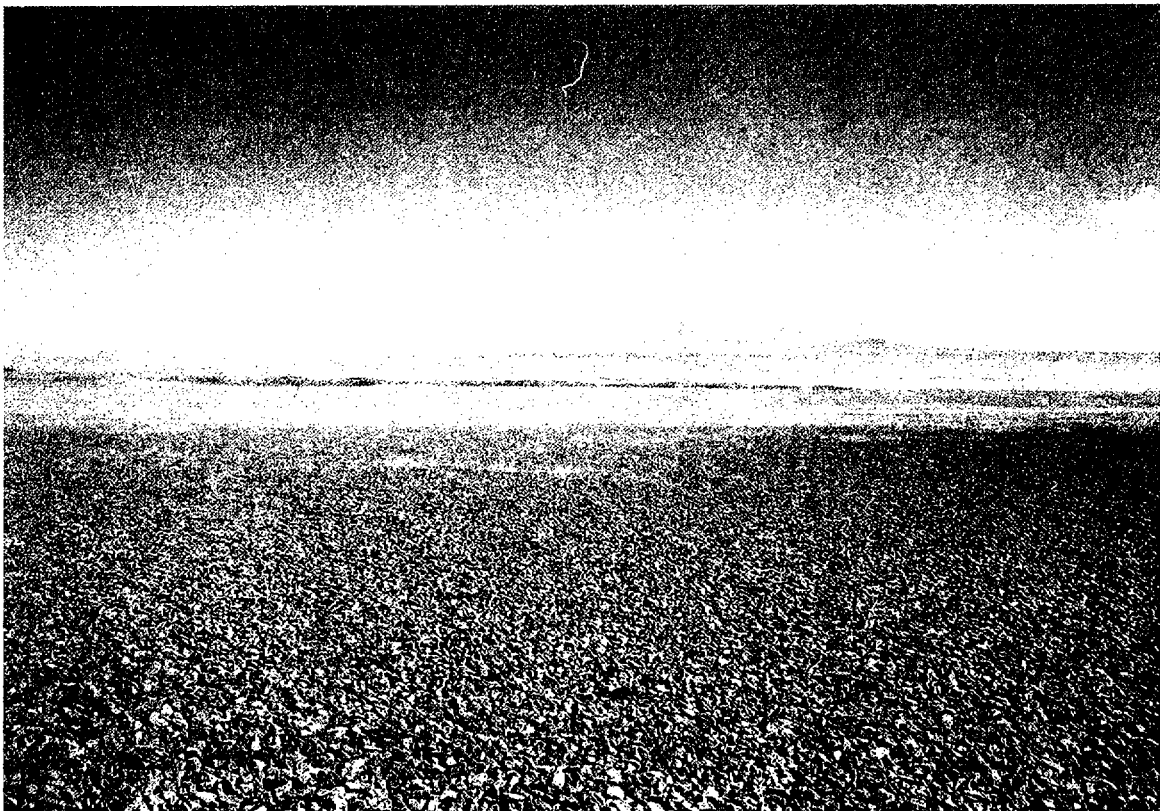
BLU 5/2003. PL-6. Top of main tailings pile, view north.

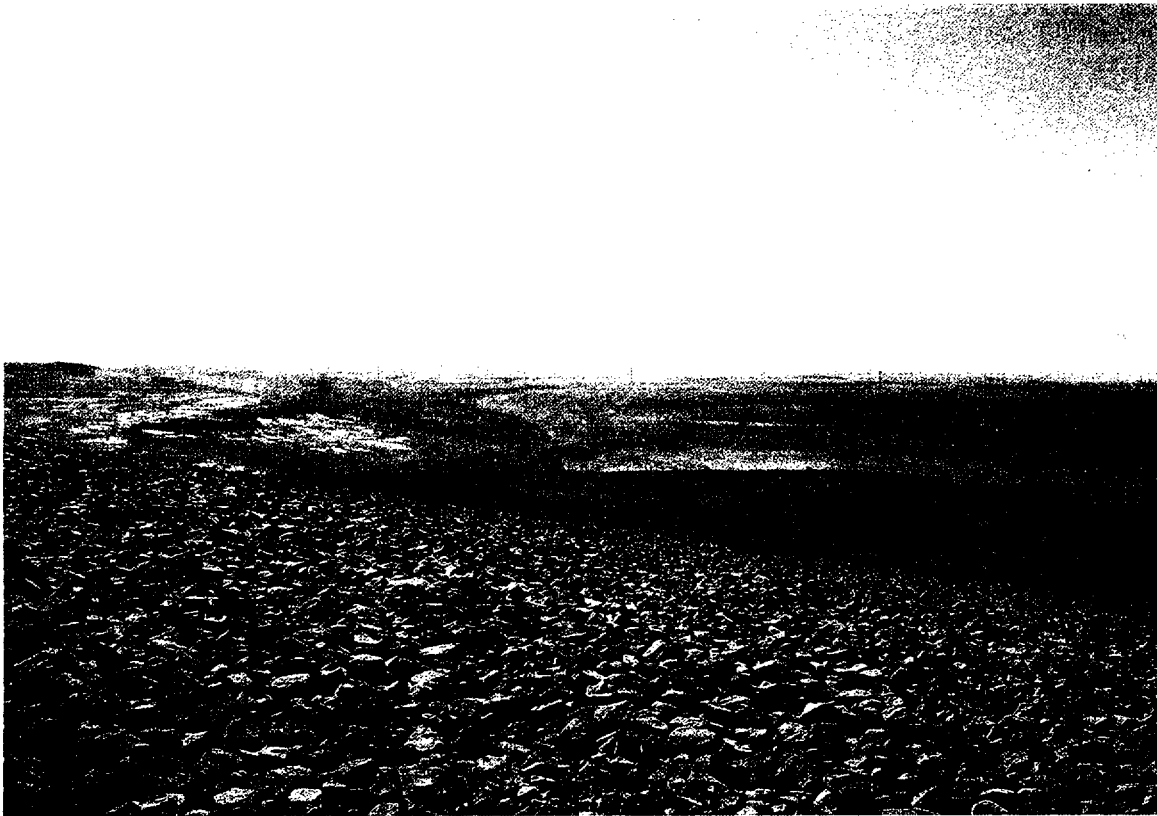
BLU 5/2003. PL-9. South bench tailings area.

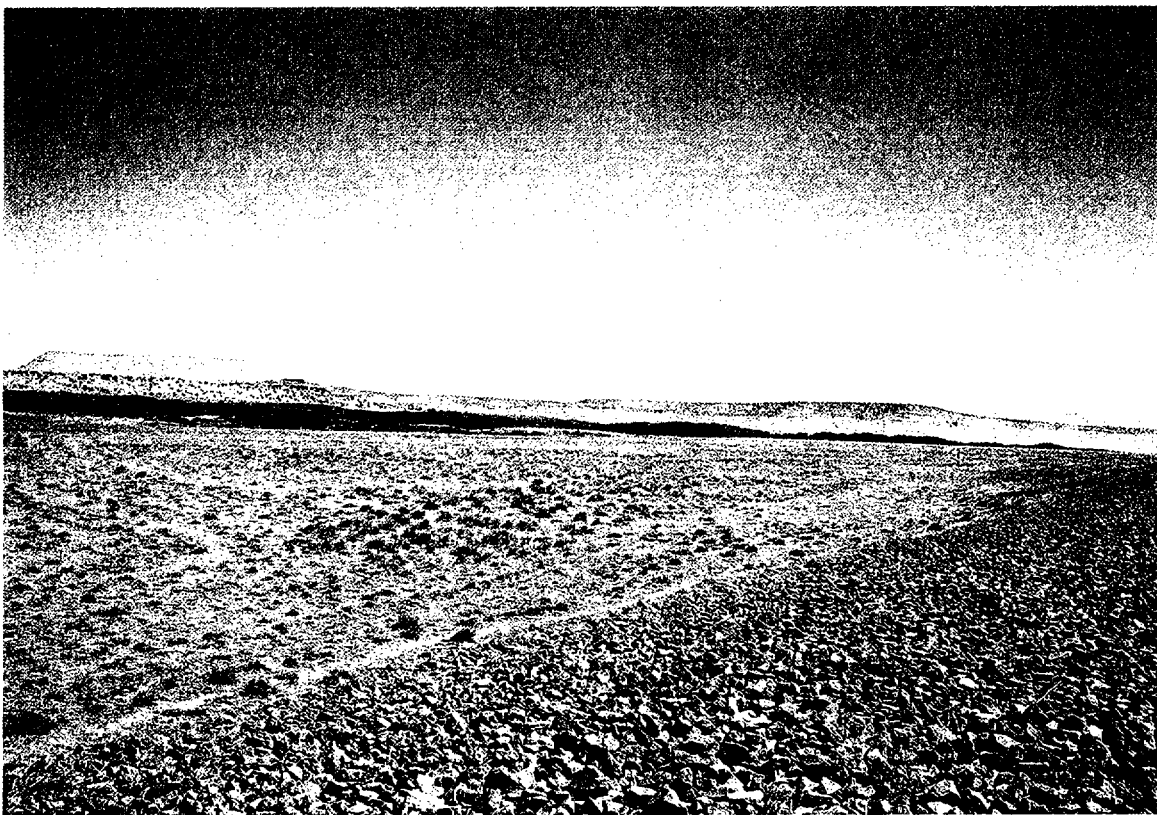
BLU 5/2003. PL-10. Cover over acid tailings.

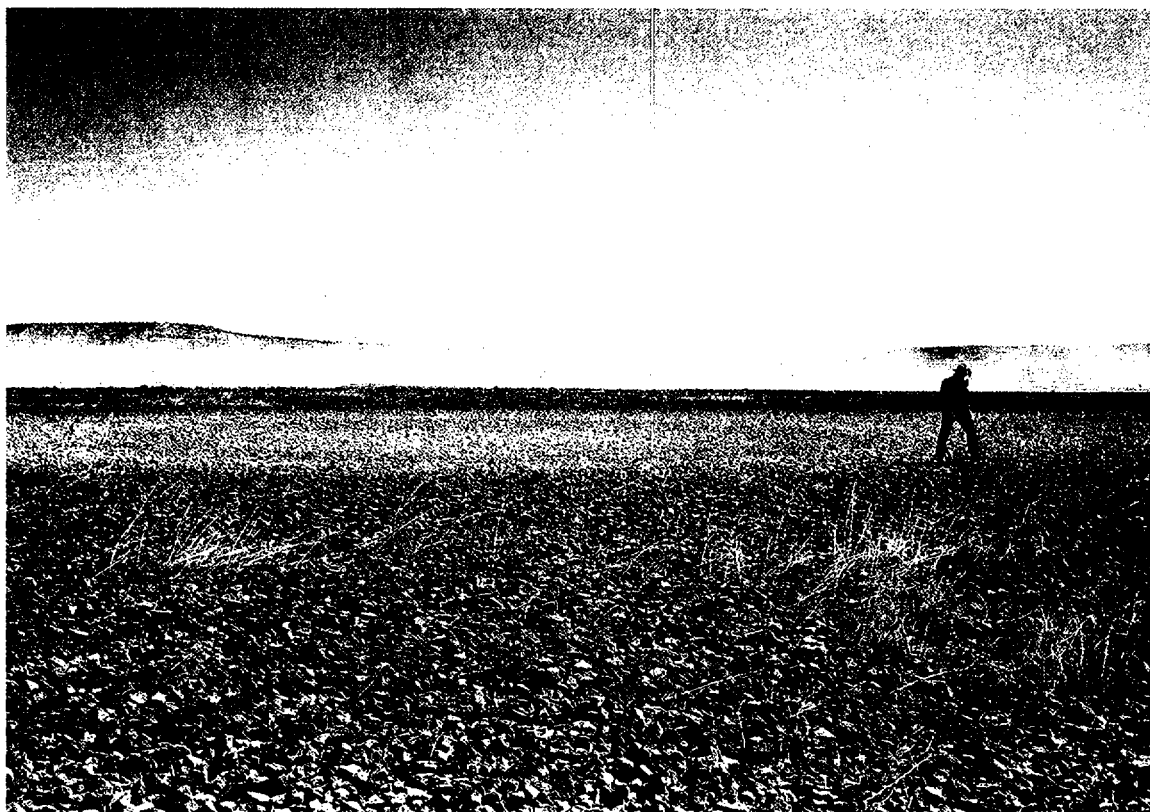
The low spots are the result of settlement or an artifact of construction. Slimes from the settling ponds were placed in the northern part of the main tailings disposal cell and areas containing slimes are more likely to settle than areas containing drier waste materials. However, a grade of less than 0.5 percent is hard to achieve over an area as large as the north end of the main tailings disposal cell. Either mechanism could account for the depressions. One small depression that was observed for the first time during this inspection has a distinctly bowl-like shape (PL-11). This depression is most likely the result of settlement.

BLU 5/2003. PL-11. Bowl shaped depression on north edge of main tailings pile.

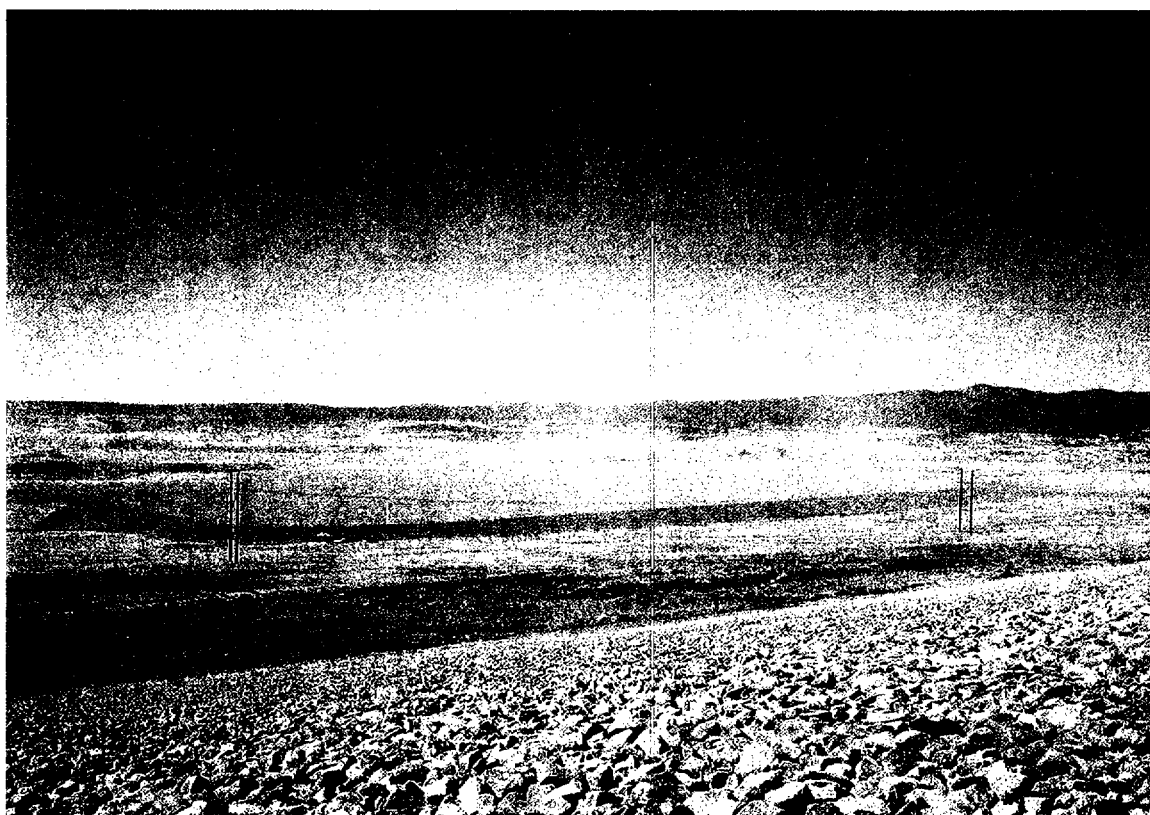
The top and side slopes of the carbonate tailings disposal cell are covered by basalt riprap (PL-12). The top, for the most part, slopes gently eastward. The small northwest and southeast extensions slope in their respective directions. The carbonate tailings disposal cell and its extensions are in excellent condition.

BLU 5/2003. PL-12. Carbonate tailings pile.

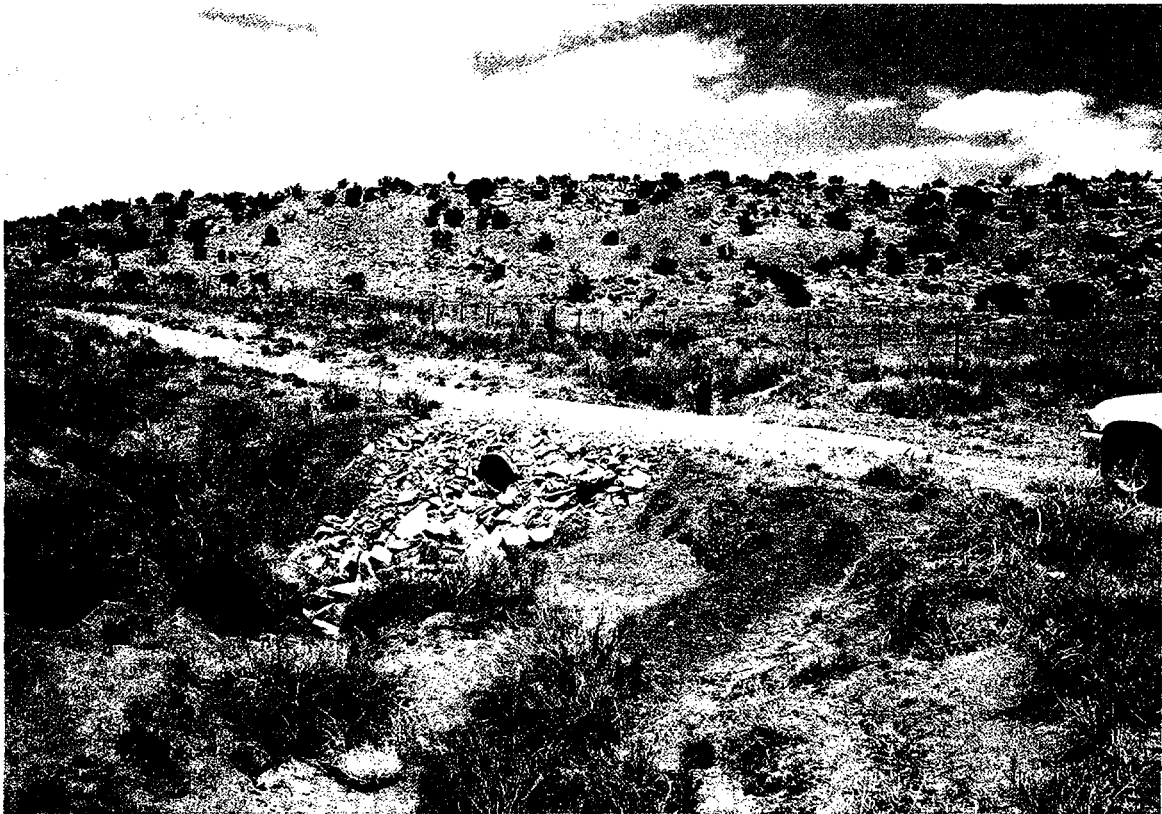
The perimeter road consists of a dirt track covered at places with crushed basalt. The road runs along the site boundary in much of the southern and most of the northern and eastern parts of the site. Most of the road is in good to excellent condition, but will require periodic maintenance. In 2001, a culvert was installed where the road was washing out south of boundary monument BM-16. The repair was inspected and remains in excellent condition (PL-13).

BLU 5/2003. PL-13. Culvert near BM-16, installed in 2001.

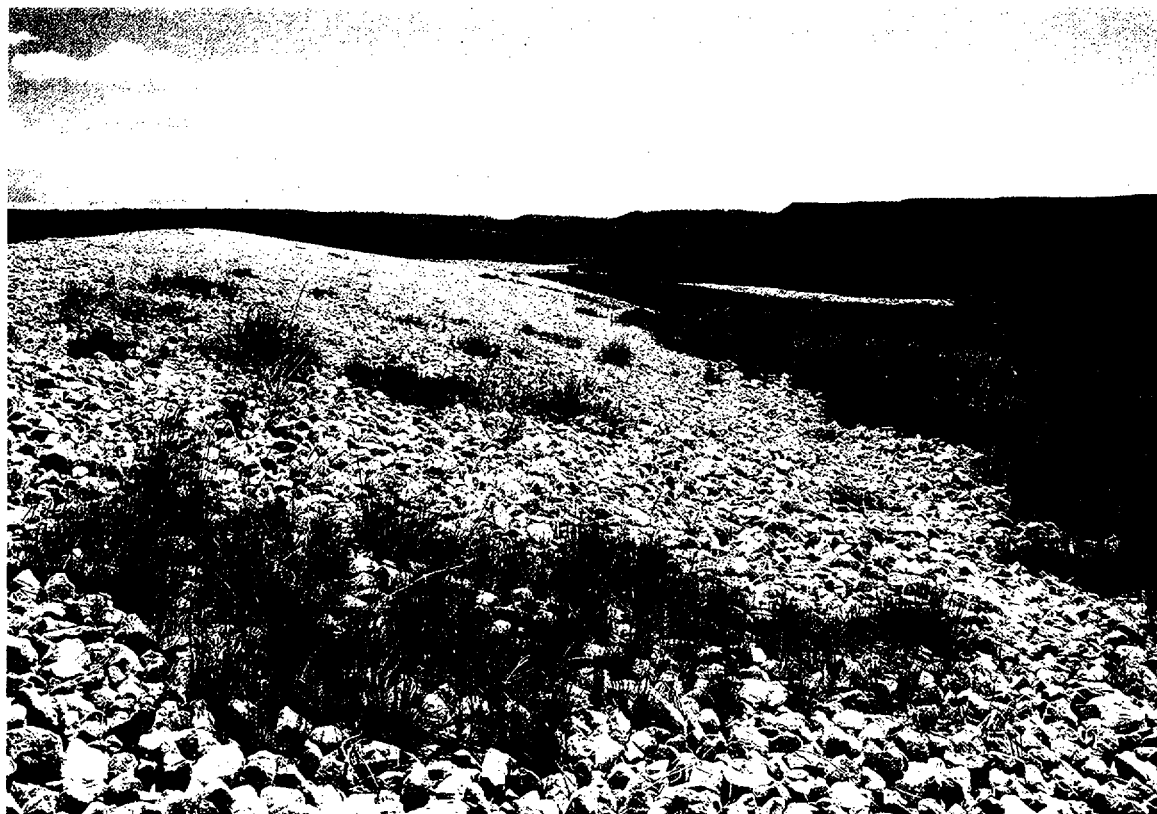
The tailings dam face, the steepest slope on site, is covered with riprap. The slope is stable and the riprap shows no signs of degradation. Scattered plants, mostly grass, grow in the riprap (PL-2). These plants do not pose an immediate threat to stability or function of this structure. The plant density has not increased over the last few years. Plant density in the riprap dam face will continue to be evaluated during future inspections.

EDG 6/2003. PL-2. Embankment face.

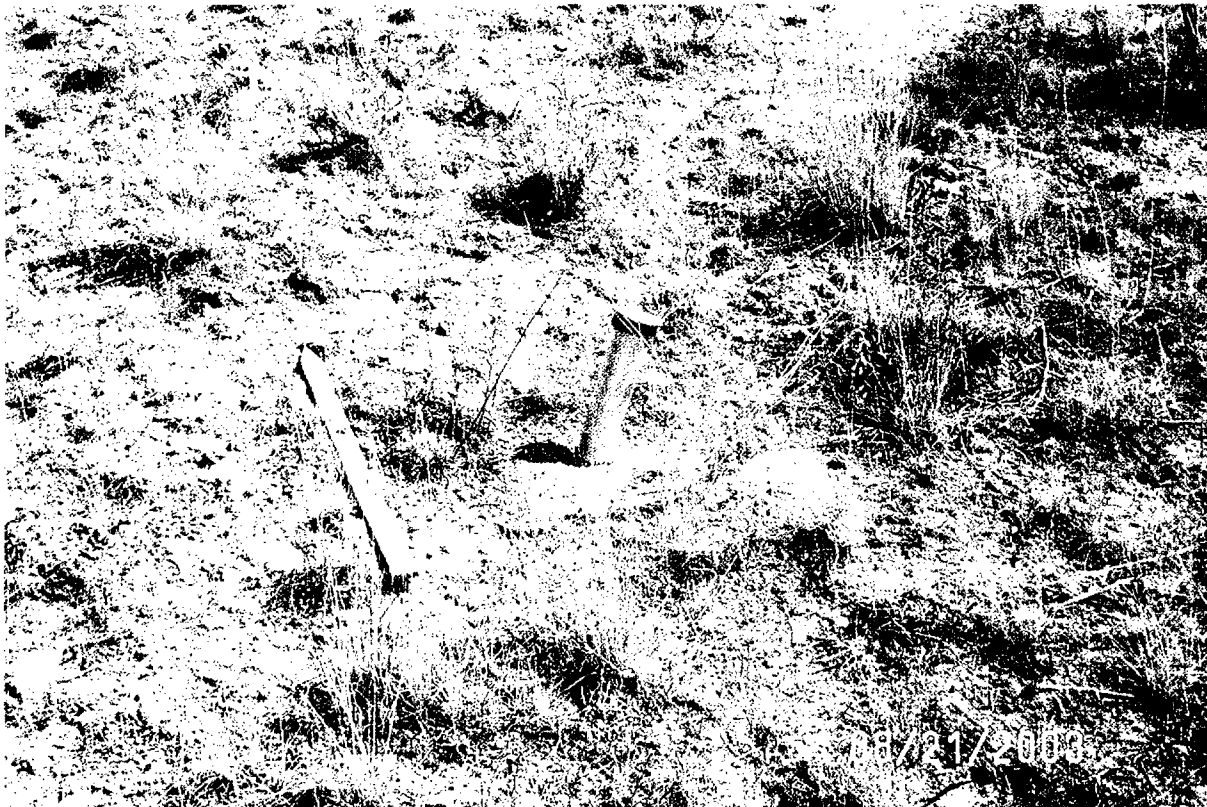
Six boundary monuments designated BM–1, BM–2, BM–3, BM–3A, BM–4, and BM–5 define the site boundary. Inspectors noted that BM–3A had been bent (PL–1); all other monuments were in excellent condition.

SHE 8/2003. PL-1. Boundary monument 3A, bent.

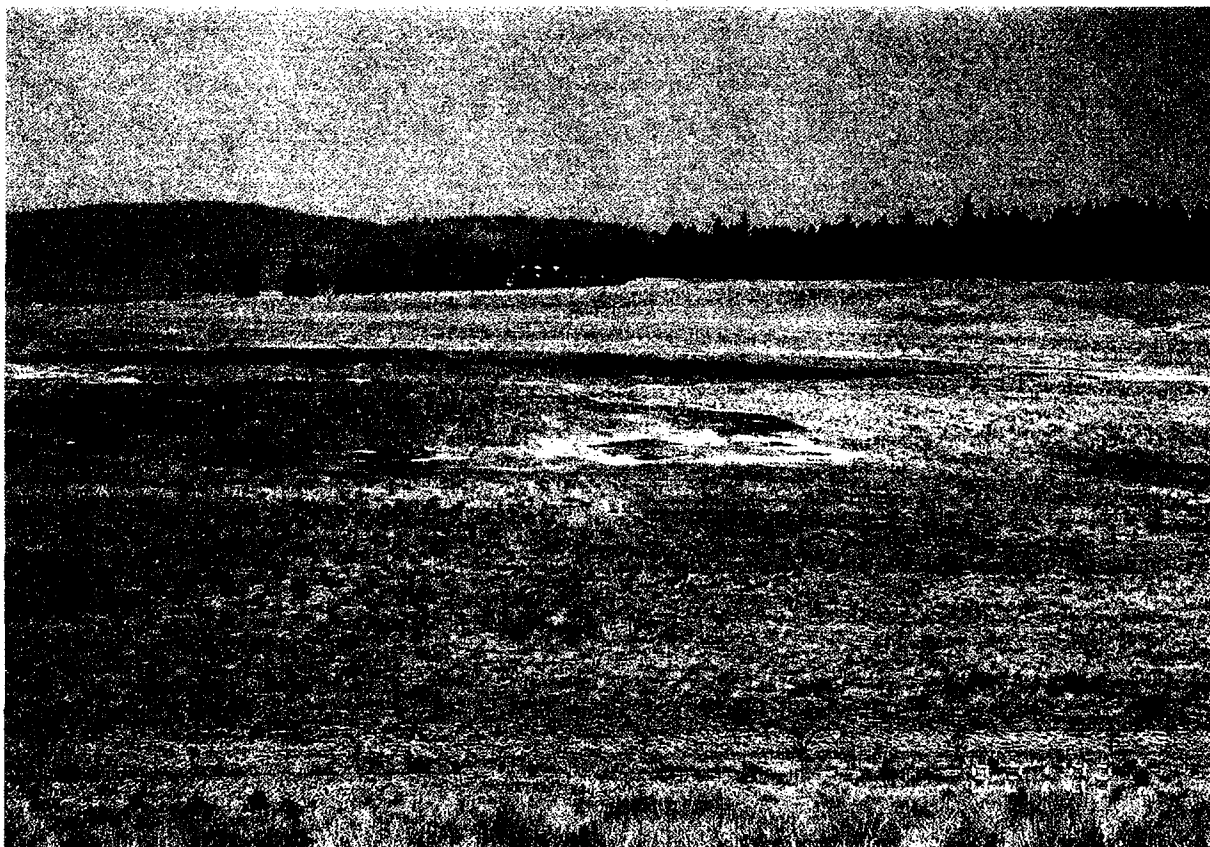
Inspectors noted an additional settlement area east of the existing pond area (PL-2). This low-lying area, 3 to 5 acres in size, contains riparian vegetation and shows indications of having saturated soils during certain times of the year. There was no water in this settled area at the time of the inspection.

SHE 8/2003. PL-2. Additional settlement area on top of tailings impoundment; pond area (dark green) is in background.

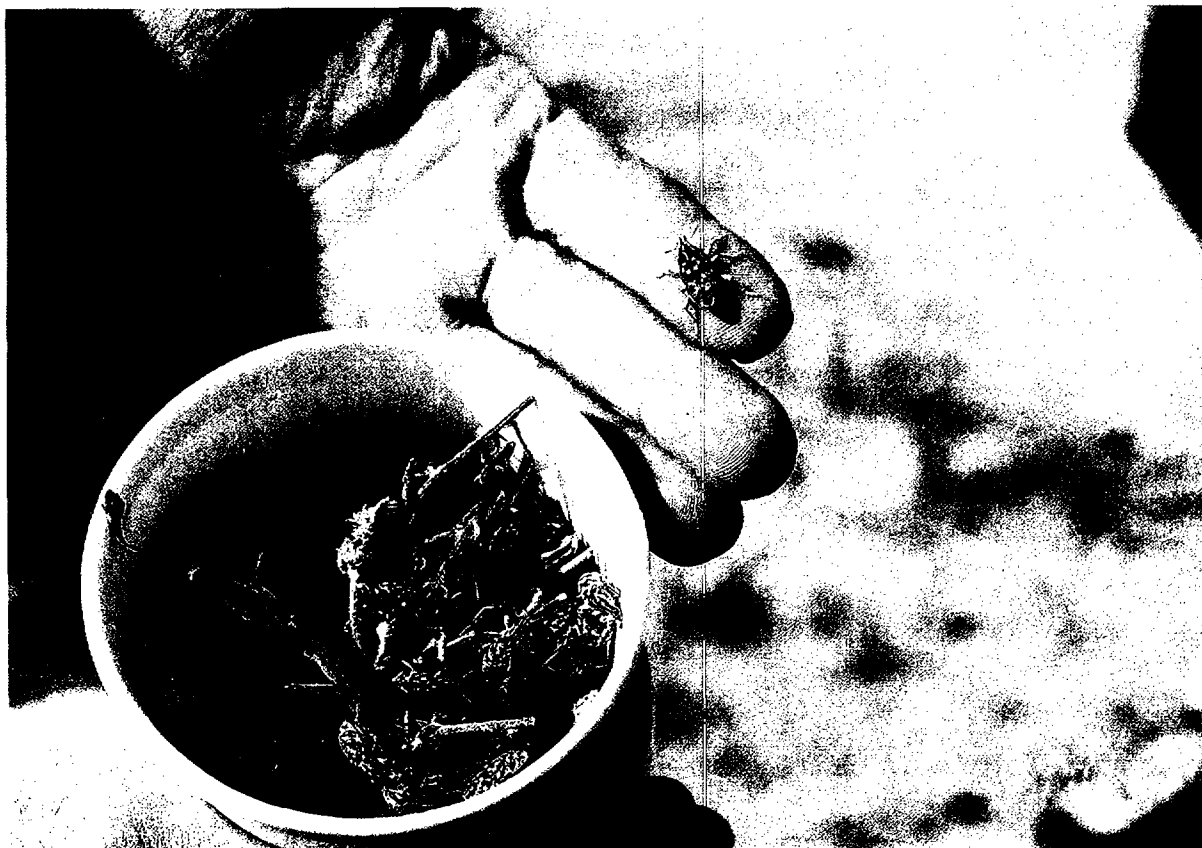
SHE 8/2003. PL-3. Knapweed root weevil (Cyphocleonus achates).

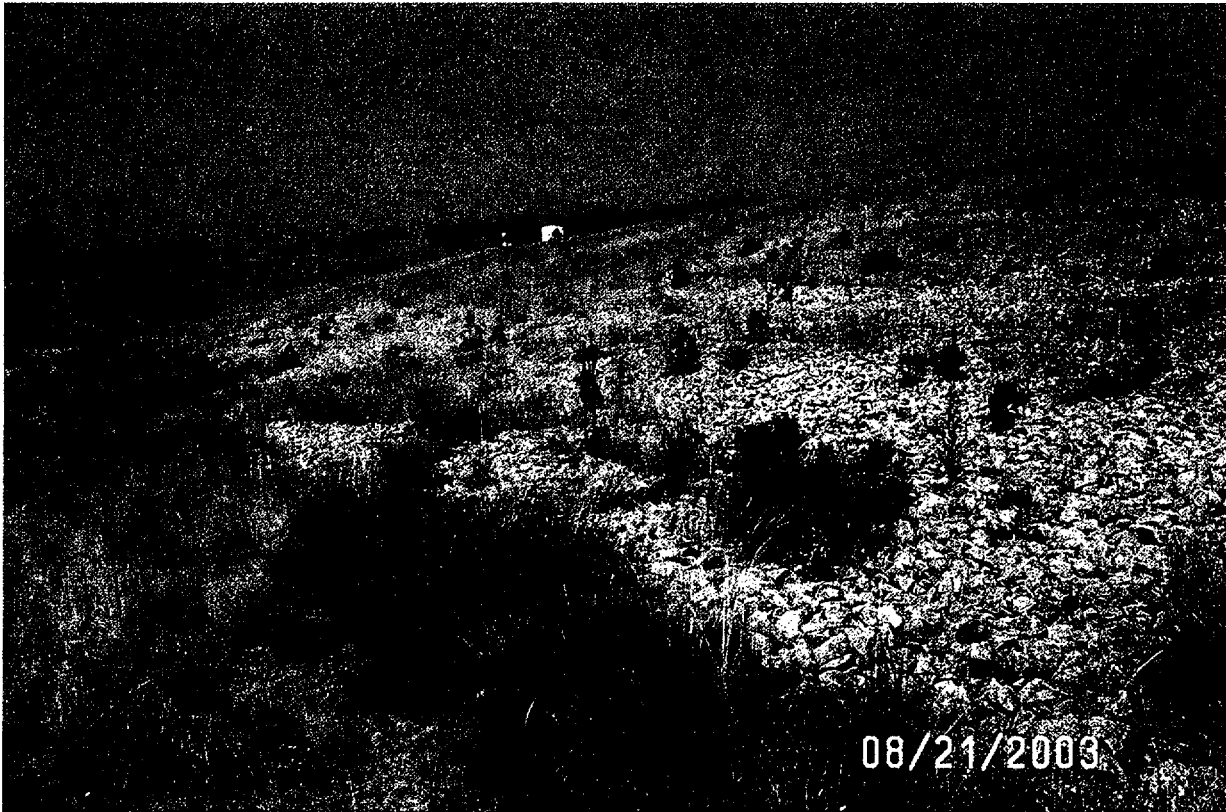
The tailings embankment on this site, classified as a dam, necessitates a dam safety inspection to assure continued compliance with the Federal Dam Safety Act. The impoundment dam face was inspected in accordance with the attached Dam Inspection Checklist and photographed (PL-4 and PL-5). No evidence of seepage, slumping, erosion, or instability was observed. Ponderosa pines, some as tall as 24 inches, were observed on the face.

SHE 8/2003. PL-5. Embankment face showing vegetation encroachment.

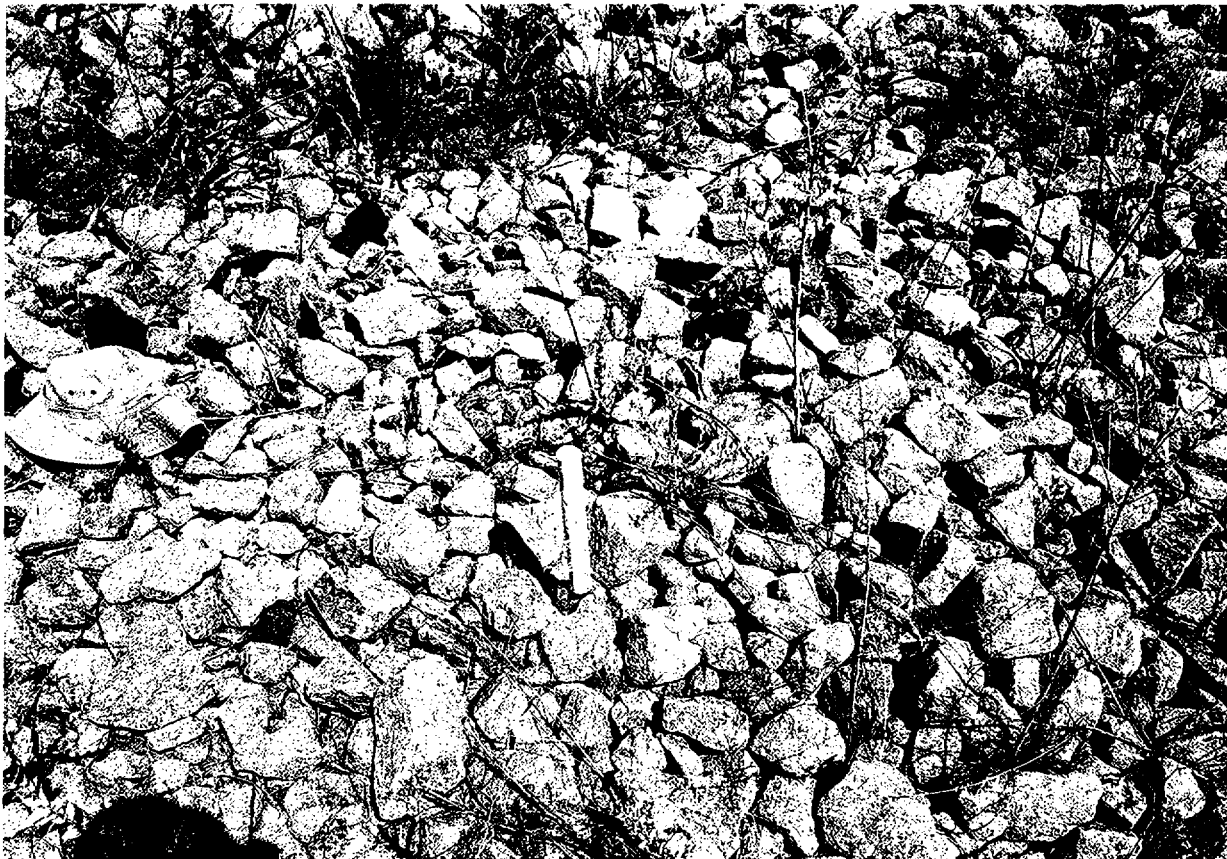
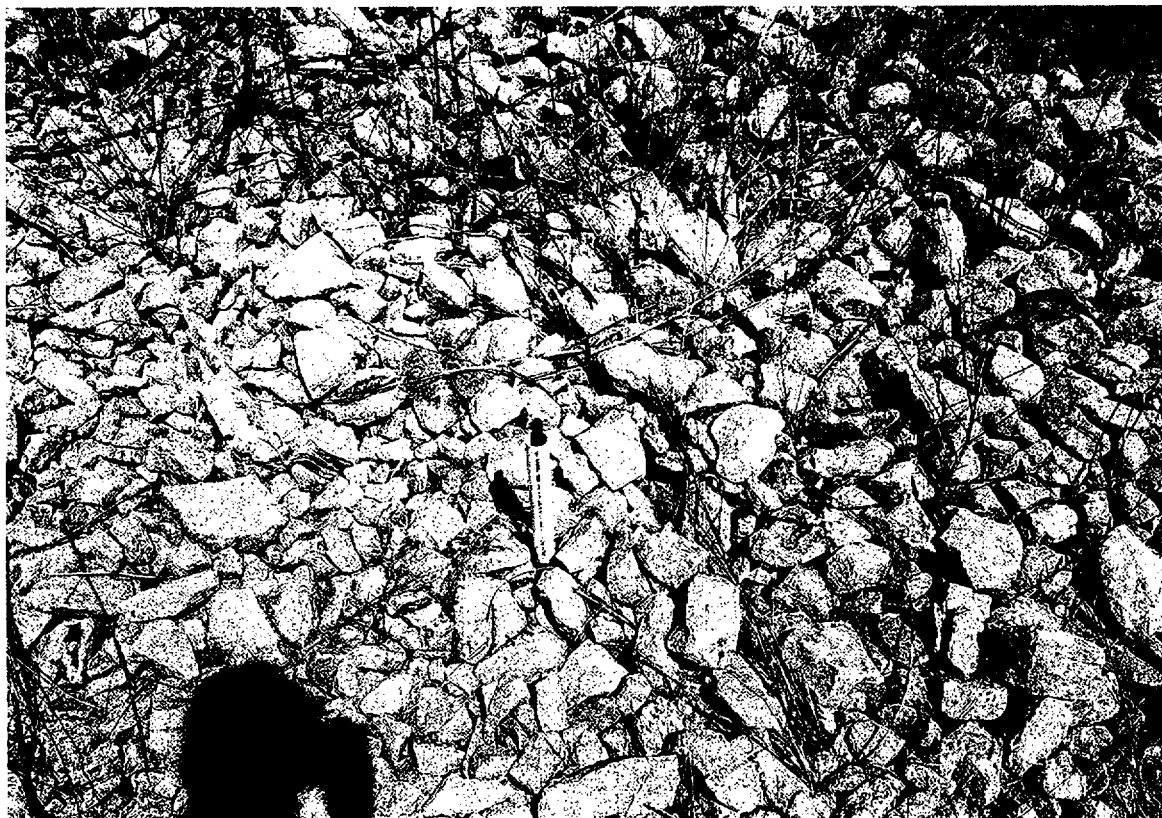
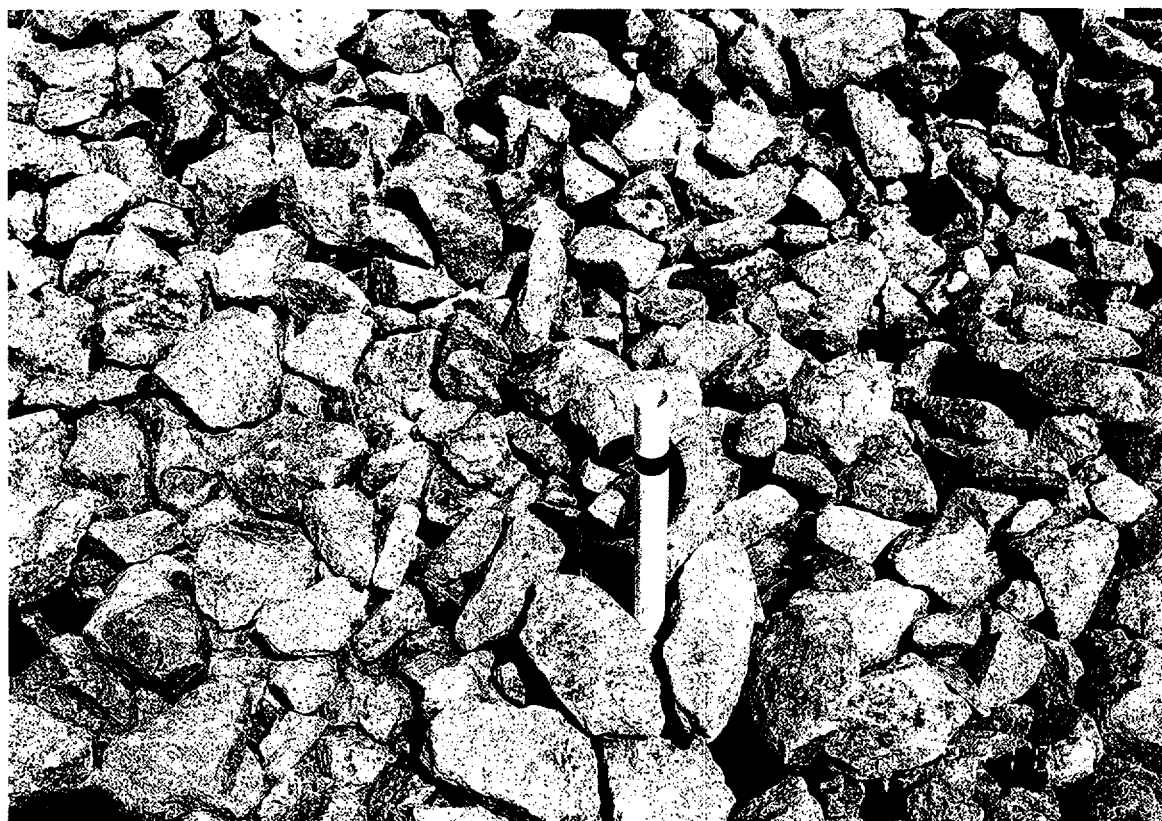
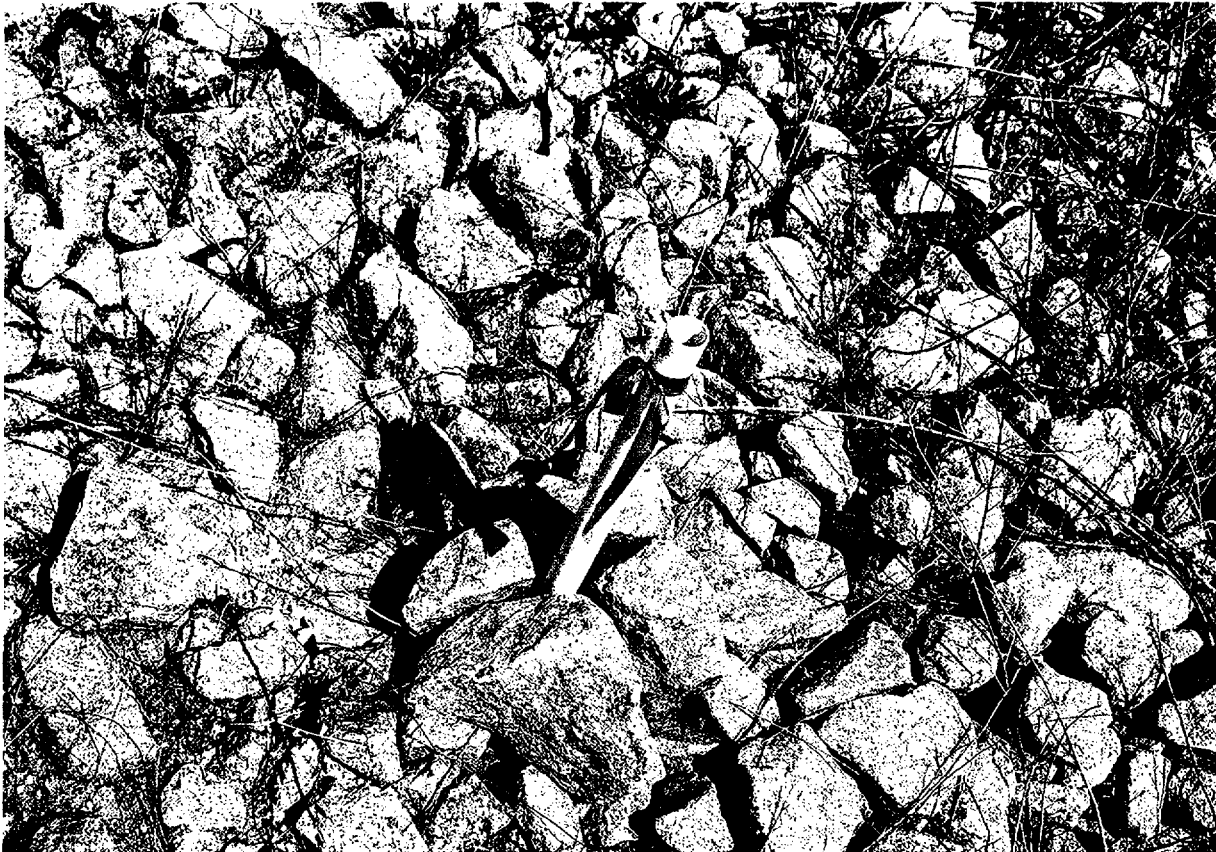
A small percentage of the riprap at the Sherwood site has crumbled. Consequently, at the recommendation of the Nuclear Regulatory Commission representative present during the 2002 inspection, plots for monitoring rock durability on portions of the dam face were established in 2003. The condition of the rock in these plots will be evaluated annually during scheduled inspections.

with a sleeve of PVC pipe or a section of PVC pipe at the center of each plot and obtained location information using global positioning system equipment. Baseline photographs were taken of each plot (facing a northerly direction) (PL-6 through PL-9). Photography should be repeated during future inspections for comparison to baseline rock quality. Future inspectors may recommend changes to the plot inspection frequency or cessation of monitoring.

SHE 8/2003. PL-6. Rock Plot 1.

SHE 8/2003. PL-7. Rock Plot 2.

SHE 8/2003. PL-8. Rock Plot 3.

SHE 8/2003. PL-9. Rock Plot 4.

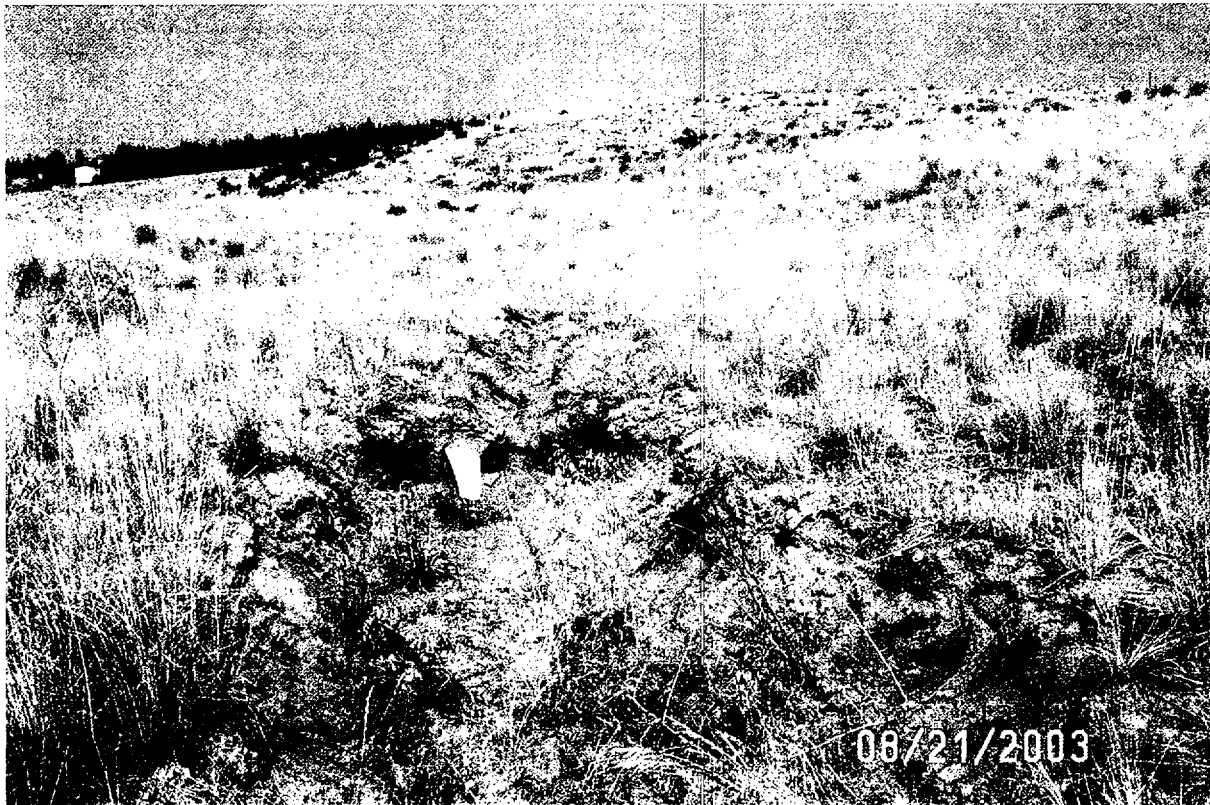
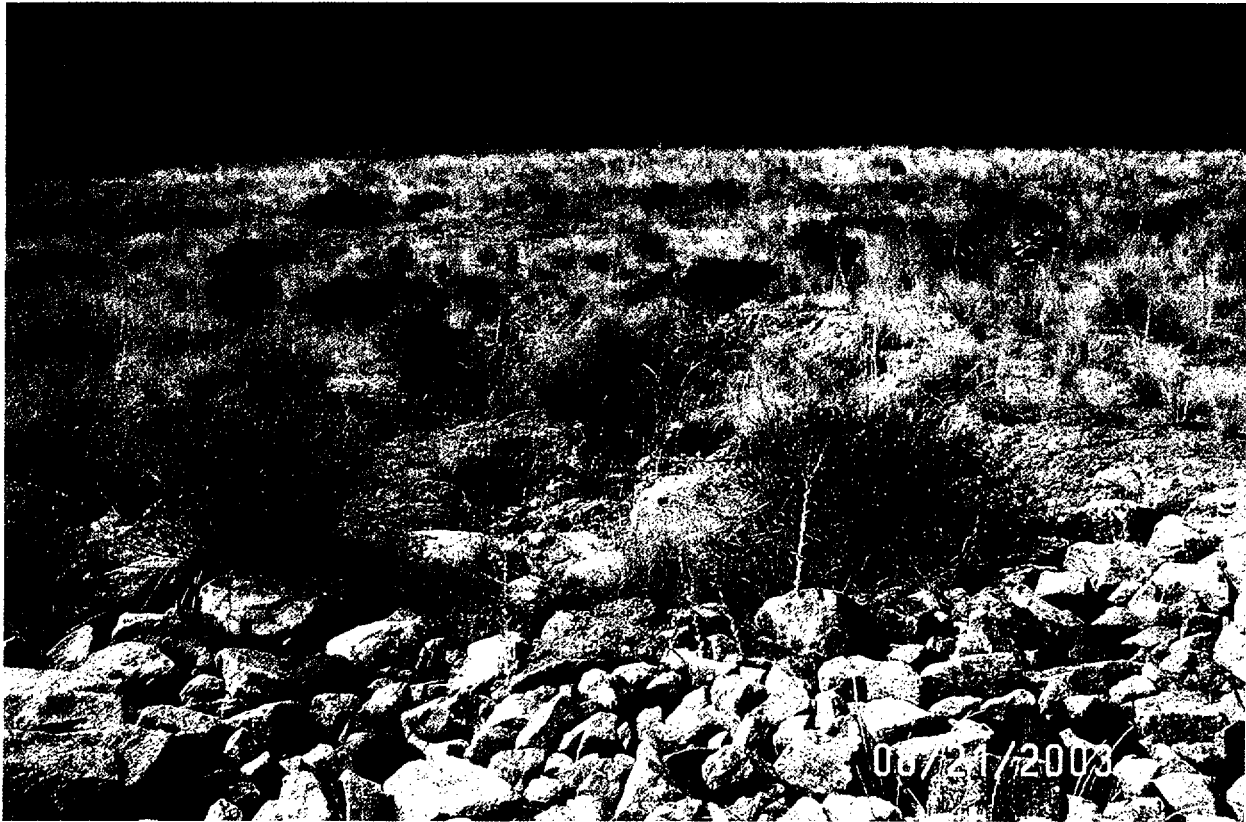
Adjacent to the eastern end of the dam face is a steep slope that is underlain by rock and covered with soil. Numerous rills and gullies noted during previous annual inspections were inspected on this slope (PL-10 through PL-13). No new rills were identified, and the size of existing rills had not increased since the 2001 and 2002 inspections. Although these erosional features do not threaten site integrity, they should be inspected annually to ensure the slope remains stable and sediment is not transported offsite.

SHE 8/2003. PL-10. Gully north of east end of embankment face.

SHE 8/2003. PL-11. Gully and headcut below riprap-armored portion of swale east of embankment face.

SHE 8/2003. PL-12. Gully below riprap-armored portion of swale east of embankment face.

SHE 8/2003. PL-13. Gully below riprap-armored portion of swale east of embankment face.
