**EXAMINATION OF THE REACTOR VESSEL (RV) HEAD DEGRADATION
AT DAVIS-BESSE**

**FRAMATOME ANP, INC.
DOCUMENT 31-5029337-02**

**PREPARED FOR
FRAMATOME ANP, INC.**

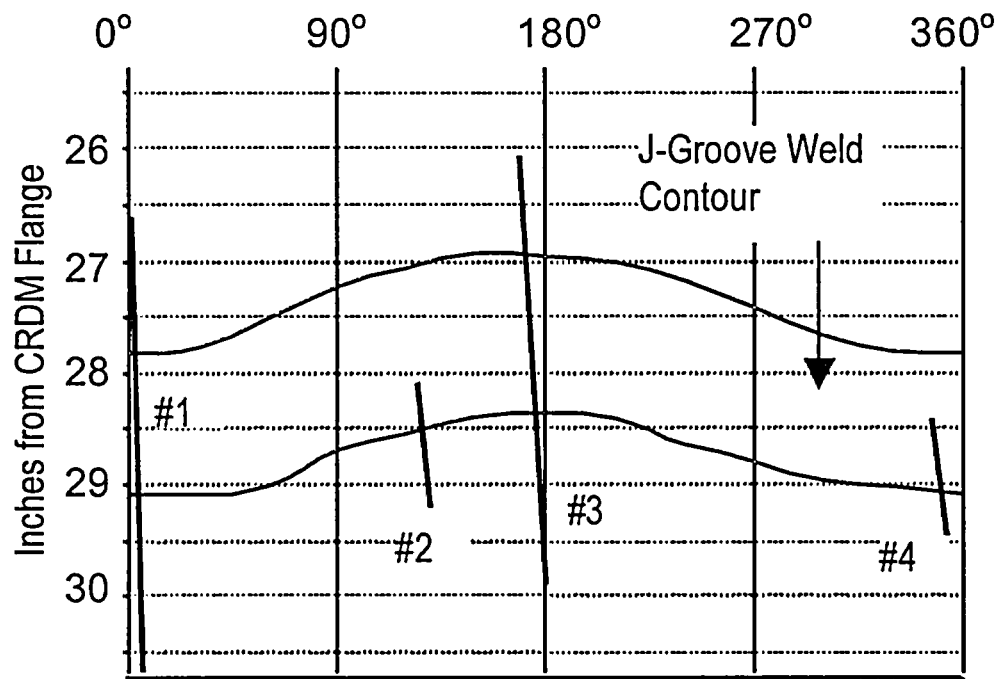
Figure 1.1.2: On-site NDE of nozzle #3 showed 4 axial cracks. Cracks #1 and #3 were through-wall, while cracks #2 and #4 were partially through-wall.

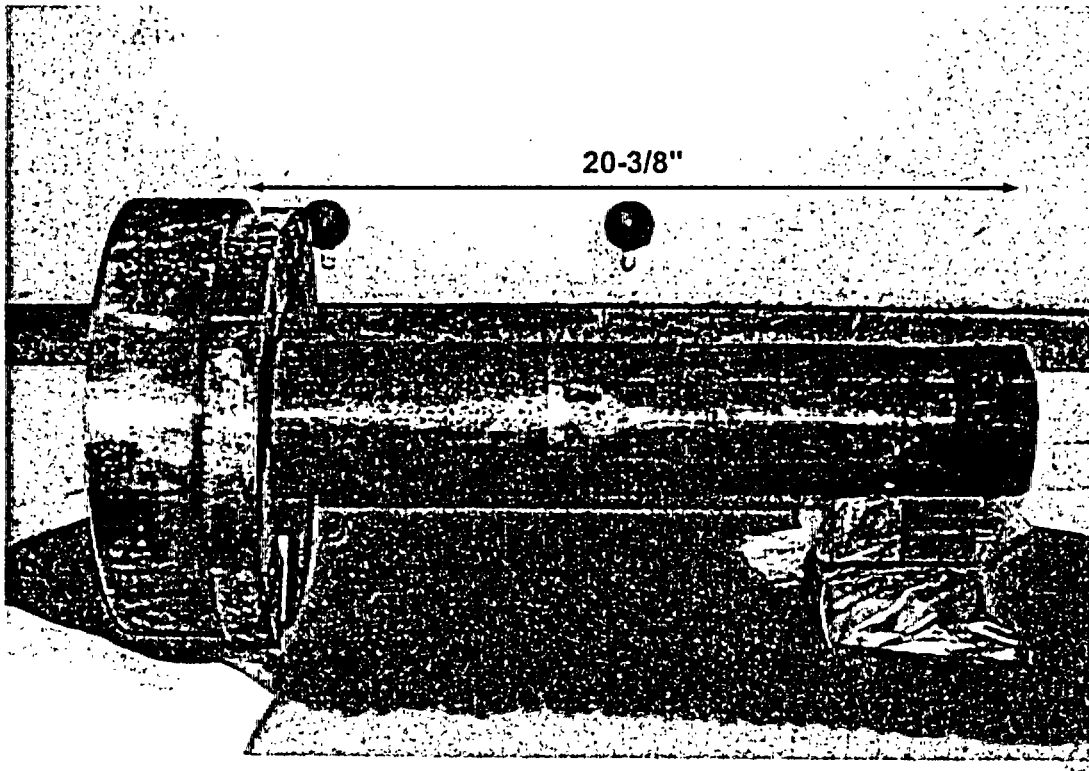
Figure 2.1.1 provides a side view macro photograph showing the as-received condition of nozzle #2. The measured distance from the underside of the flange to the end of the nozzle was $20\text{-}3/8$ " and the reduced diameter portion of the nozzle end measured $3\text{-}3/8$ ". These measurements indicated approximately $7\text{-}5/8$ " of the nozzle end was bored away during the nozzle removal process from the RV head. Figure 2.1.2 shows the end view of nozzle #2. It was determined that the boring tool extended approximately 3" up into the lower end of the nozzle. Visual inspections on the lower end of this nozzle revealed no evidence of cracking; it is believed that the cracks were bored out during the removal process.

Figure 2.1.1: Nozzle #2 side view. Approximately 7-5/8" was bored away during the removal process.

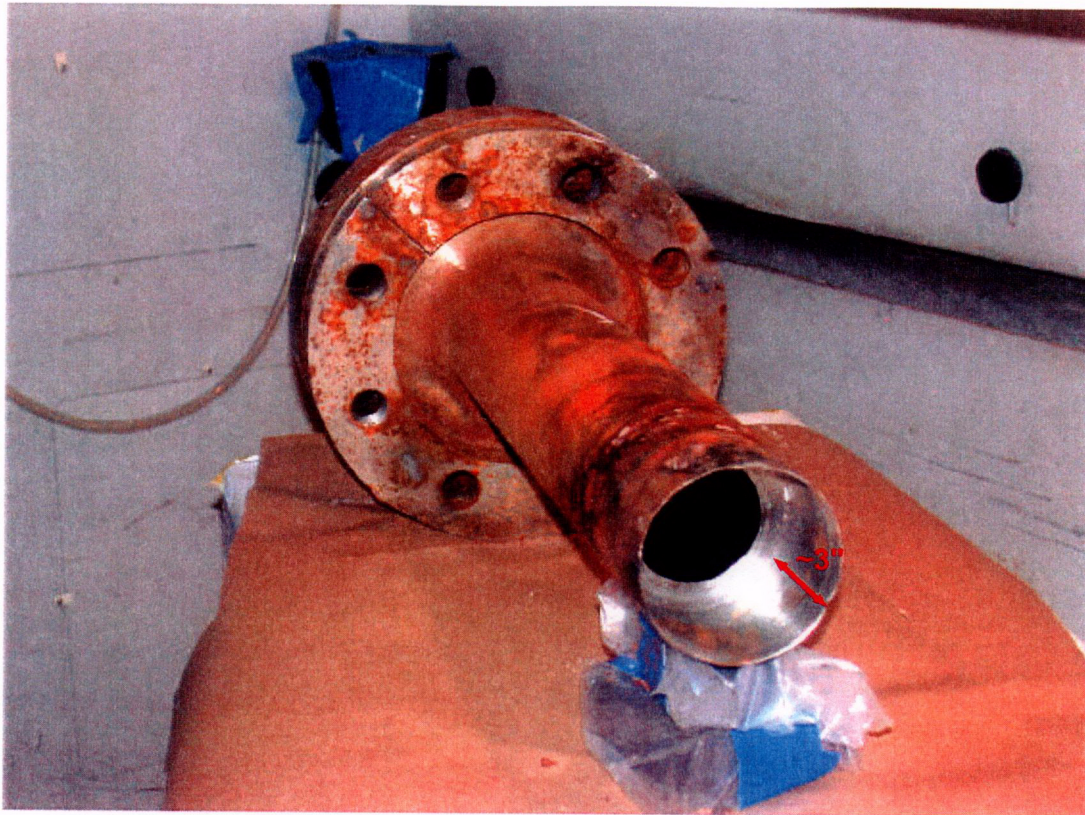
Figure 2.1.2: Nozzle #2 end view looking at bottom. The boring tool extended ~3" up from the bottom of the nozzle. There was no evidence of cracking found.

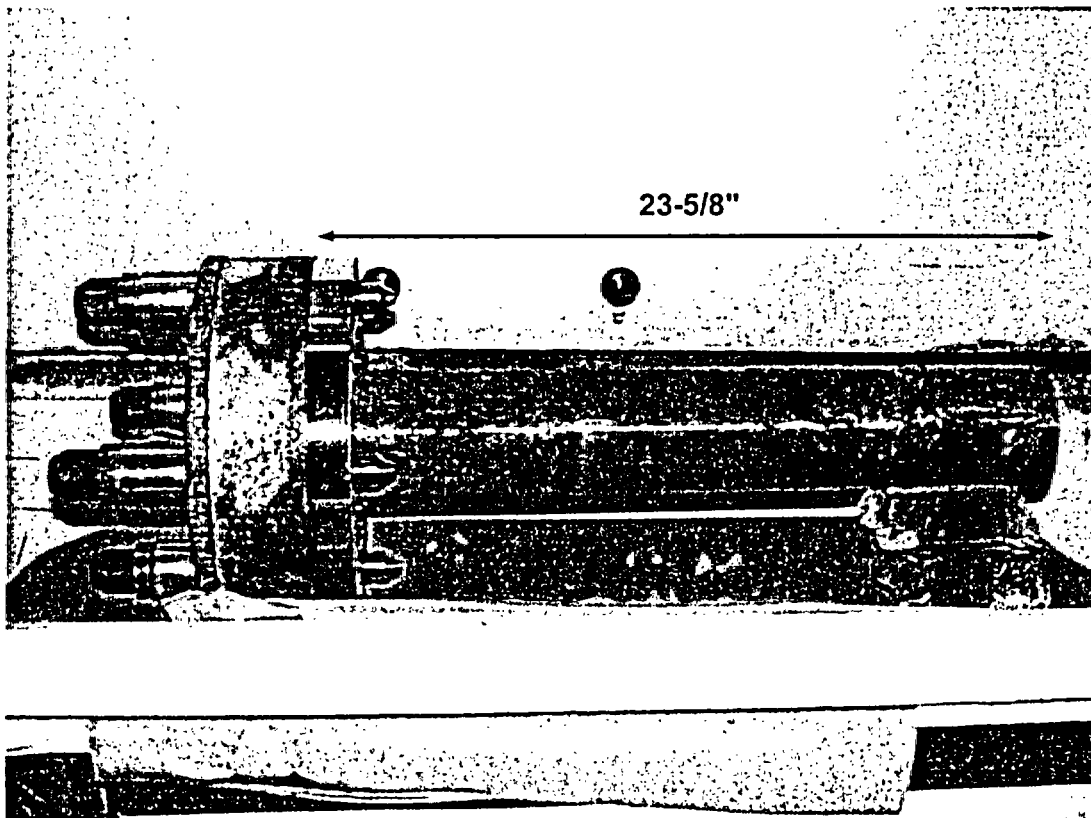
An overall photograph showing the as-received condition of nozzle #3 is presented in Figure 2.2.1. The measured distance from the underside of the flange to the end of the nozzle was $23\text{-}5/8$ " and the reduced diameter portion of the nozzle end measured $6\text{-}1/2$ ". These measurements indicated approximately $4\text{-}1/2$ " of the nozzle end was bored away

Figure 2.2.1: Nozzle #3 side view. Approximately 4-1/2" was bored away during the removal process. 0° orientation is upward in photo.

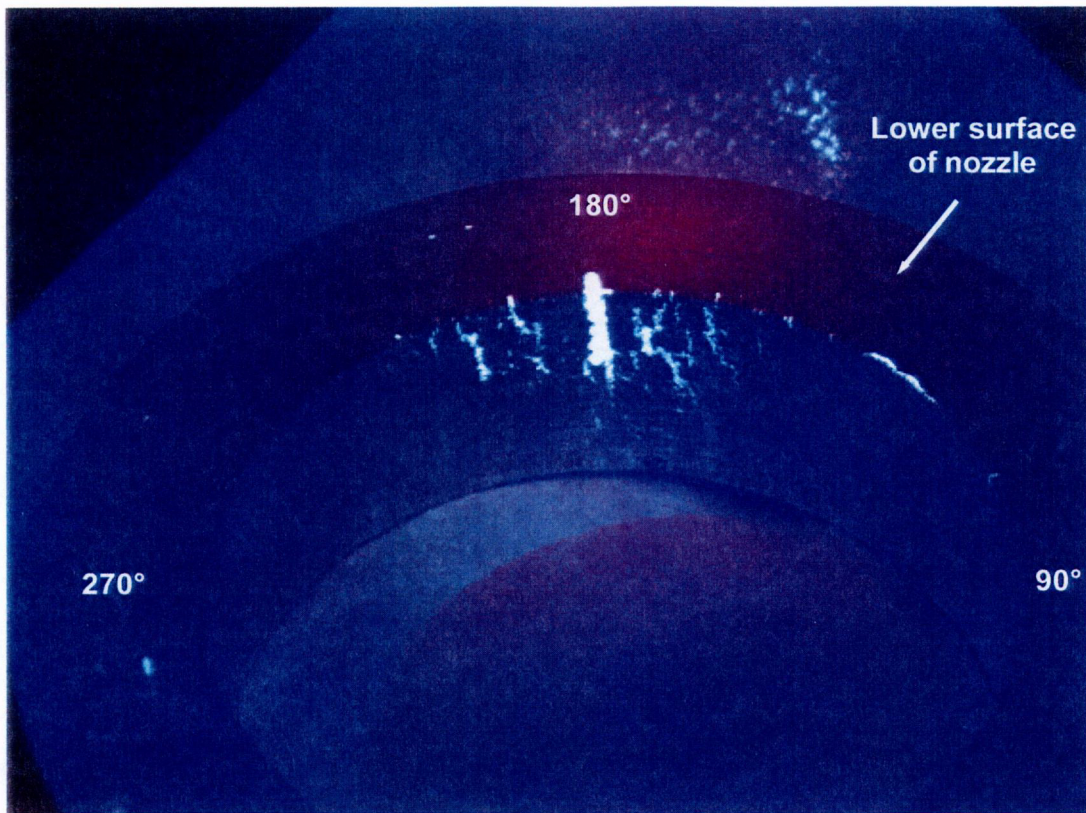
A fluorescent dye penetrant test was performed on the exposed surfaces of piece C. This test revealed several axial cracks present on the lower portion of the nozzle inner diameter (ID) surface near the 180° orientation (i.e., uphill side of nozzle opposite the cavity). Refer to Figure 2.4.1 for the results of this examination. The largest crack in this area extended approximately 0.5" in length axially and ~0.125" deep radially from the ID surface of the nozzle. No other indications were found. It is evident that all other cracks identified by on-site NDE were within the 4-1/2" section bored away during the CRDM nozzle removal process.

Figure 2.4.1: Photograph taken under a black light showing the PT results for nozzle #3. Several axial cracks were present near 180°; the largest crack extended ~0.5" in length axially and ~0.125" deep radially from the ID surface.

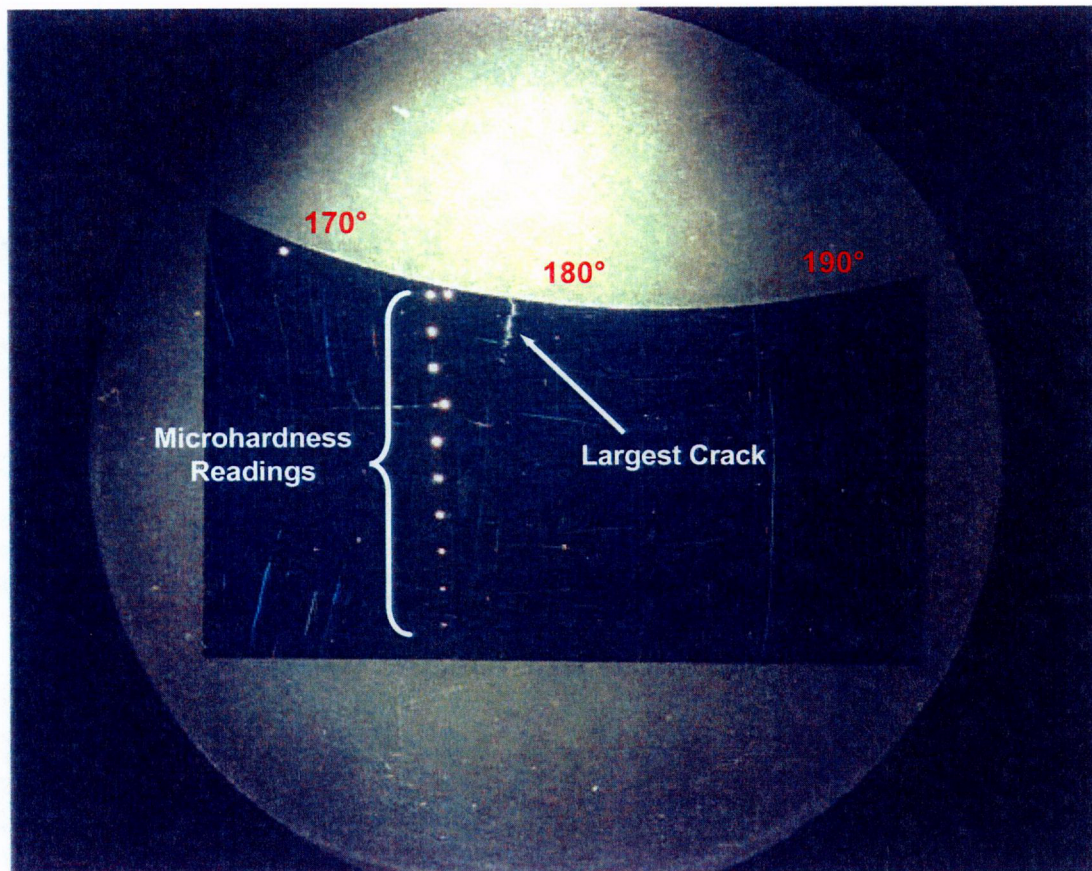
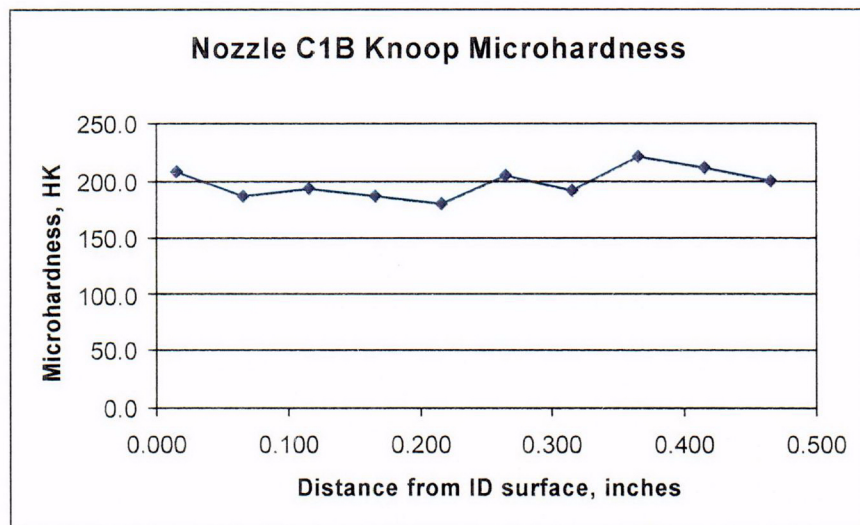
Figure 2.6.1 provides a low magnification photograph of the mounted sample C1B. In this photograph, the largest crack is visible near 180° along with the string of Knoop microhardness indents near 175°. The base material hardness was generally uniform across the nozzle wall in the area tested and ranged from HK 179.1 to 221.3 (refer to the table in Figure 2.6.1).

Figure 2.6.1: Low magnification photograph of the nozzle #3 C1B metallographic mount showing location of largest crack and Knoop microhardness indents (top) and microhardness results (bottom).

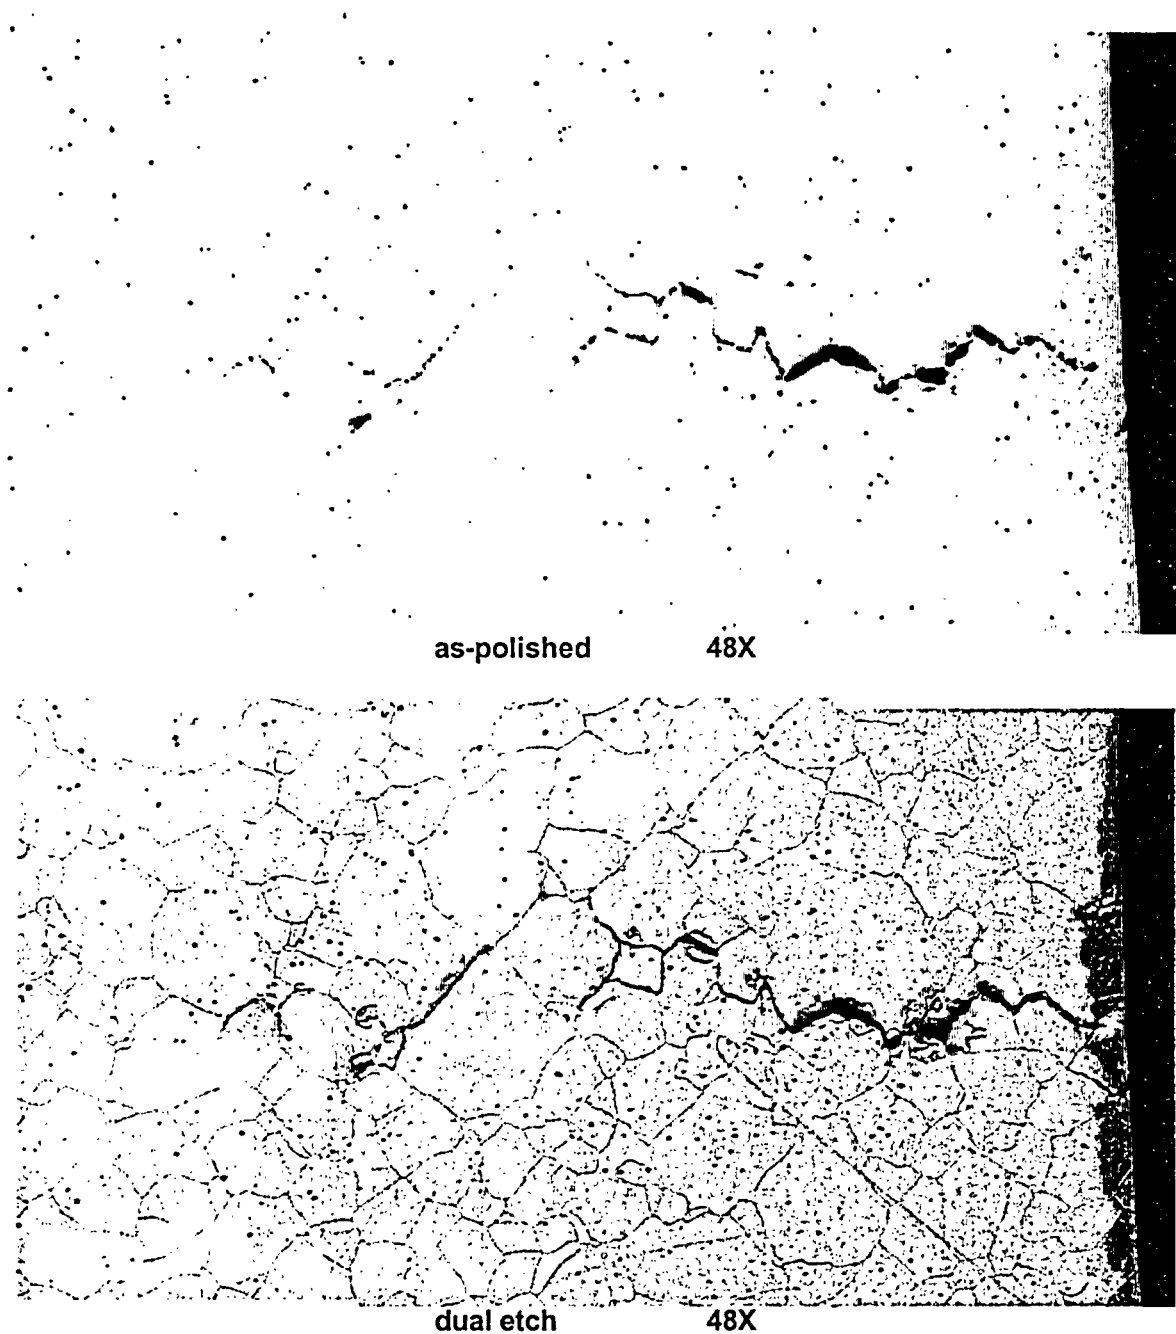
Figure 2.6.2 provides higher magnification micrographs of the largest crack at 180°, which extended approximately 0.1" below the nozzle ID surface. The crack path is clearly intergranular in nature. The same crack morphology was observed for a smaller crack located near 170° (Figure 2.6.3). This crack extended approximately 0.05" below the nozzle ID surface. Micrographs showing the typical appearance of the nozzle base material microstructure are provided in Figure 2.6.4 (100X) and Figure 2.6.5 (375X). The microstructure consisted of equiaxed grains ranging in size from ASTM 1 to 6, with an average size of ASTM 3. Also observed throughout the microstructure were titanium or niobium carbonitrides (large yellow-to-orange color particles in Figure 2.6.6) and a semi-continuous to discontinuous network of grain boundary carbides.

Figure 2.6.2: Micrographs showing the intergranular nature of the largest crack near 180°. The crack extended approximately 0.1" below the nozzle ID surface (located to the right in these micrographs).

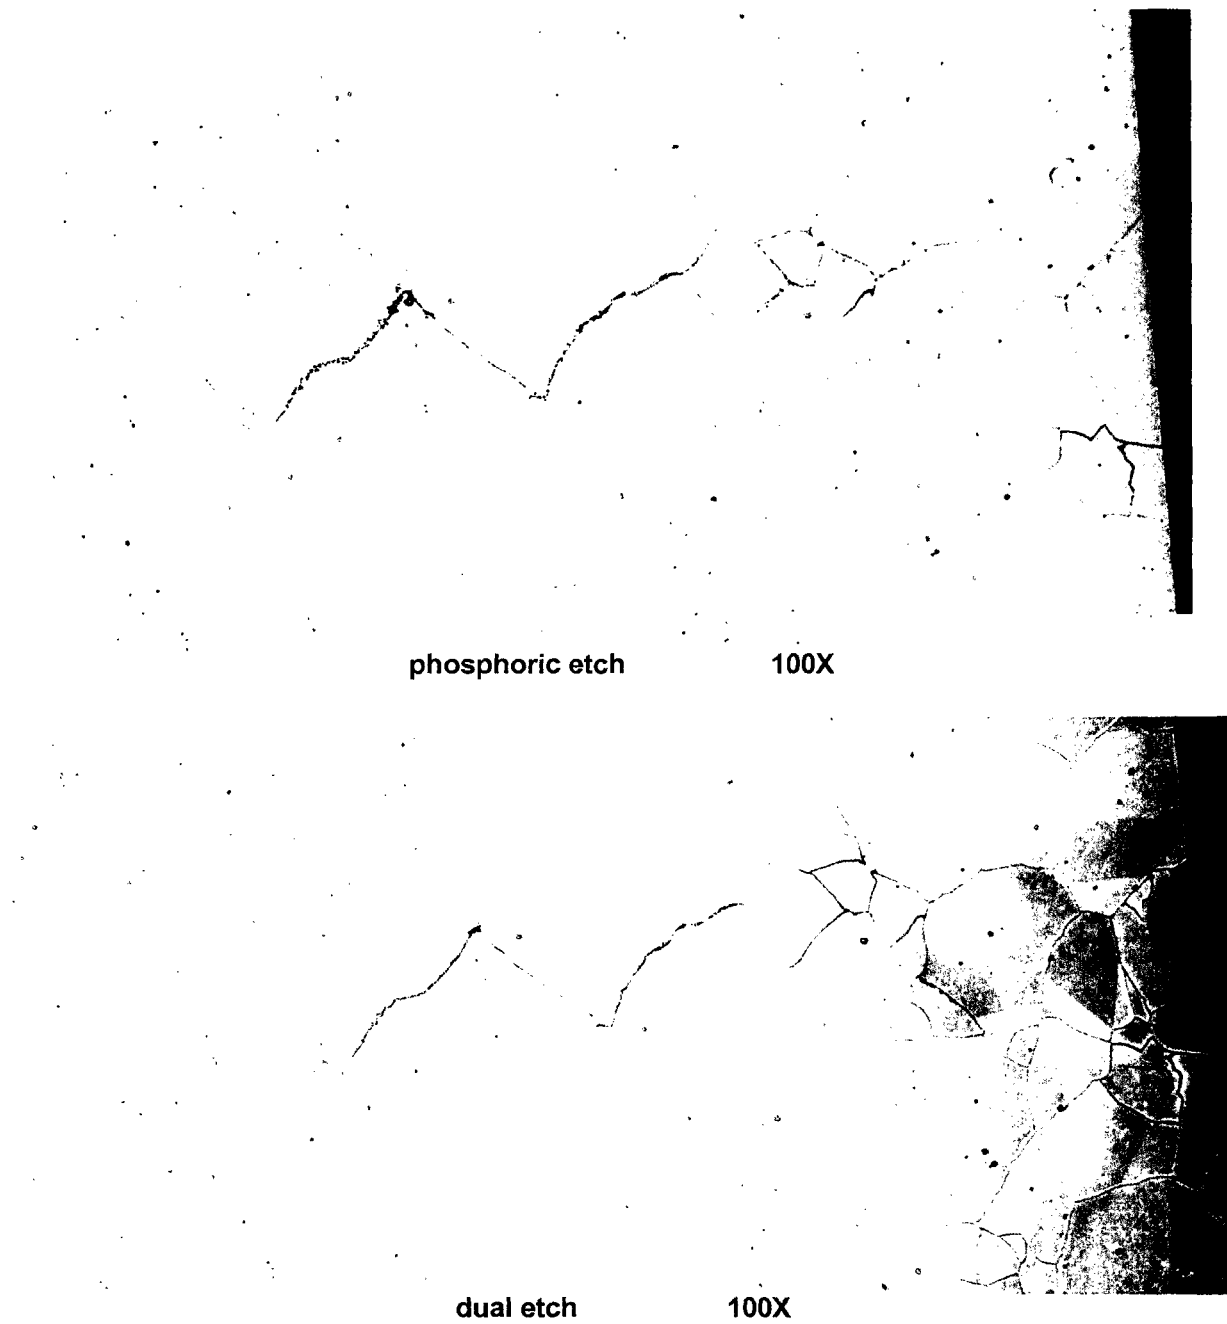
Figure 2.6.3: Micrograph showing the intergranular nature of a smaller nozzle crack located near 170°. This crack penetrated approximately 0.05" below the nozzle ID surface (located to the right in these micrographs).

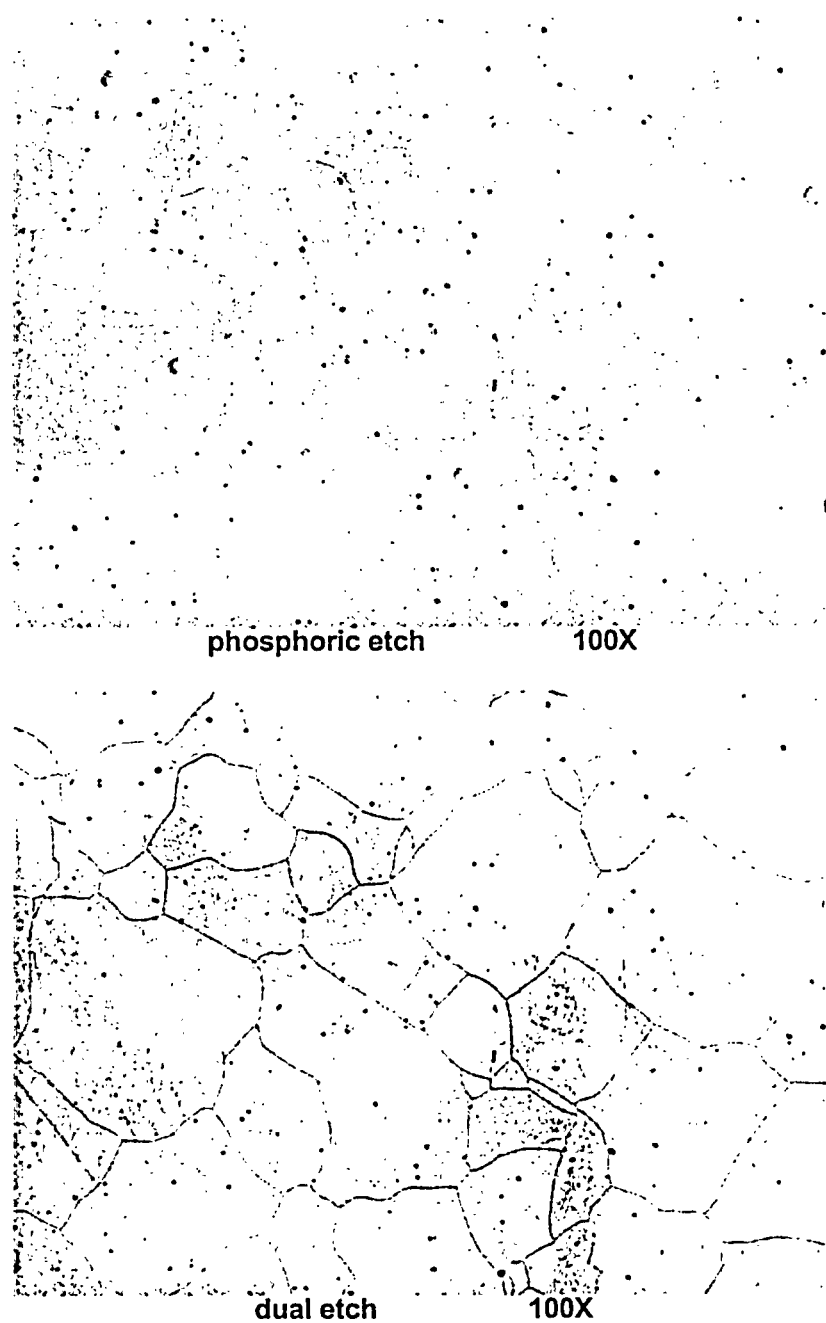
Figure 2.6.4: Typical micrographs of the nozzle base material. The grain size ranged from ASTM 1-6 and averaged ASTM 3.

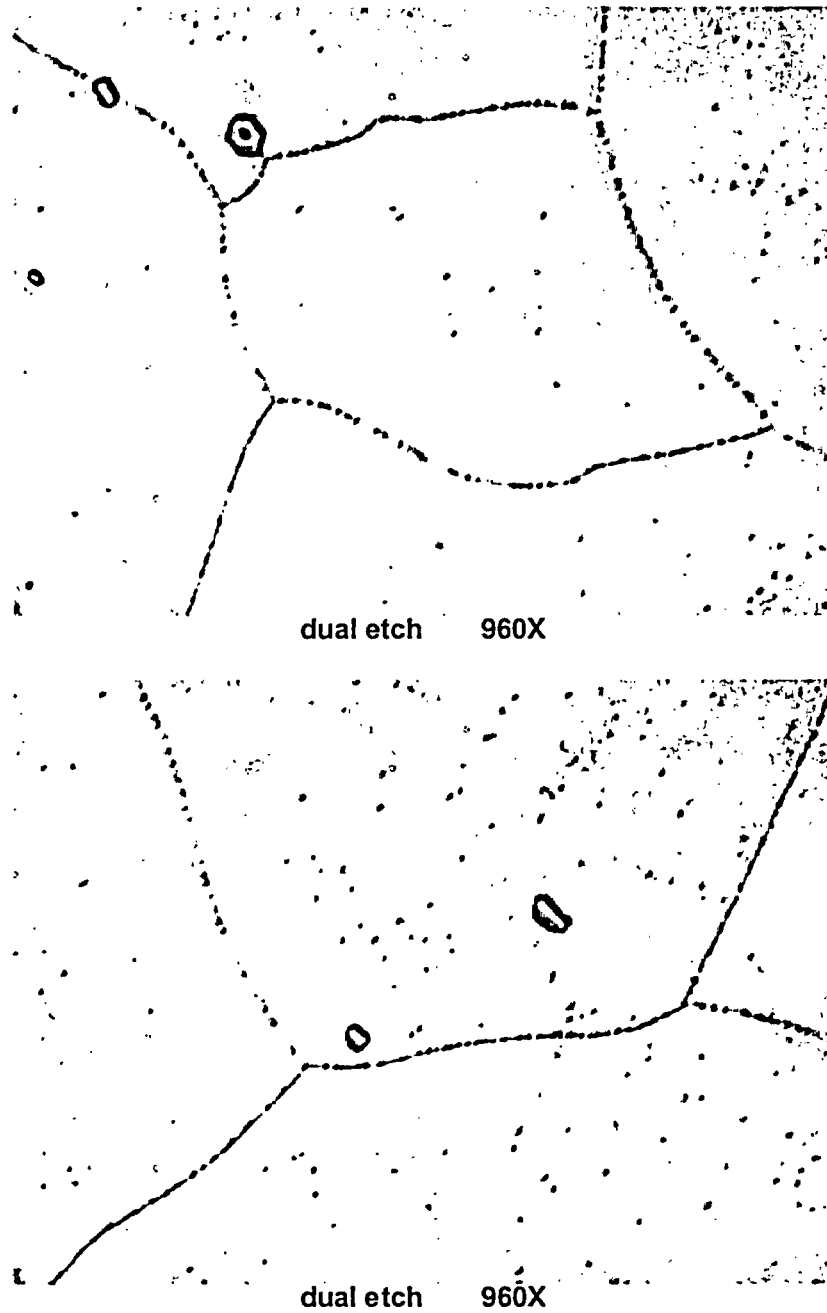
Figure 2.6.6: Higher magnification micrographs showing the discontinuous nature of the carbides at the grain boundaries.

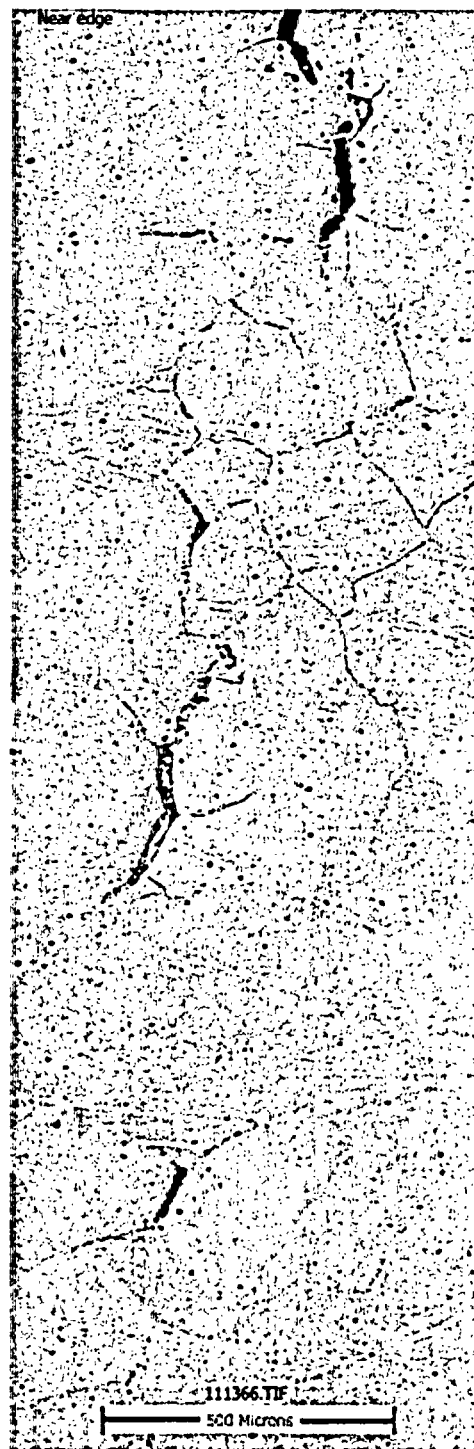
Figure 2.7.2: Mosaic showing full crack length (BSE), which was approximately 0.08" below the ID surface. Cracking was intergranular. ~82X

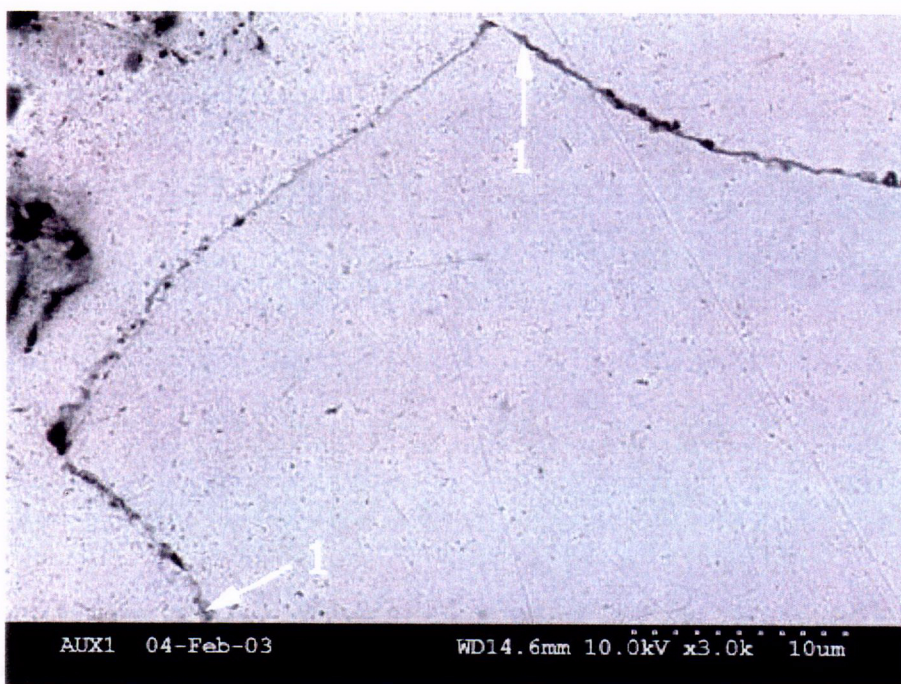
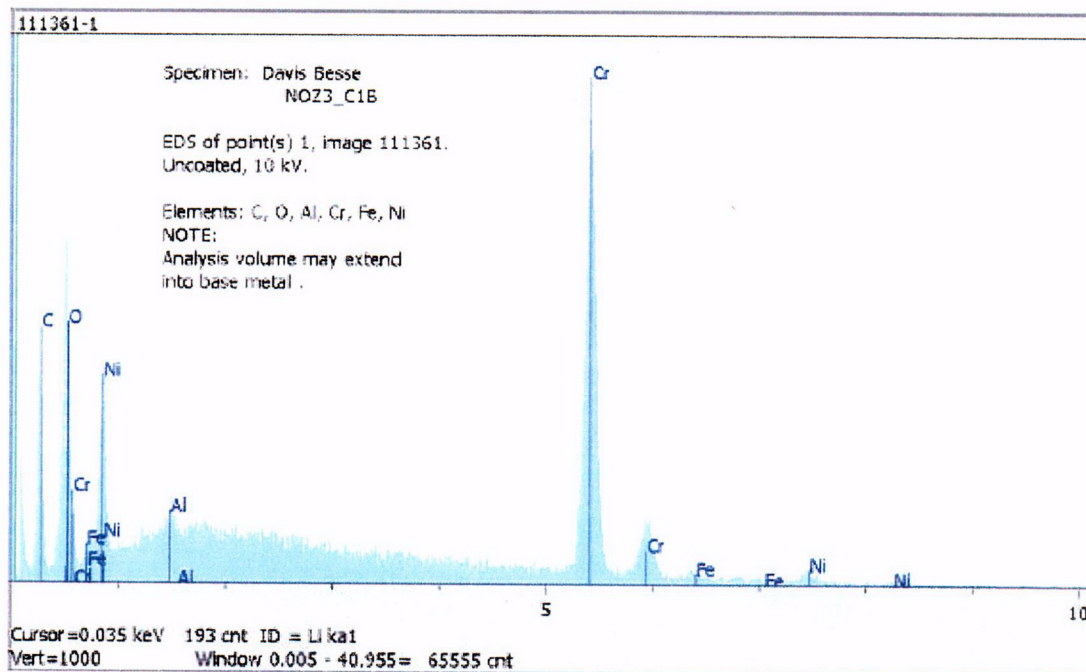
Figure 2.7.3: The grain boundary (points designated "1") contained carbon, oxygen, aluminum, chromium and nickel.

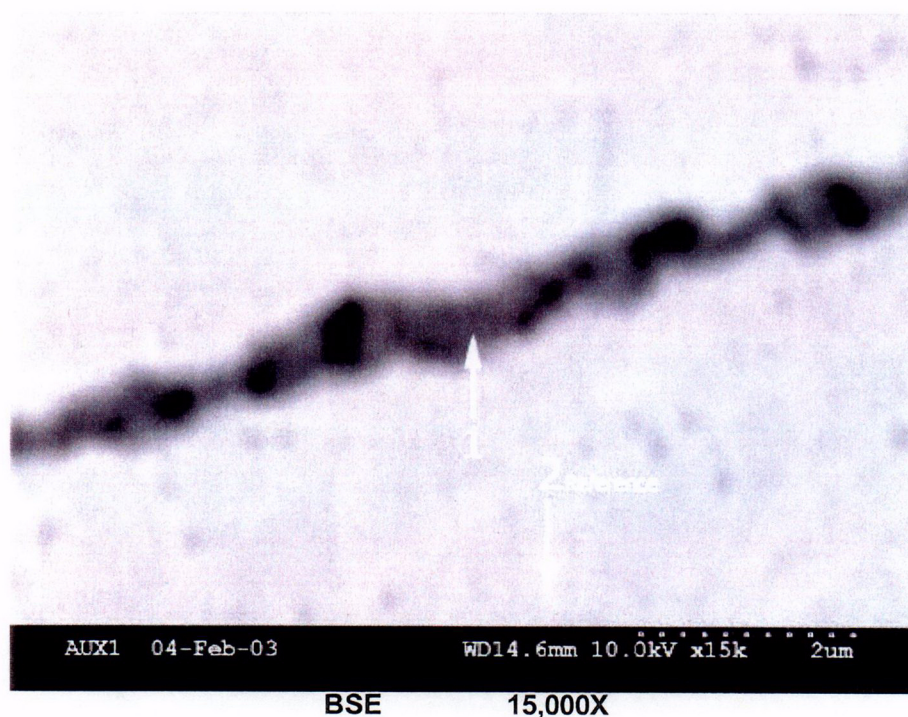
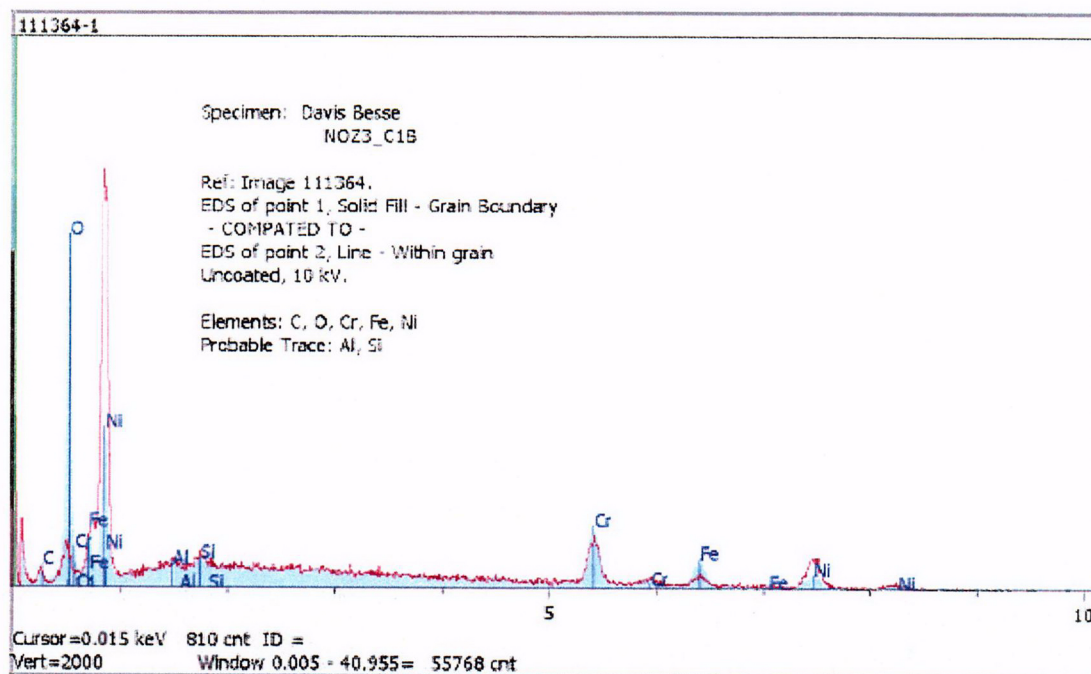
Figure 2.7.4: The grain boundary (solid fill) contained higher oxygen and chromium compared to the bulk grain (line spectrum) (Note: The BSE image was defocused in order to optimize the EDS count rate.)

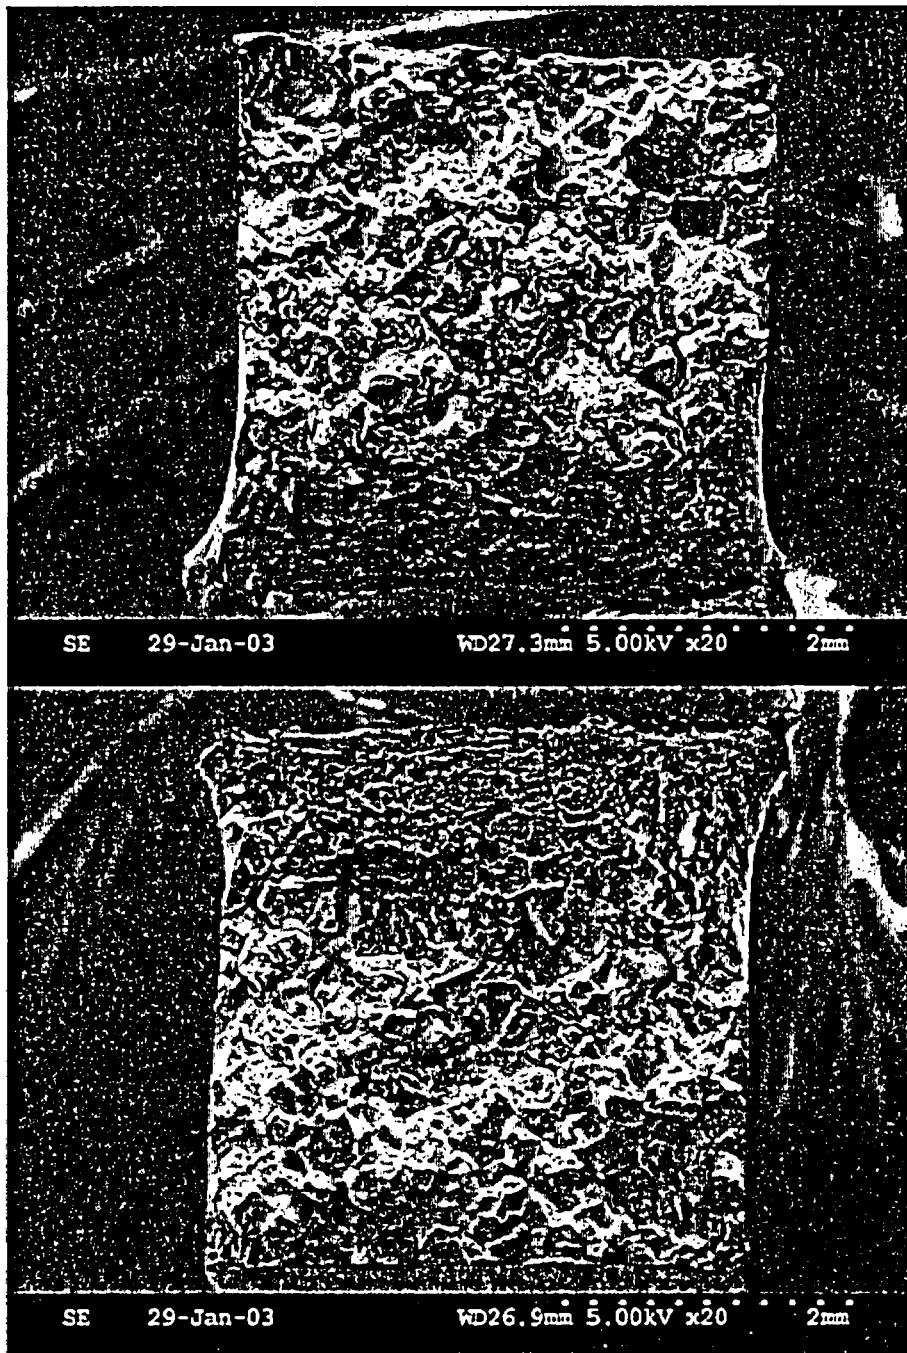
The lower portion of the largest crack was opened up for SEM/EDS examinations. Low magnification micrographs taken in the SE and BSE imaging modes are presented in Figures 2.7.6 and 2.7.7, respectively. The in-service cracking was intergranular and extended approximately 0.12" maximum below the nozzle ID surface. In the BSE imaging mode, the in-service fracture surface exhibited a darker contrast compared to the laboratory fracture, which is indicative of an oxide layer (i.e., lower atomic number) on the in-service fracture surface. SE micrographs showing the typical appearance of the fracture surface near the nozzle ID surface and toward the crack tip are provided in Figure 2.7.8. The intergranular grain facet selected for EDS analysis is shown in Figure 2.7.9 along with the EDS spectrum. In this area, the grain boundary layer contained carbon, oxygen, aluminum, silicon, chromium, iron, and nickel, along with a trace amount of titanium.

Figure 2.7.6: SE images of two halves of nozzle open crack sample. In-service cracking was intergranular in nature and extended a maximum ~0.12" deep. The laboratory fracture was ductile. 20X

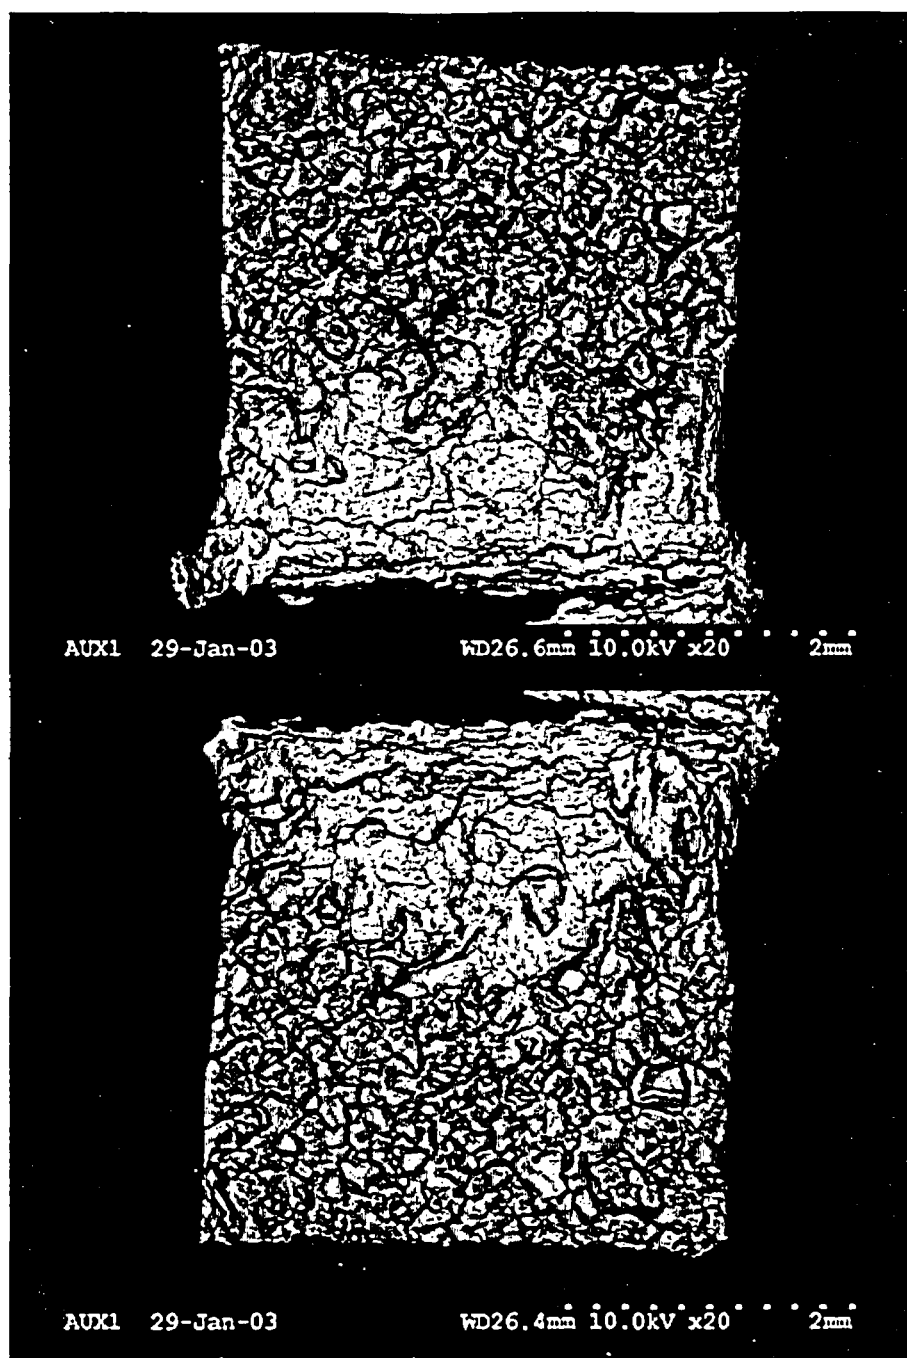
Figure 2.7.7: BSE images of two halves of nozzle open crack sample. The darker contrast of the in-service crack indicates the presence of an oxide layer (lab fracture is fresher) 20X

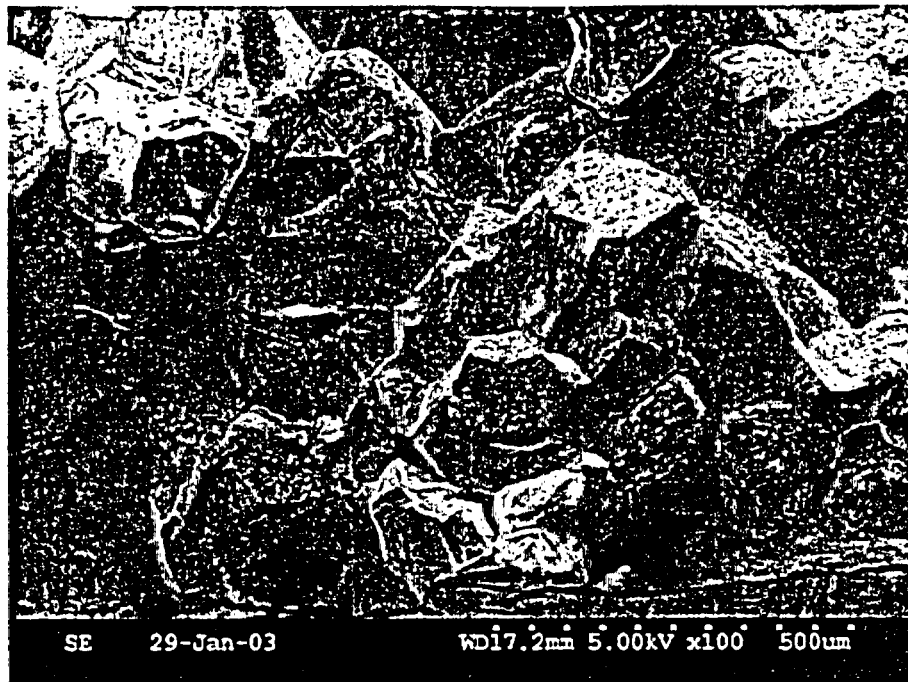
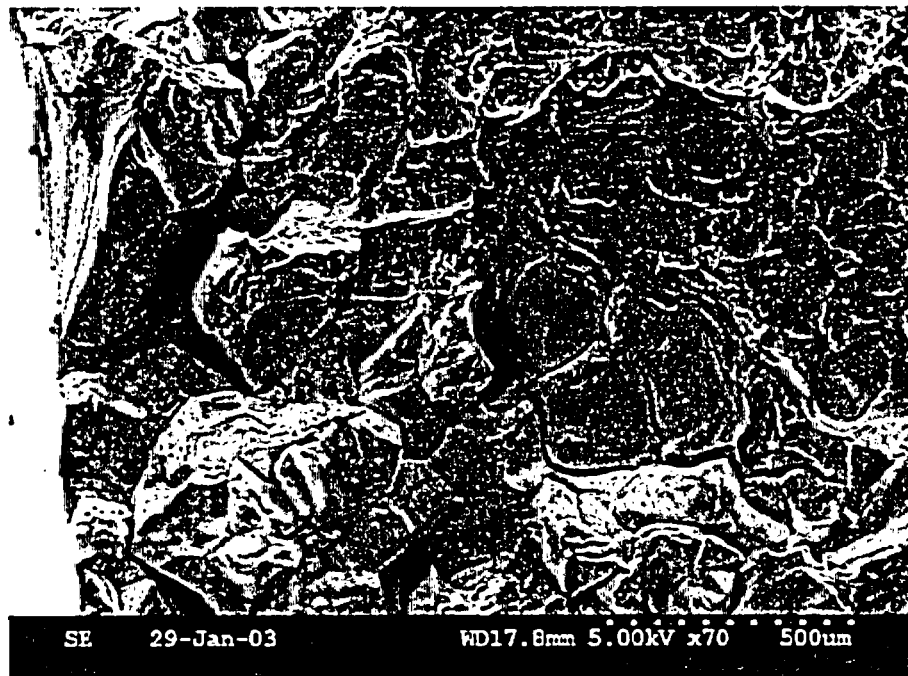
Figure 2.7.8: Micrographs showing typical intergranular appearance of in-service crack (top-near ID; bottom-at crack tip).

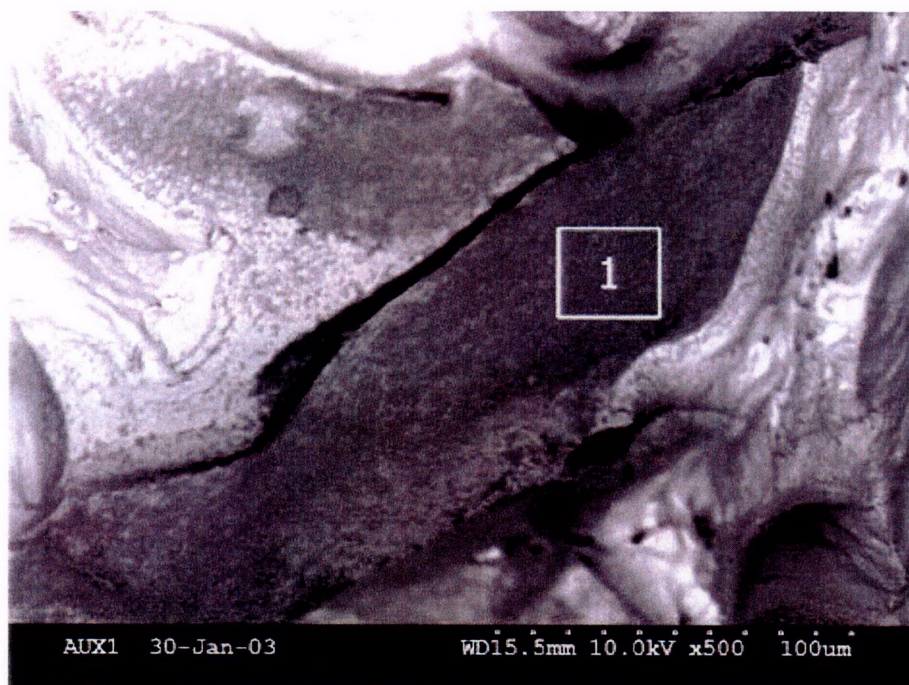
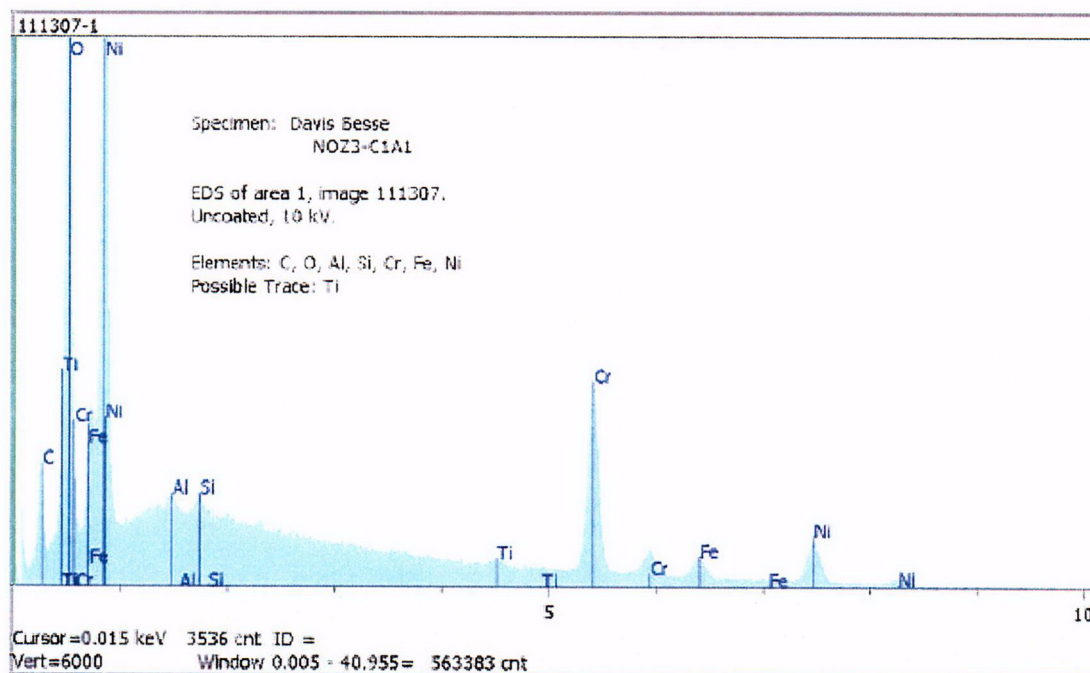
Figure 2.7.9: EDS spectrum collected from area 1 above. This area contained carbon, oxygen, aluminum, silicon, chromium, iron, and nickel, along with a trace amount of titanium.
