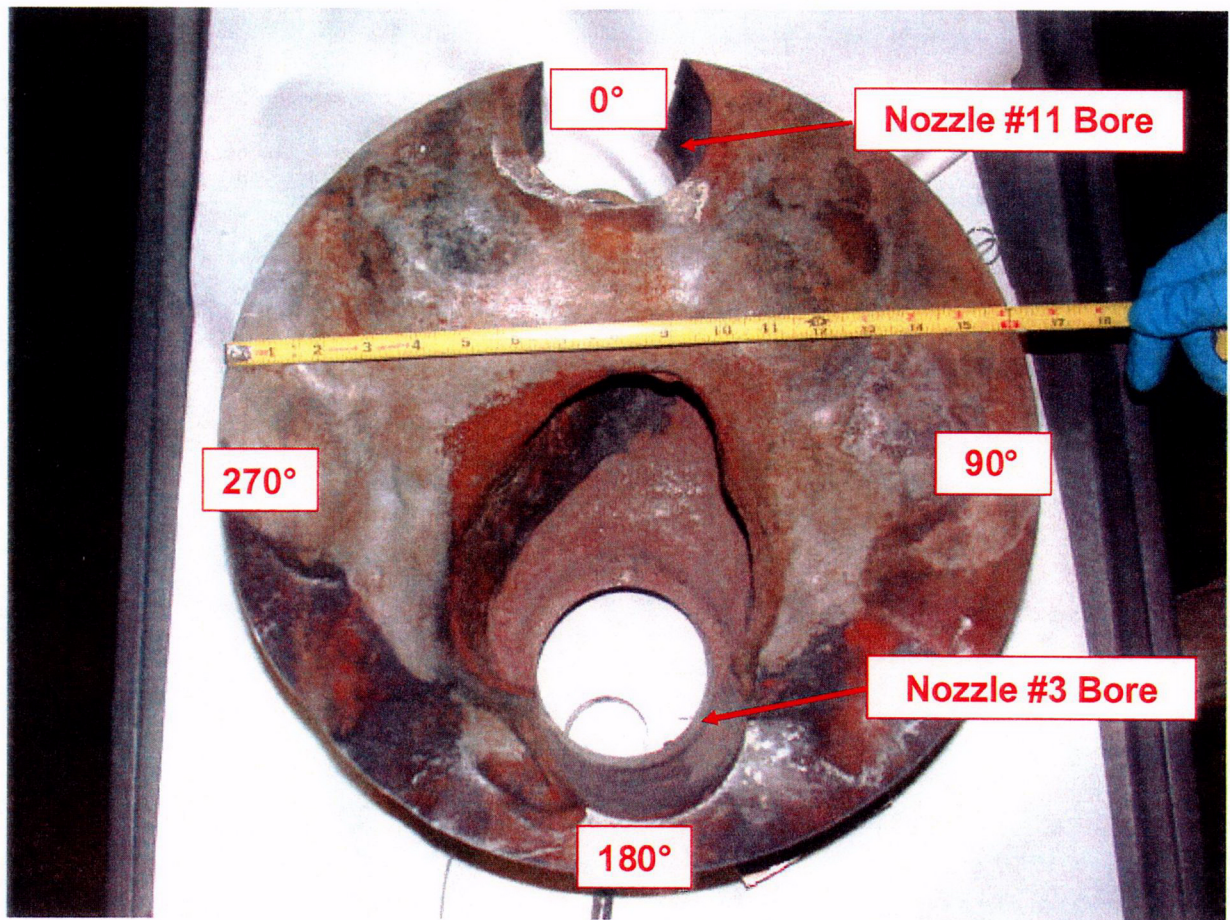
Figure 3.1.1: Top view of as-received cavity sample.

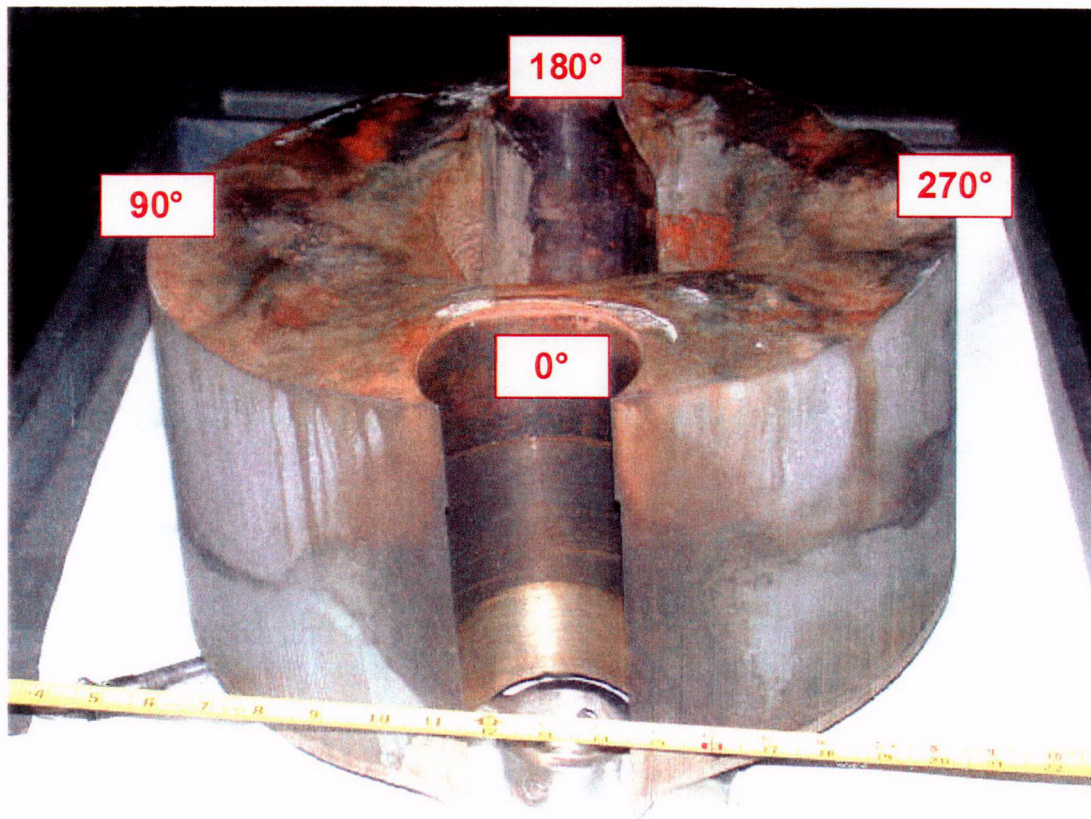
Figure 3.1.2: View of as-received cavity sample from nozzle #11 bore side.

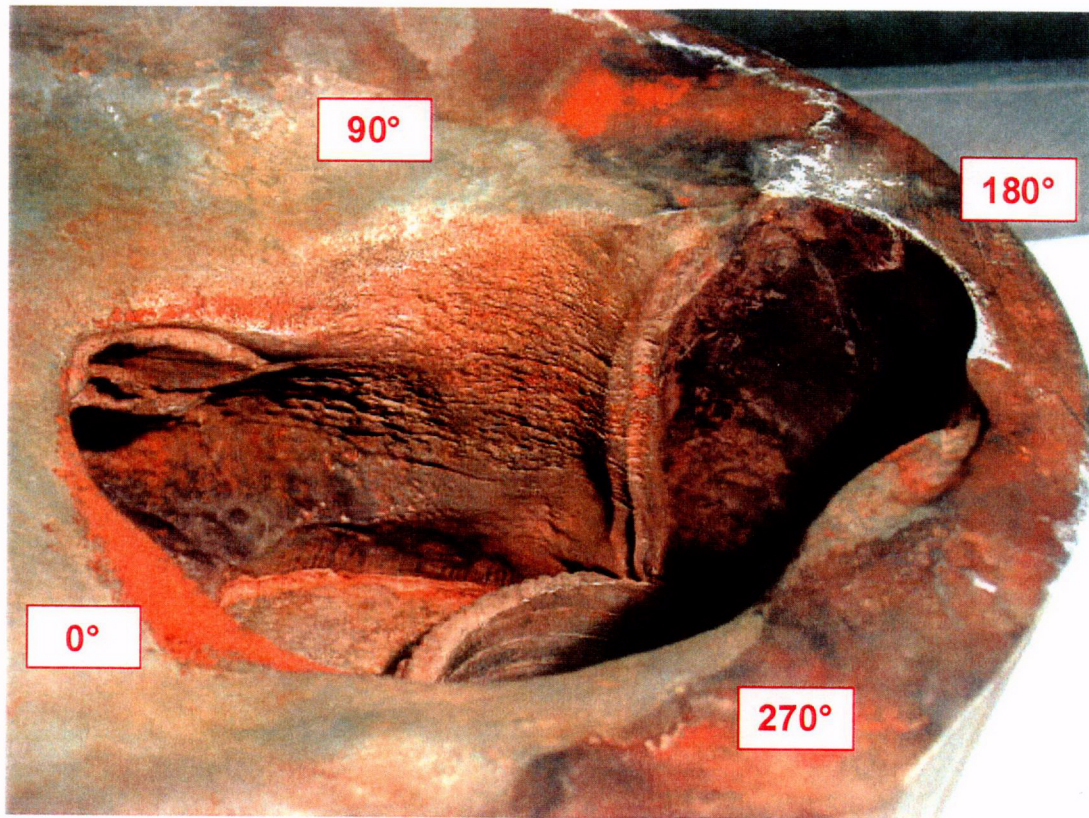
Figure 3.1.3: View of cavity looking toward 90°.

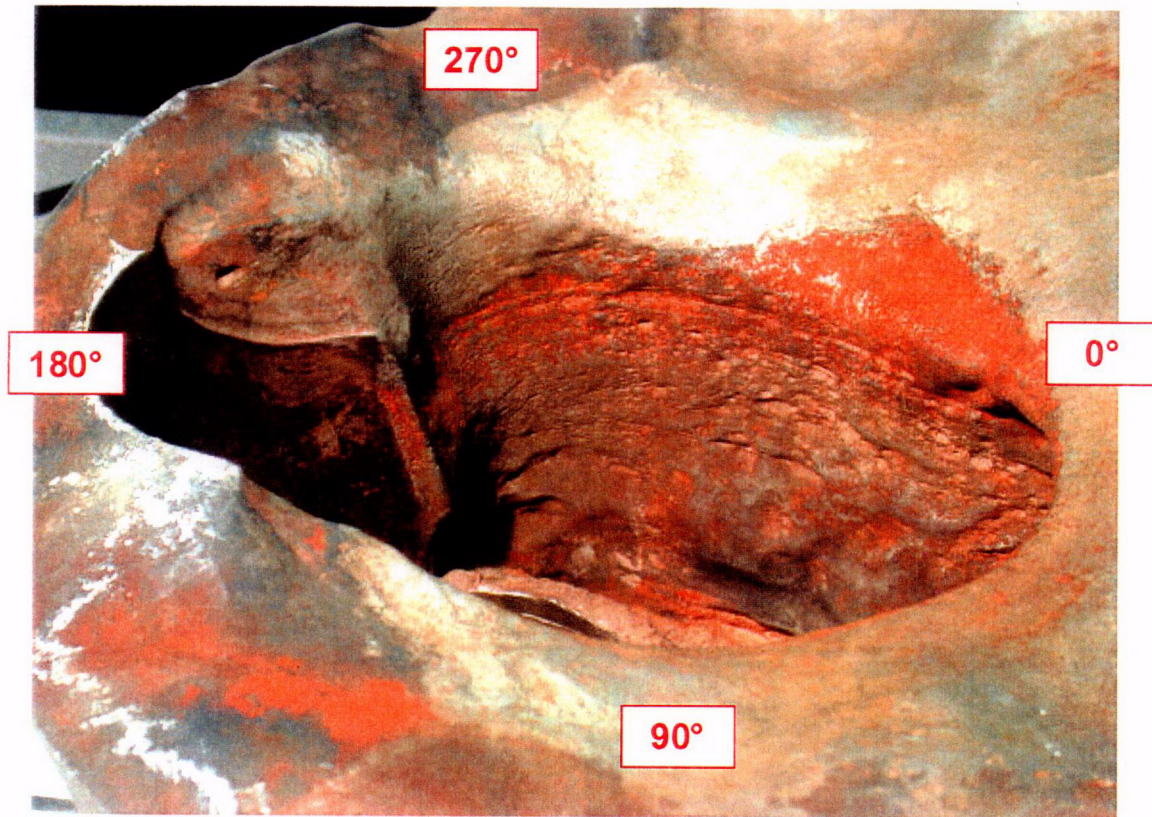
Figure 3.1.4: View of cavity looking toward 270°.

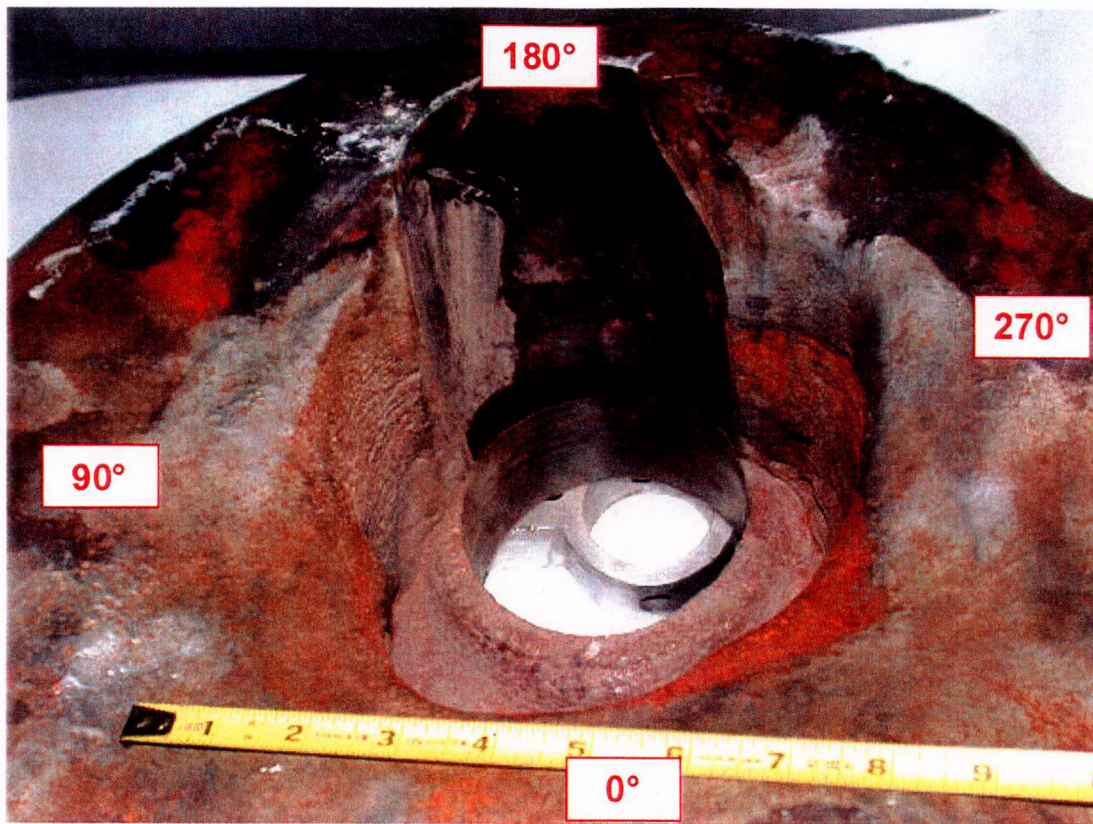
Figure 3.1.5: Looking toward 180°.

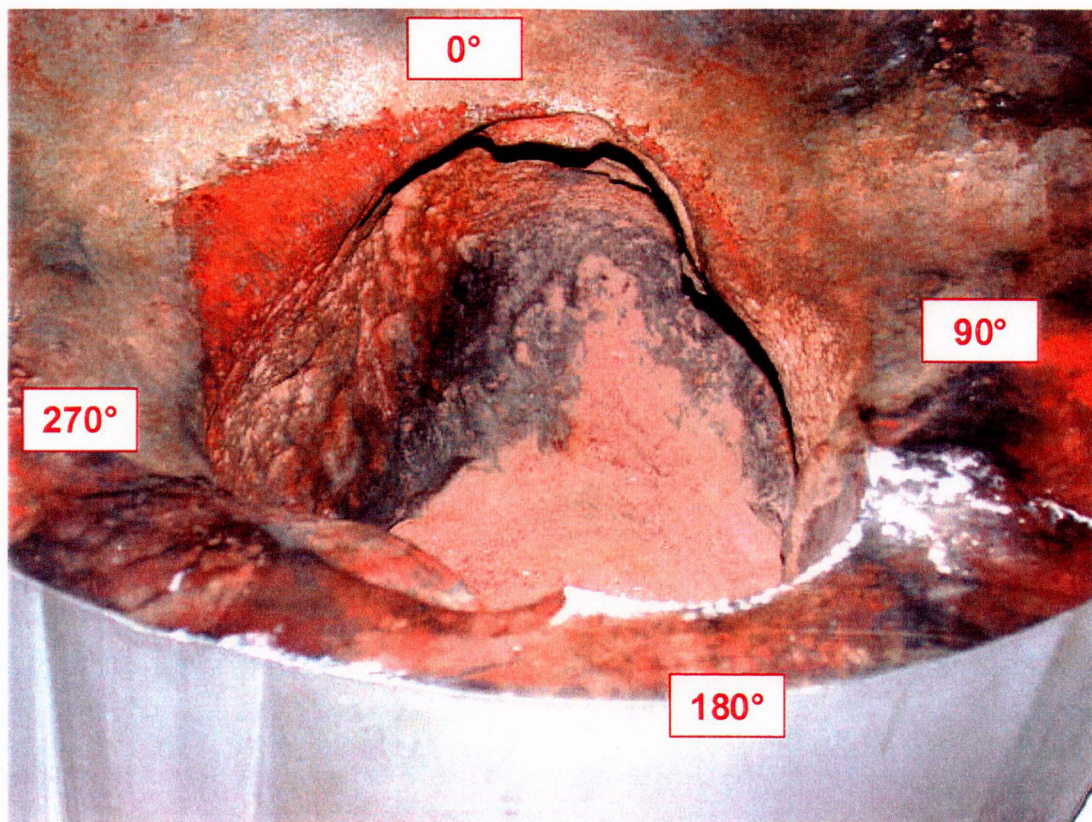
Figure 3.1.6: View of cavity looking toward nose (~10°).

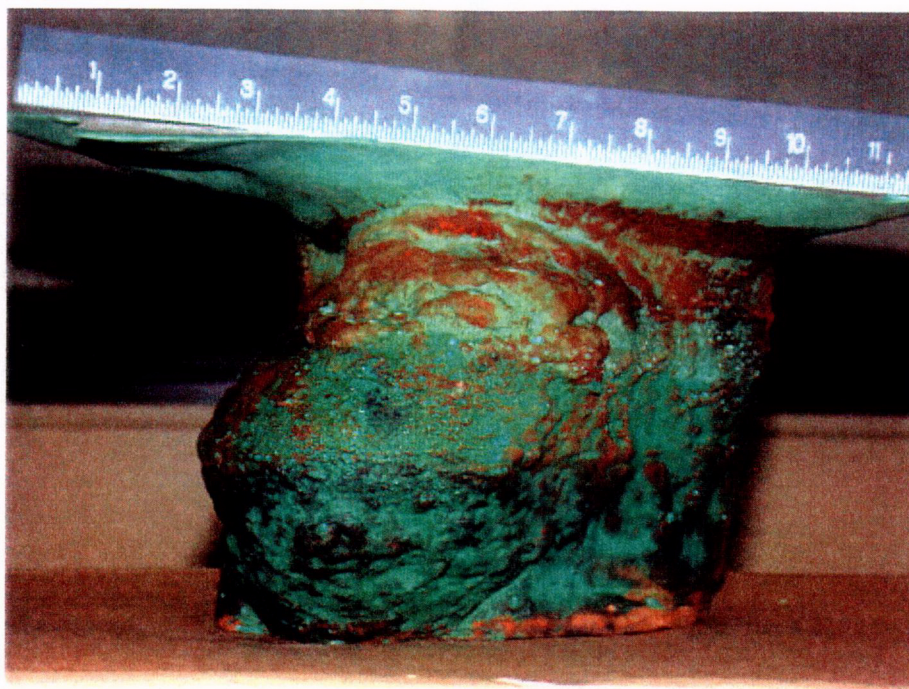
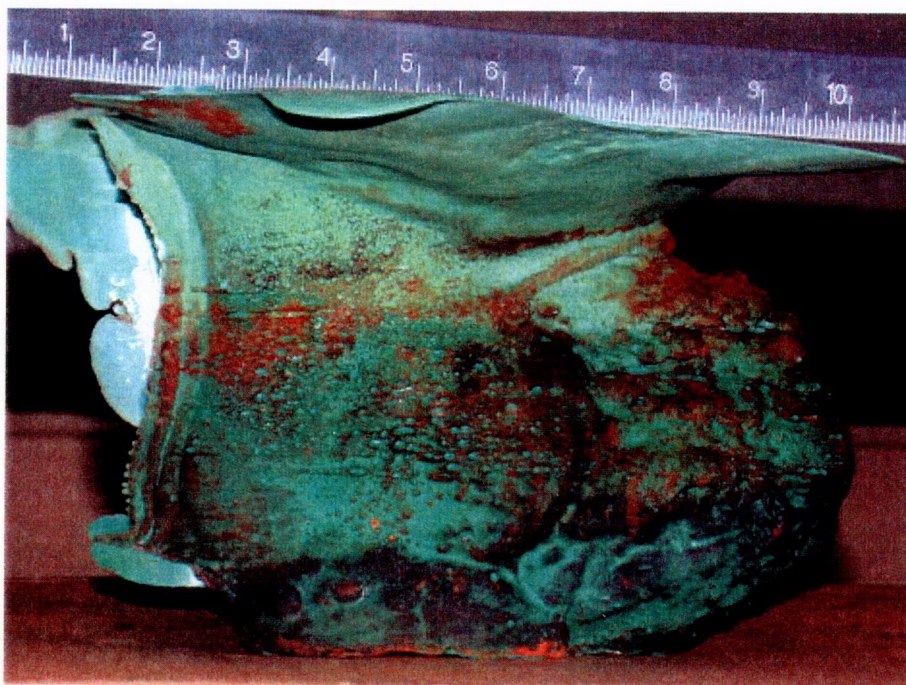
Figure 3.2.2: Photographs of cavity dental mold.

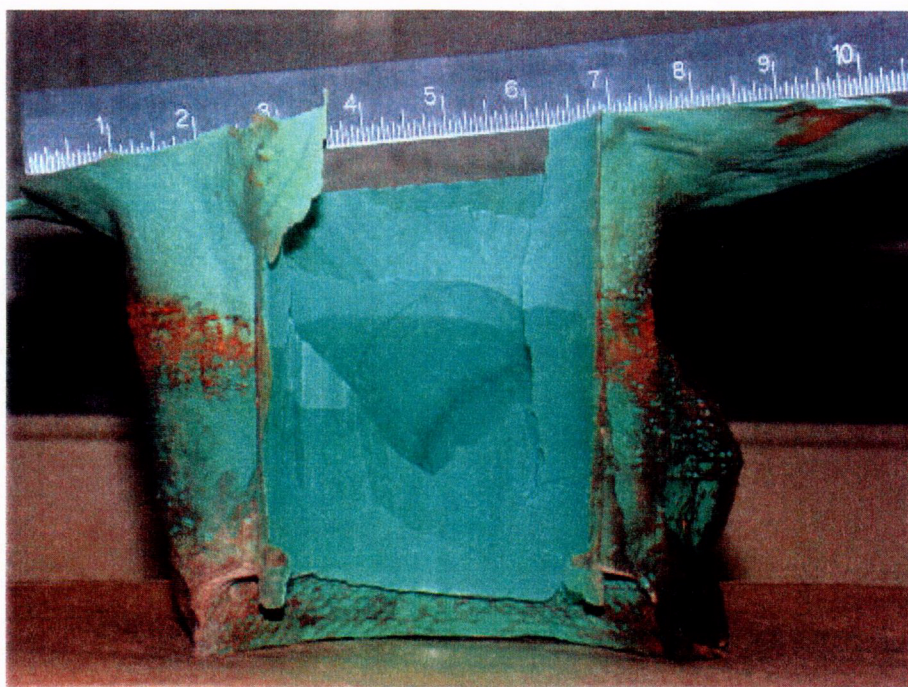
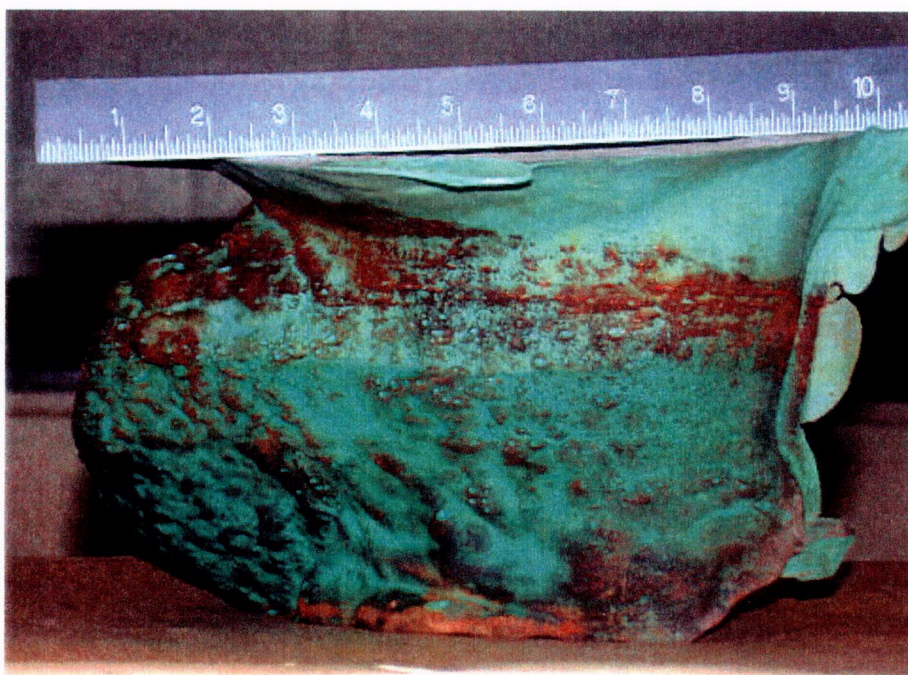
Figure 3.2.2 (cont.): Photographs of cavity dental mold.

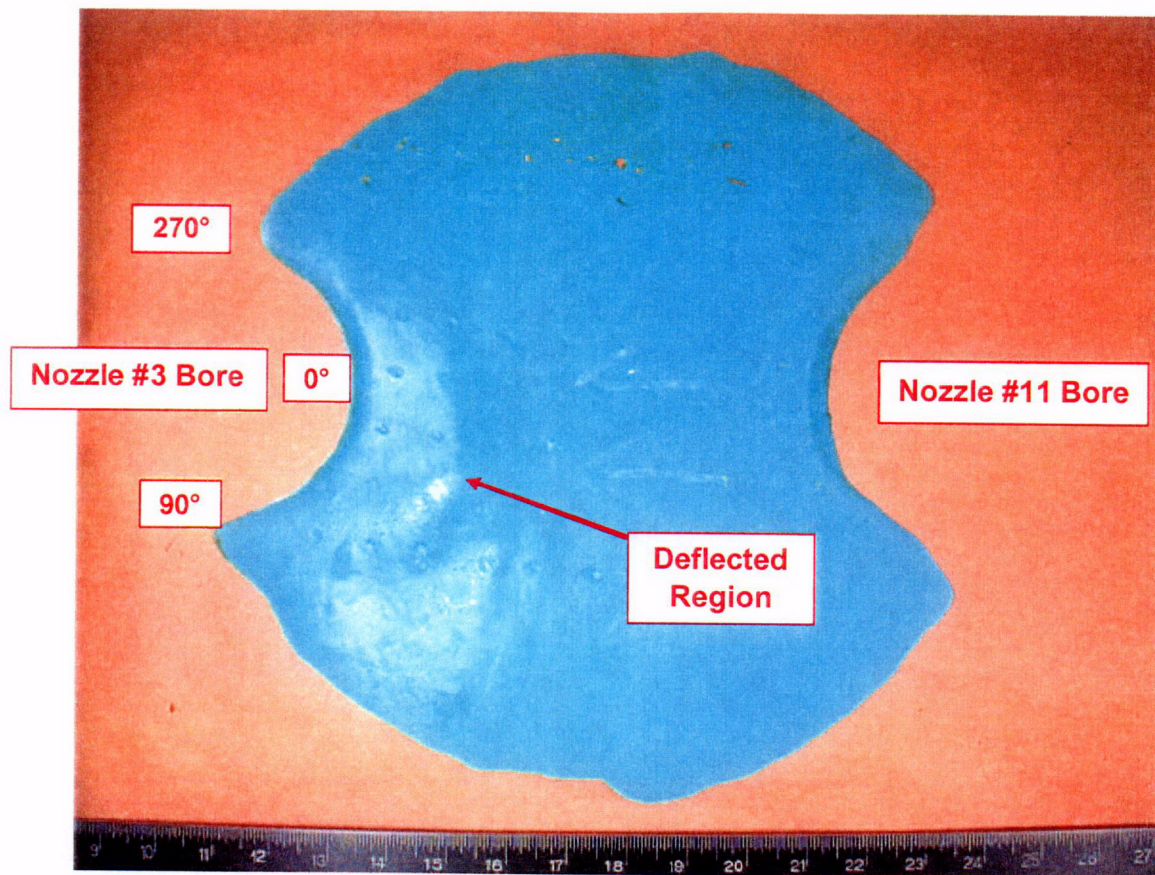
Figure 3.2.3: Photograph showing dental mold of RCS side of cladding.
