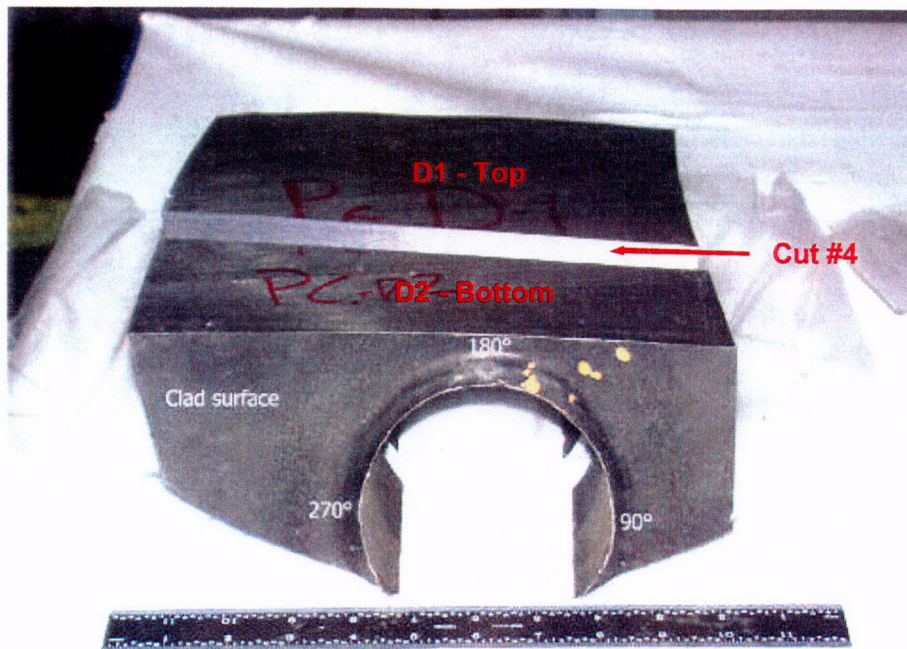
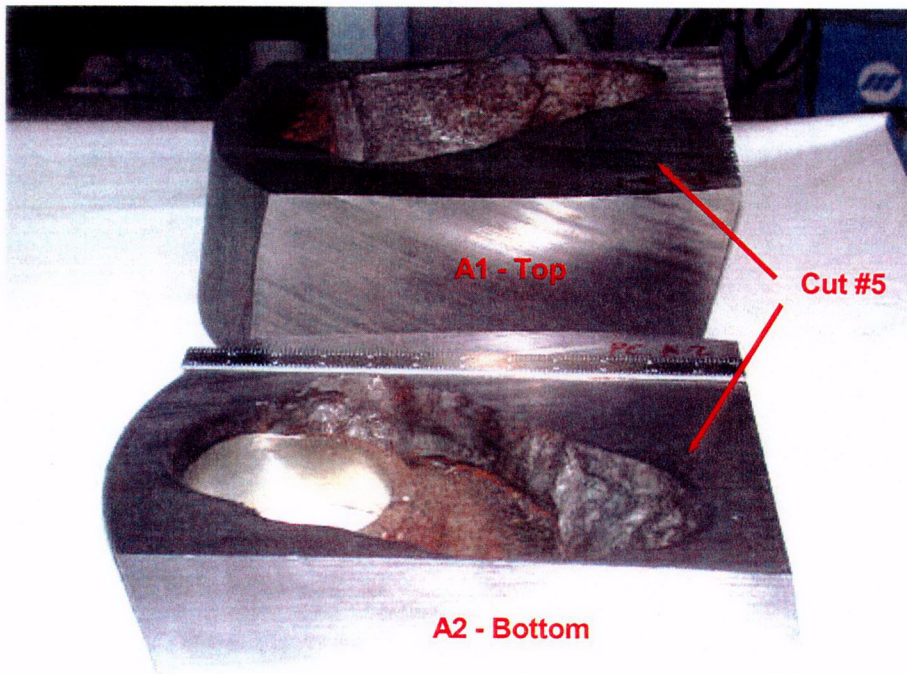
Figure 3.3.2: Photographs showing locations of cut #4 (top) and cut #5 (bottom). Piece A2 contained the exposed cladding.

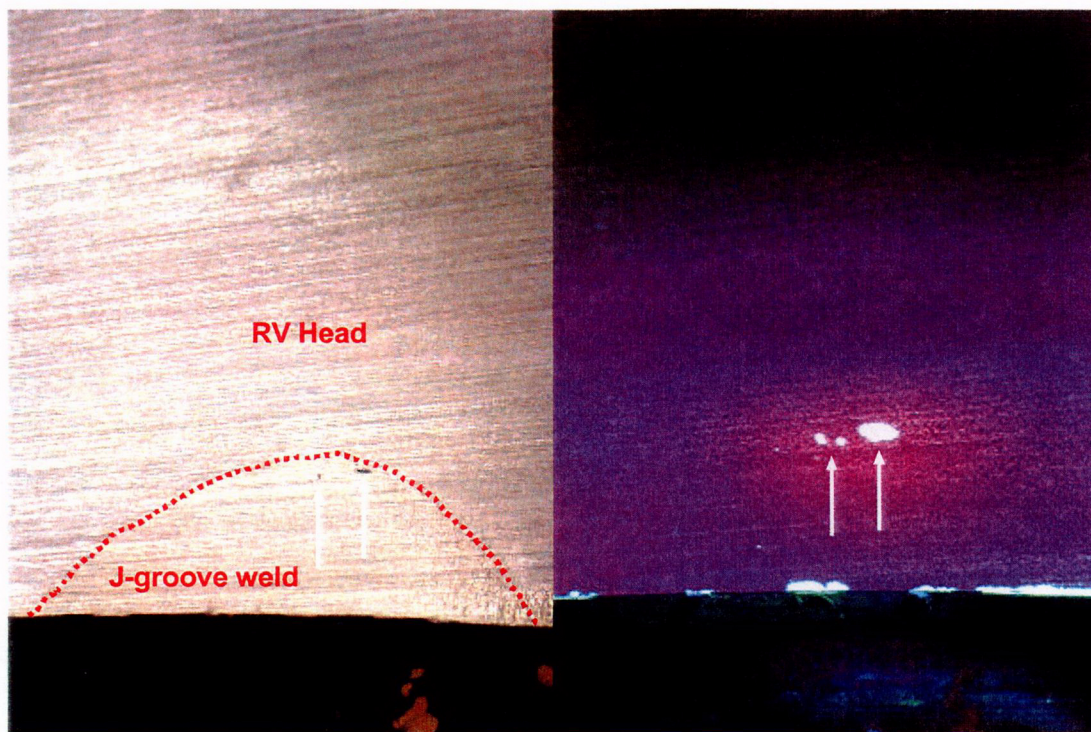
Figure 3.4.1: PT results for cut #3. A small weld void was present near the root of the nozzle #11 J-groove weld. Normal photo is on the left, black light photo on right. There was no evidence of cladding disbond noted on any of the cut faces examined. ~1X

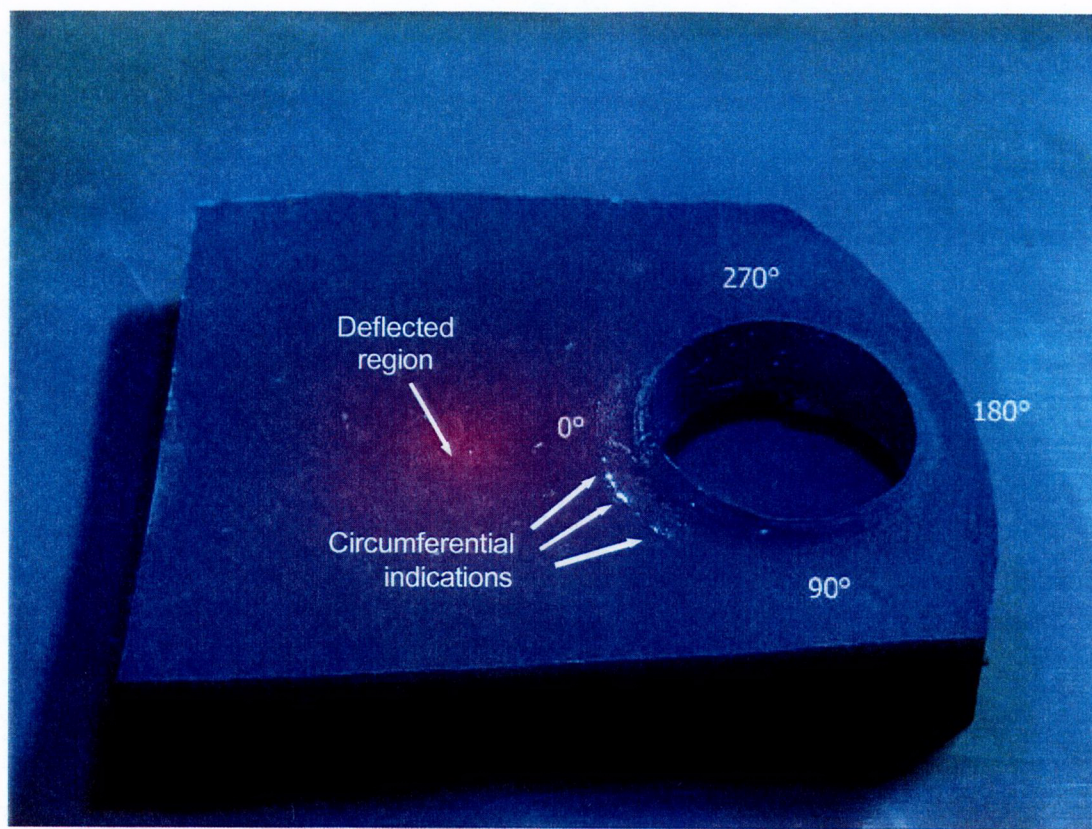
Figure 3.4.2: Circumferential indications on RCS side of cladding from $\sim 0^\circ$ to 45° . No indications were present in the upward-deflected region of the cladding.

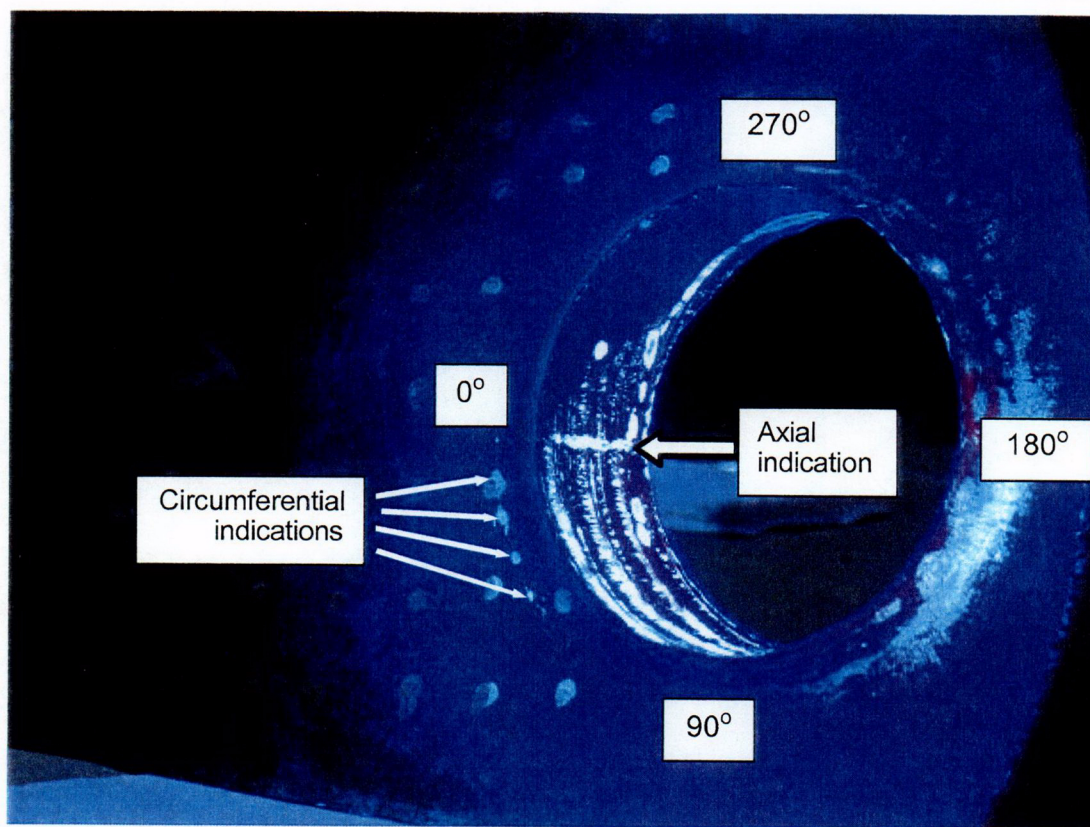
Figure 3.4.3: PT results for nozzle #3 J-groove weld bore and cladding underside. The J-groove weld contained an axial indication near 10° on the bore ID and circumferential indications on the RCS side from ~20° to ~45°.

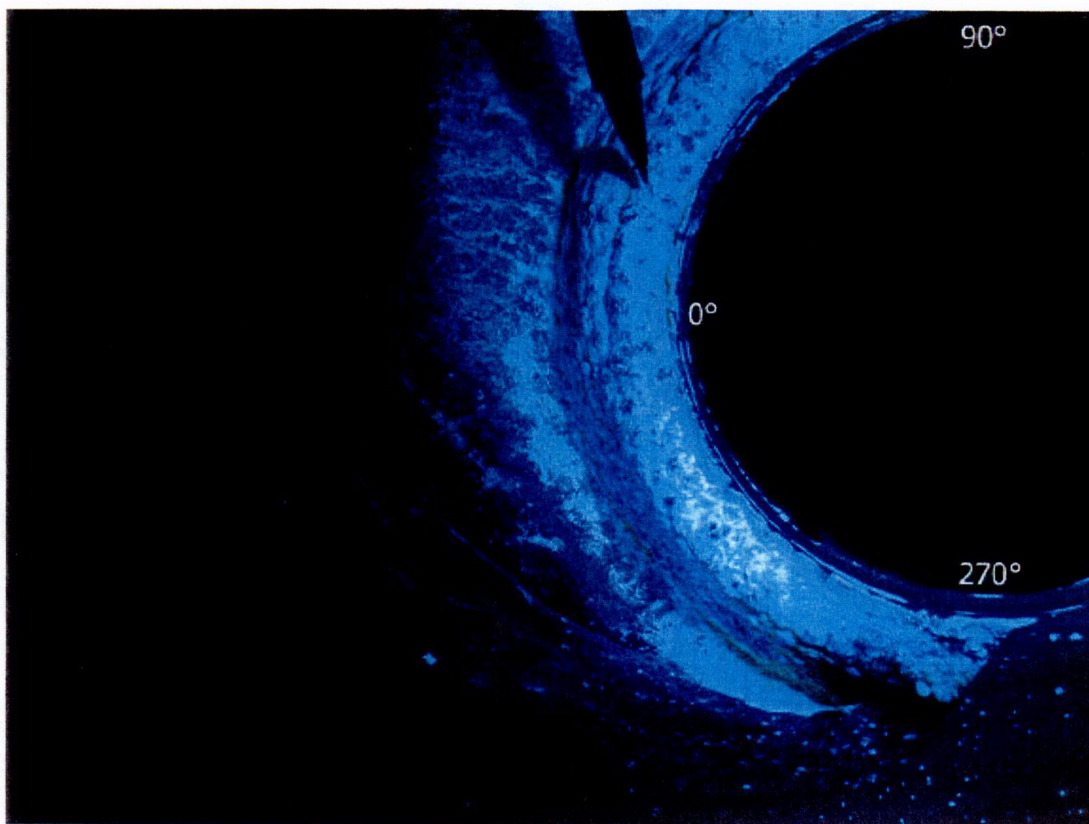
Figure 3.4.4: PT results for upper surface of exposed J-groove weld. The axial crack is visible near 10° (rough weld texture produced high PT background).

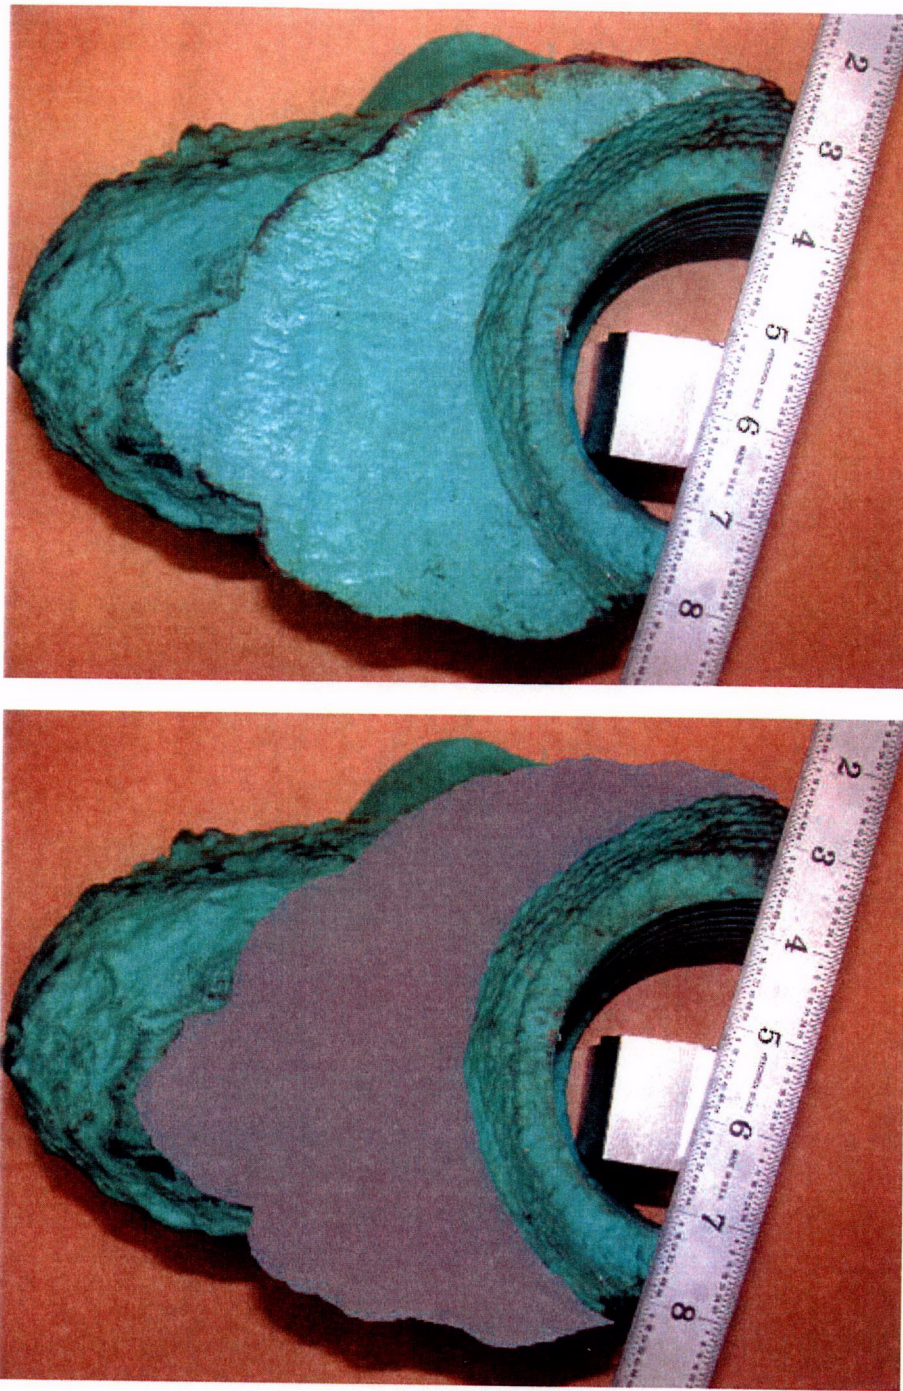
Figure 3.5.1: Photographs showing exposed cladding surface. The gray mask in the lower photograph was used to calculate the exposed cladding surface area.

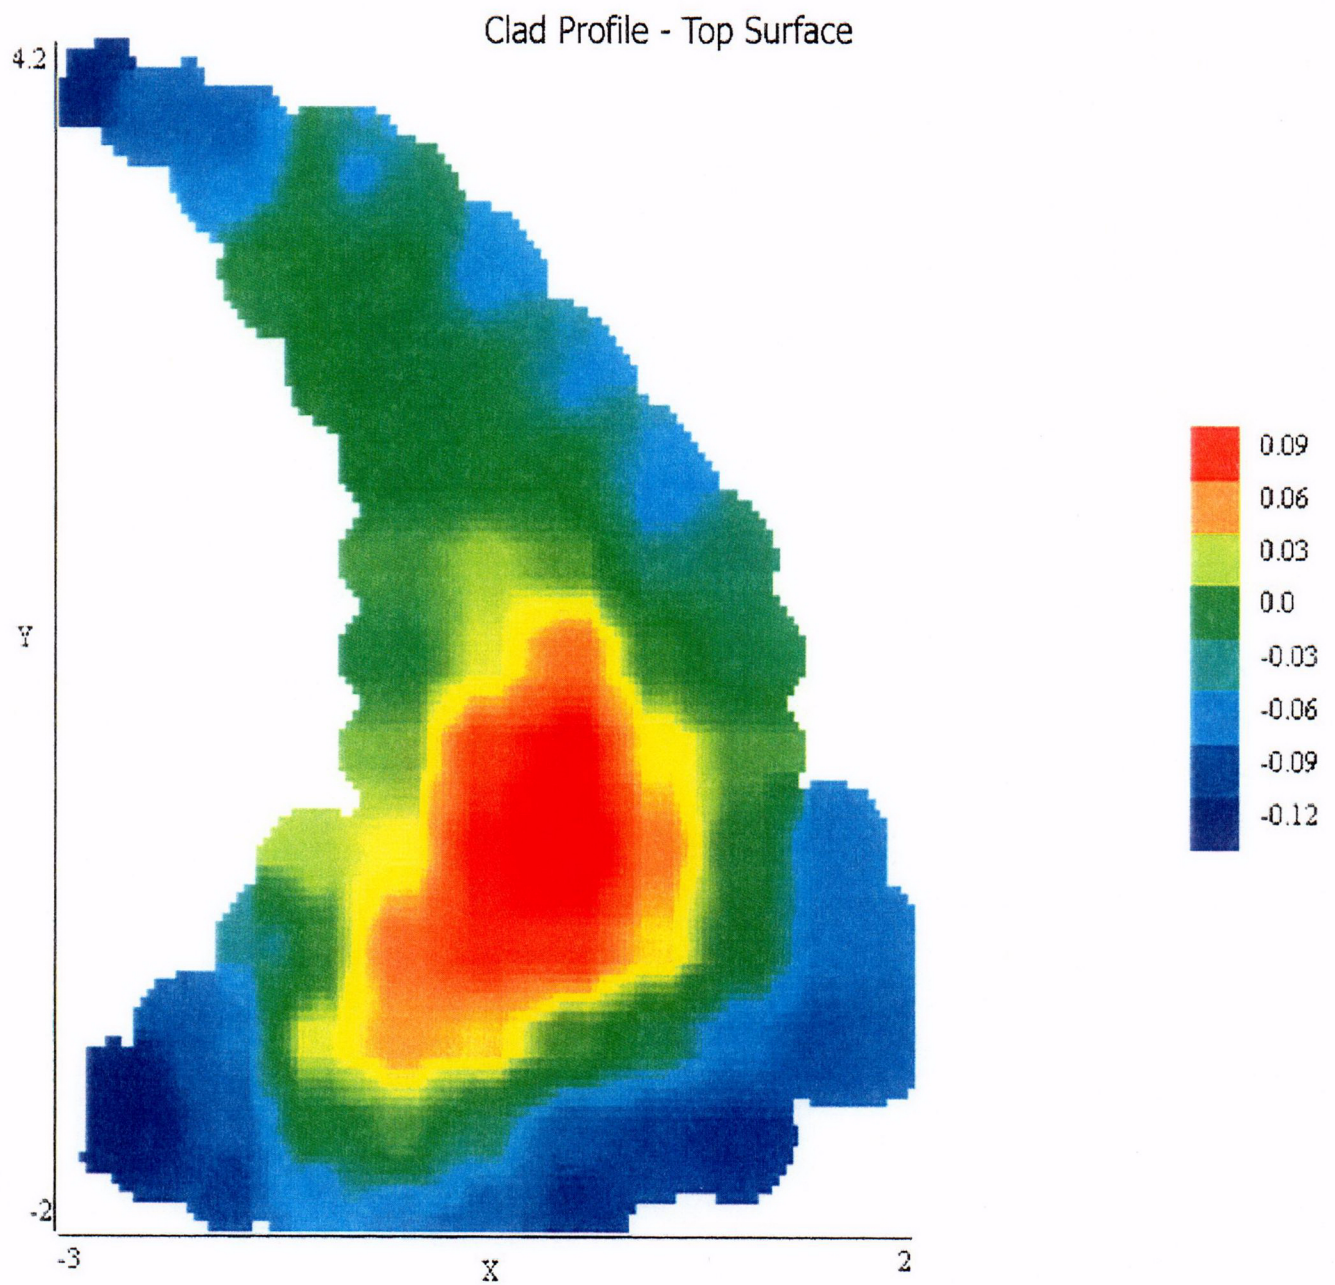
Figure 3.5.5: Colorized representation of exposed cladding profile. Red area denotes area of maximum deflection.
