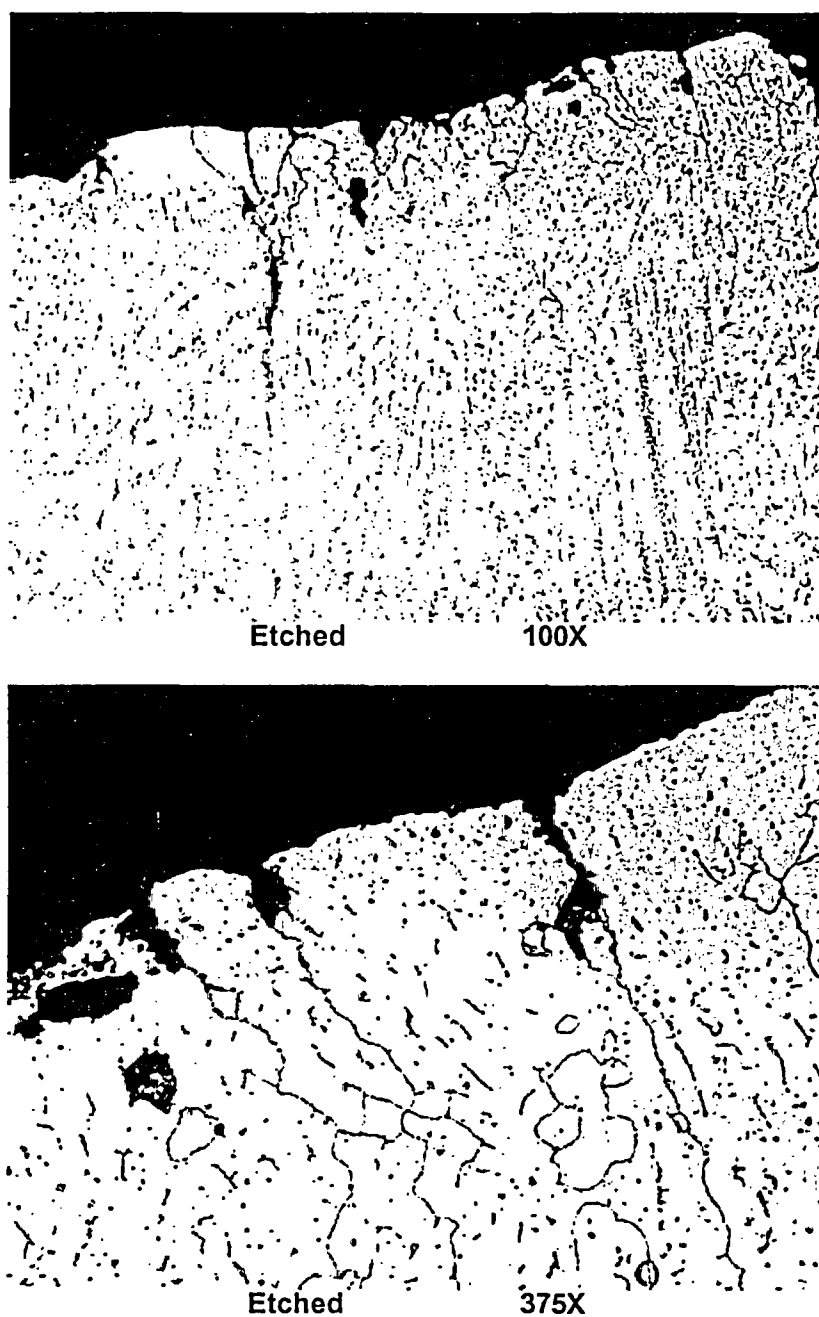
Figure 6.1.1.2: Micrographs showing intergranular attack (IGA) and intergranular or interdendritic cracking on the exposed stainless steel cladding.

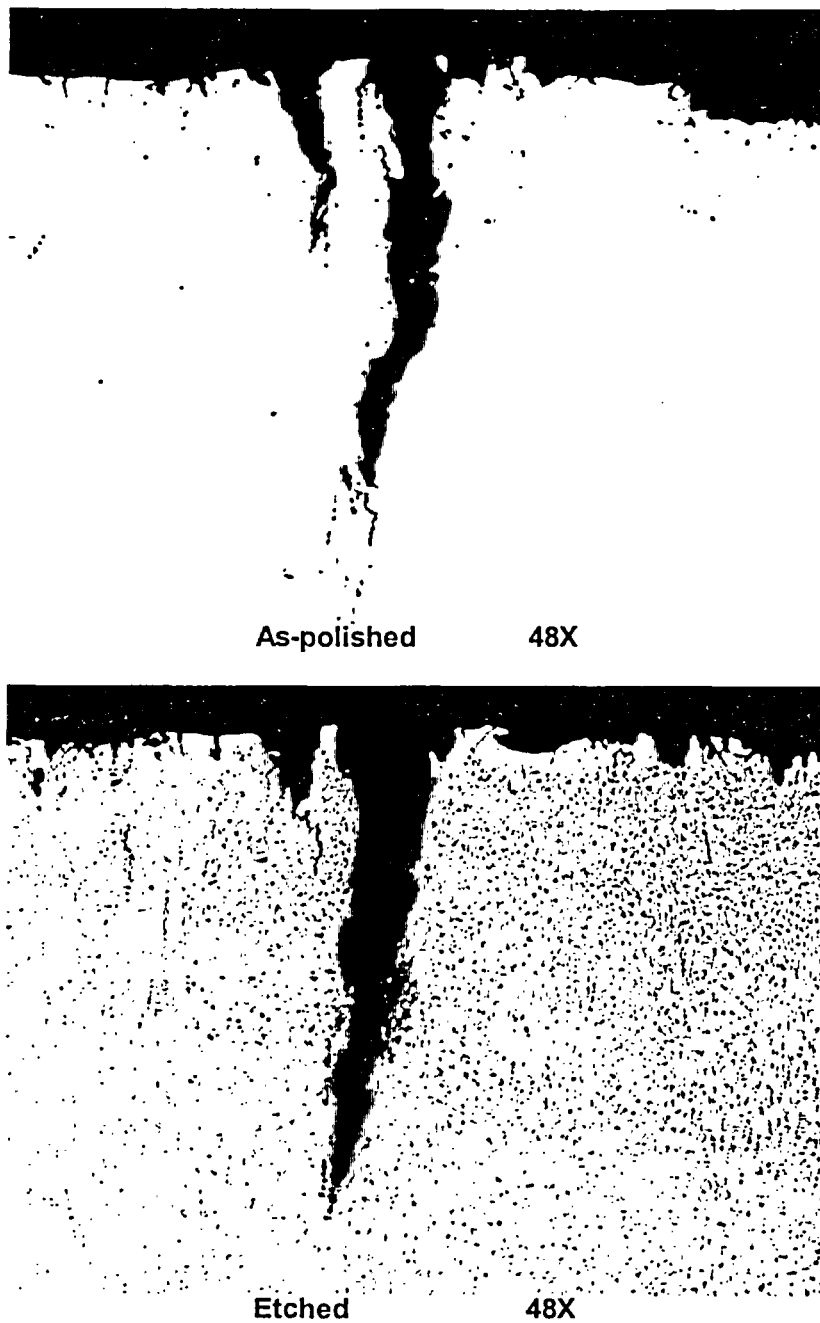
Figure 6.1.1.3: Micrographs showing the deepest crack observed in A2A7M. Fine intergranular or interdendritic cracks emanating from the crack tip are visible. The crack tip is estimated to be approximately 0.057" (1.47 mm) below the surface. The cracks in the above two photos are the same, but are shown at slightly different planes due to re-polishing.

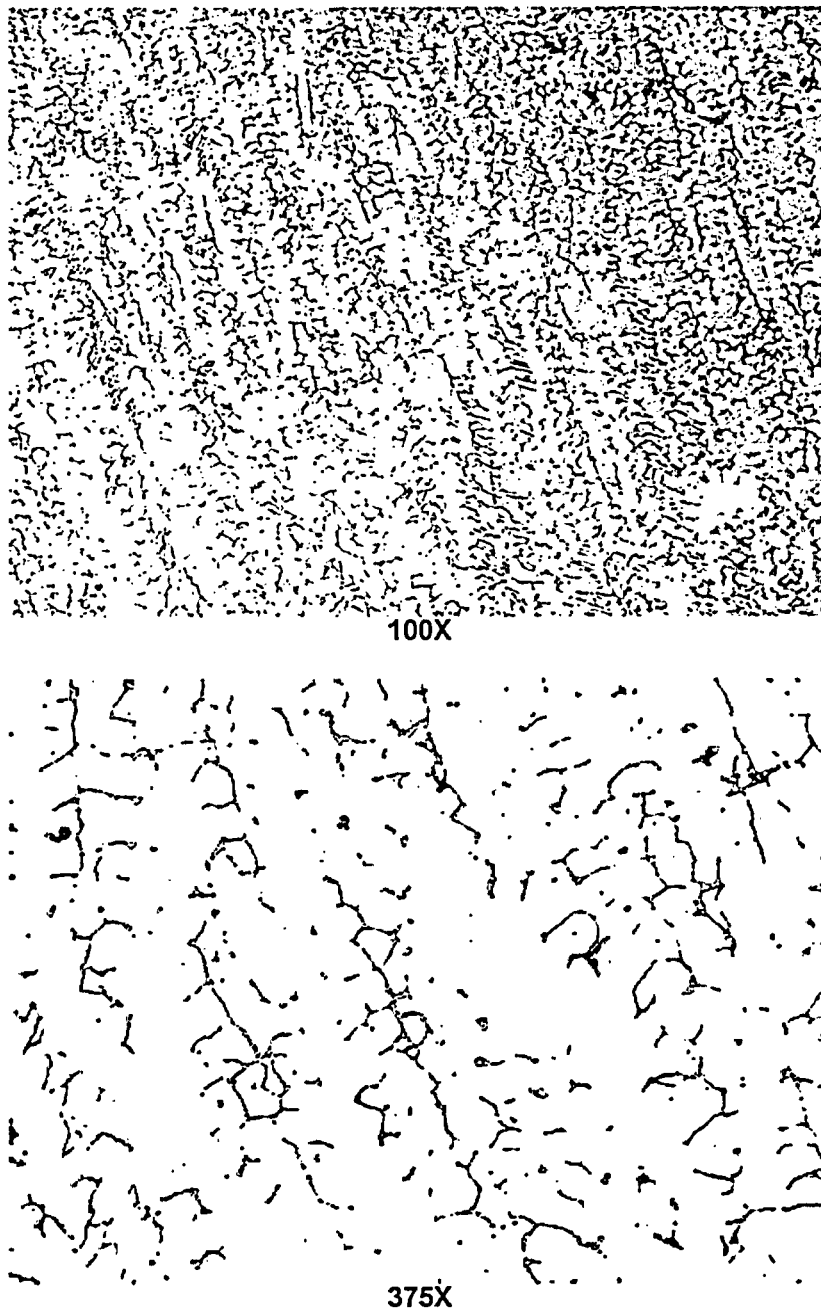
Figure 6.1.1.4: Typical clad microstructure in the mid-thickness of the cladding.

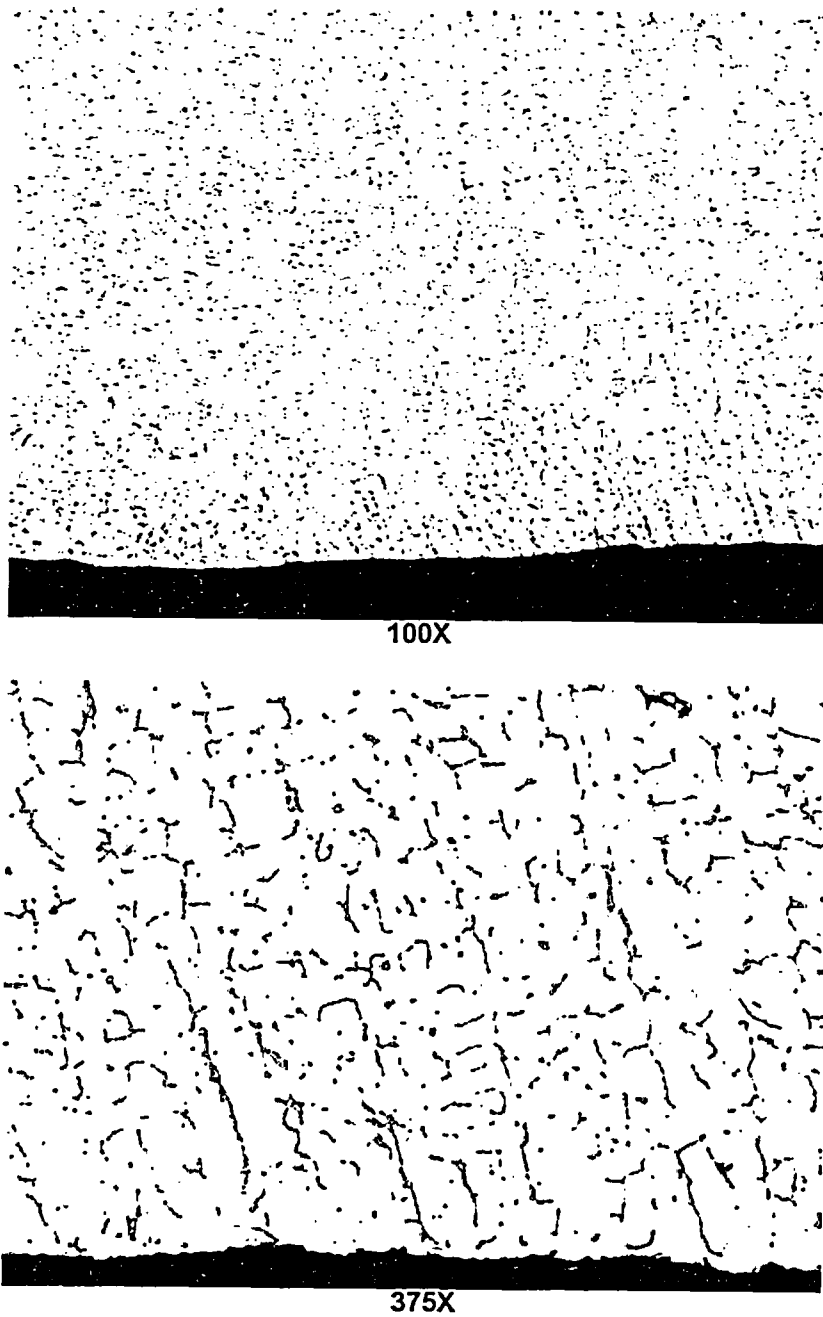
Figure 6.1.1.5: Typical clad microstructure near RCS side surface of the cladding. No intergranular attack (IGA) was present.

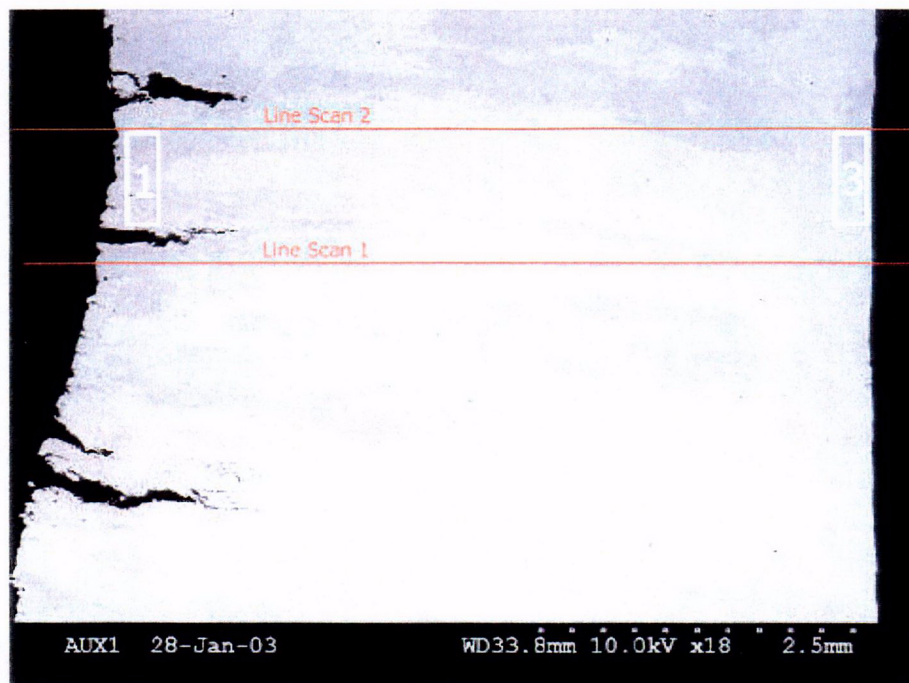
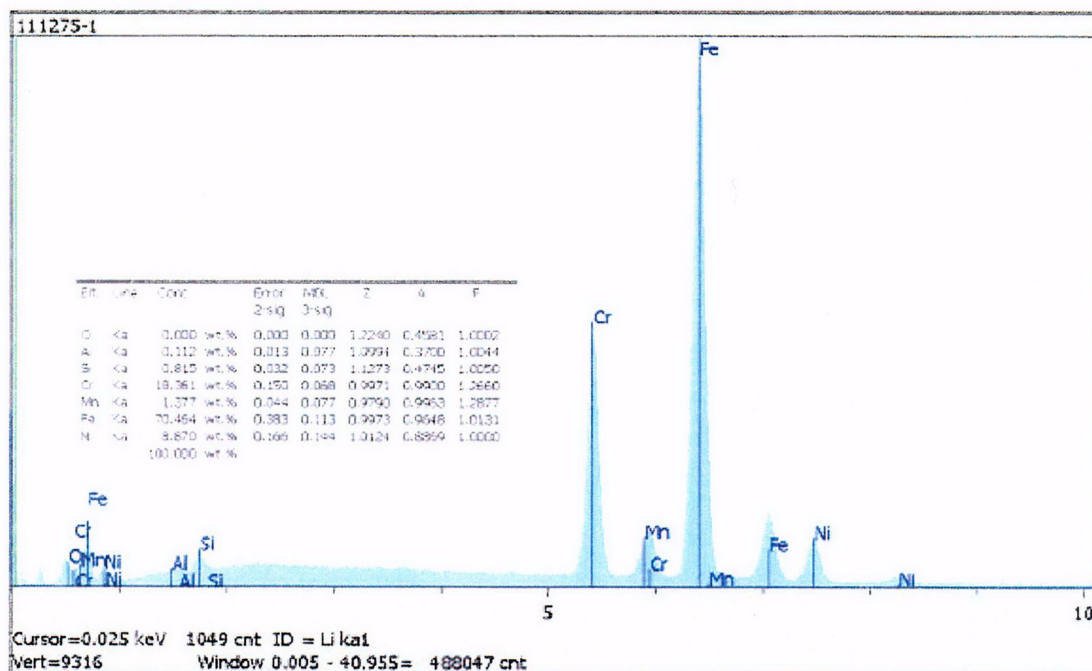
Figure 6.1.2.1: SEM micrograph showing the three deepest cracks in A2A7M. Crack tips are 0.042" to 0.069" (1.1 to 1.75 mm) below the surface. It is noted that these three crack tips are at approximately the same distance of 0.199" (5.06 mm) from the underside surface. EDS scans of areas 1, 2, and 3 and line scans 1 and 2 (not included) indicated a generally uniform chemical composition (including Cr content) across the cladding thickness.

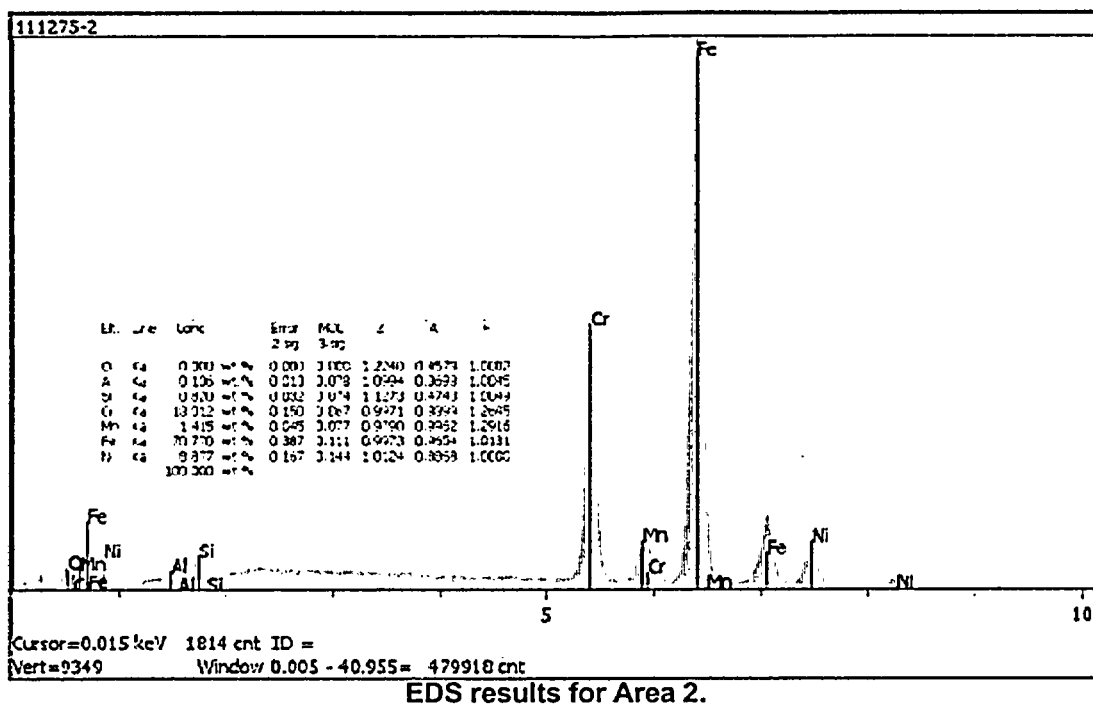
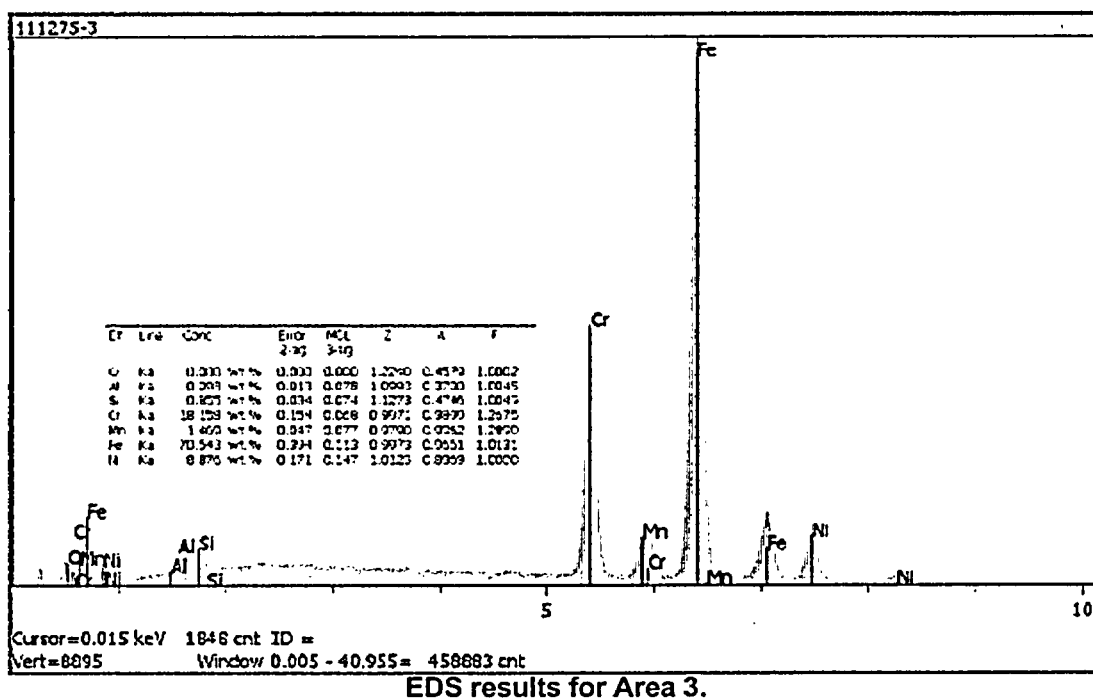
Figure 6.1.2.1 (cont.): EDS results for Areas 2 and 3.

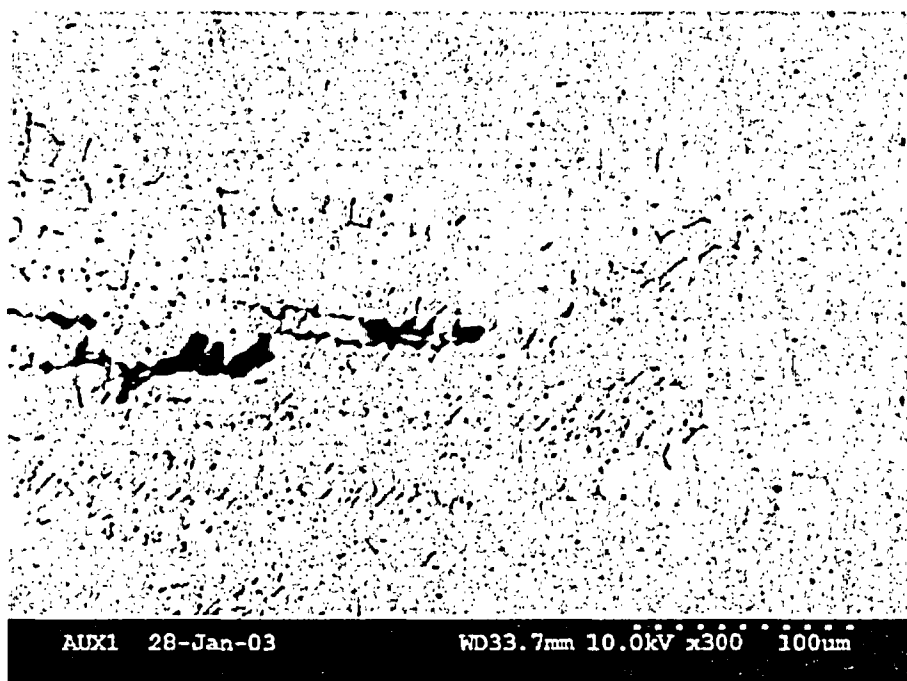
300X

Figure 6.1.2.2: SEM micrographs showing interdendritic crack path along the elongated ferrite pools.

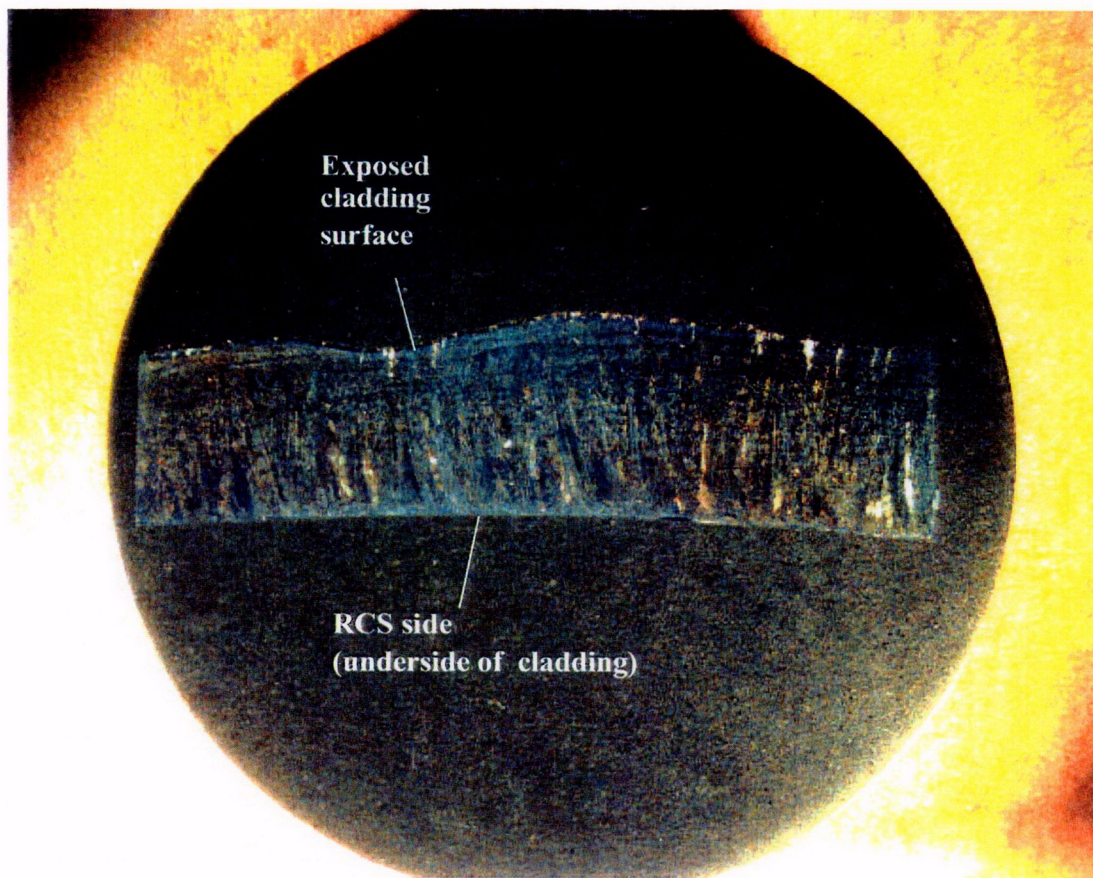
Figure 6.2.1.1: 4X macro photograph of metallurgical mount A2A7N. Refer to Figure 5.11 for the sample orientation.

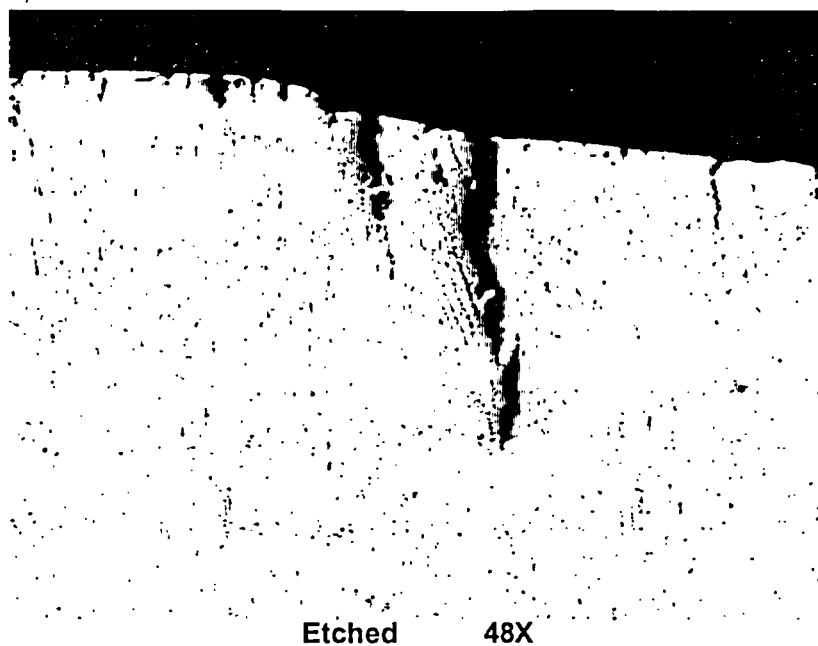
Figure 6.2.1.2: Micrograph of a crack observed on A2A7N. The crack tip is estimated to be approximately 0.036" (0.91 mm) below the surface.

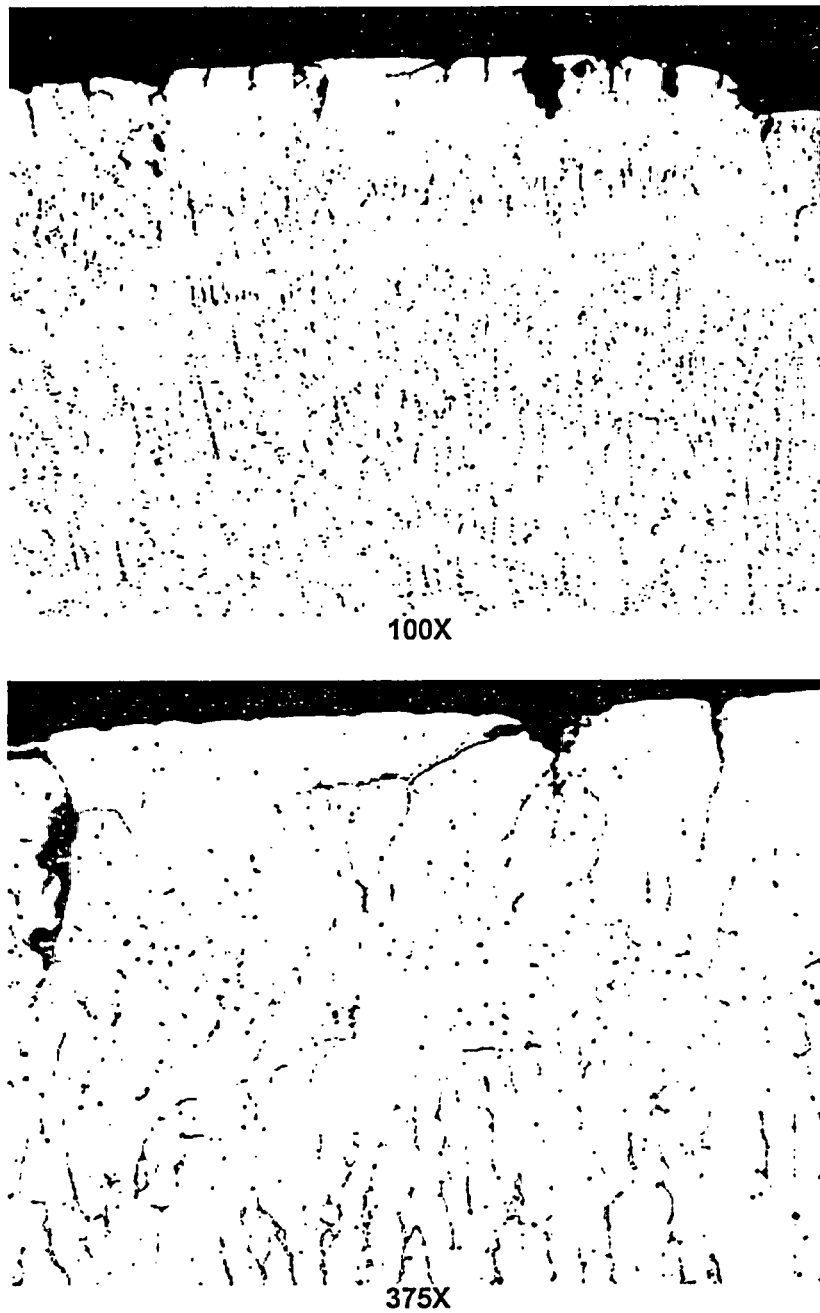
Figure 6.2.1.3: Micrographs showing intergranular attack (IGA) and intergranular cracking on the exposed stainless steel cladding.

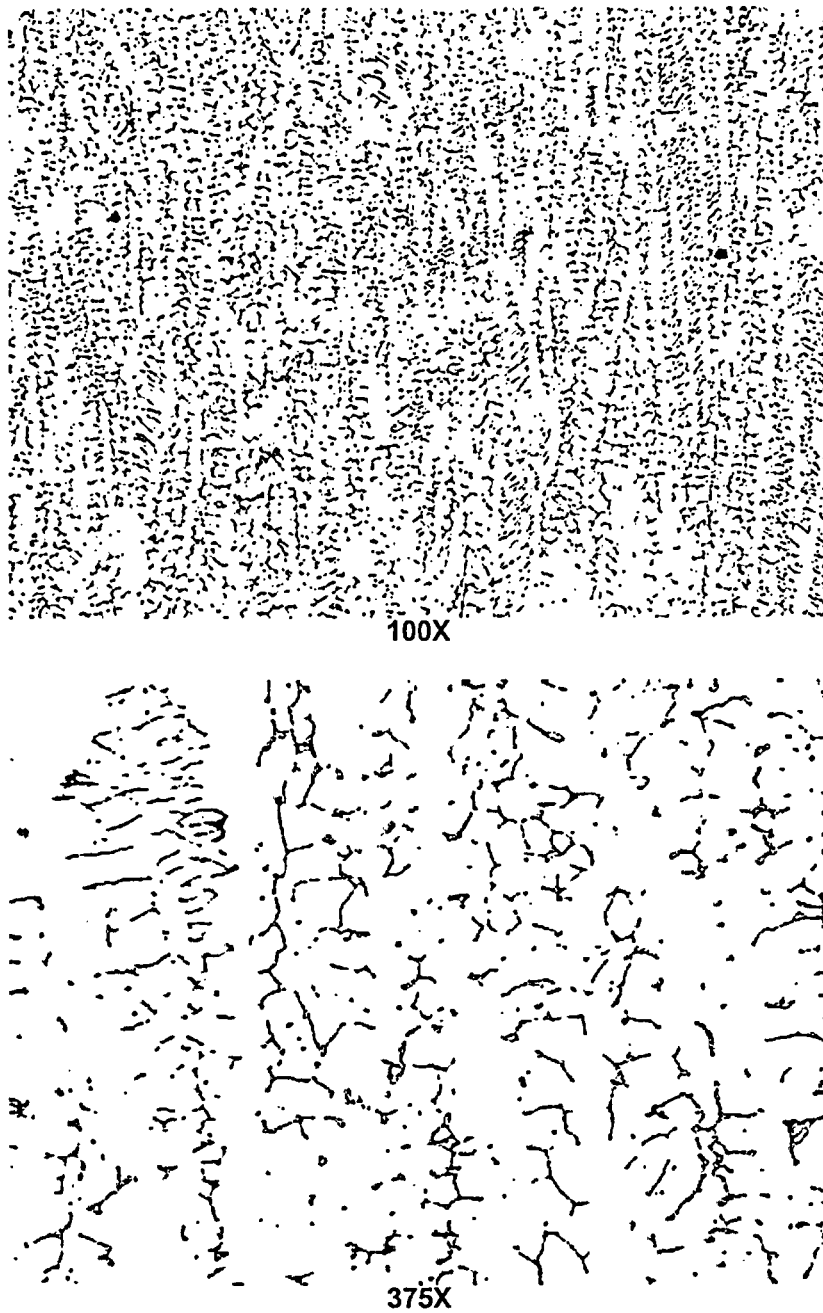
Figure 6.2.1.4: Typical clad microstructure in the mid-thickness of the cladding.

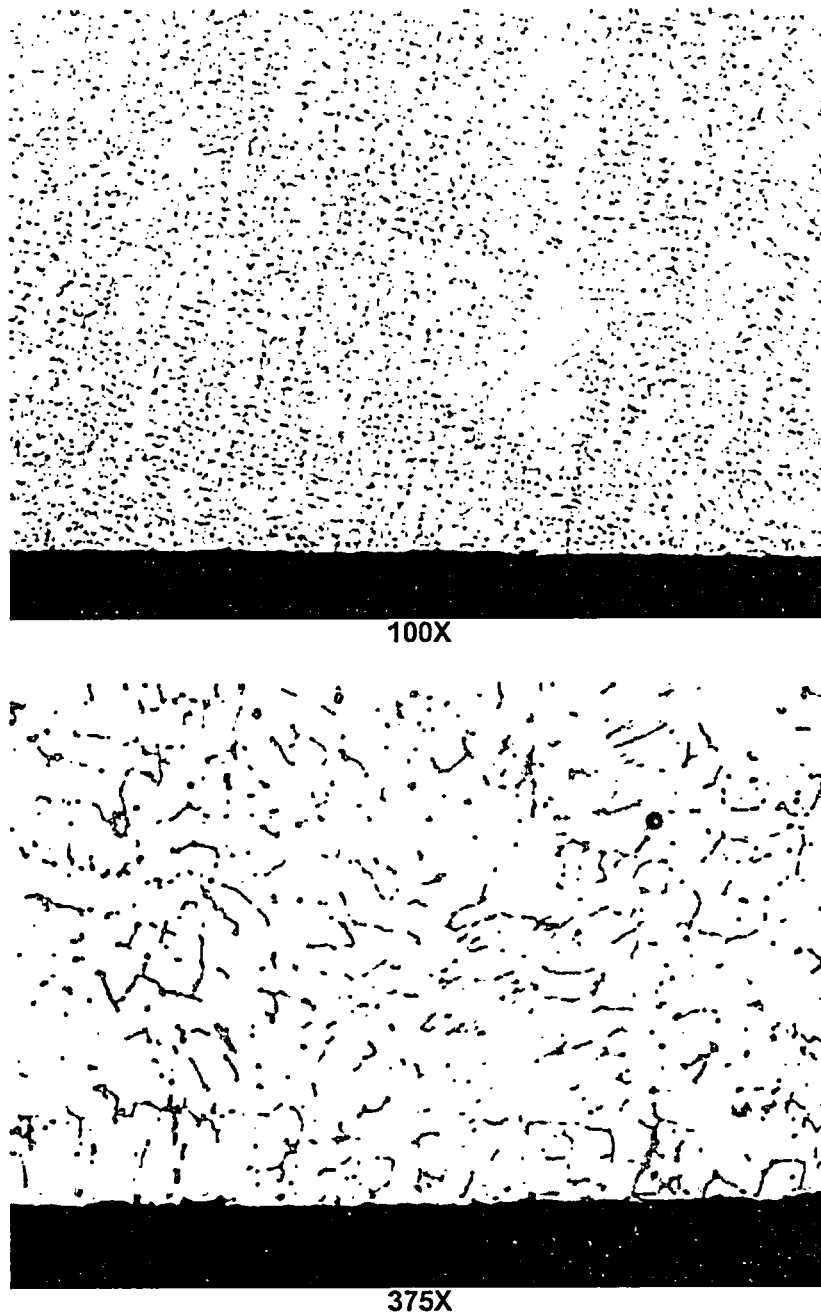
Figure 6.2.1.5: Typical clad microstructure near RCS side surface of the cladding. No intergranular attack (IGA) was present.

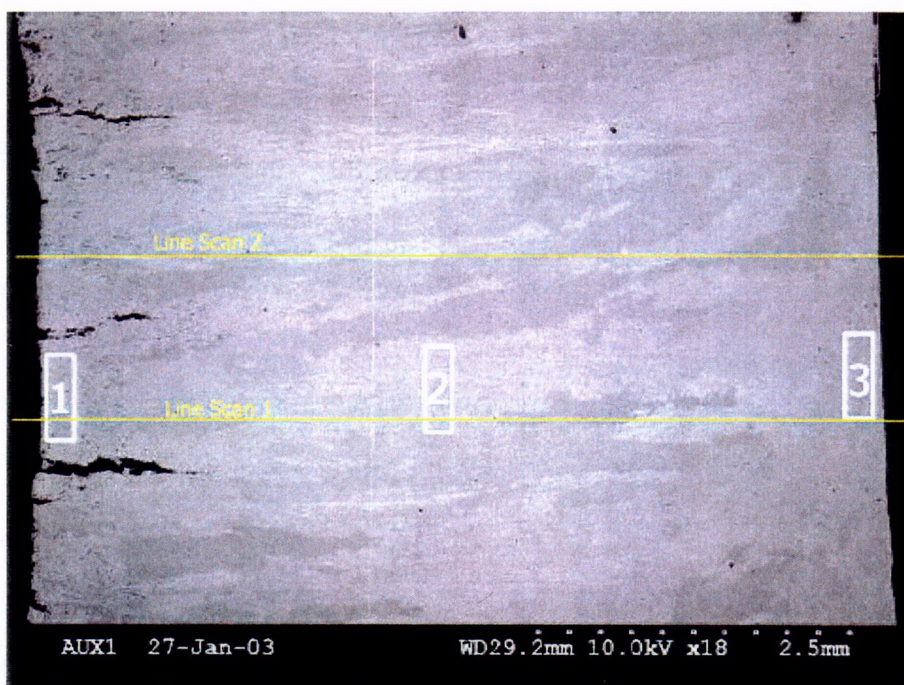
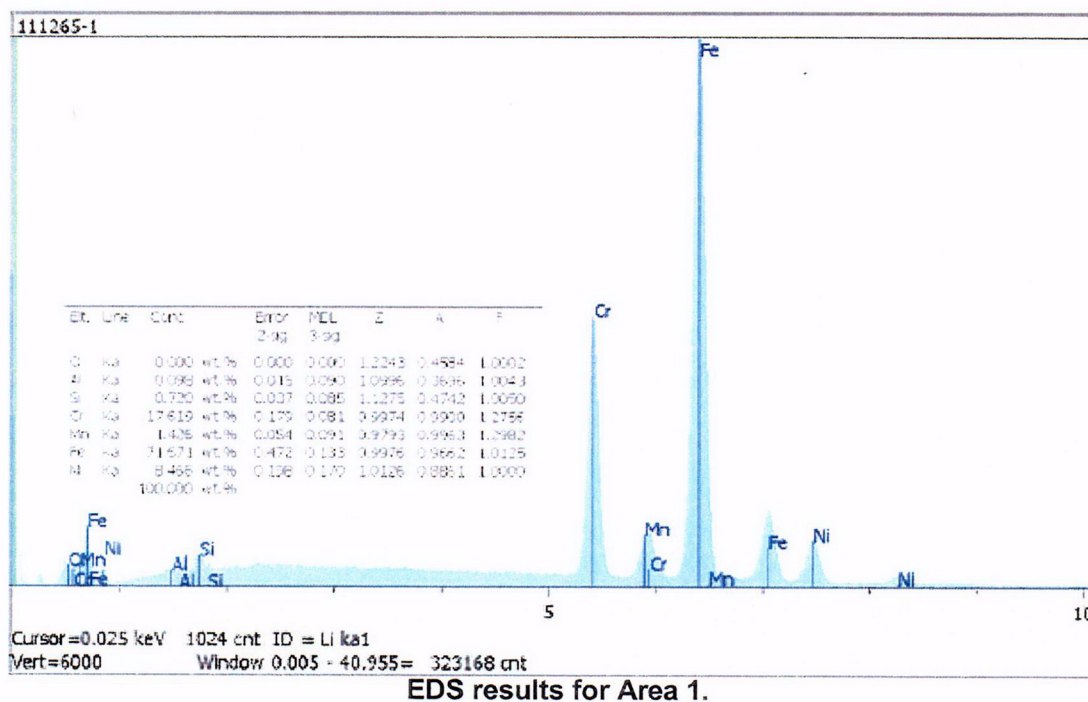
Figure 6.2.2.1: SEM micrograph showing the three deepest cracks in A2A7N. The maximum crack depth was approximately 0.056" (1.42 mm). EDS scans of areas 1, 2, and 3 and lines 1 and 2 (not included) indicated a generally uniform chemical composition (including Cr content) across the cladding thickness.

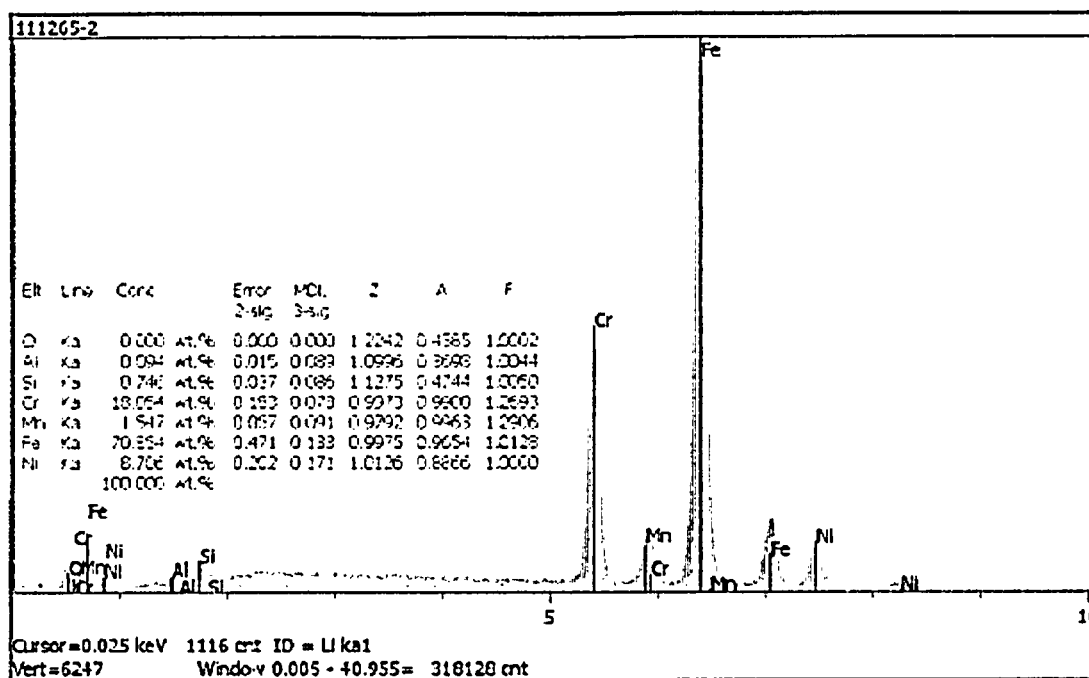
Figure 6.2.2.1 (cont.): EDS results for Areas 2 and 3.

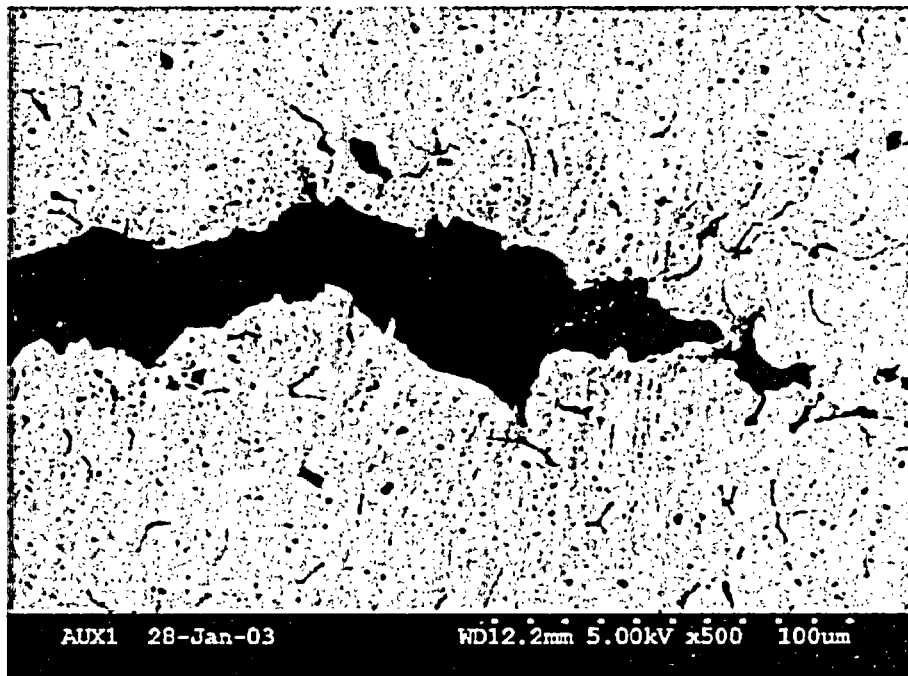
BSE 500X

Figure 6.2.2.2: Higher magnification SEM micrographs of crack tip, showing the interdendritic crack path along the elongated ferrite pools.

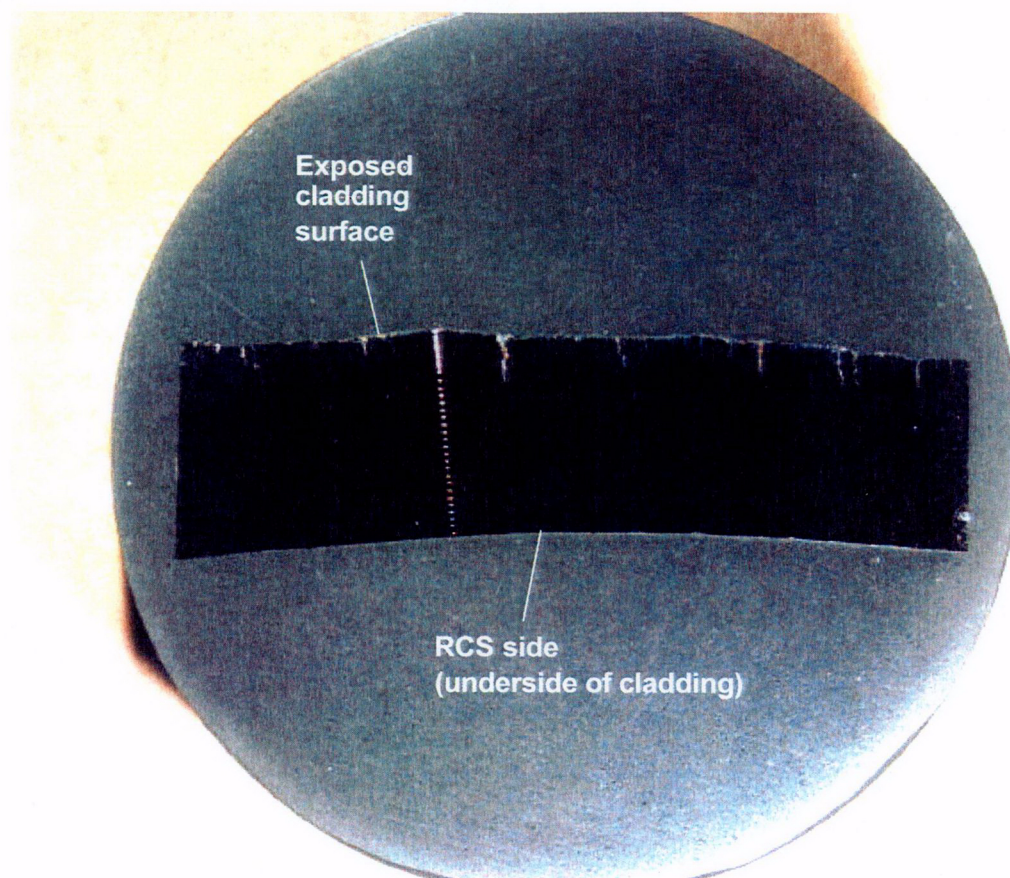
Figure 6.3.1.1: 4X macro photograph of metallurgical mount A2A7S. Refer to Figure 5.11 for the sample orientation. Knoop microhardness values exhibited lower hardness readings toward the exposed clad side (left side of graph), which was in contrast to A2A7M.

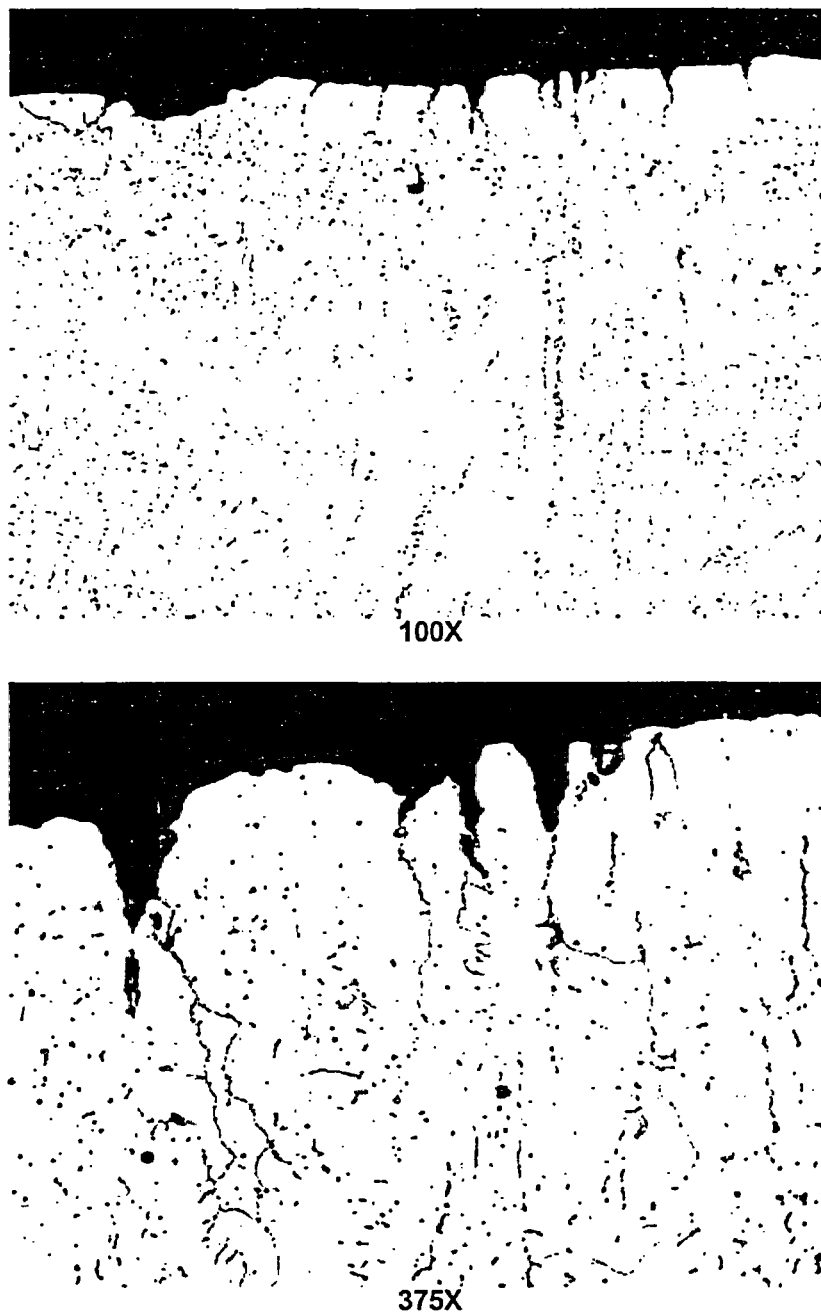
Figure 6.3.1.2: Micrographs showing intergranular attack (IGA) and intergranular or interdendritic cracking on the exposed stainless steel cladding.

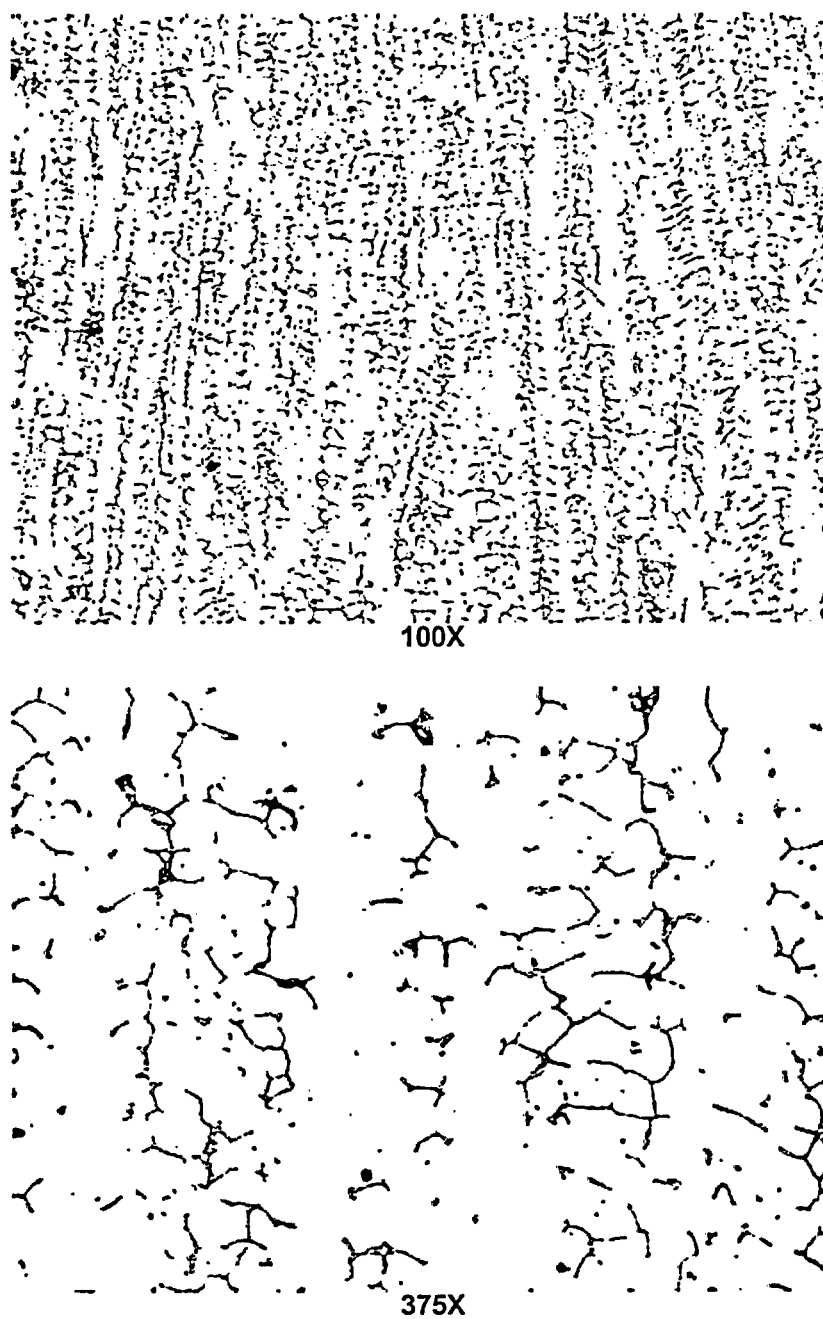
Figure 6.3.1.4: Typical clad microstructure in the mid-thickness of the cladding.

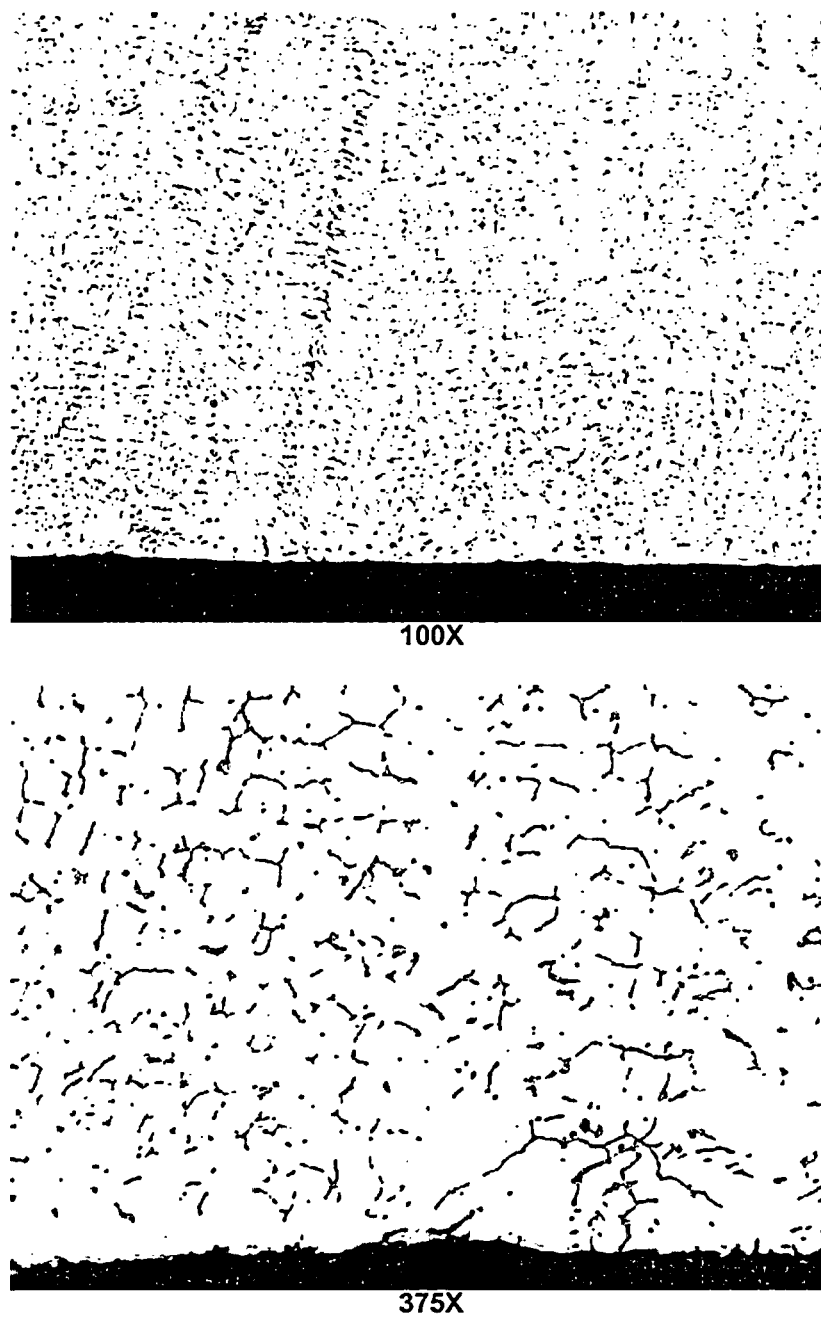
Figure 6.3.1.5: Typical clad microstructure near RCS side surface of the cladding. No intergranular attack (IGA) was present.

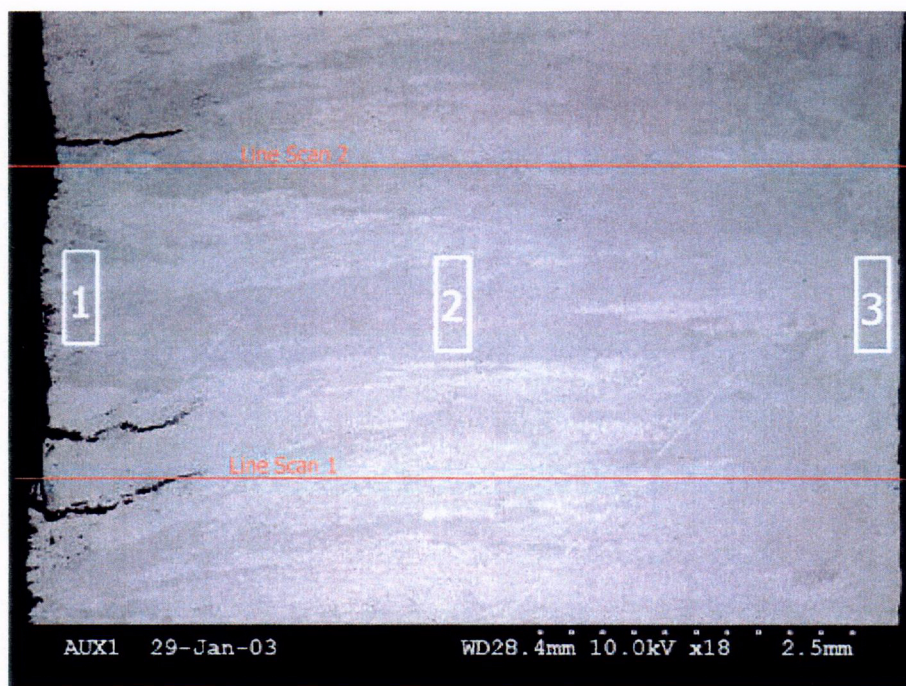
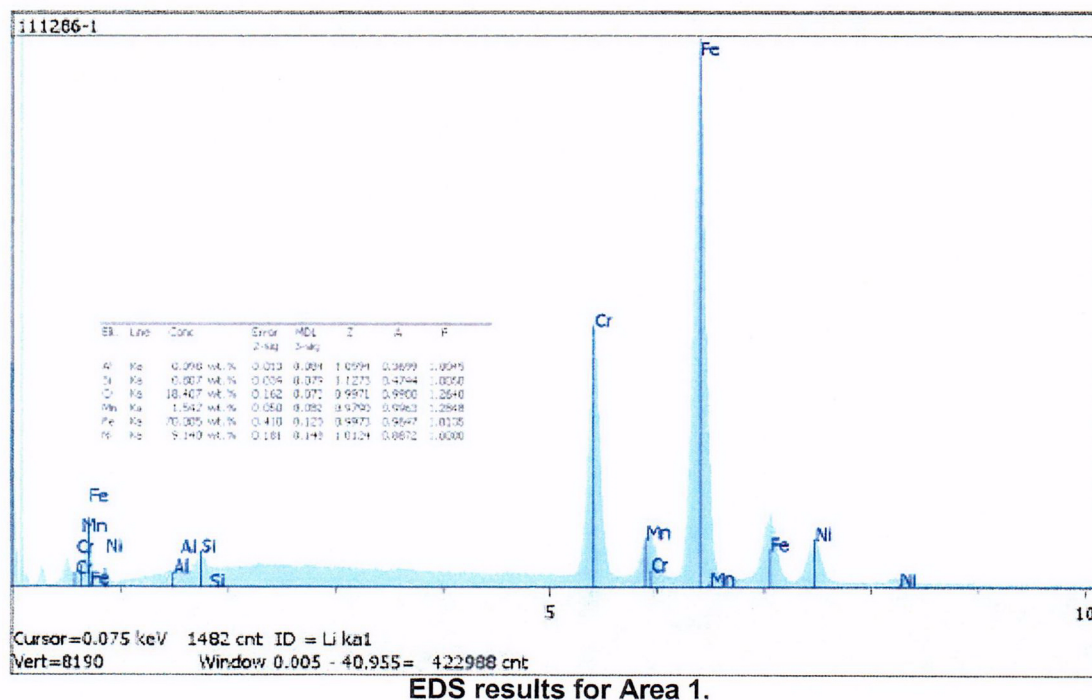
Figure 6.3.2.1: SEM micrograph of the three deepest cracks in A2A7S. The maximum crack depth was approximately 0.056" (1.42 mm). These three crack tips are approximately the same distance from the underside surface. EDS scans of areas 1, 2, and 3 and lines 1 and 2 (not included) indicated a generally uniform chemical composition (including Cr content) across the cladding thickness.

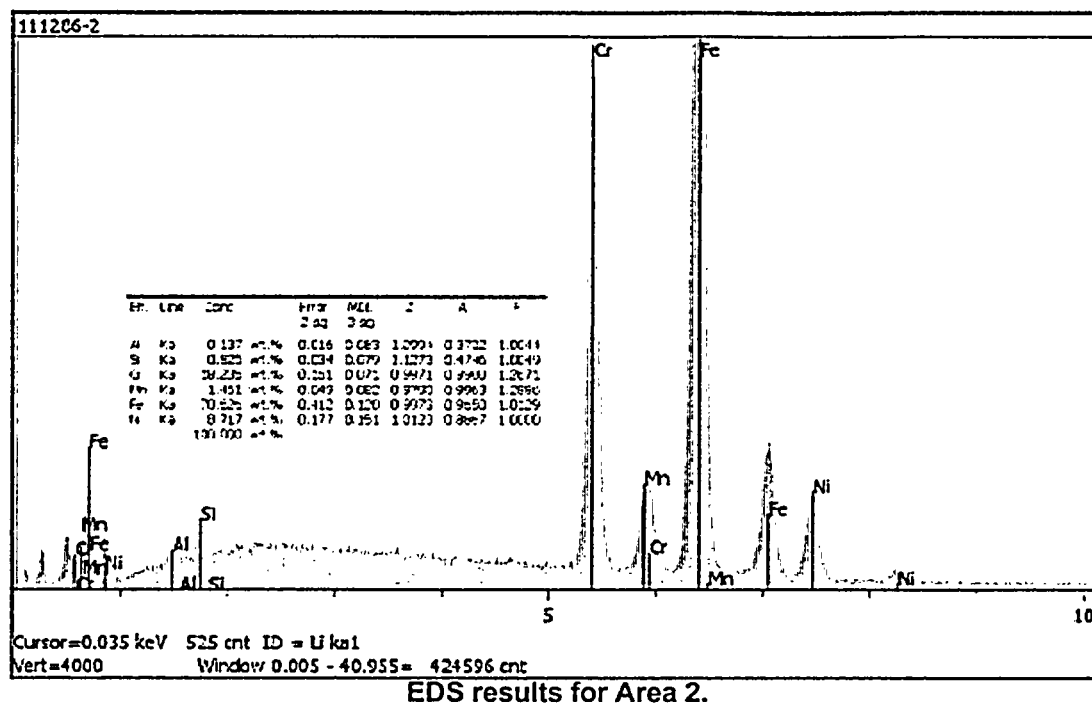
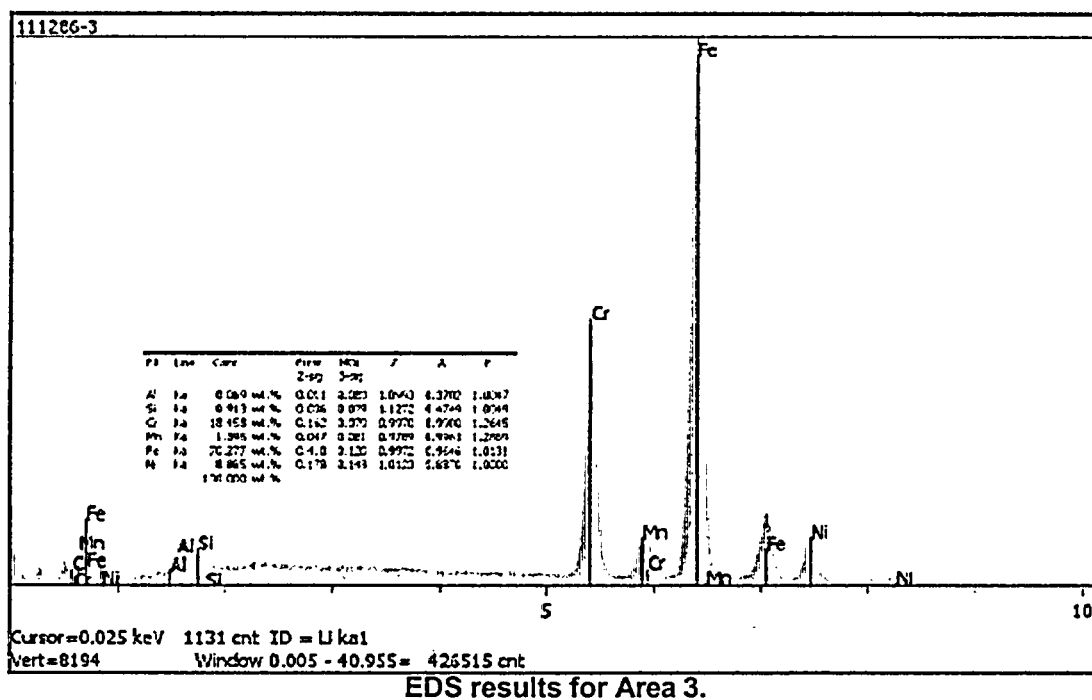
Figure 6.3.2.1 (cont.): EDS results for Areas 2 and 3. Note that the Cr peak was set at full screen height for Area 2.
