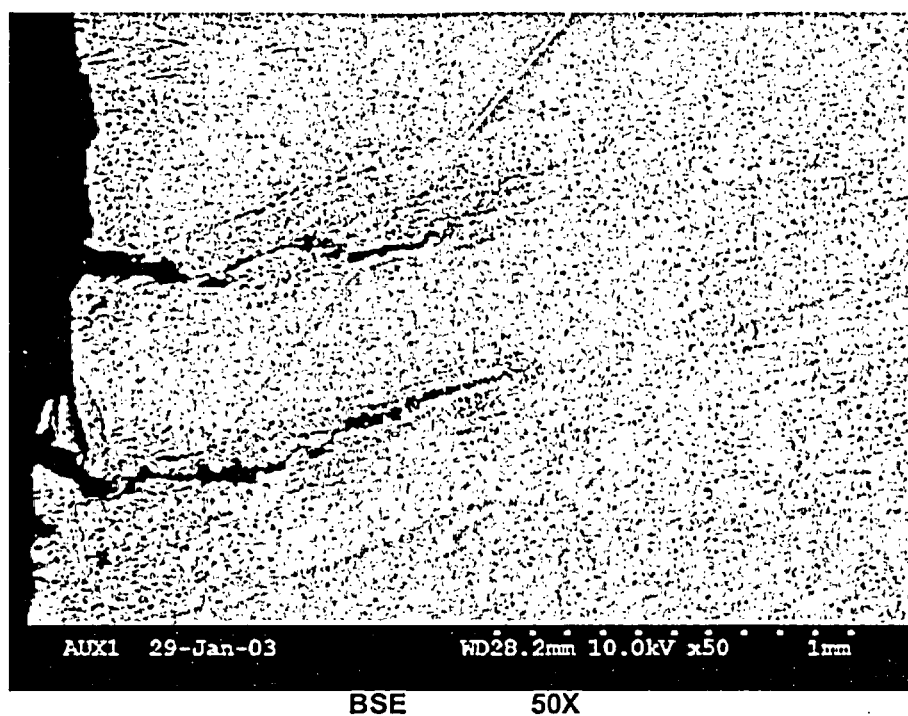
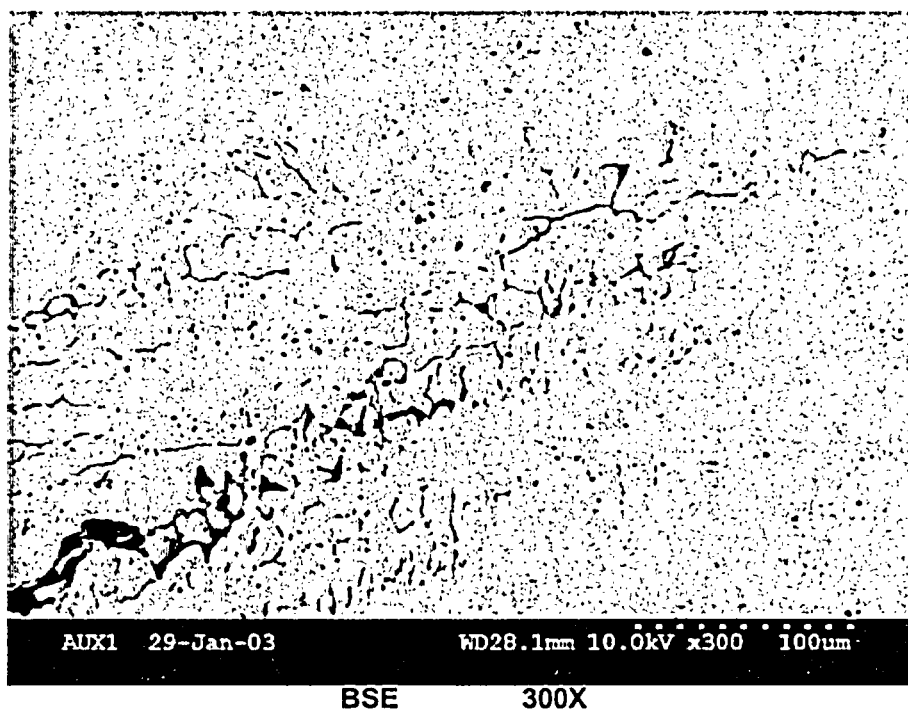
Figure 6.3.2.2: Higher magnification SEM micrographs of crack tip, showing the interdentritic crack path along the elongated ferrite pools.

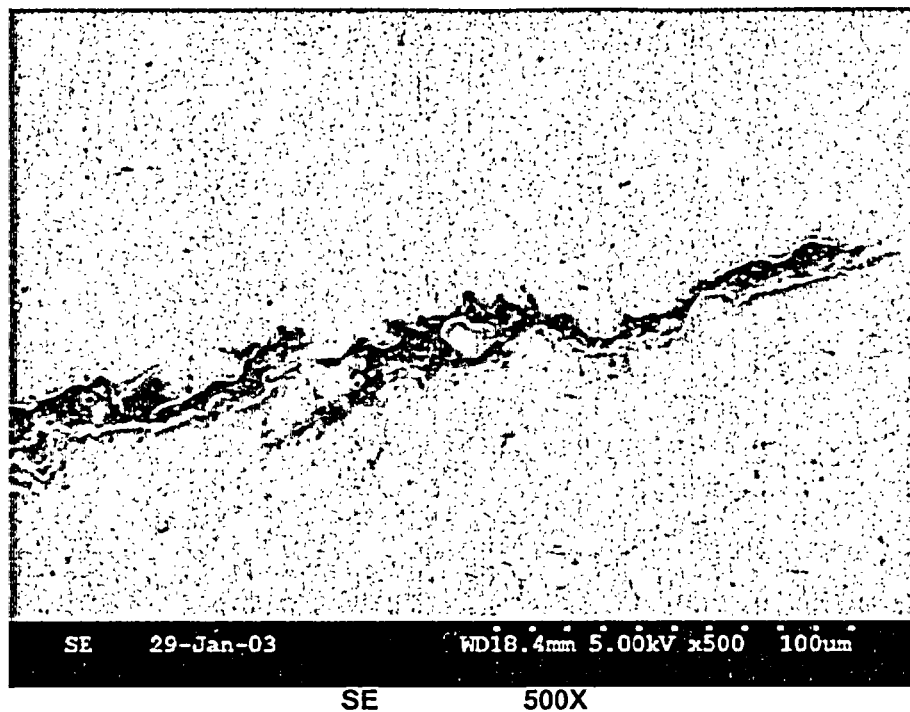
Figure 6.3.2.3: Secondary electron SEM images of crack tip, showing the interdendritic crack path along the elongated ferrite pools.

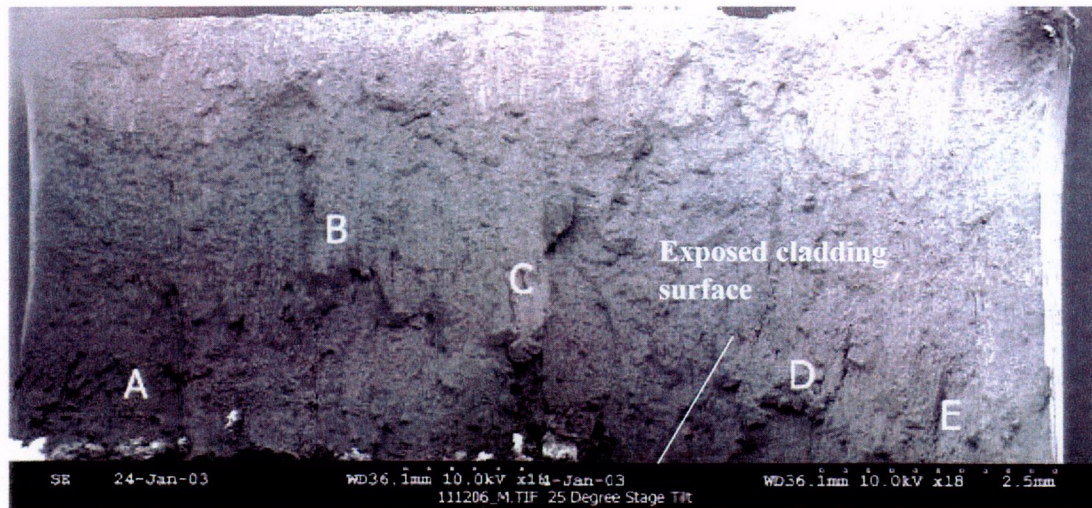
Figure 6.4.1.1: Low magnification SEM mosaic showing the opened main crack (sample A2A7-L1A). Refer to Figures 5.11 and 5.12 for the sample location. The exposed cladding surface is oriented downward in the SEM micrographs.

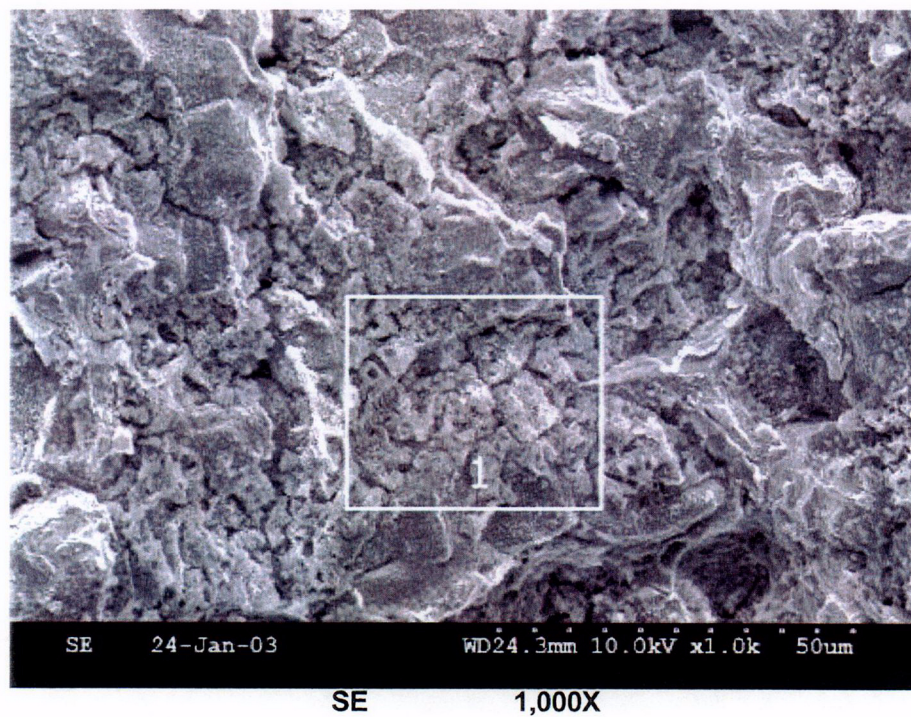
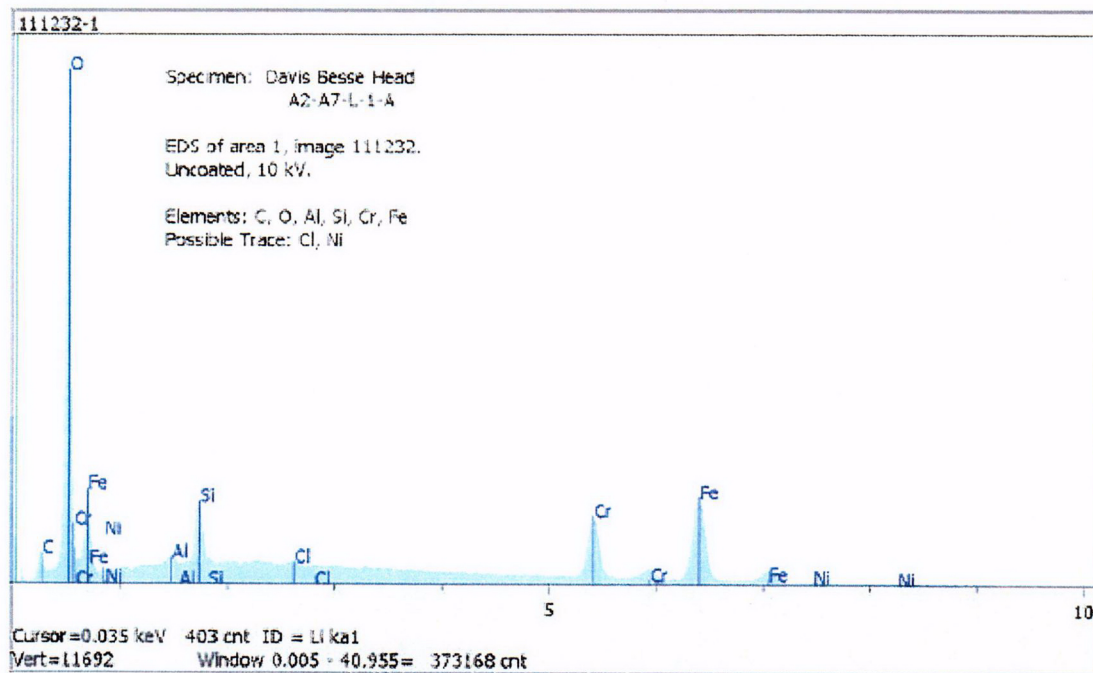
Figure 6.4.1.7: SEM micrograph and EDS results for deposited region near area "E". The corrosion deposits contained carbon, oxygen, along with iron, aluminum, silicon, and chromium. Possible trace levels of nickel and chlorine were also detected in this area.

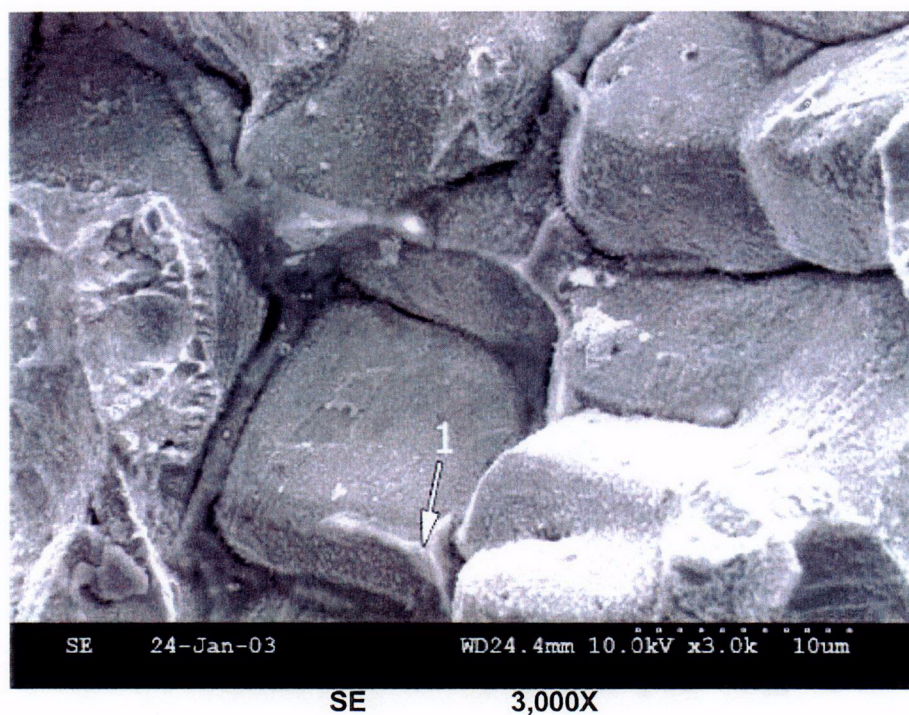
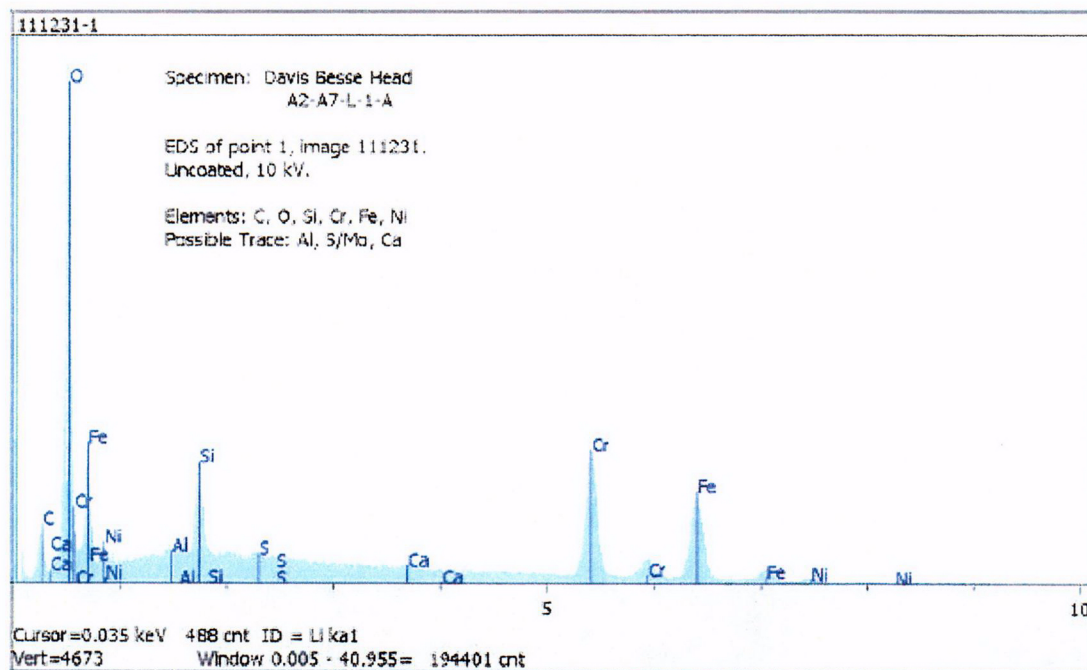
Figure 6.4.1.8: Higher magnification SE micrograph and EDS results for a grain boundary deposit near area "E". This area contained primarily carbon, oxygen, silicon, chromium, iron, and nickel. Lesser amounts of aluminum, sulfur, and calcium were also detected.

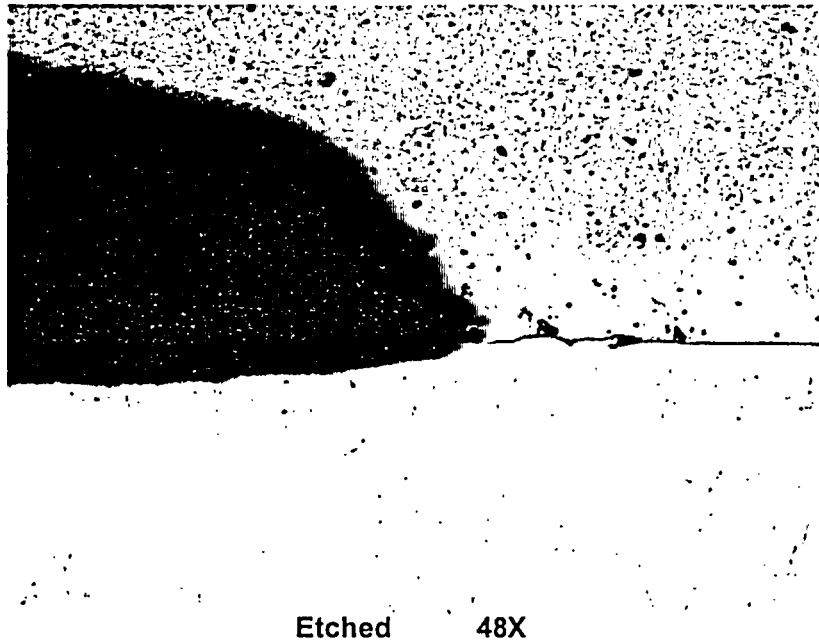
Figure 6.5.1.3: Micrograph showing the undercutting due to boric acid corrosion in the RV head low alloy steel at the interface between low alloy steel (above the notch) and stainless steel cladding (below the notch).

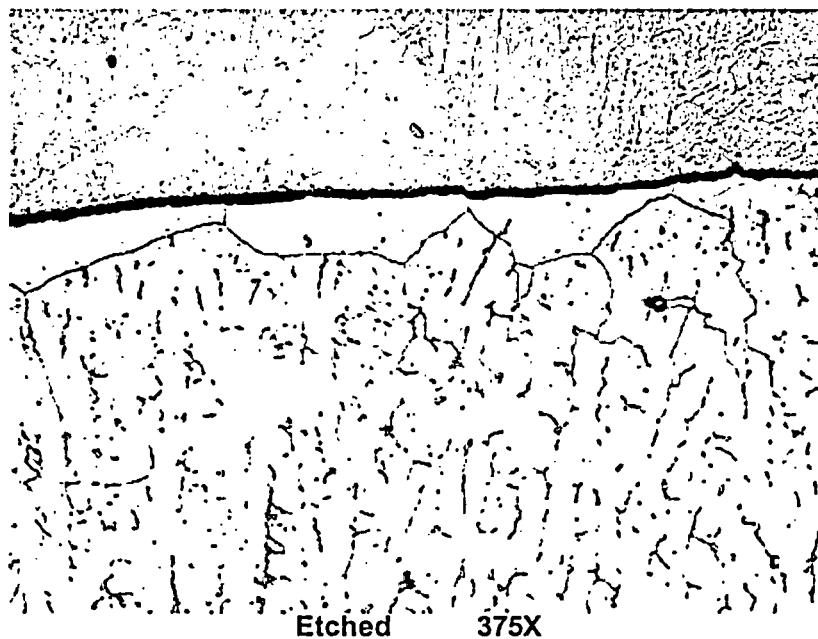
Figure 6.5.1.4: Micrograph showing the interface between low alloy steel (above) and stainless steel cladding (below). The austenitic grains in the first interface layer on the stainless steel cladding side are equiaxed and growing preferentially from the ferrite grains (low alloy steel). The subsequent grain growth in the cladding is columnar.

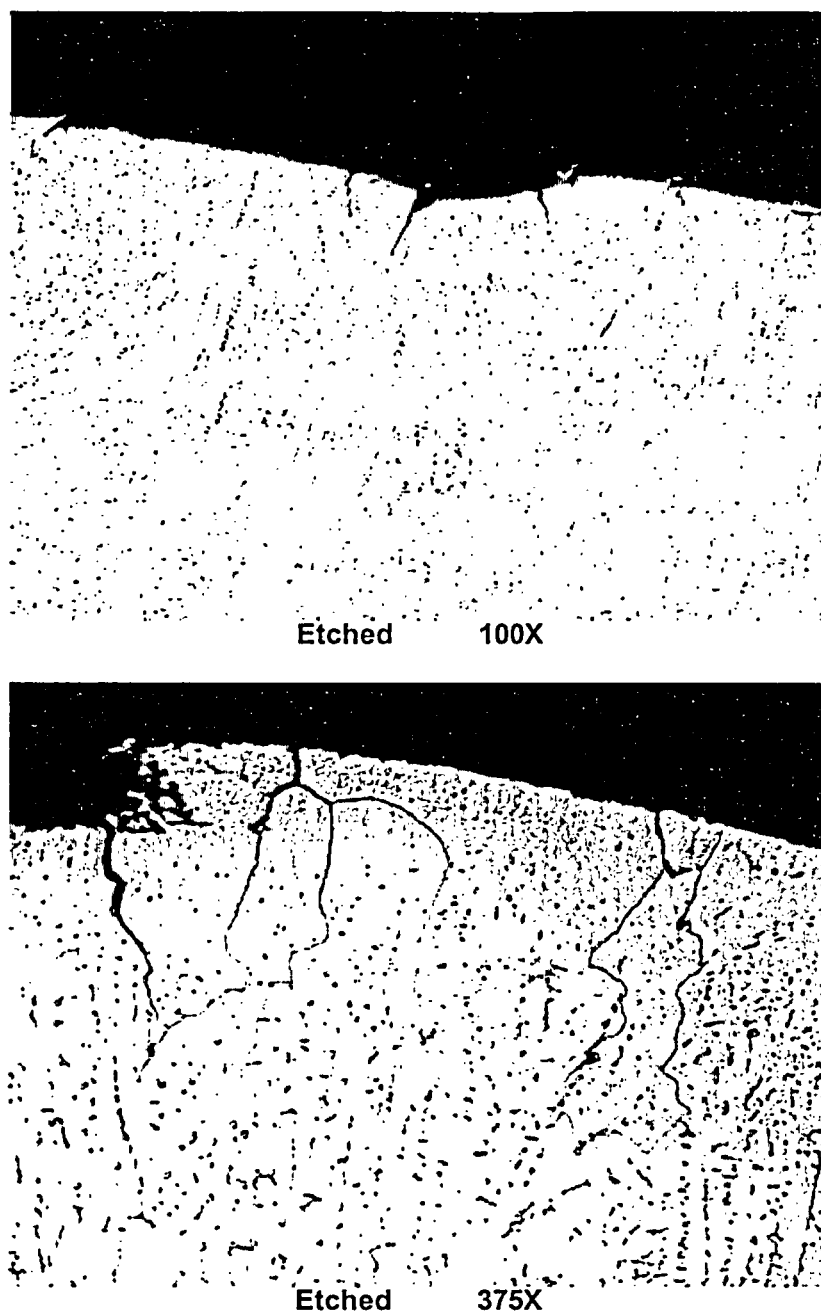
Figure 6.5.1.5: Micrographs of the cladding surface exposed due to boric acid corrosion of the RV head low alloy steel. Intergranular attack (IGA) of stainless steel cladding to a depth of the first or second layers of grains is clearly visible. The IGA is probably due to oxygenated and highly concentrated boric acid. There was no evidence of plastic deformation observed in the cladding in this area.

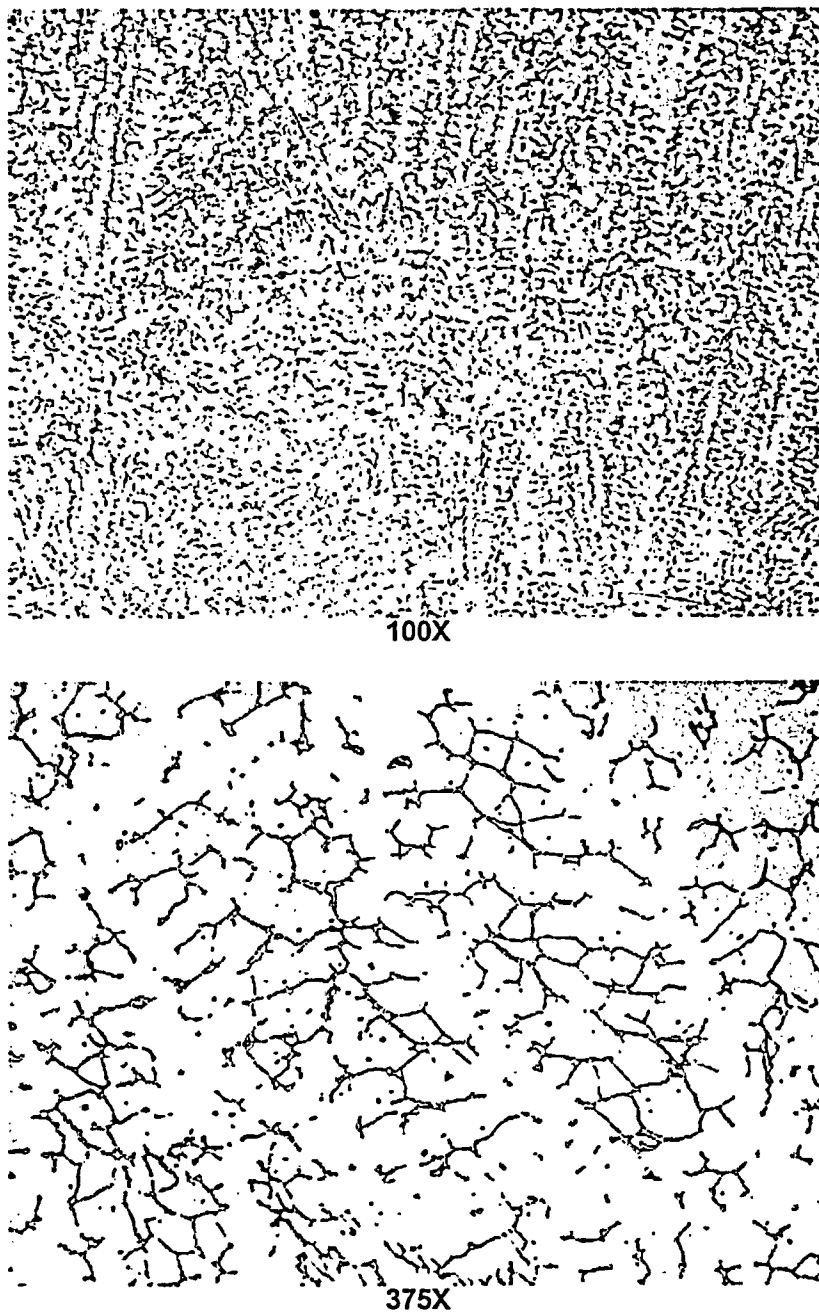
Figure 6.5.1.6: Micrographs showing typical stainless steel cladding microstructure. The dendritic solidification structure is delineated by small pools (or islands) of ferrite in an austenitic matrix.

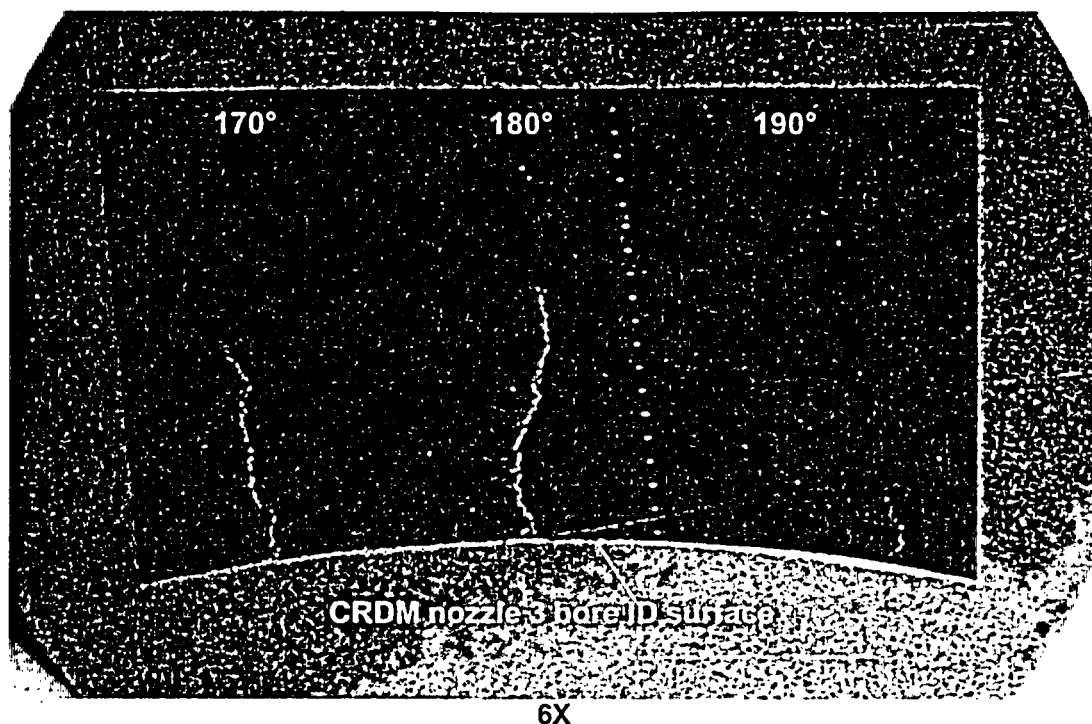
Figure 7.1.1.1: Macro photograph and Knoop microhardness results for metallographic sample A2A2B3 (see Figure 5.2 for the sample orientation). The lower concave surface is the I.D. of the nozzle 3 bore from the nozzle removal process. The crack tips of the two cracks are estimated to be approximately 0.24" and 0.20" below the surface, respectively. The indentations from the microhardness traverse are visible. The elevated microhardness level near the surface is due to the surface cold work layer from the boring of nozzle 3 removal process (see Figures 5.2 and 7.1.1.5).

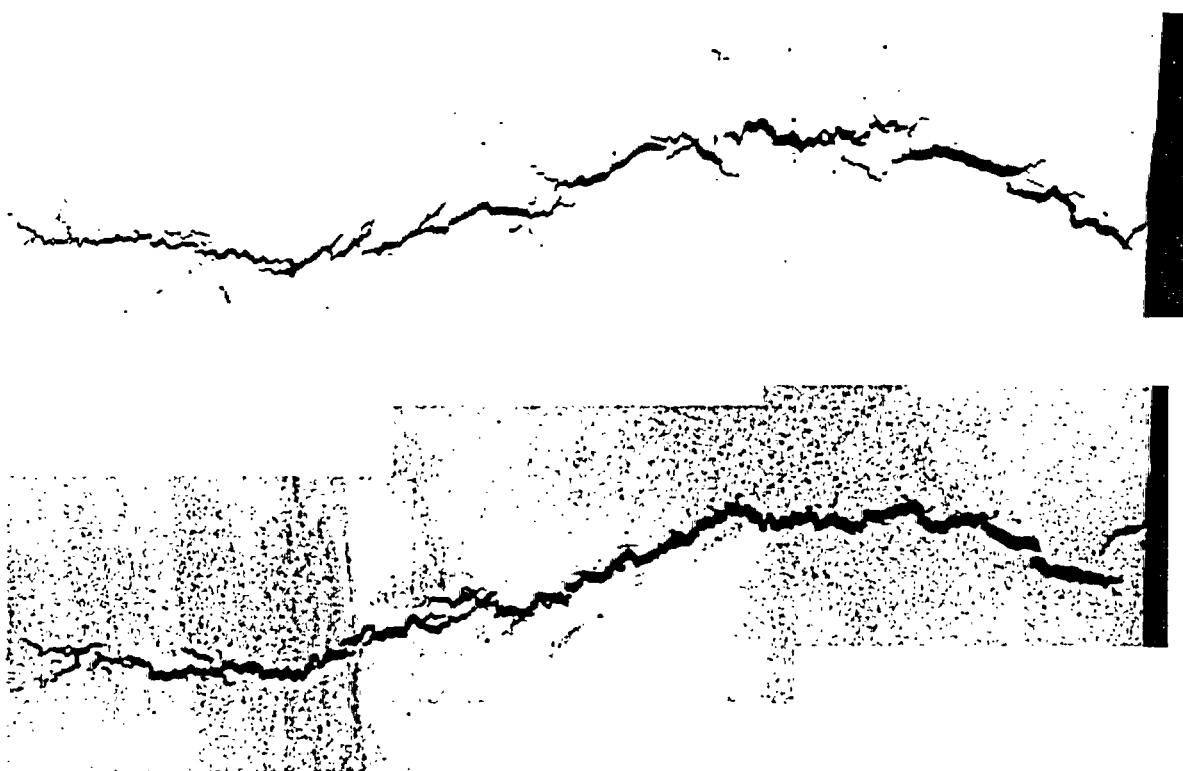
Figure 7.1.1.2: Micrographs showing the crack at $\sim 180^\circ$ in sample A2A2B3. Top as-polished, bottom etched. Both micrographs 24X.

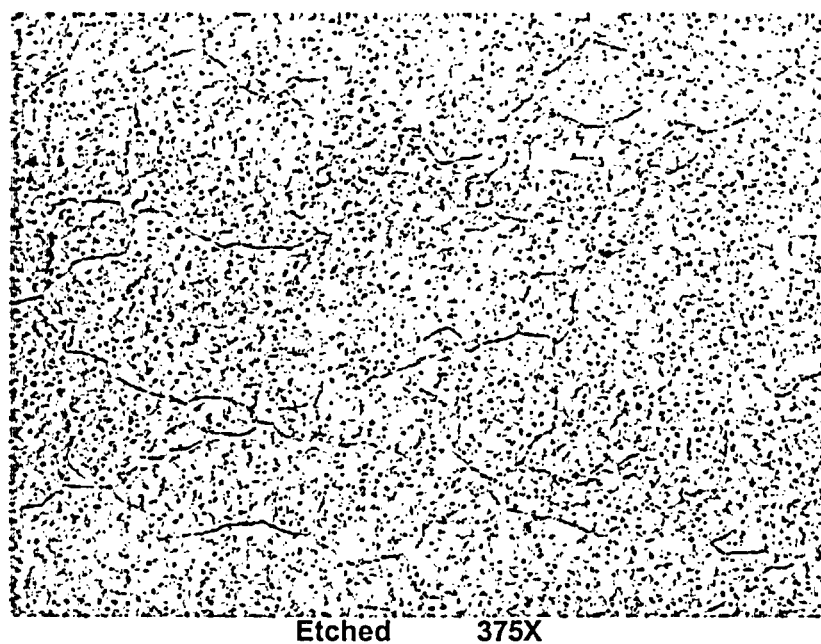
Figure 7.1.1.3: Typical microstructure of sample A2A2B3. The grain size and dendritic structure within each grain are consistent with typical Alloy 182 weld.

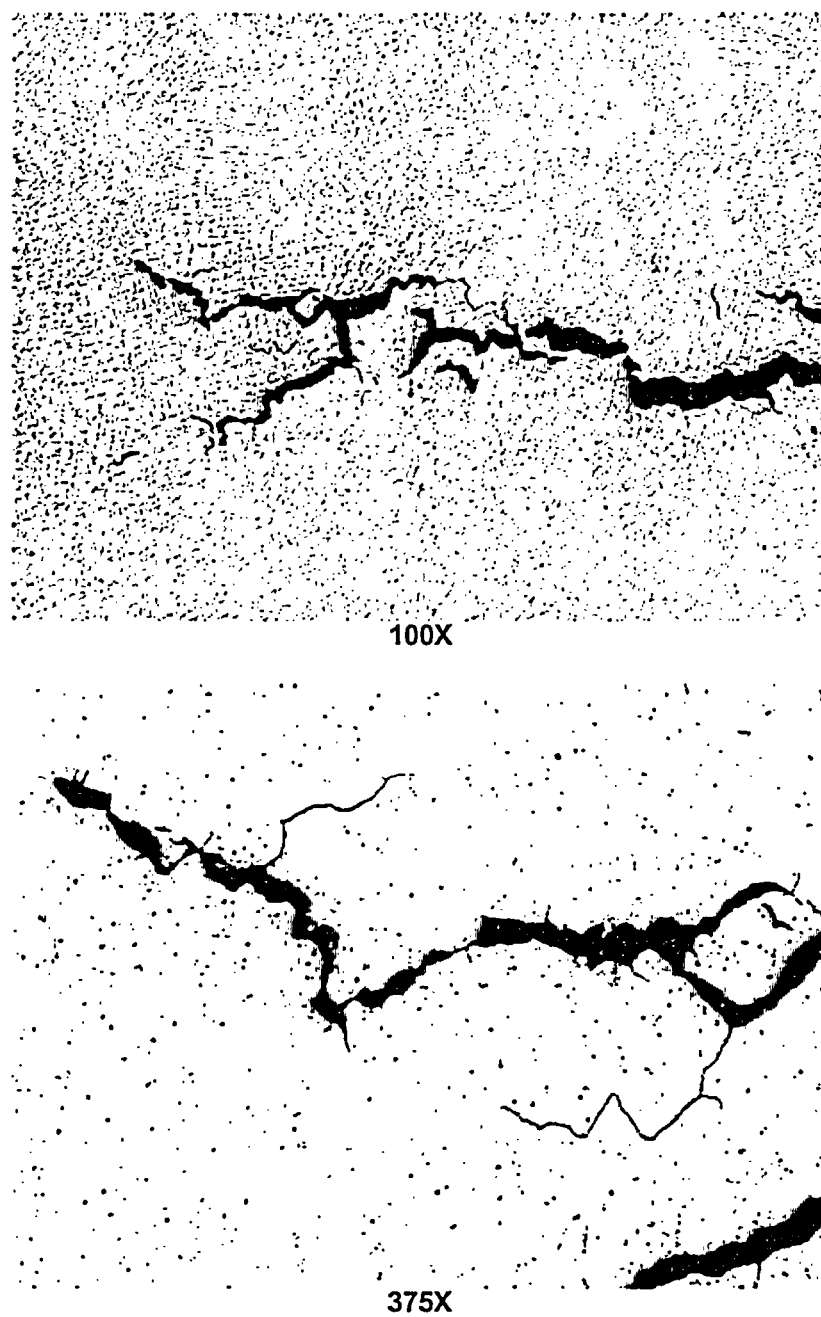
Figure 7.1.1.4: Higher magnification micrographs of the crack tips. Cracking is intergranular or interdendritic.

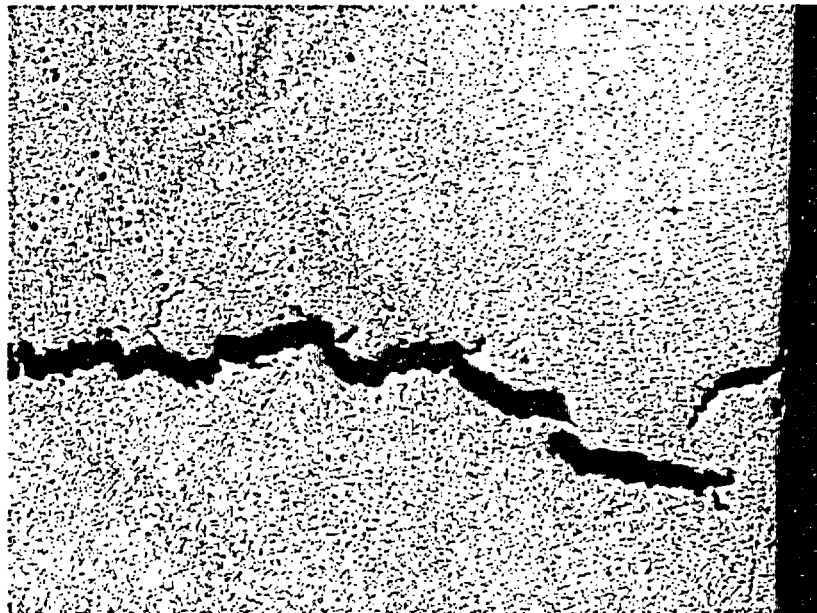
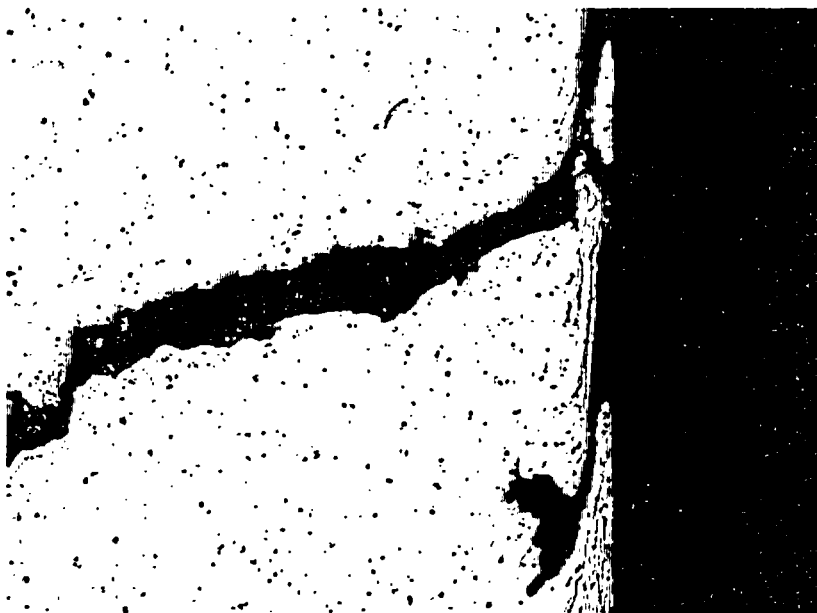
Figure 7.1.1.5: Higher magnification micrographs of the cracking at $\sim 180^\circ$ near the bored surface. The bored surface shows evidence of surface cold work. The surface cold work is due to the nozzle removal from the RV head and is not related to the J-groove weld fabrication process.

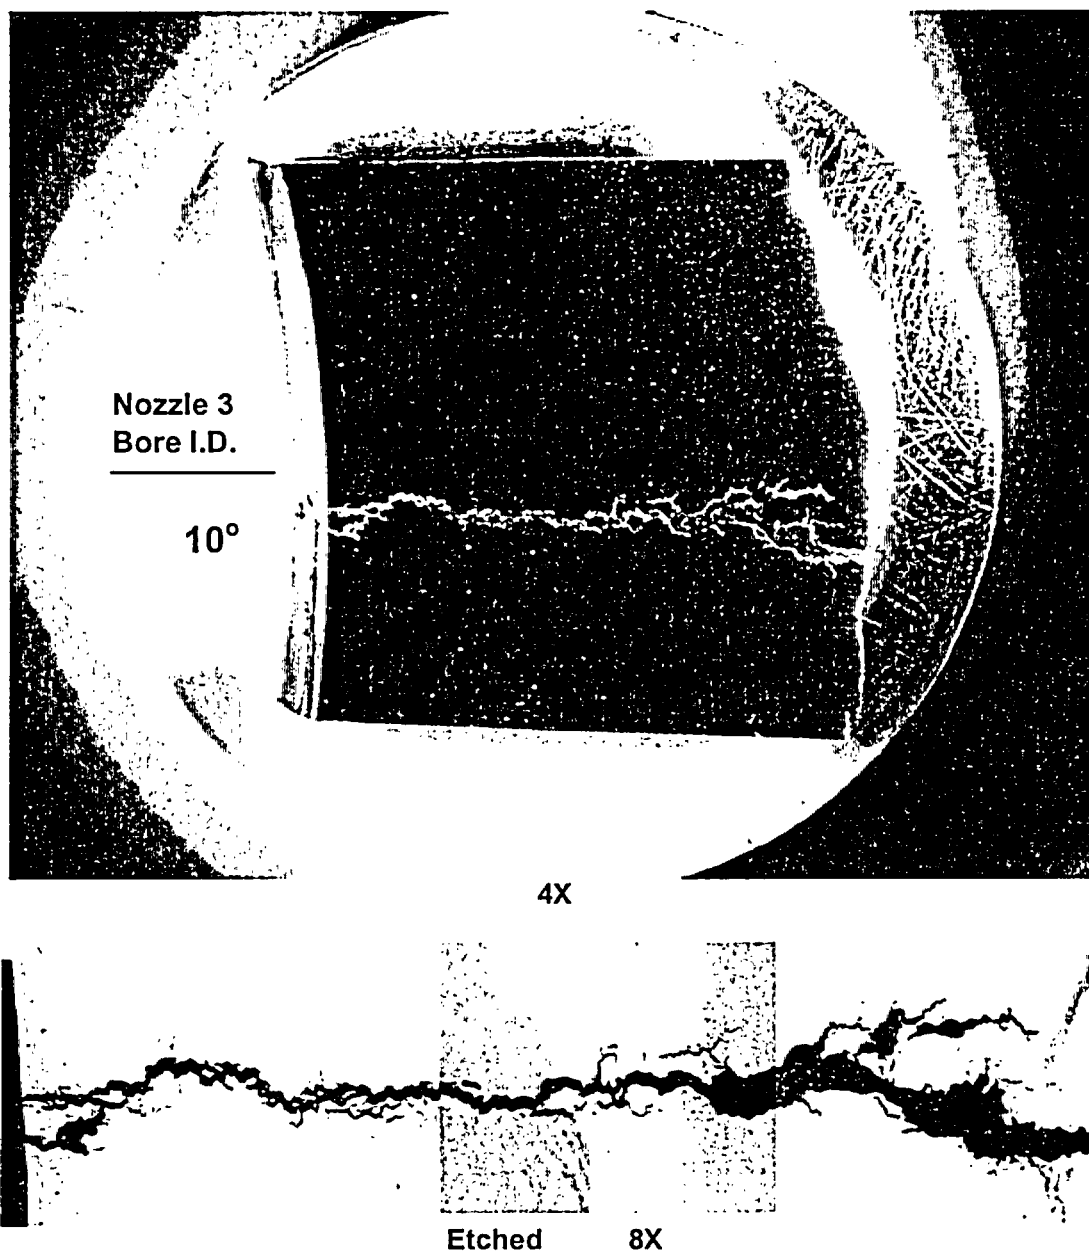
Figure 7.2.1.1: Macro photograph of metallographic mount sample A2A6B2 (see Figures 5.4 and 5.5 for the sample orientation). The axial cracking at $\sim 10^\circ$ is through the J-groove weld, in contrast to the cracking near 180° , which was partially through the weld. A slightly higher magnification micrograph is also provided.

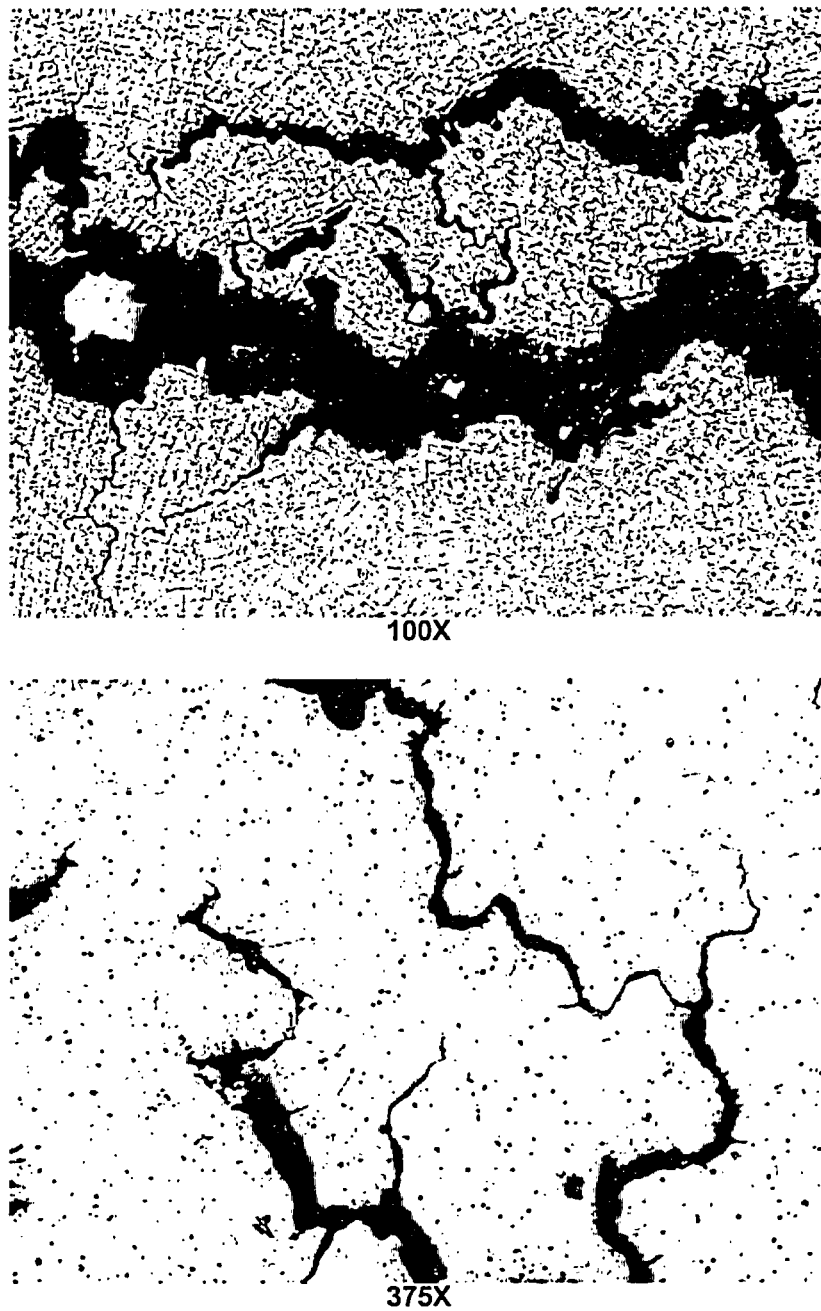
Figure 7.2.1.2: Higher magnification micrographs of the J-groove weld cracking. Cracking is intergranular or interdendritic, similar to the cracking at $\sim 180^\circ$ in Figure 7.1.1.4.

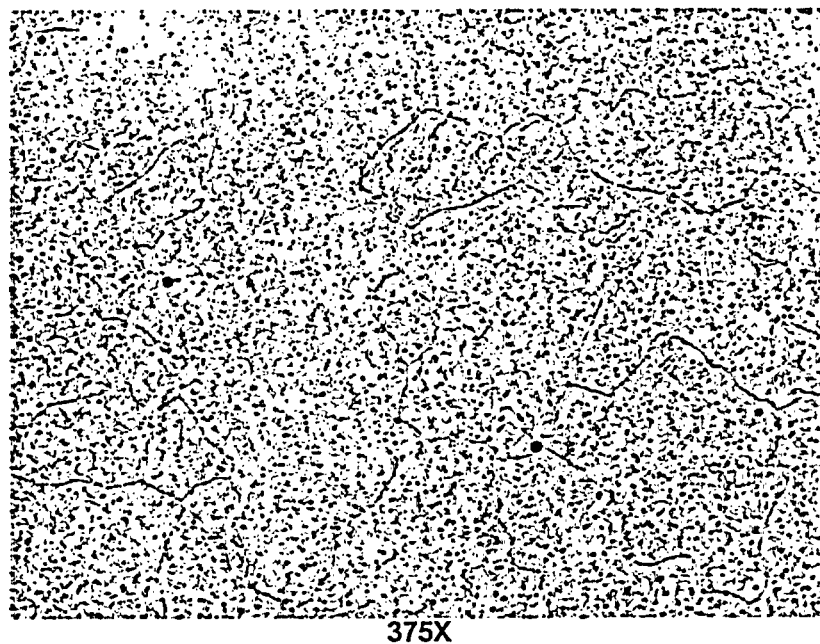
Figure 7.2.1.3: Typical microstructure of sample A2A6B2, which was similar to Figure 7.1.1.3 (at $\sim 180^\circ$).

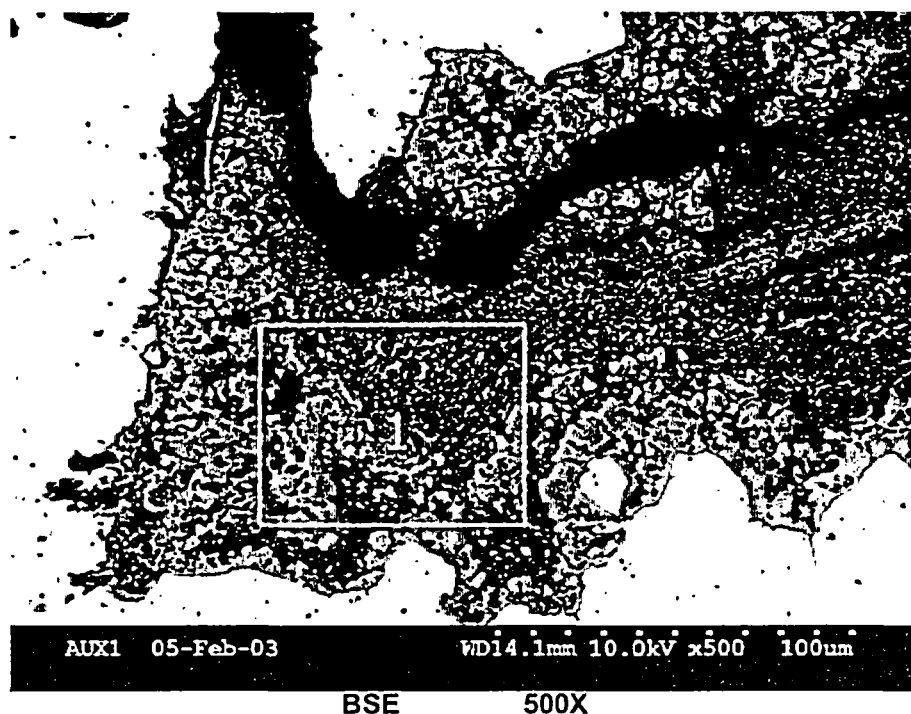
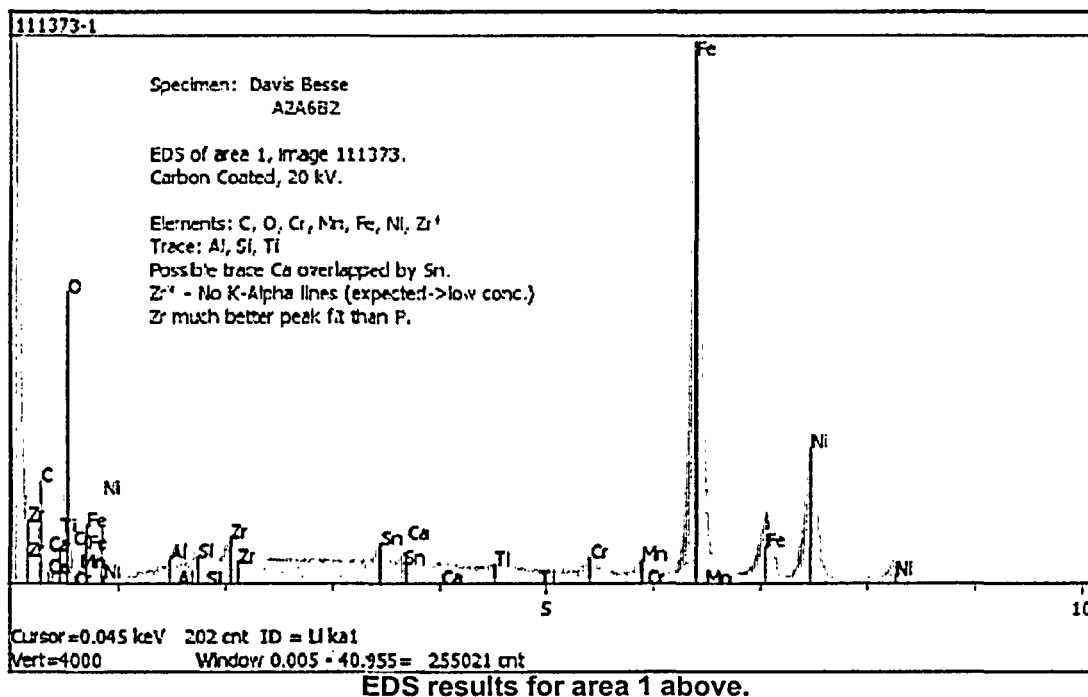
Figure 7.2.2.1: BSE micrograph showing portion of crack filled with corrosion products. The EDS results indicated high concentrations of carbon, oxygen, iron, and nickel.

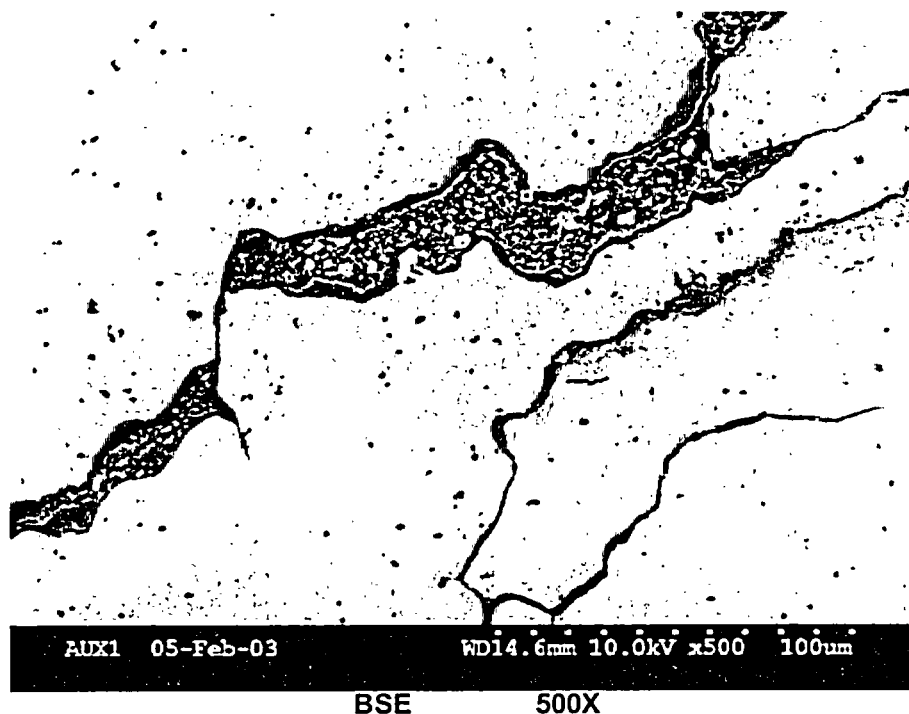
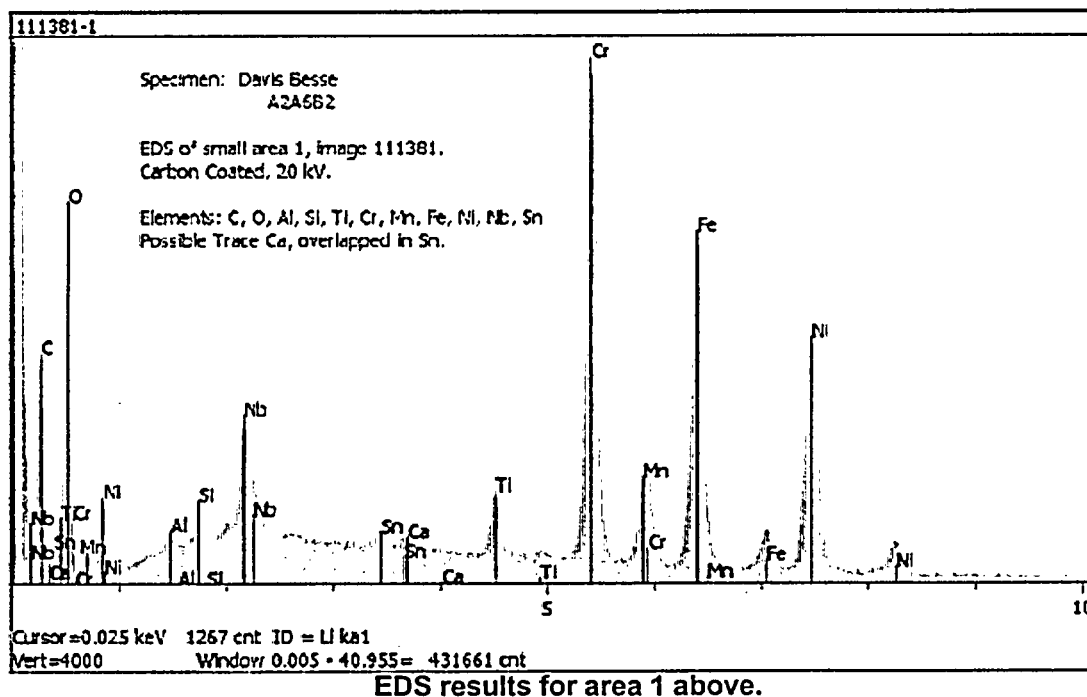
Figure 7.2.2.2: BSE micrograph showing corrosion products near crack tip. The EDS results collected from the area 1 indicated high concentrations of carbon, oxygen, niobium, titanium, chromium, manganese, iron, and nickel.

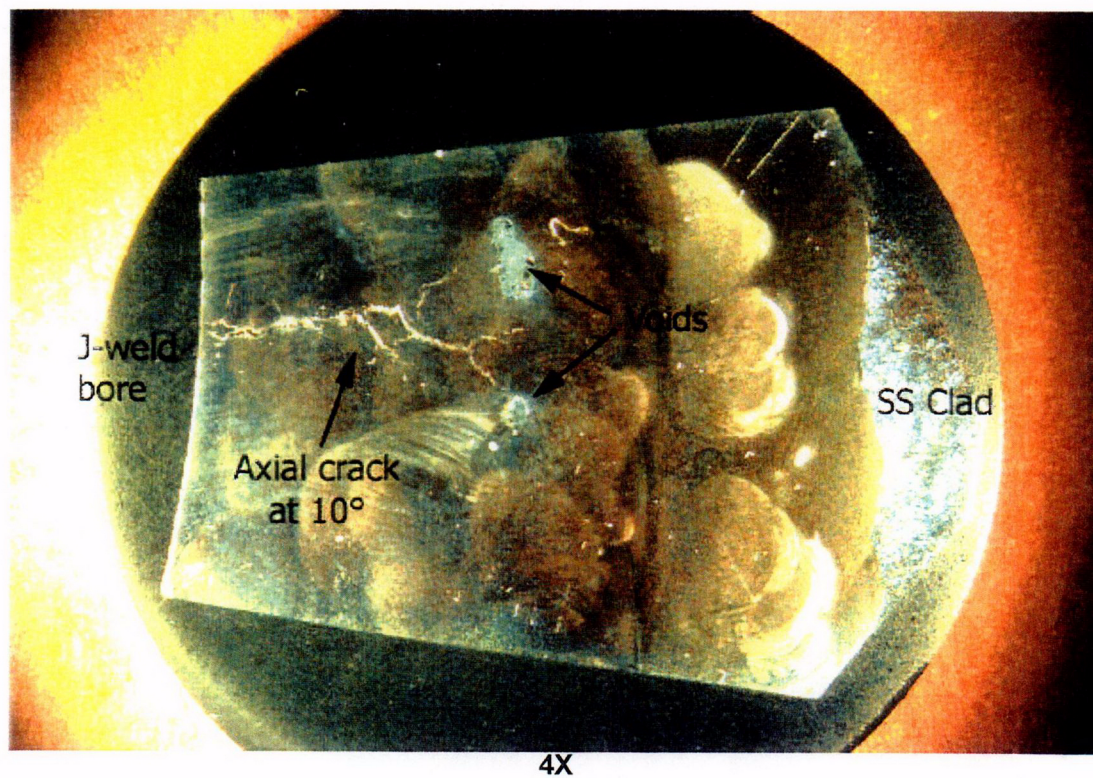
Figure 7.2.3.1: Macro photograph of metallographic mount A2A6A2E1 (see Figure 5.6 and 5.10 for the sample orientation). Cracking was partially through the J-groove weld in the sample plane.

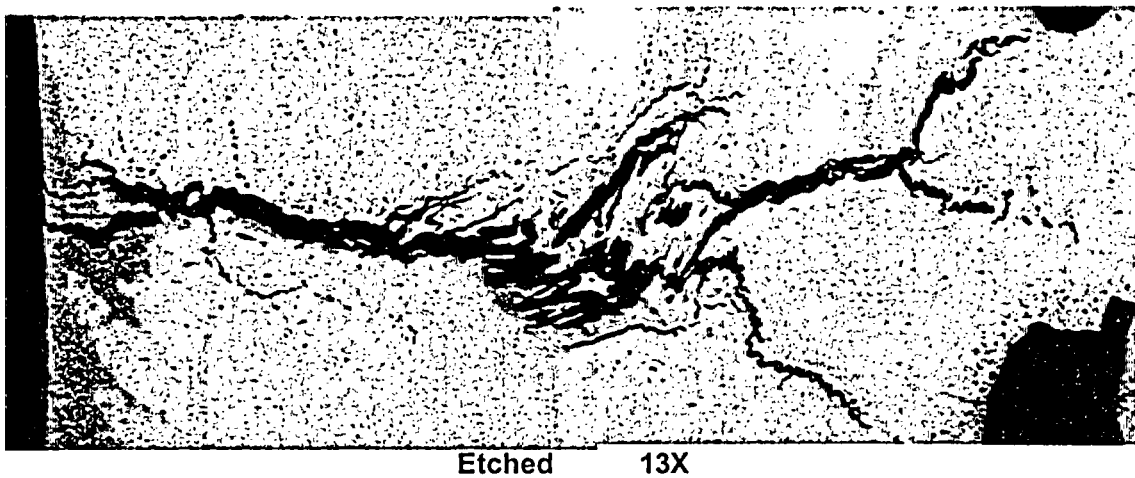
Figure 7.2.3.2: Micrograph showing axial cracks in the lower portion of the J-groove weld at $\sim 10^\circ$. The crack maximum depth is approximately 0.45" beneath the bore I.D. surface.

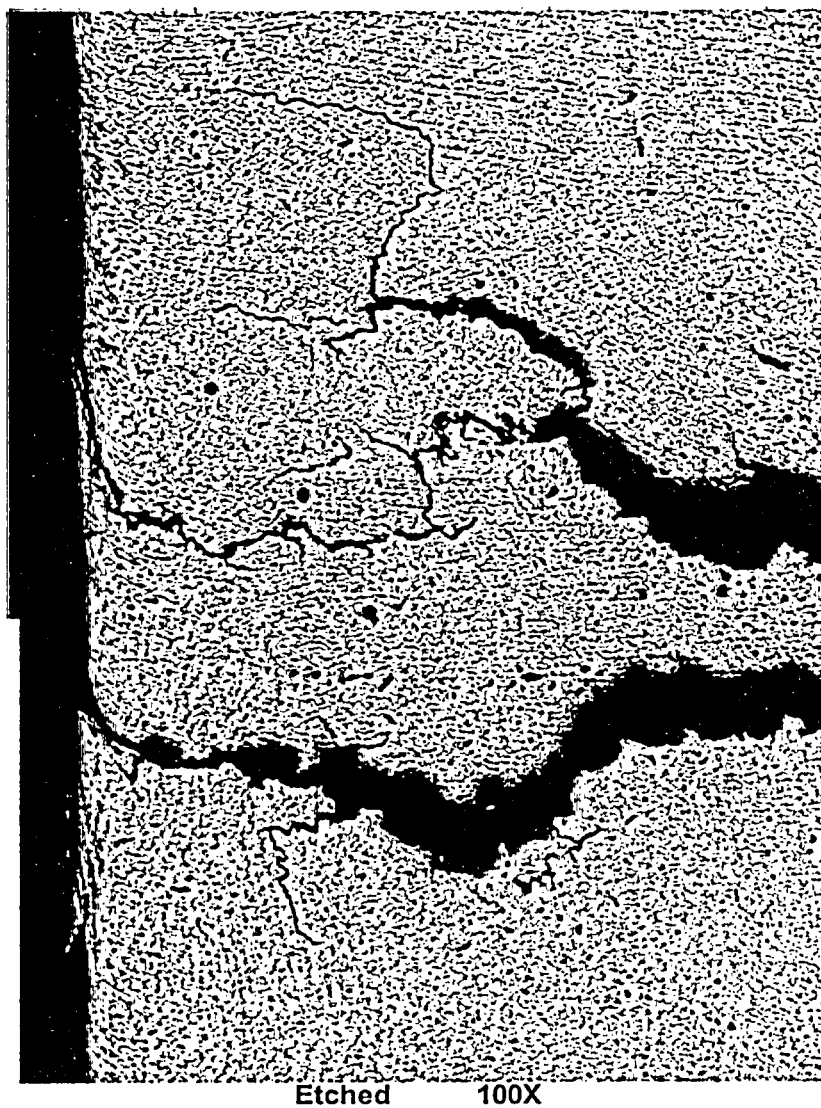
Figure 7.2.3.3: Cracks located near the bored surface. Surface cold work layer is due to the boring (nozzle removal) process.
