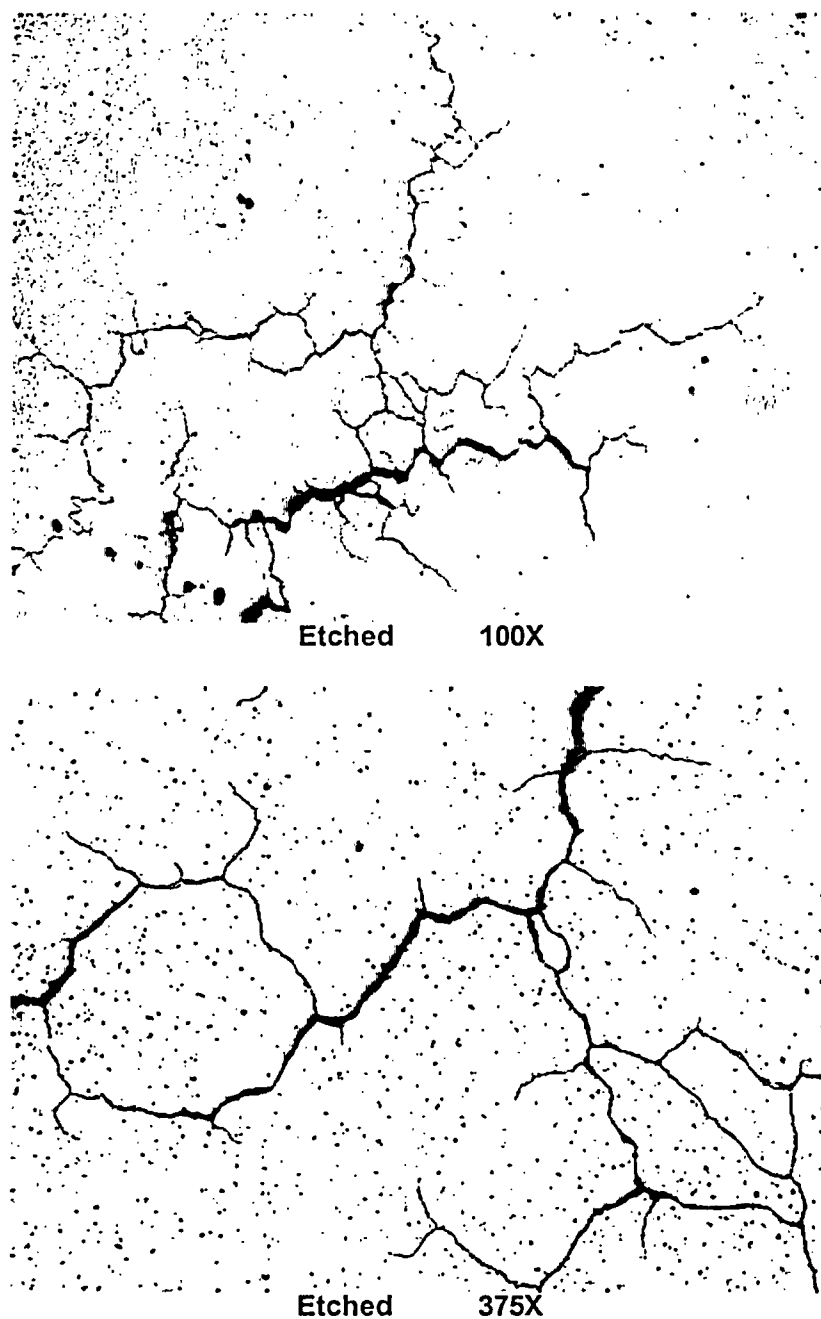
Figure 7.2.3.4: Interdentritic or intergranular cracking in the J-groove weld away from the bore I.D. surface.

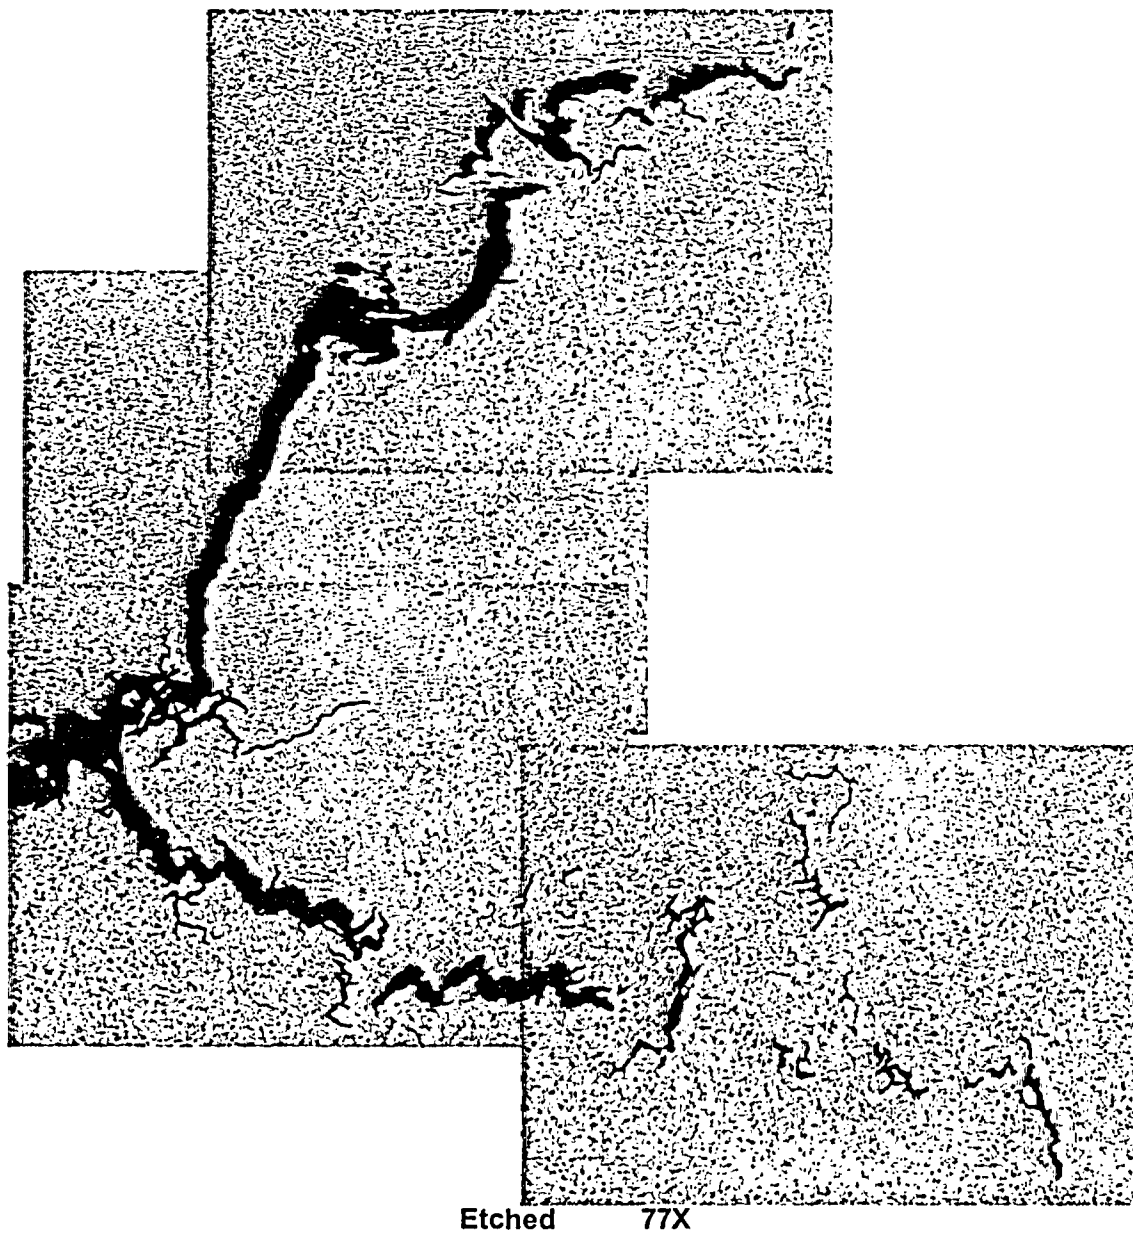
Figure 7.2.3.5: Crack tips toward the J-groove weld O.D.

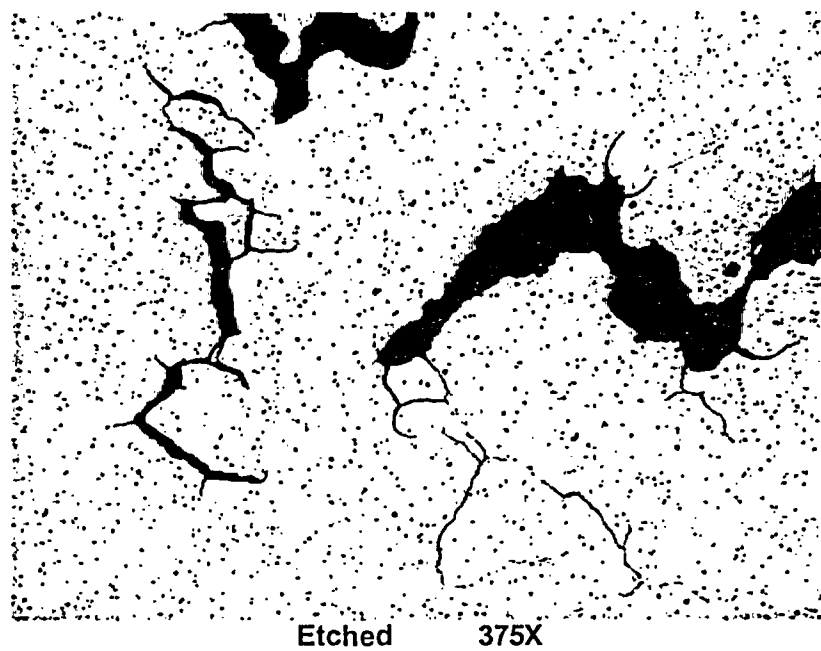
Figure 7.2.3.6: Crack detail from Figure 7.2.3.5.

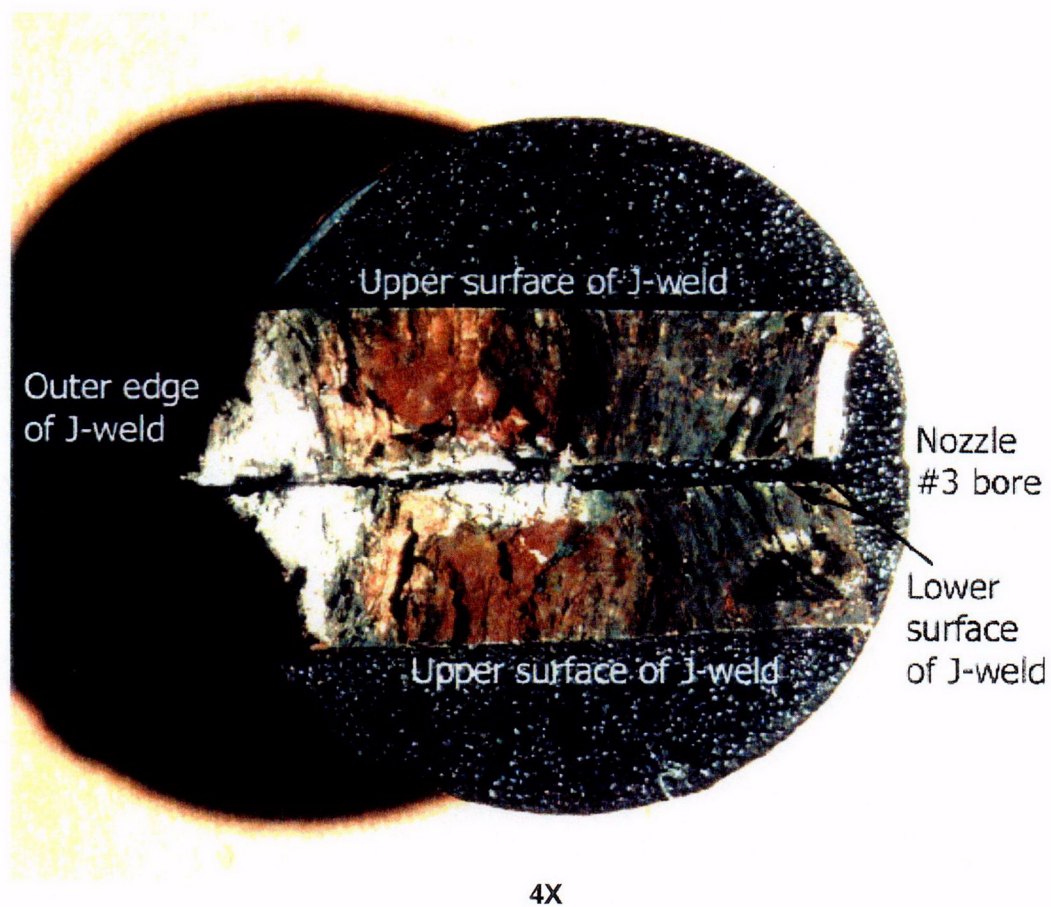
Figure 7.2.4.1: Macro photograph of sample A2A6B3 with the middle portion of the axial cracking at $\sim 10^\circ$ opened-up for SEM. Refer to Figures 5.4 and 5.5 for the sample location.
