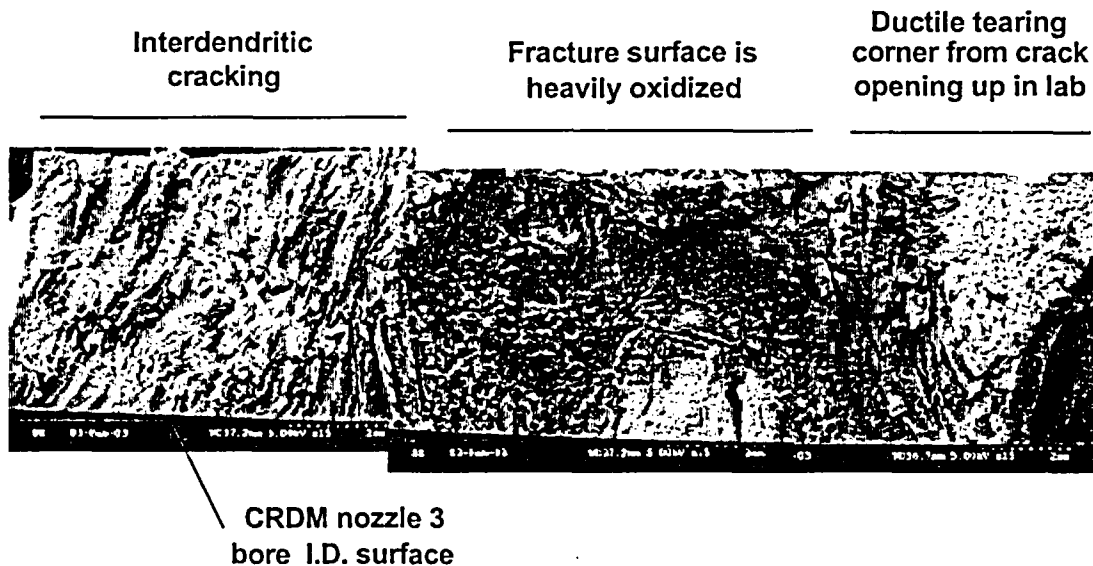
Figure 7.2.4.2: Low magnification SEM mosaic of the fracture surface after opening-up the axial crack. BSE 6.7X

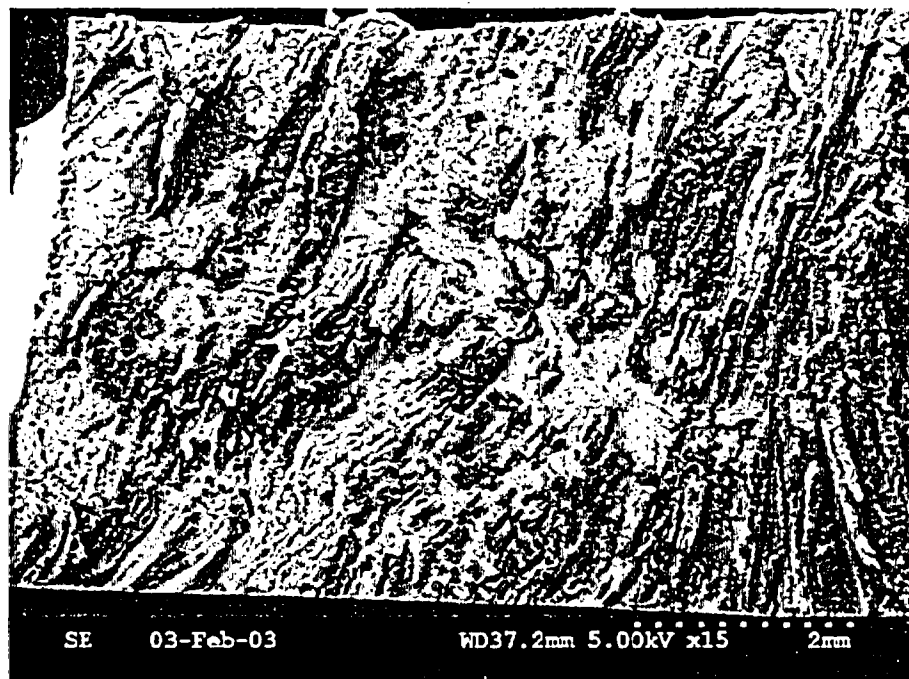
Figure 7.2.4.3: Higher magnification of the left section in Figure 7.2.4.2. Cracking is interdendritic exposing a well-defined columnar solidification structure.

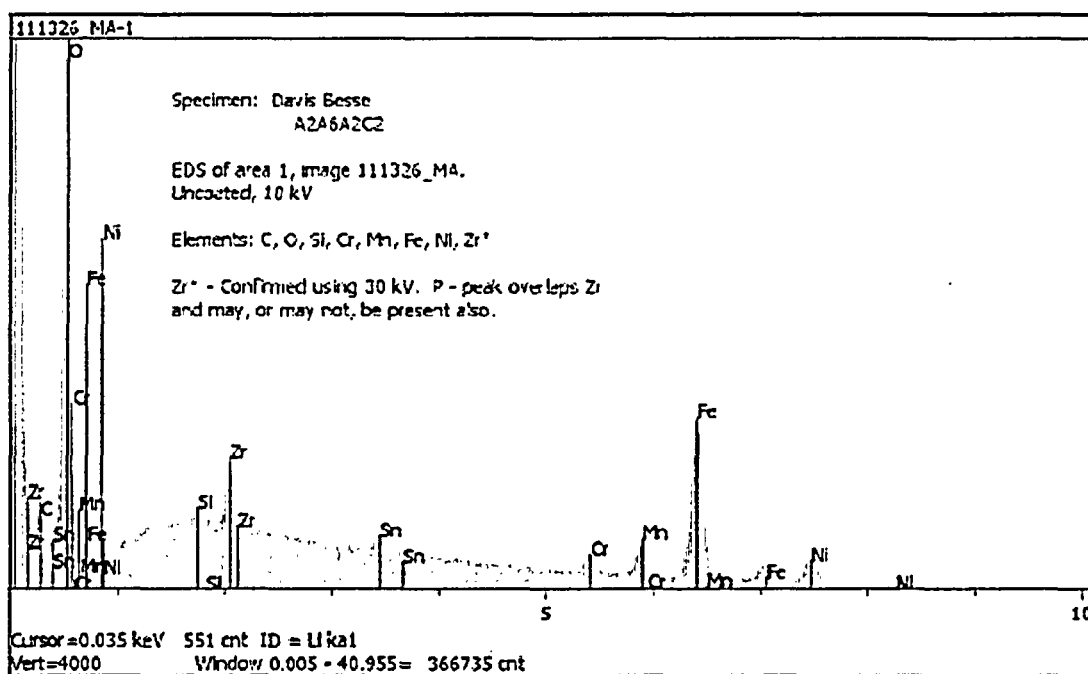
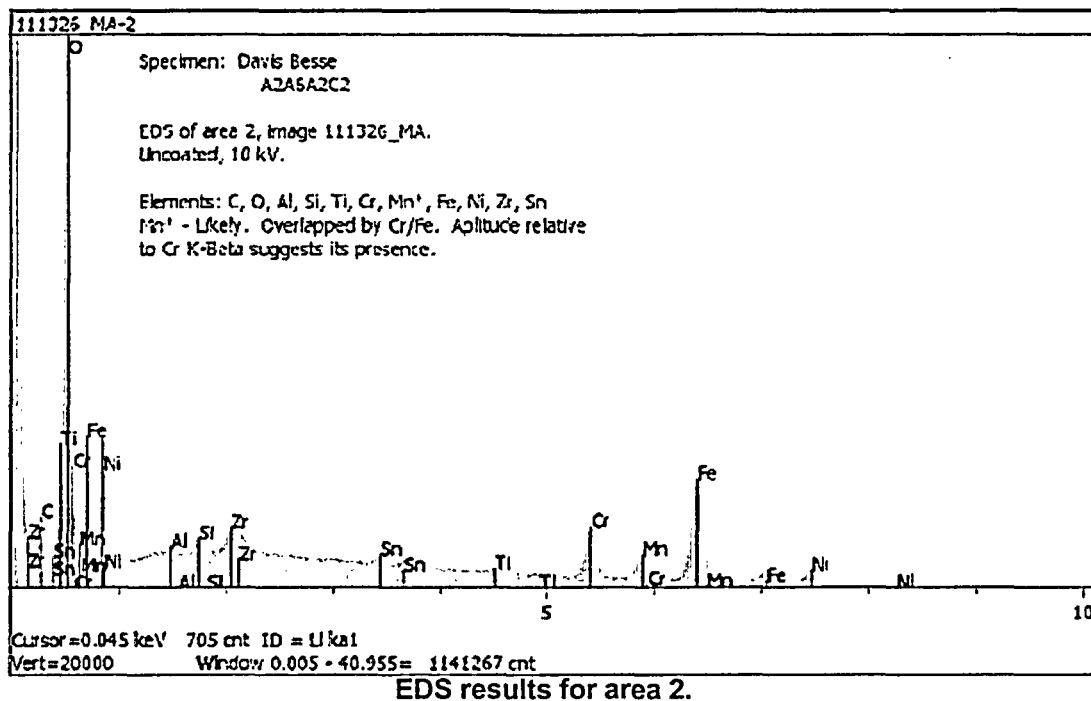
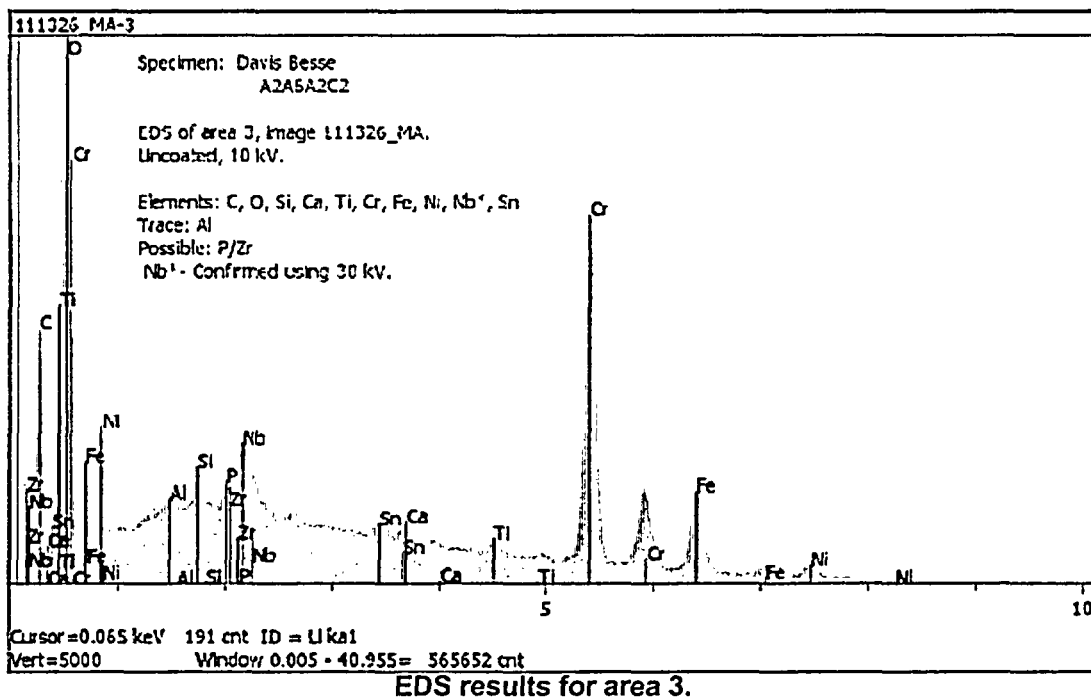
Figure 7.2.4.6: BSE micrograph mosaic of the open crack surface (same area as Figure 7.2.4.2) along with EDS results for three areas of the fracture surface. The dark area in the BSE image indicates the fracture surface was covered by a thick oxide layer. The light area (right side) indicates a fresh fracture surface due to crack opening-up (i.e., less oxide on surface). For area 1, the primary elements included carbon, oxygen, silicon, chromium, manganese, iron, nickel, and zirconium.

Figure 7.2.4.6 (cont.): For area 2, the primary elements included carbon, oxygen, silicon, chromium, manganese, iron, nickel, and zirconium. Similar results were obtained for area 3, except area 3 also contained niobium and calcium.

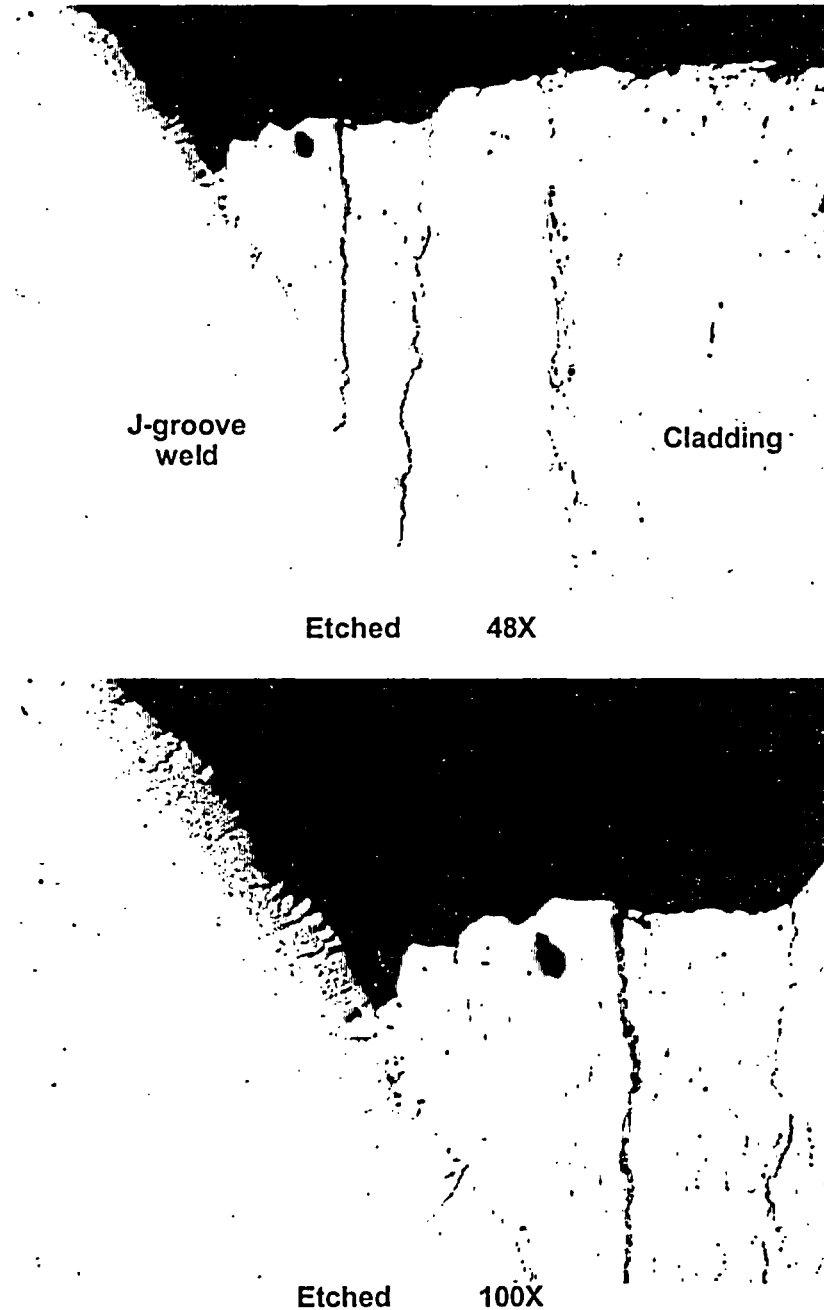
**Figure 7.3.1.3: Intergranular or interdendritic cracking initiating at the cladding surface and extending into the J-groove weld. Note that the micrographs shown are mirror image of the photo in Figure 7.3.1.2. Intergranular attack (IGA) is also evident on the exposed surface of J-groove weld and cladding (surface exposed to oxygenated boric acid). This cracking is likely initiated by IGA.**

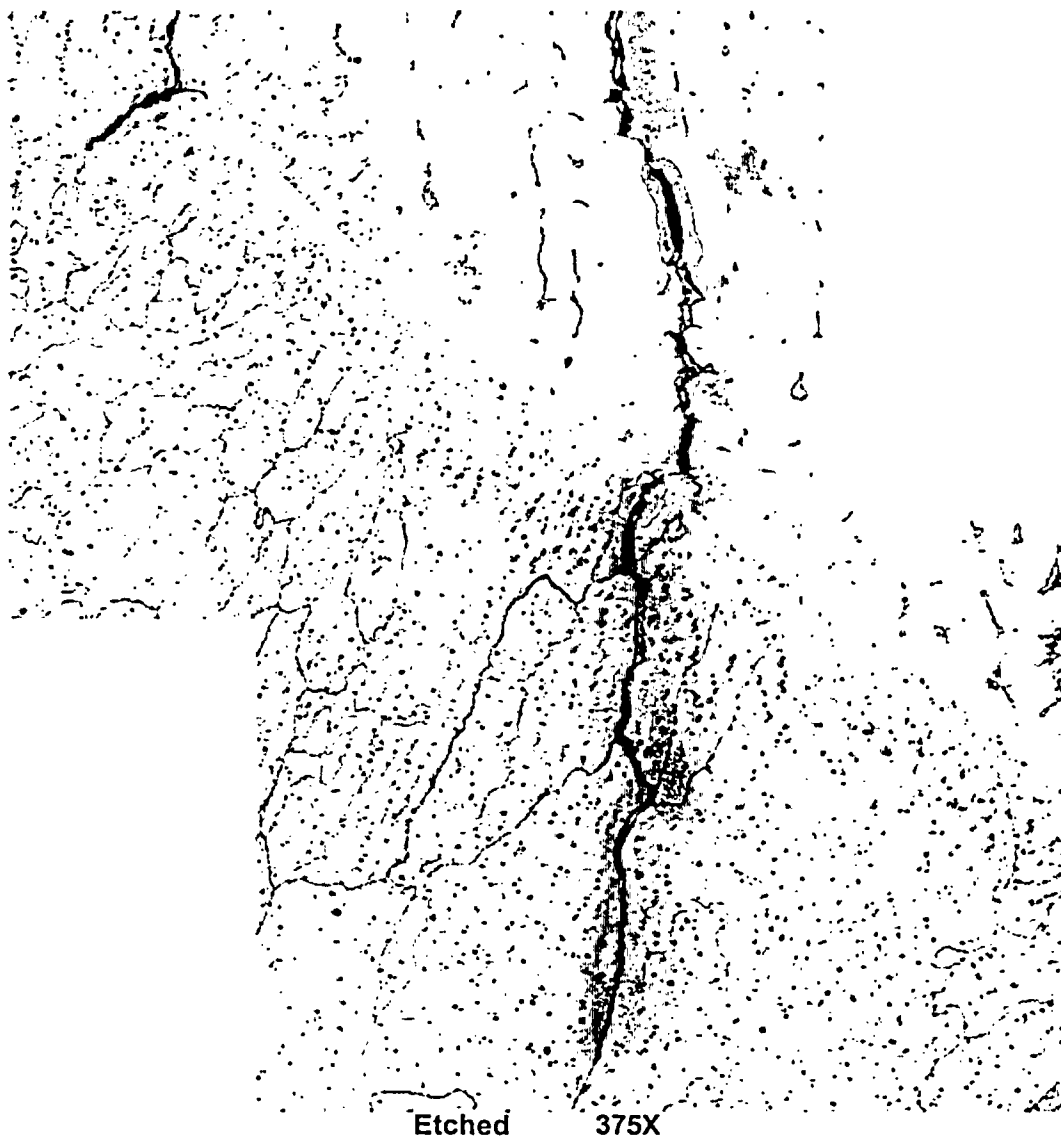
Figure 7.3.1.4: Higher magnification micrograph showing intergranular or interdendritic cracking initiating at the cladding surface and extending into the J-groove weld.

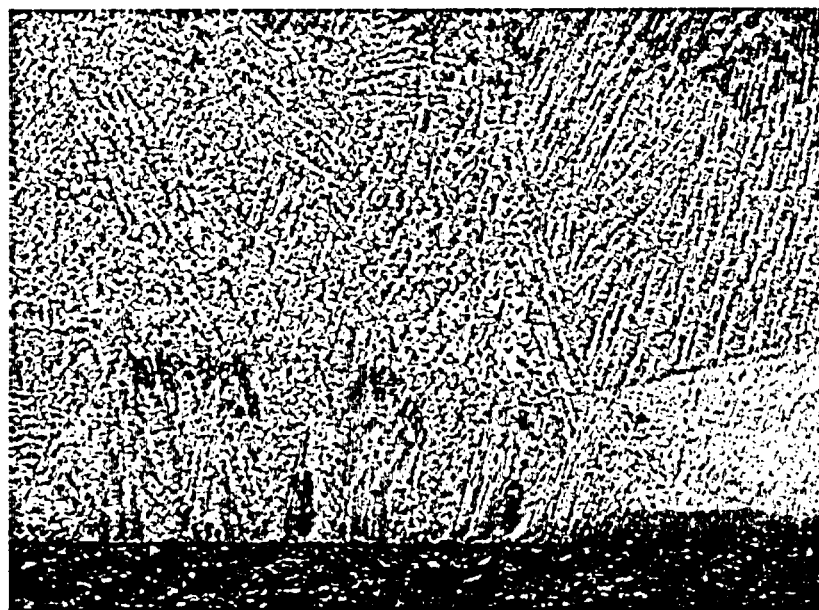
Figure 7.3.1.5: Low magnification micrographs showing shallow circumferential cracking in the J-groove weld.

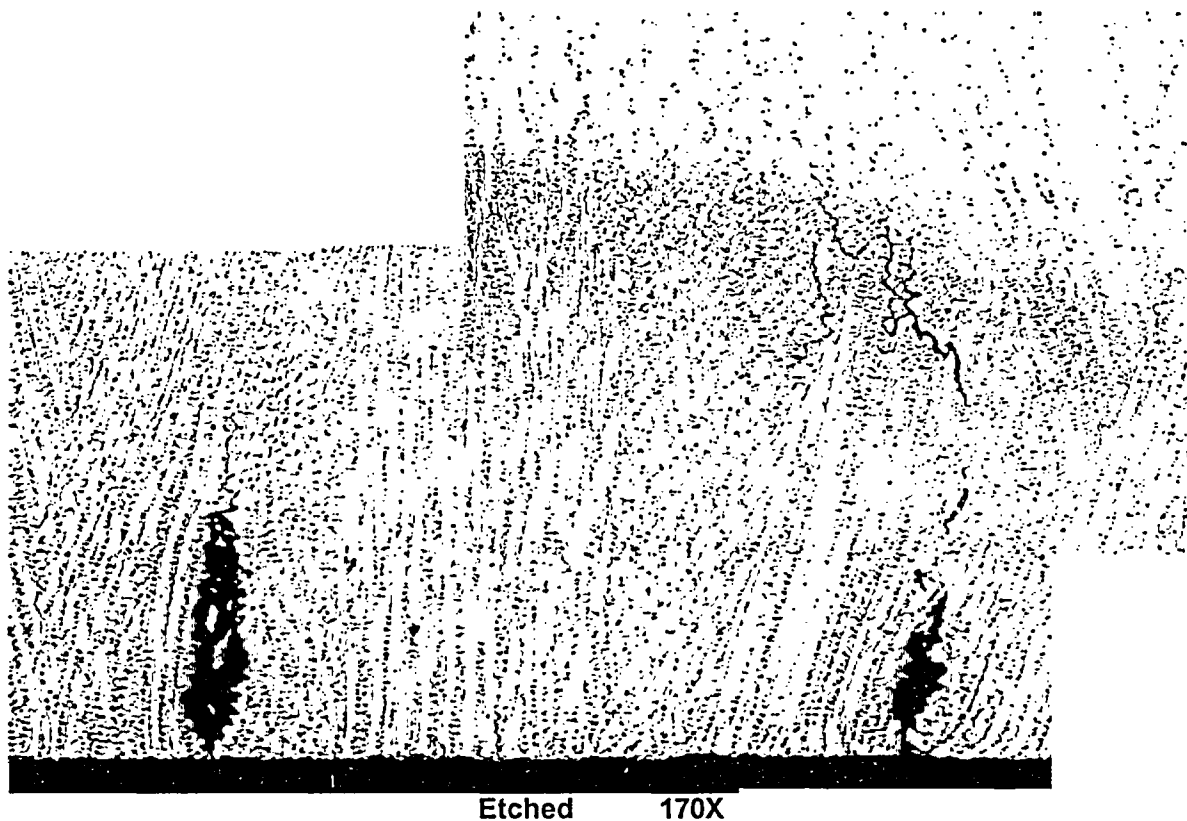
**Figure 7.3.1.6: Micrograph showing the shallow circumferential cracks in the J-groove weld. The cracking is intergranular or interdendritic, with a maximum depth of approximately 0.019" below the surface. The two wider crack regions just below the surface may have been dendrites or grains encircled by cracks that subsequently dropped out during sample preparation.**

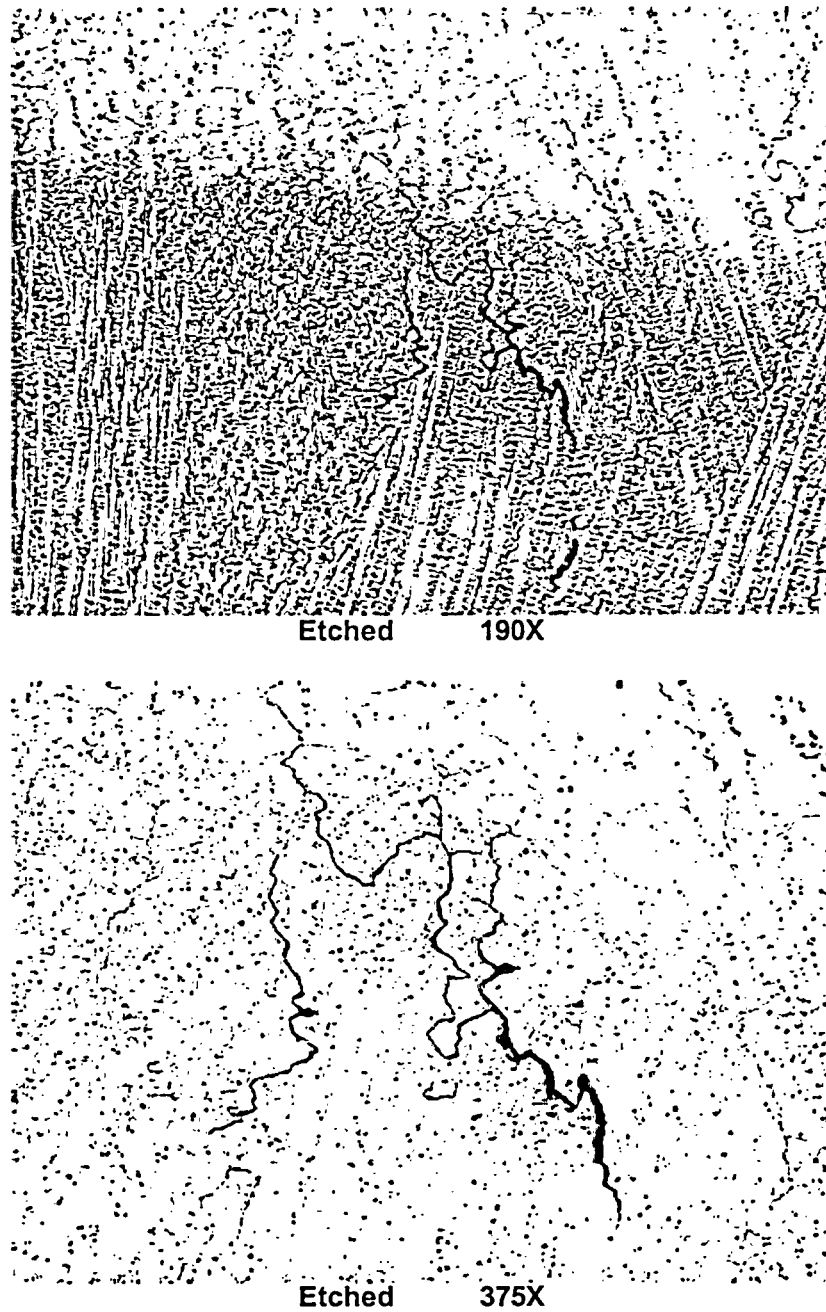
**Figure 7.3.1.7: Micrographs showing crack tips of the circumferential cracking in the J-groove weld.**

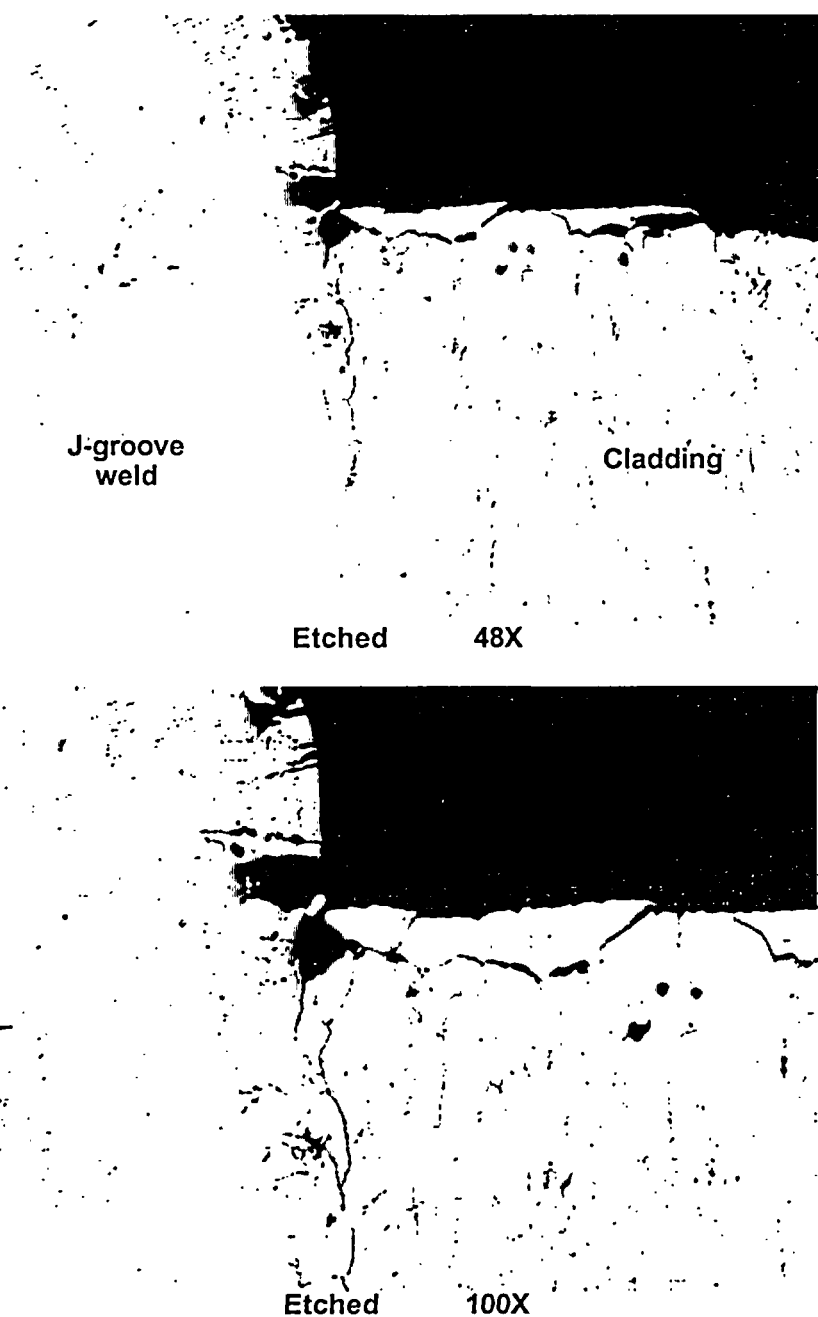
**Figure 7.3.2.3: Micrographs showing the intergranular or interdendritic cracking between the J-groove weld and cladding interface. The micrographs shown here are mirror of the photo in Figure 7.3.2.1. Intergranular attack (IGA) is also evident on the exposed surface of J-groove weld and cladding (surface exposed to oxygenated boric acid). This cracking was likely initiated by IGA.**

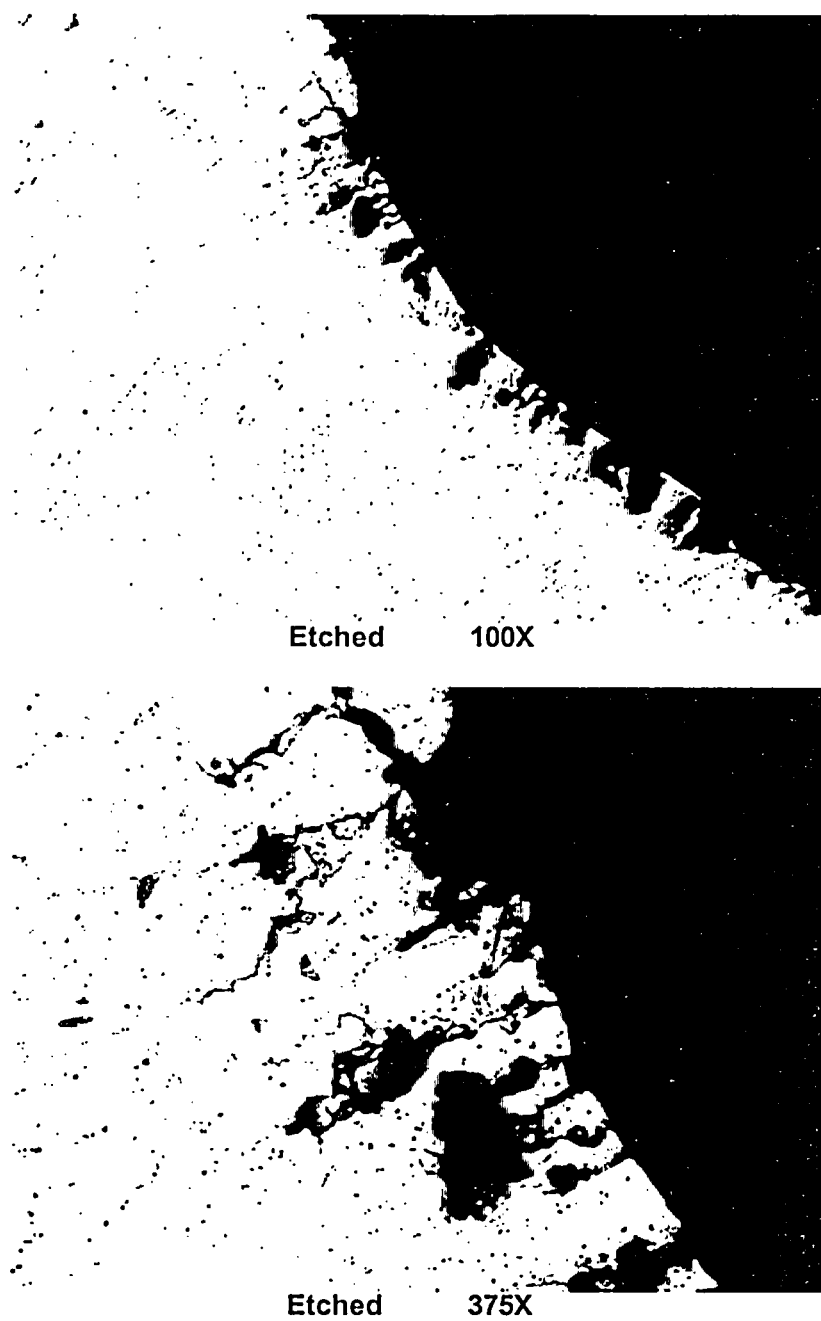
Figure 7.3.2.4: Intergranular attack (IGA) on the J-groove weld surface exposed to oxygenated boric acid.

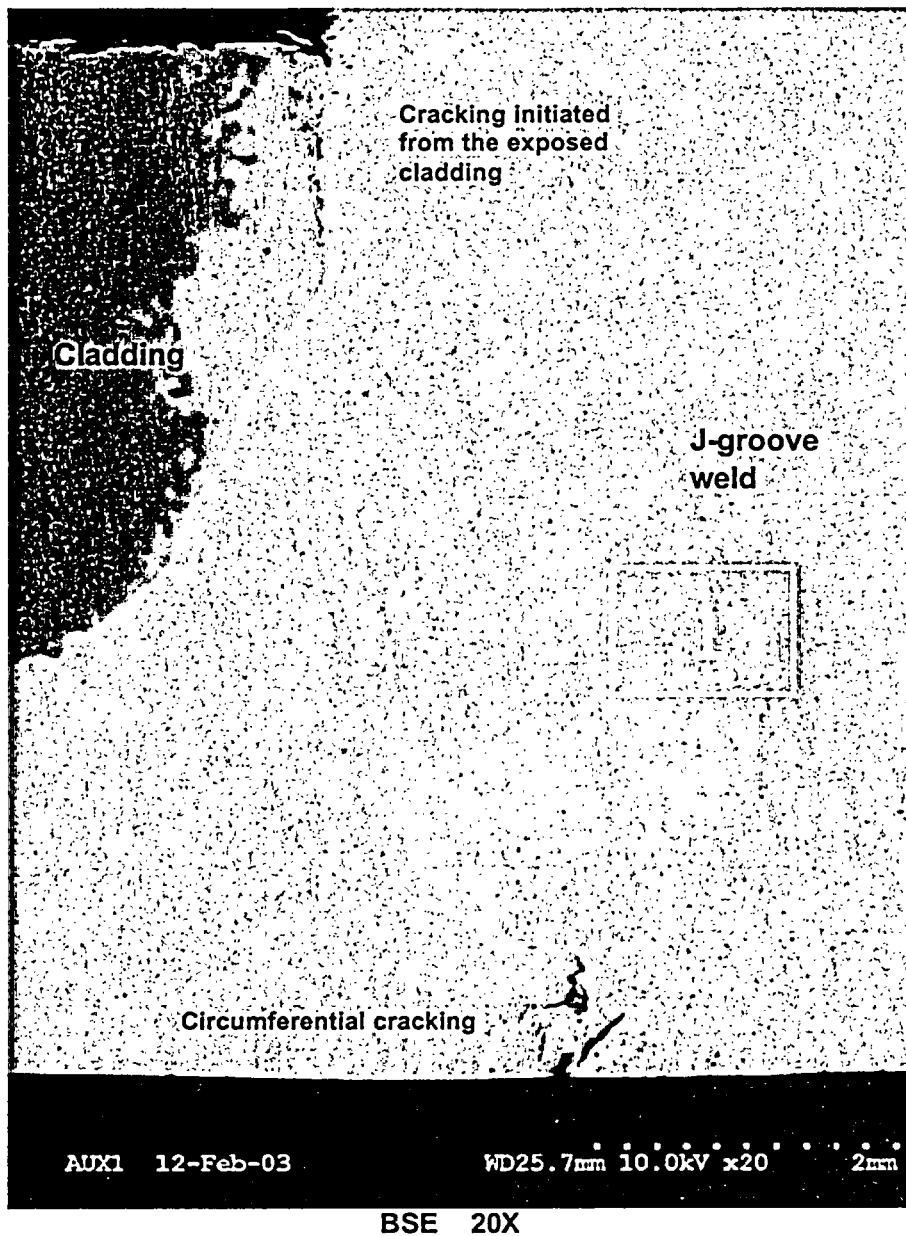
Figure 7.3.3.1: Low magnification BSE micrograph of sample A2A6A2D2 showing the cracking in the exposed cladding surface and the axial cracking in the J-groove weld surface exposed to RCS. The EDS spectrum collected from area 1 is presented in Figure 7.3.3.2.

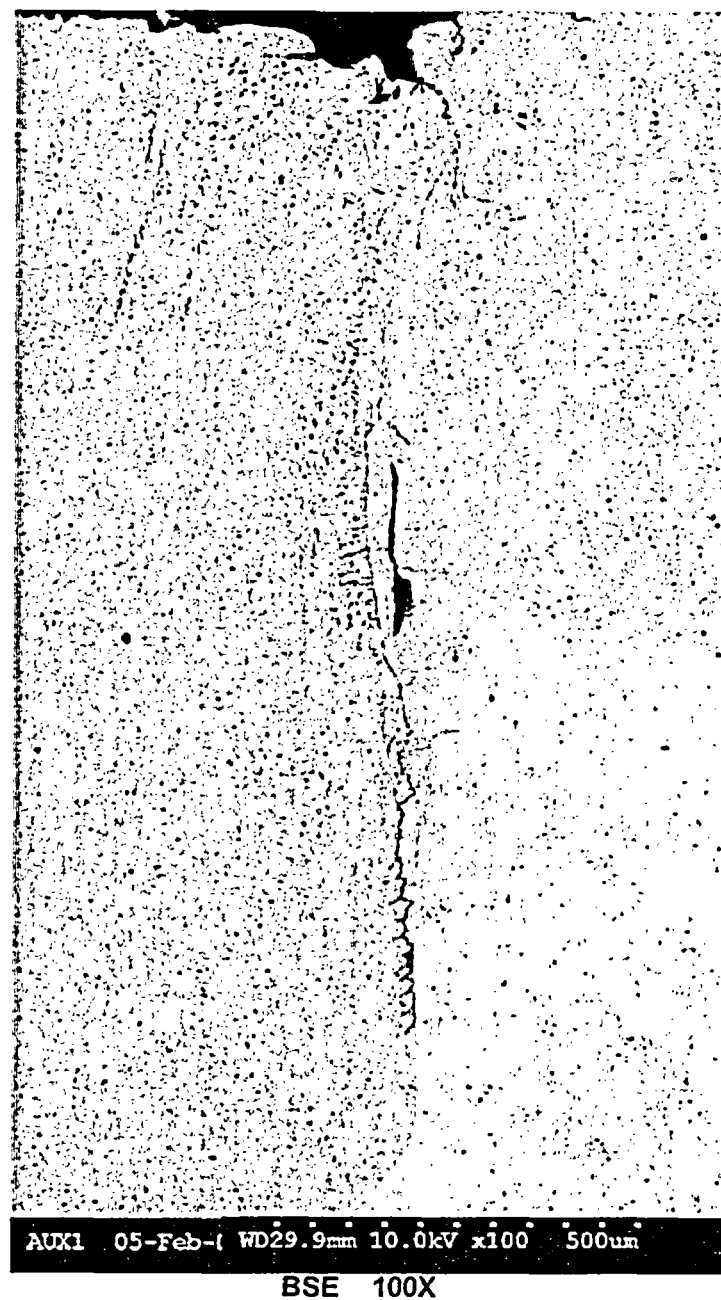
Figure 7.3.3.3: Low magnification BSE micrograph showing the cracking that initiated from the exposed cladding surface (left side of figure). The maximum crack depth is approximately 0.055" below the cladding surface.

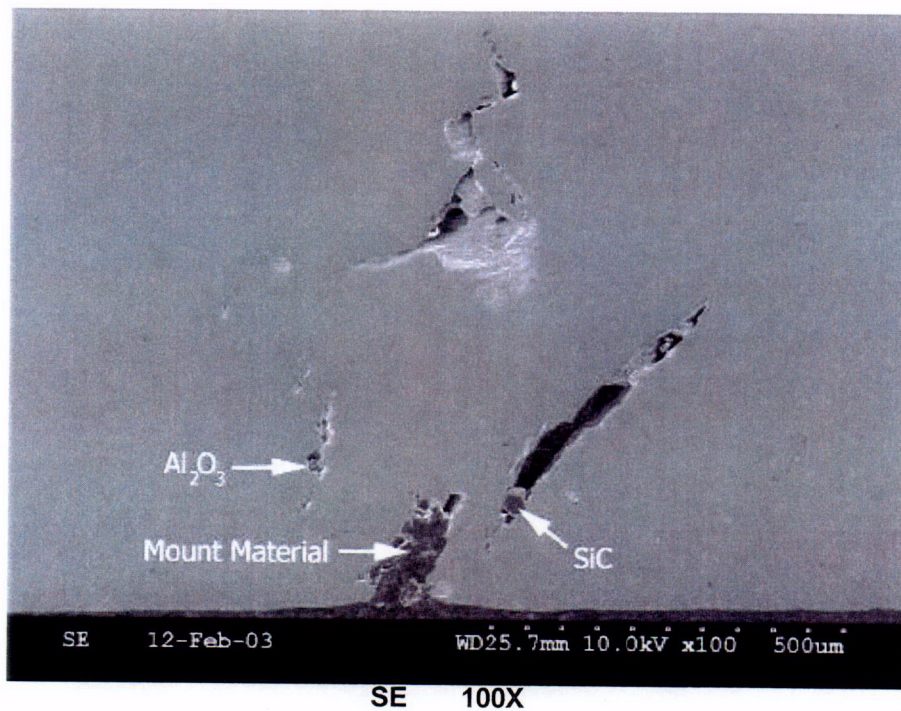
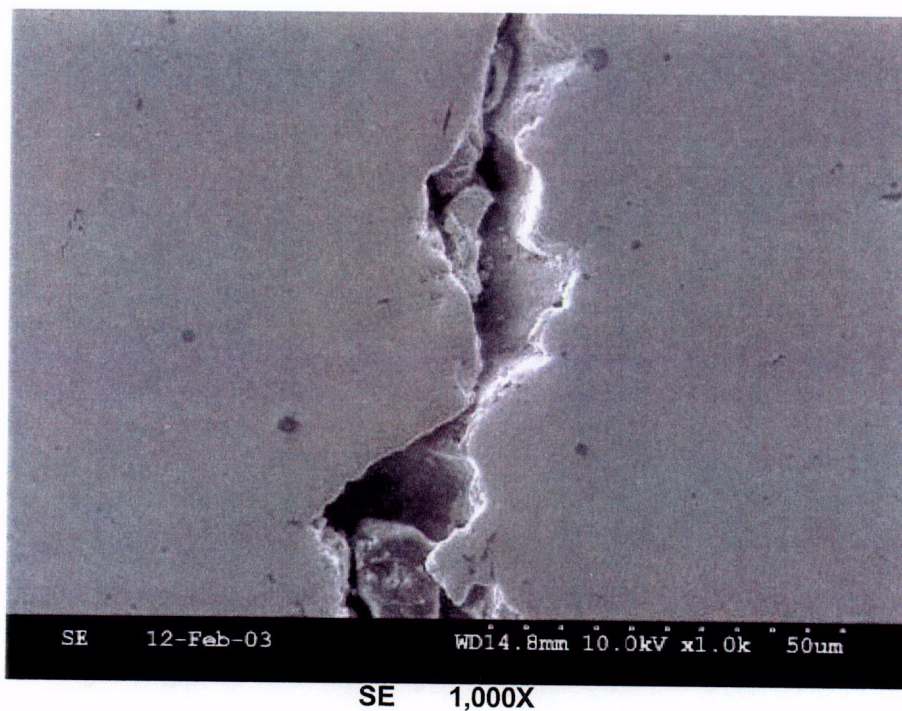
Figure 7.3.3.4: SE micrographs of the circumferential cracking in the J-groove weld. The maximum circumferential cracking depth is approximately 0.032" below the surface. Cracking was interdendritic in nature.

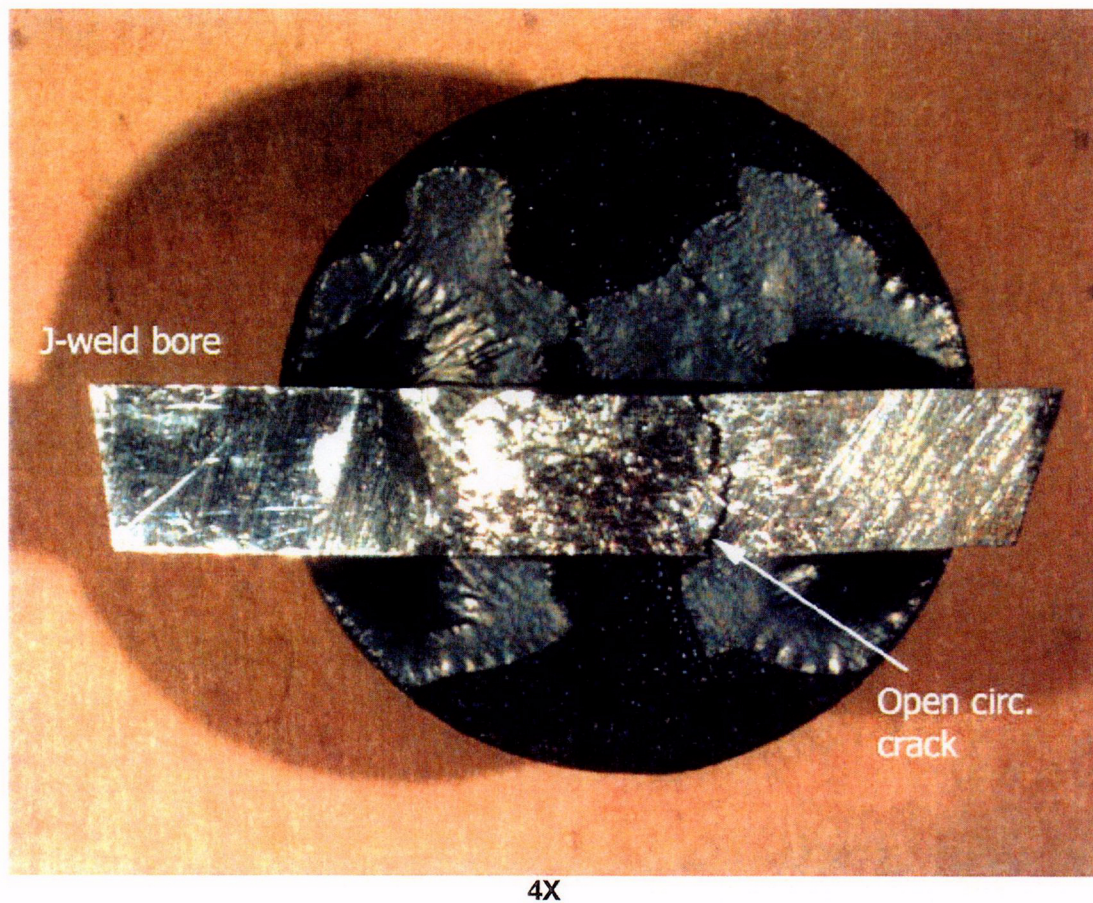
Figure 7.3.4.1: Macro photograph of the opened-up circumferential cracking in the J-groove weld at  $\sim 30^\circ$ . The underside surface of the J-groove weld (in contact with RCS) is shown. Refer to Figures 5.6 and 5.8 for the sample location. The rectangular sample (A2A6A2C2) is secured to the round SEM stub with black carbon tape.

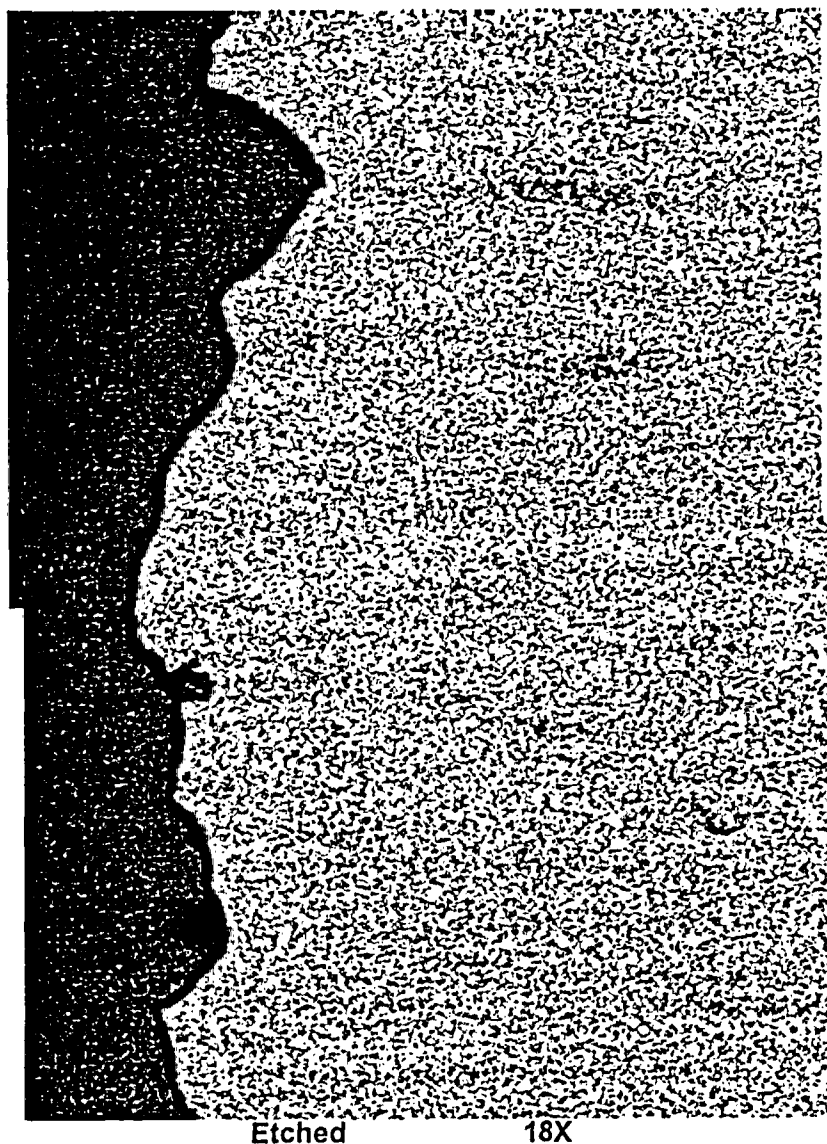
**Figure 8.1.1.2:** Low magnification micrograph showing horizontal striations aligned with the major axis of the RV head low alloy steel plate (SA-533, Gr. B (mod), Cl. 1). The striations are due to the segregation of carbides, which promote a slightly faster local corrosion rate along the striations. Note that this micrograph is a mirror image of Figure 8.1.1.1.

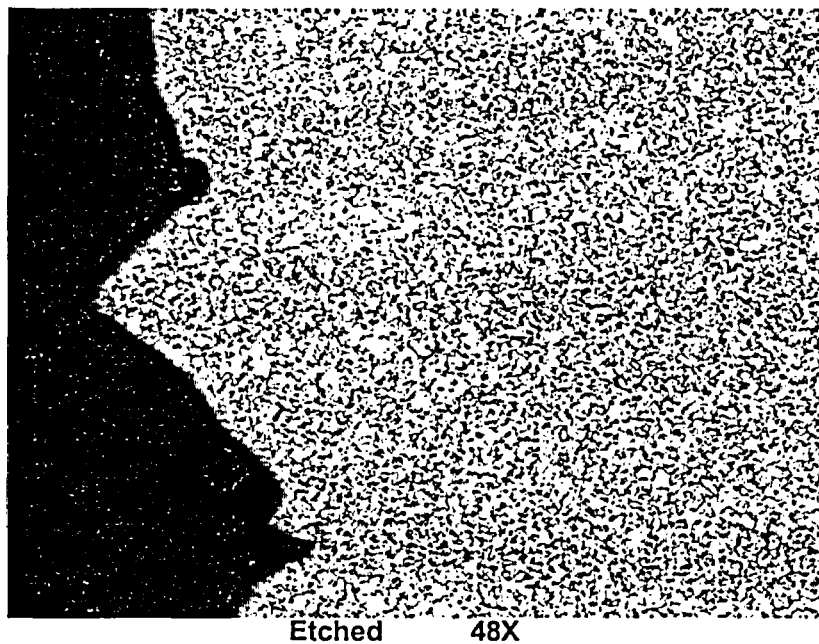
**Figure 8.1.1.3: Higher magnification micrograph, which indicates a slightly faster local corrosion rate along the striations.**

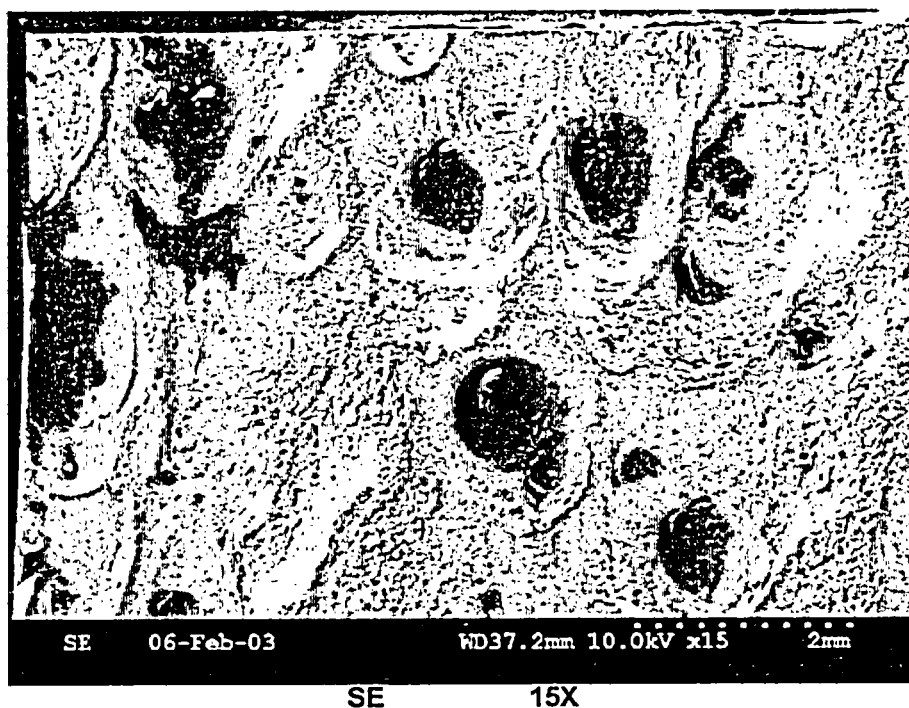
Figure 8.1.3.1: Low magnification SE micrographs of cavity wall surface near 90°. The surface contains generally round depressions measuring ~0.039" or less in diameter.

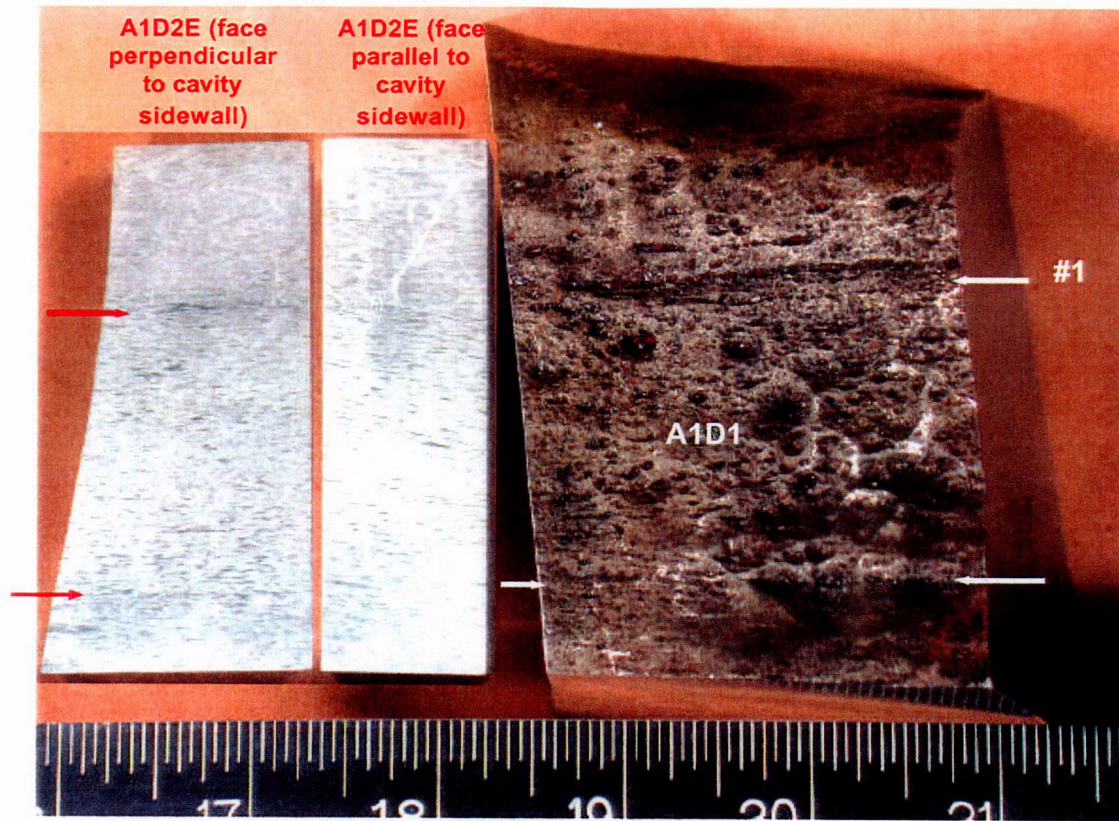
Figure 8.2.1.1: Low magnification photographs showing macro etch results. Arrows indicate corrosion grooves associated with corresponding micro-structural banding. Macro etch was performed on two surfaces of sample A1D2E ground with 400 grit paper. Etchant: 10% nital.

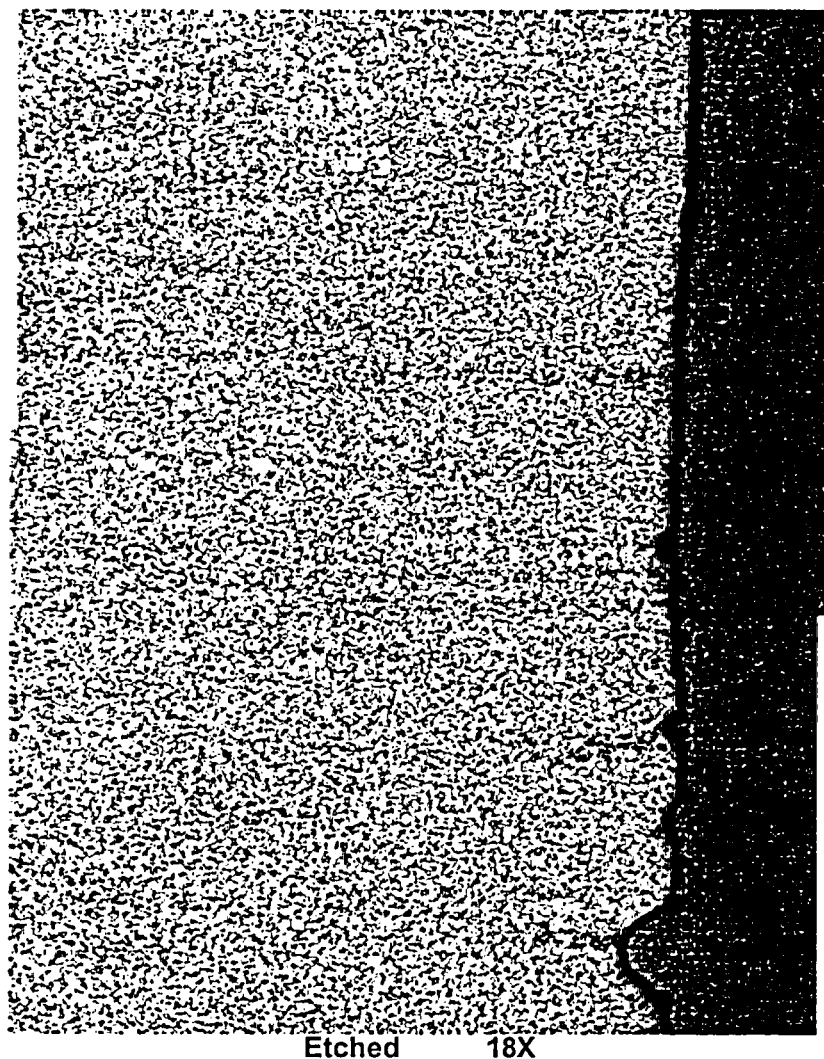
Figure 8.2.2.2: Slightly higher magnification micrograph showing the horizontal striations aligned with the major axis of the RV head low alloy steel plate (SA-533, Gr. B (mod), Cl. 1). Striations appear to be caused by a very slightly faster local corrosion rate. Note that this micrograph is a mirror image of Figure 8.2.2.1.

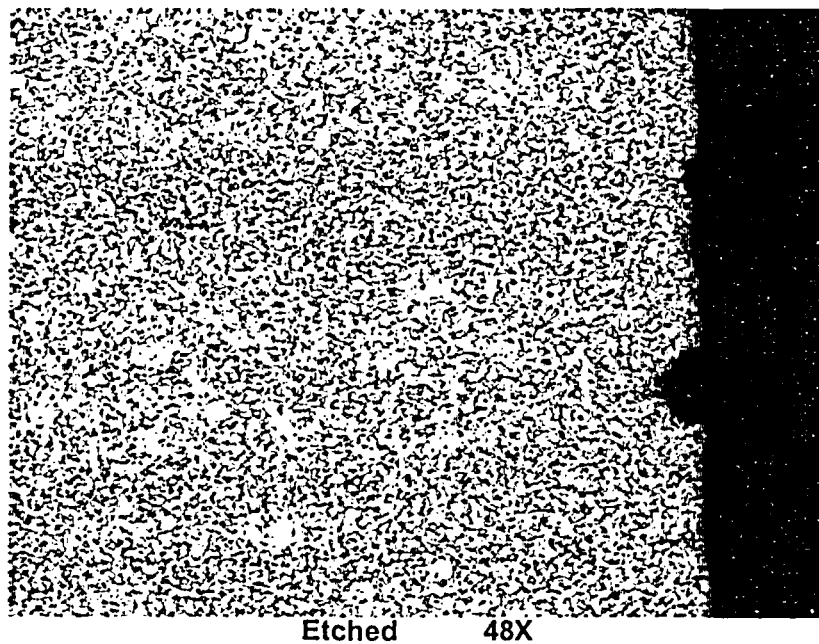
Figure 8.2.2.3: Higher magnification detail of Figure 8.2.2.2, which suggests a slightly faster local corrosion rate along the striations.

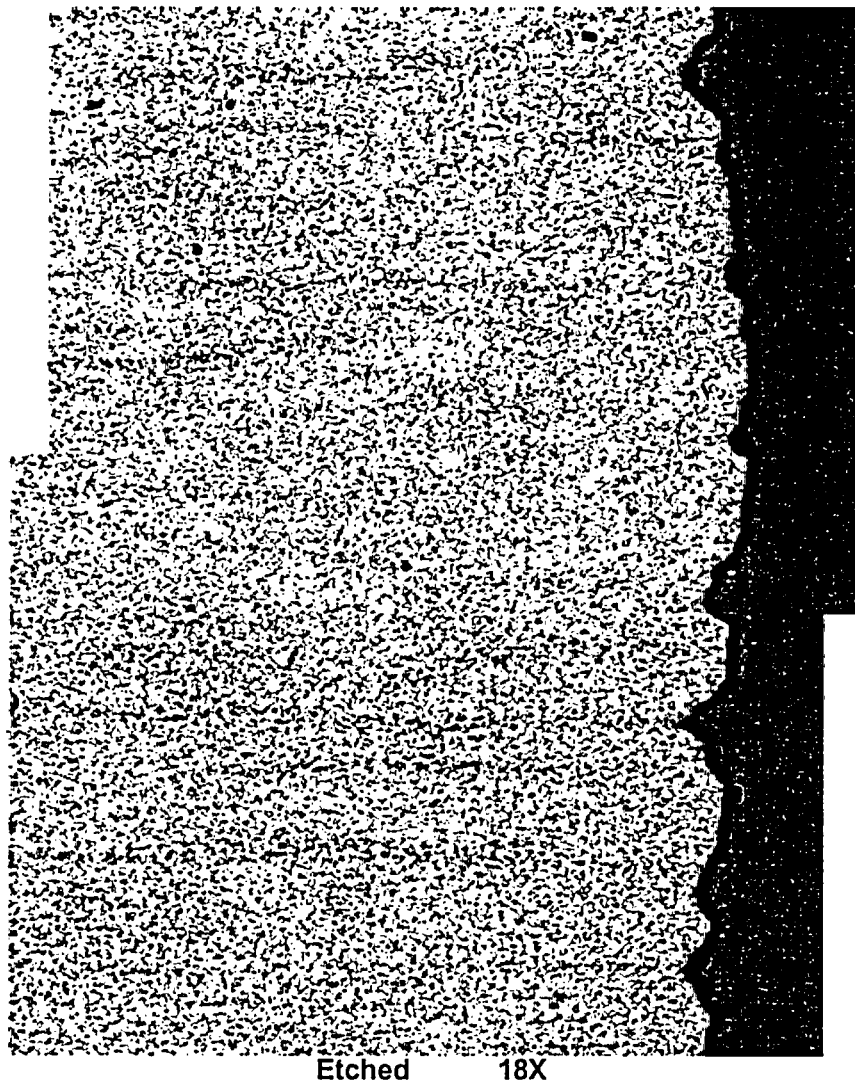
Figure 8.2.3.2: Higher magnification detail of Figure 8.2.3.1 showing the horizontal striations aligned with the major axis of the RV head low alloy steel plate (SA-533, Gr. B (mod), Cl. 1). Striations appear to be caused by a very slightly faster local corrosion rate.

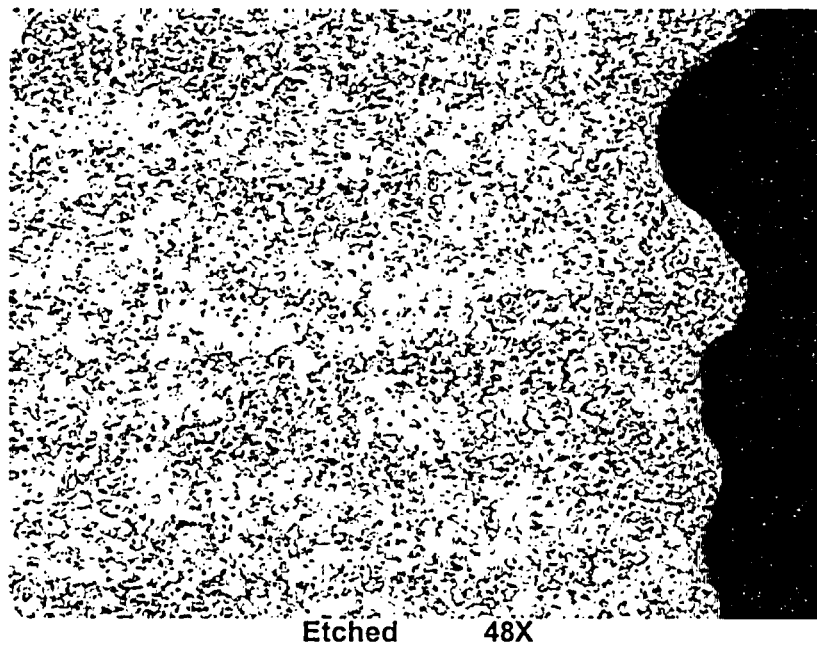
Figure 8.2.3.3: Higher magnification detail of Figure 8.2.3.2, which suggests a slightly faster local corrosion rate along the striations.

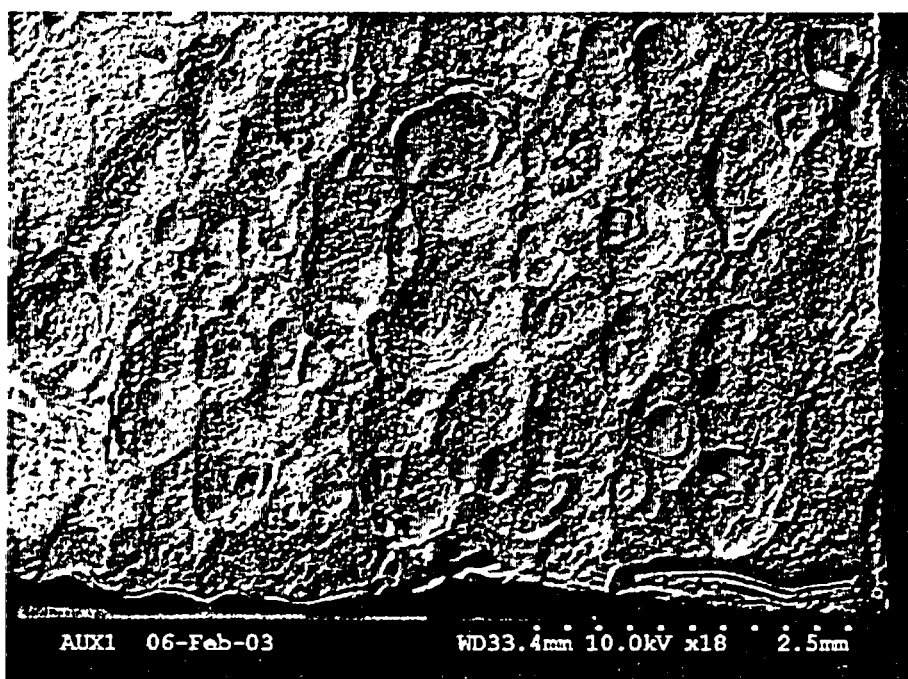
Figure 8.2.4.1: SE (top) and BSE (bottom) micrographs of the cavity wall surface near 270°. The surface contained rounded depressions measuring 0.020" in diameter or less. Orientation of micrographs: lower portion of cavity to the right and upper portion to the right. Nozzle #3 is closer to lower edge of micrograph.
