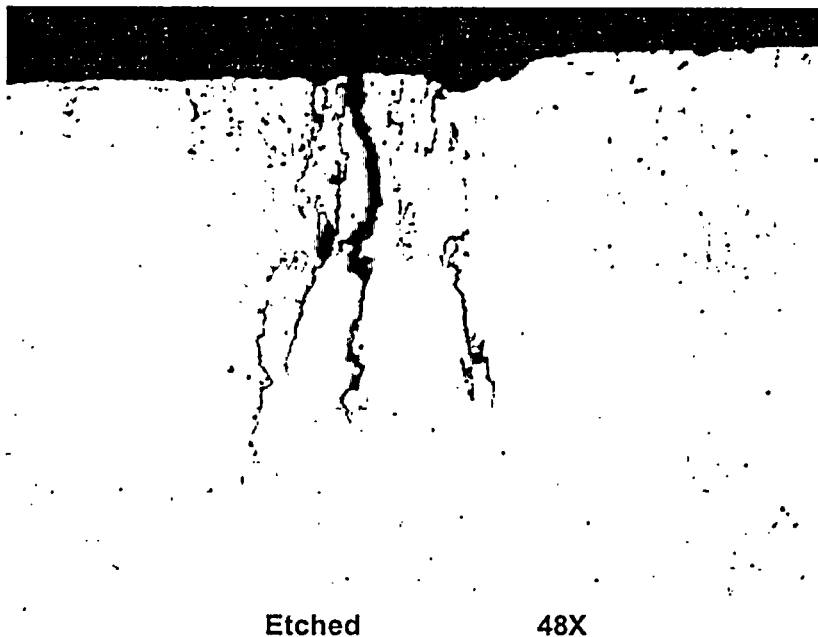
**Figure 8.3.1.3:** Micrograph showing intergranular attack (IGA) and intergranular or interdendritic cracking in the cladding. The maximum depth of the crack tip is approximately 0.047" below the exposed cladding surface.

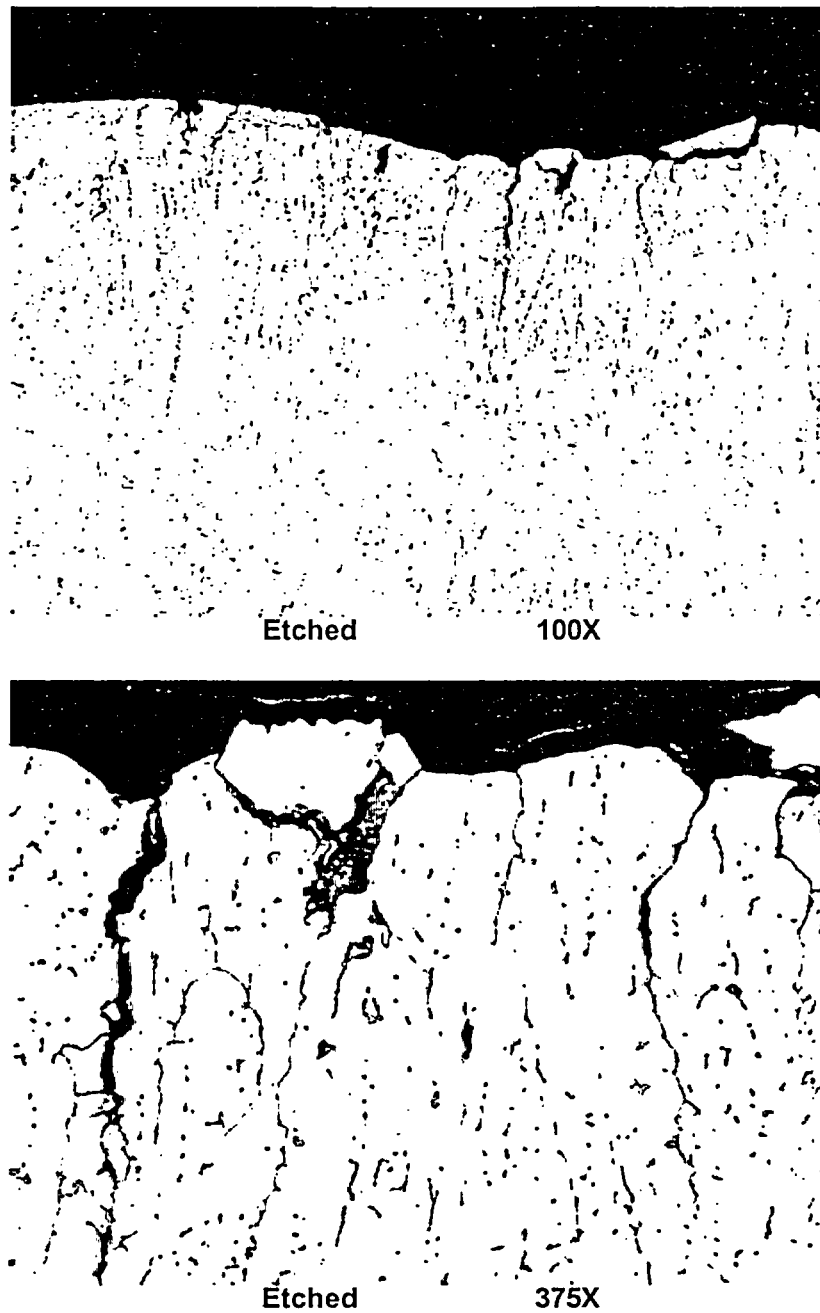
Figure 8.3.1.4: Micrographs showing intergranular attack (IGA) and intergranular or interdendritic cracking on the exposed cladding surface.

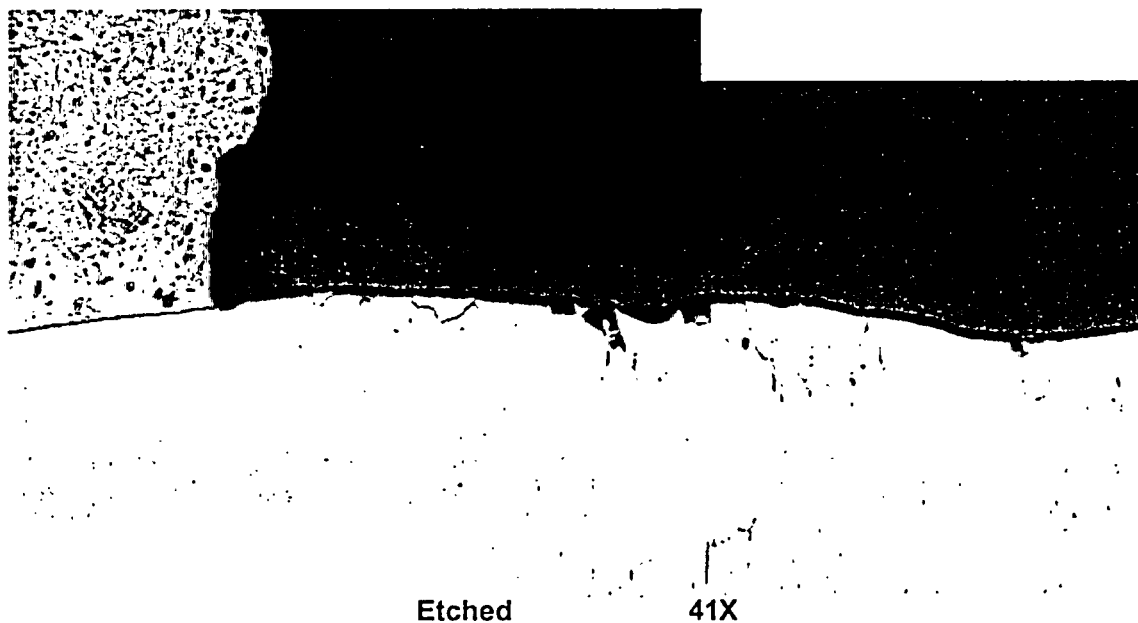
Figure 8.3.2.2: Micrograph showing the exposed cladding surface. A slight undercut is evident in the low alloy steel. Note: the micrograph is a mirror image of the macrograph in Figure 8.3.2.1.

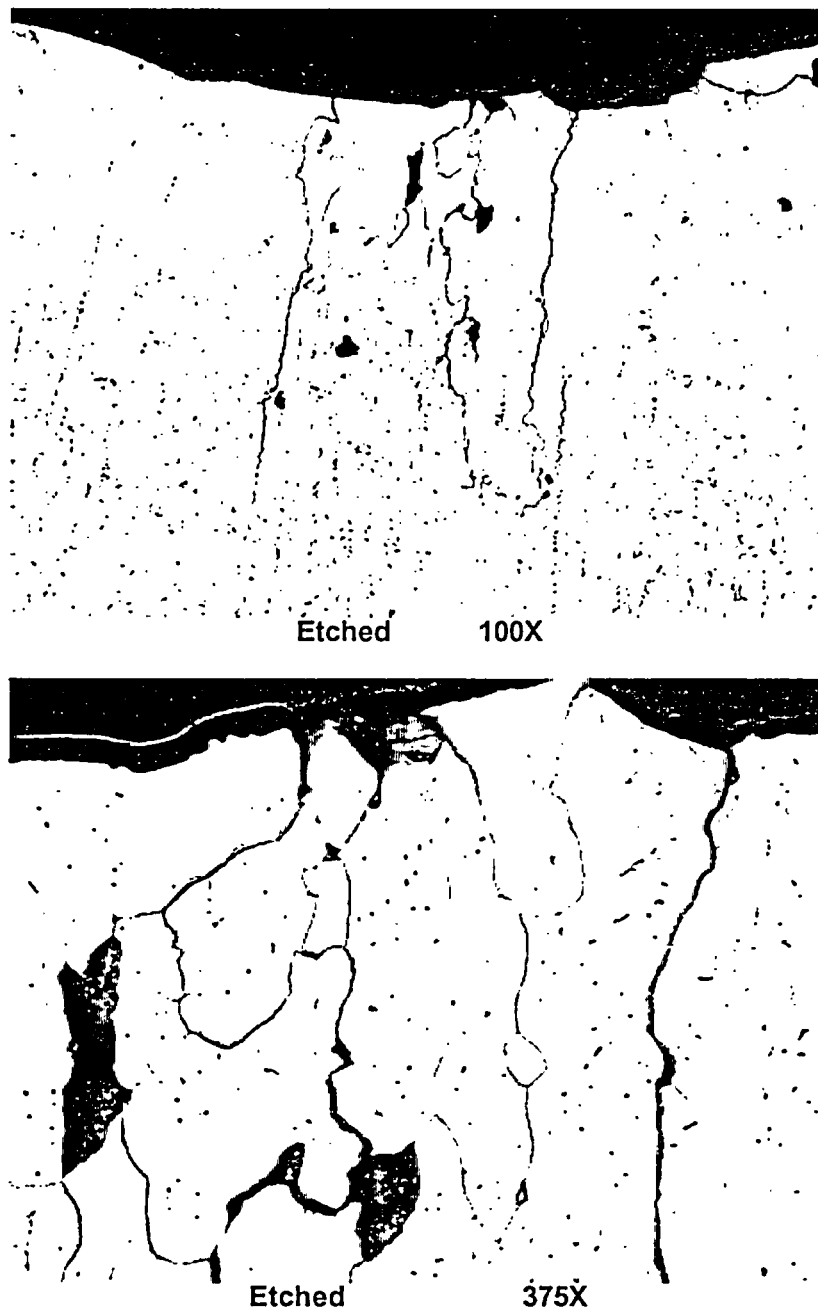
Figure 8.3.2.3: Micrographs showing intergranular attack (IGA) and intergranular or interdendritic cracking. The maximum depth of the crack tip is approximately 0.024" below the exposed cladding surface.
