Subject: Beaver Valley Power Station, Unit No. 1 and No. 2
BV-1 Docket No. 50-334, License No. DPR-66
BV-2 Docket No. 50-412, License No. NPF-73
NRC Bulletin 2003-02
BV-2 Lower Head Inspection 60-Day Report

Evaluation Report for 2R10
Inspection
of
Beaver Valley Unit 2
RPV Lower Head Penetrations

(Ref: NRC Bulletin 2003-02)

November 2003

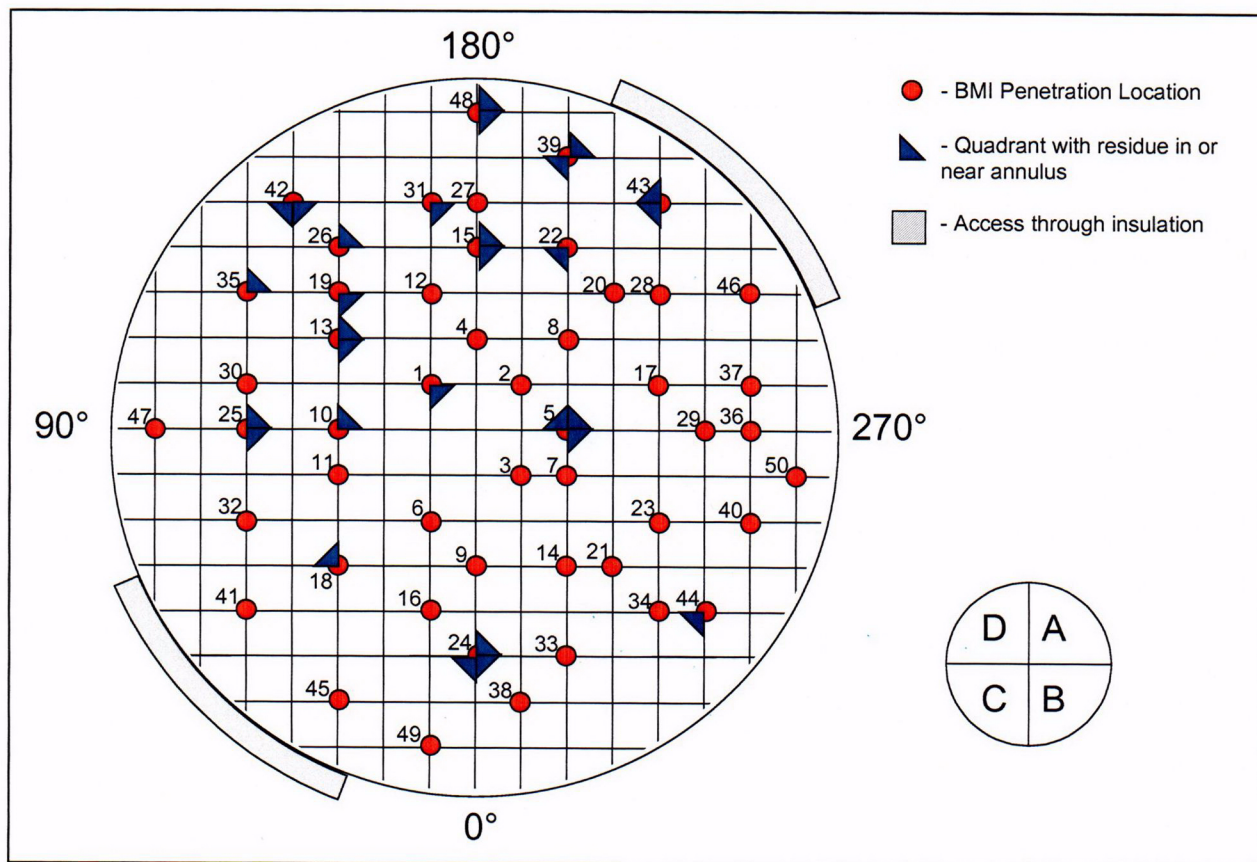
The visual inspection found no indications characteristic of RCS through-wall leakage or boric acid accumulation around any of the 50 RPV lower head penetrations. The VT-2 examiner logs did identify the presence of material (debris), on and around the RPV lower head penetration area of interest. This condition was noted on 29 quadrants of 18 penetrations (See Figure 1). Similar debris was also noted on the vessel surface and boss surface around virtually every penetration (See Figure 2). Visual evidence from the inspection video indicates that the debris appears to be adhesive residue from tape that had been removed at some point during plant construction. Supplemental evaluation and follow-up chemical analysis performed on samples concluded that the residue was from tape used in the packaging and shipment of the reactor vessel. The results of the evaluation were identified in the BVPS Corrective Action Program (Condition Report # 03-09647). A summary of the supplemental evaluation and follow-up chemical analysis is provided in the following sections of this report.

Figure 1: Locations of residue observed in or near penetration annulus.

As shown in Figure 1 of this response, residue was observed in or near the annulus on the uphill, downhill, and sidehill orientations. The residue observed on the boss around many penetrations is randomly oriented in all directions. As shown in Figure 2, similar residue is observed on the vessel surface as well.

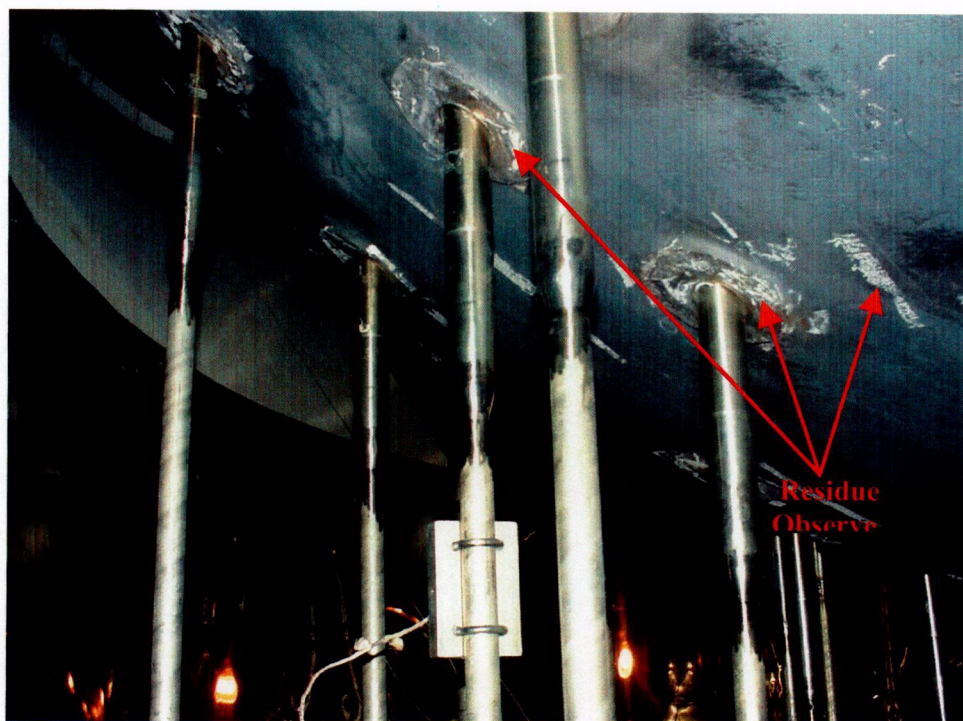
Figure 2: BVPS Unit 2 lower head observed during 2R10.

There is evidence of residue on or around virtually every nozzle as shown in Figure 2. However, only 18 penetrations showed residue in or near the annulus and were thus called out for further evaluation during the visual exam.

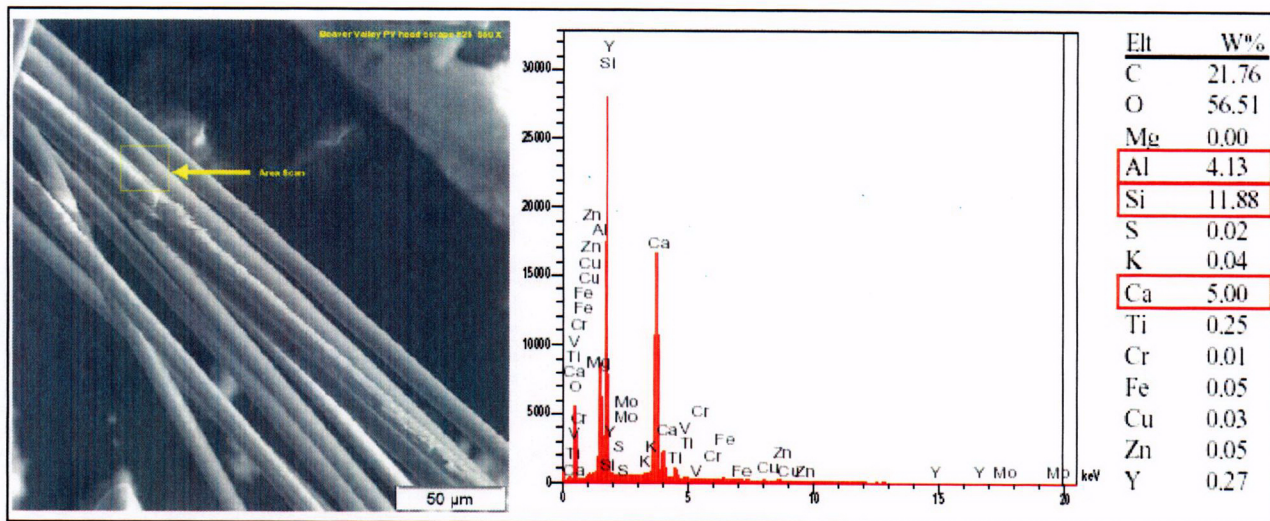
Figure 7: SEM-EDS analysis of fibers visible on particle scraped from the annulus of Penetration 25. Note the significant amounts Al, Si, and Ca present.

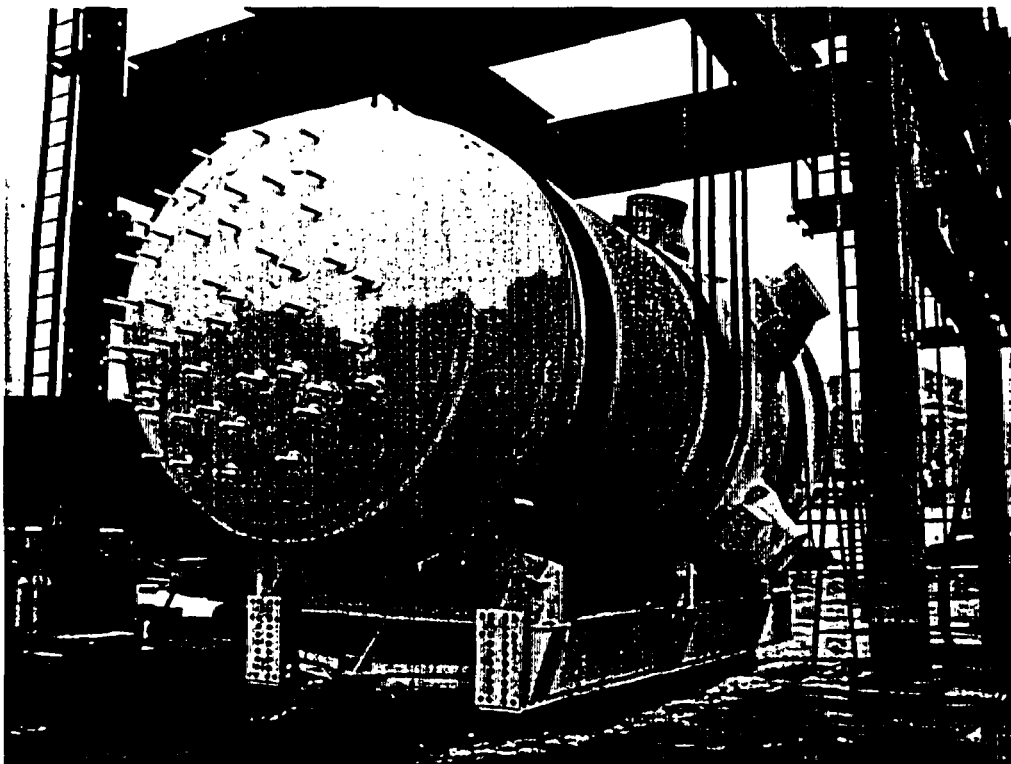
An image of the Beaver Valley Unit 2 pressure vessel prior to installation is shown in Figure 8. Note the bright appearance from the Spraylat protective coating on the outer surface in the black and white photograph.

Figure 8: BVPS Unit 2 reactor vessel with Spraylat coating applied.

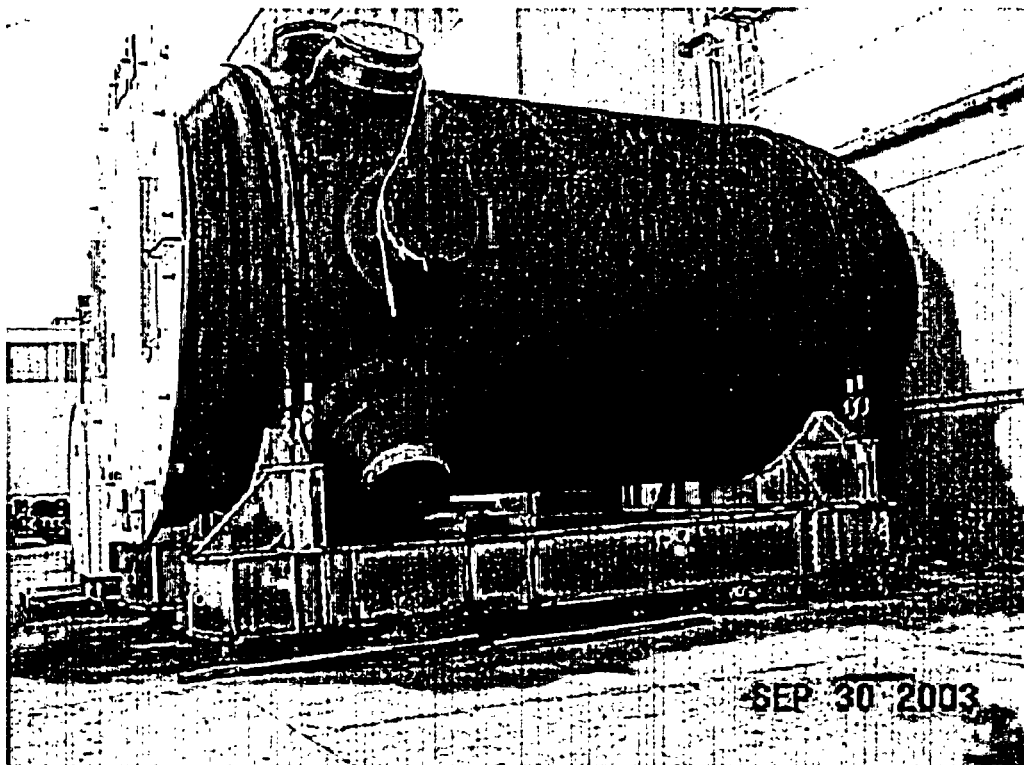
Figure 9 show a pressure vessel that had its original order cancelled. This vessel has remained stored outside at the Westinghouse Chattanooga site for over twenty years with the shipping materials still intact. Examples of this common storage practice around the head penetrations are shown in Figure 10.

Figure 9: A Nuclear Reactor Pressure Vessel from a Cancelled Order (Note: This vessel has been stored outside at the Westinghouse-CE Chattanooga Site for over 20 years.)

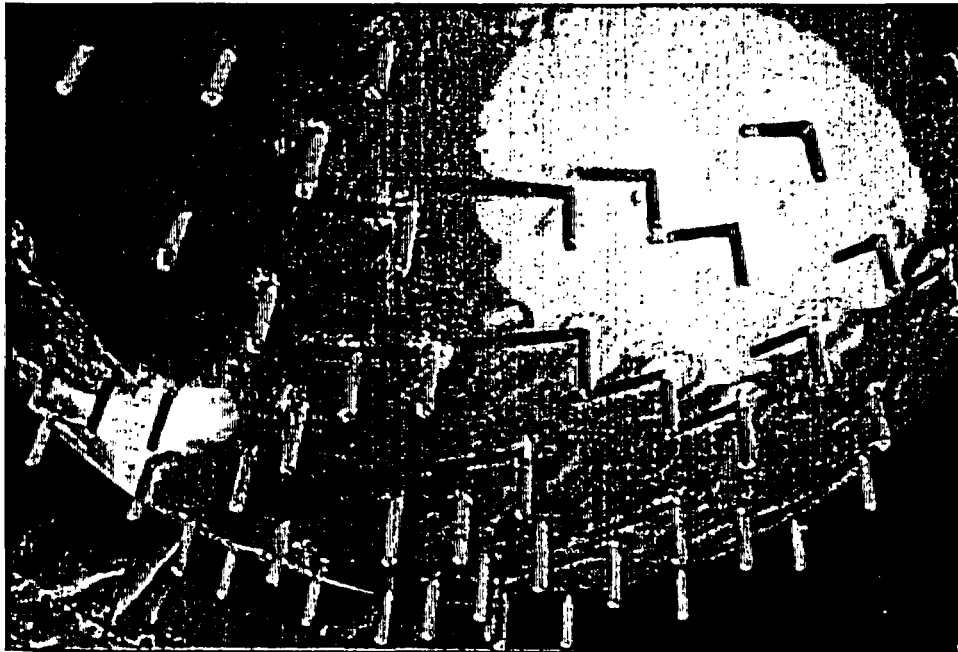
Figure 12: Bottom head of another CE vessel of similar vintage to BVPS Unit 2 with packaging of the BMI penetrations intact.
