Point Beach Nuclear Plant, Units 1 and 2
Dockets 50-266 and 50-301
License Nos. DPR-24 and DPR 27
Supplemental Response To NRC Bulletins 2001-01, 2002-01, And 2002-02 For
Reactor Vessel Head And Vessel Head Penetration Nozzle Inspection Findings

ENCLOSURE 1
PBNP Unit 1 Reactor Pressure Vessel Head and Vessel Head Penetration Nozzle
Inspection Discussion

Framatome ANP, NCR 602883, Revision 1 (and associated discussion)

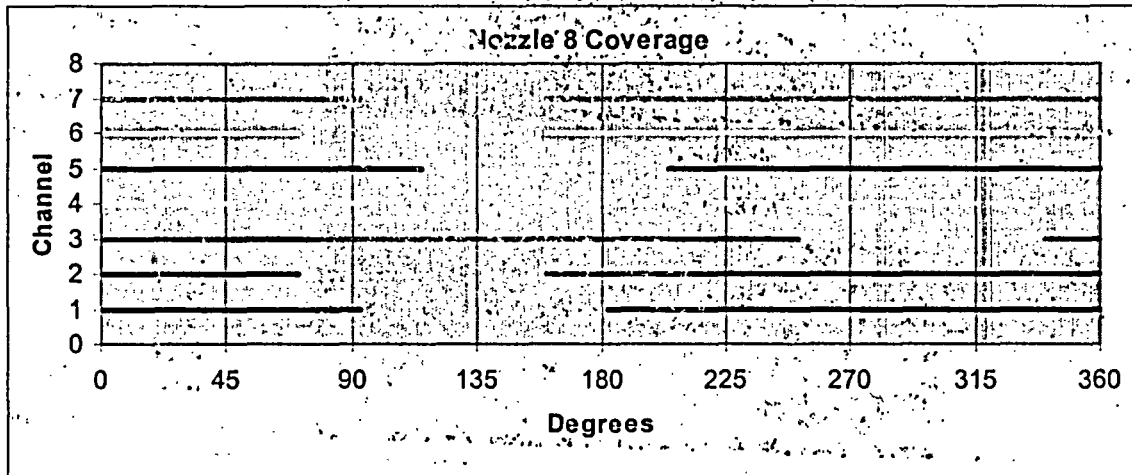
Nozzle 8	Area effected:		min.: 93	max: 182	Total: 89		
	Channel	Degree	Beam Direction	Defects	Probe Location	Limitation Start	End
	1	0	normal	vol	0	93	182
	2	30-L	axial	circ	338	71	160
	3	60-S	axial	circ	158	251	340
	4	45-LE	circ	axial	0	93	182
	5	60-SE	circ	axial	22	115	204
	6	60-SE	circ	axial	338	71	160
	7	0, 30L, 45LE	Leak Path		combined	93	160

Horizontal line denotes the stall area.

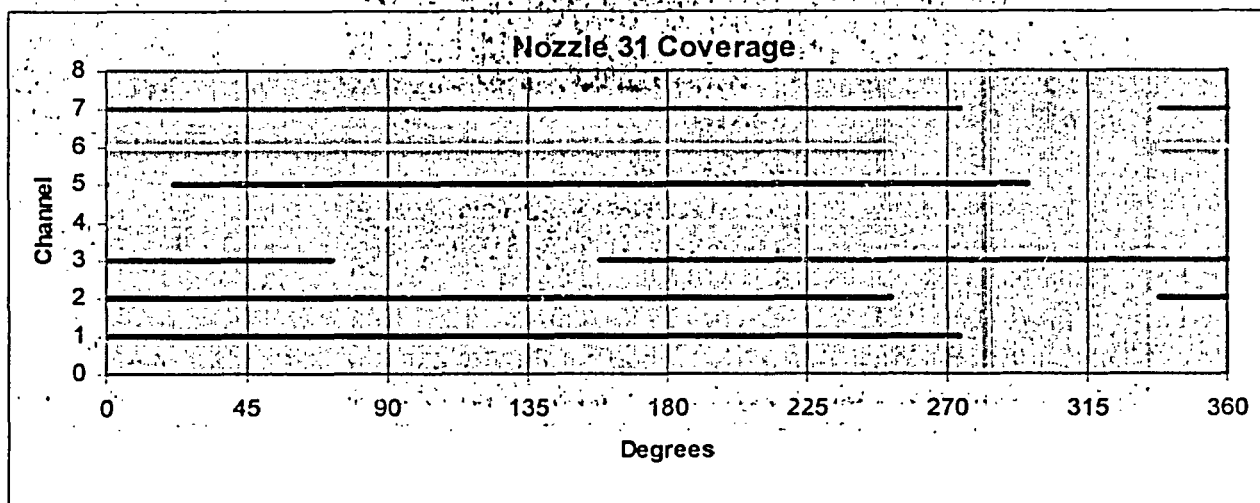
Nozzle 31	Area effected:		min:	max:	Total:		
			274	360	86		
			Beam		Probe	Limitation	
	Channel	Degree	Direction	Defects	Location	Start	End
	1	0	normal	vol	0	274	0
	2	30-L	axial	circ	338	252	338
	3	60-S	axial	circ	158	72	158
	4	45-LE	circ	axial	0	274	0
	5	60-SE	circ	axial	22	296	22
	6	60-SE	circ	axial	338	252	338
	7	0, 30L, 45LE	Leak Path		combined	274	338

Horizontal line denotes the stall area.

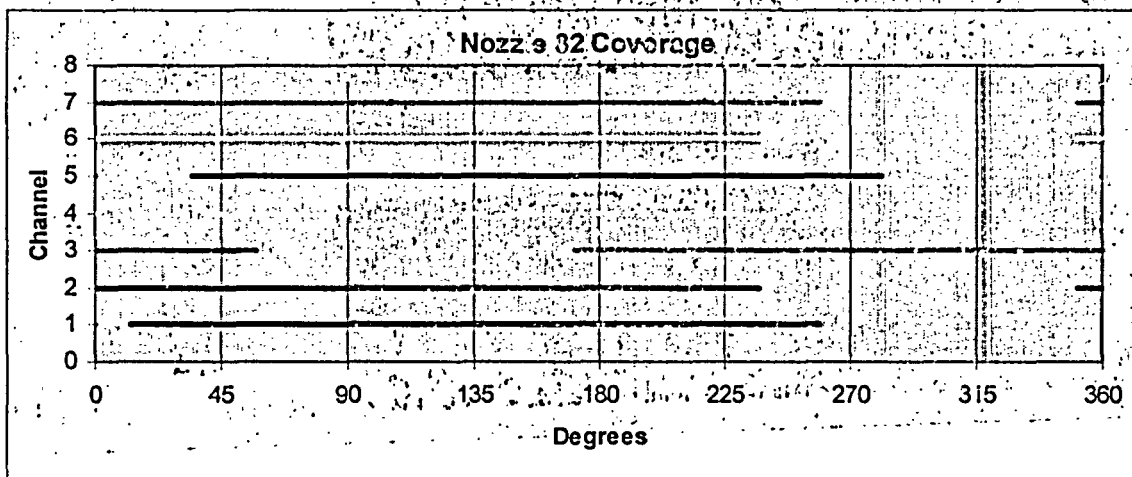
Area effected:			min.:	max:	Total:		
				259	13	127		
Nozzle 32	Channel	Degree	Beam Direction	Defects	Probe Location	Limitation Start	End	
	1	0	normal	vol	0	259	13	
	2	30-L	axial	circ	338	237	351	
	3	60-S	axial	circ	158	57	171	
	4	45-LE	circ	axial	0	259	13	
	5	60-SE	circ	axial	22	281	35	
	6	60-SE	circ	axial	338	237	351	
	7	0, 30L, 45LE	Leak Path		combined	259	351

Horizontal line denotes the stall area.

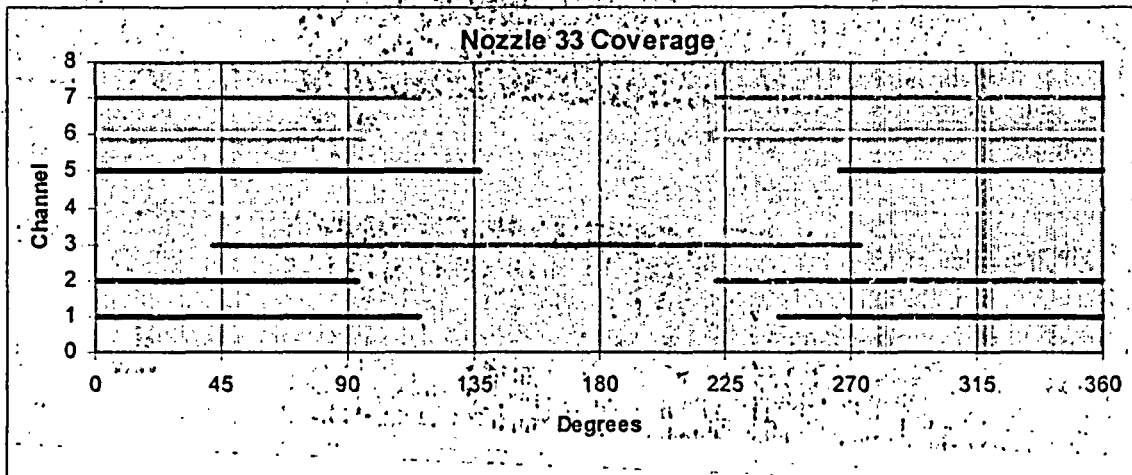
Nozzle 33	Area effected:		min:	max:	Total:		
			115	244	129		
			Beam	Probe	Limitation		
	Channel	Degree	Direction	Defects	Location	Start	End
	1	0	normal	vol	0	115	244
	2	30-L	axial	circ	338	93	222
	3	60-S	axial	circ	158	273	42
	4	45-LE	circ	axial	0	115	244
	5	60-SE	circ	axial	22	137	266
	6	60-SE	circ	axial	338	93	222
	7	0, 30L, 45LE	Leak Path		combined	115	222

Horizontal line denotes the stall area.

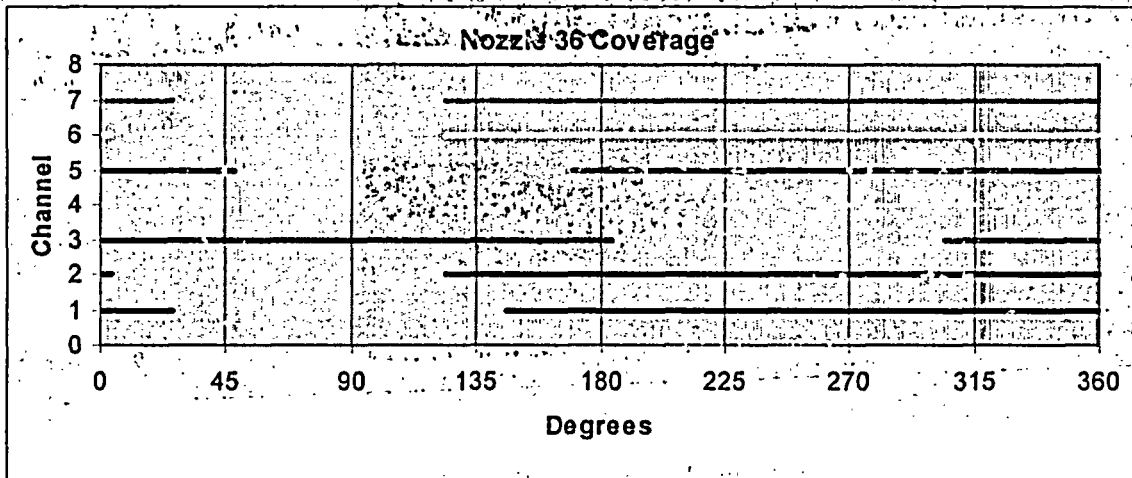
Area effected:			min:	max:	Total:		
	Channel	Degree	Beam Direction	Defects	Probe Location	Limitation Start	End	
Nozzle 36	1	0	normal	vol	0	26	146	
	2	30-L	axial	circ	338	4	124	
	3	60-S	axial	circ	158	184	304	
	4	45-LE	circ	axial	0	26	146	
	5	60-SE	circ	axial	22	48	168	
	6	60-SE	circ	axial	338	4	124	
	7	0, 30L, 45LE	Leak Path		combined	26	124

Horizontal line denotes the stall area.

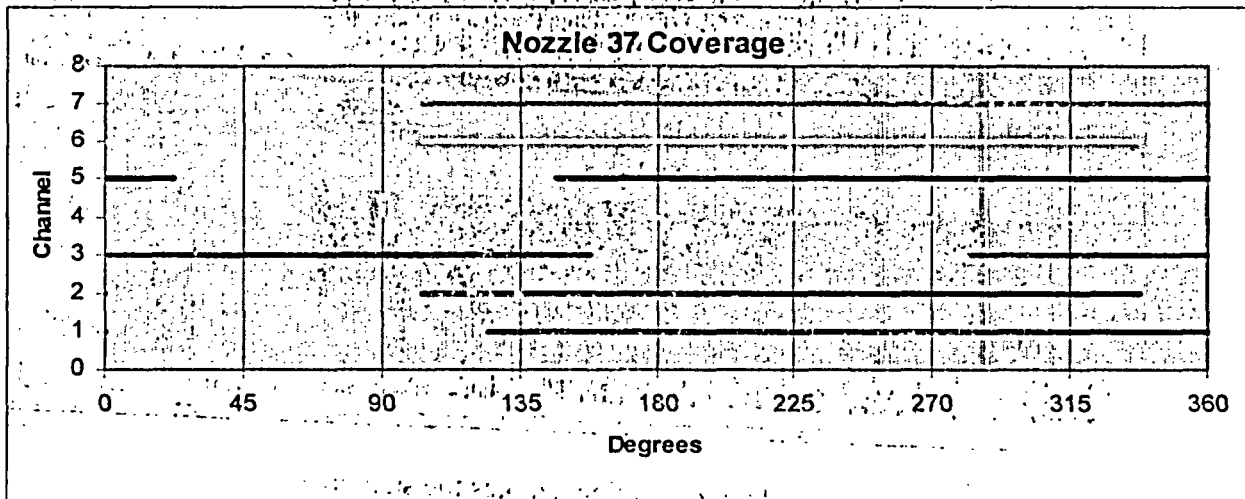
Nozzle 37	Area effected:		min:	max:	Total:		
			0	125	125		
	Channel	Degree	Beam Direction	Defects	Probe Location	Limitation Start	End
	1	0	normal	vol	0	0	125
	2	30-L	axial	circ	338	338	103
	3	60-S	axial	circ	158	158	283
	4	45-LE	circ	axial	0	0	125
	5	60-SE	circ	axial	22	22	147
	6	60-SE	circ	axial	338	338	103
	7	0, 30L, 45LE	Leak Path		combined	0	103

Horizontal line denotes the stall area.

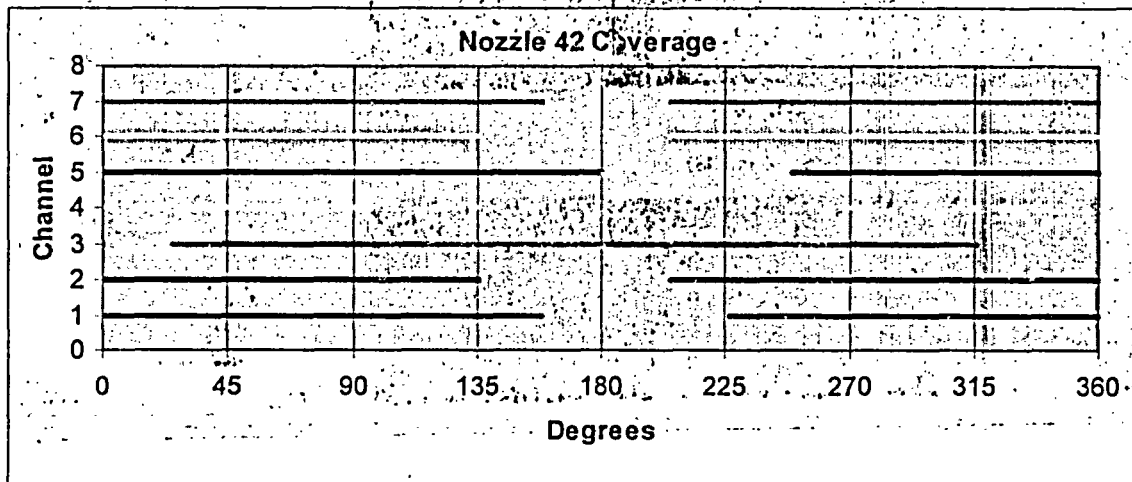
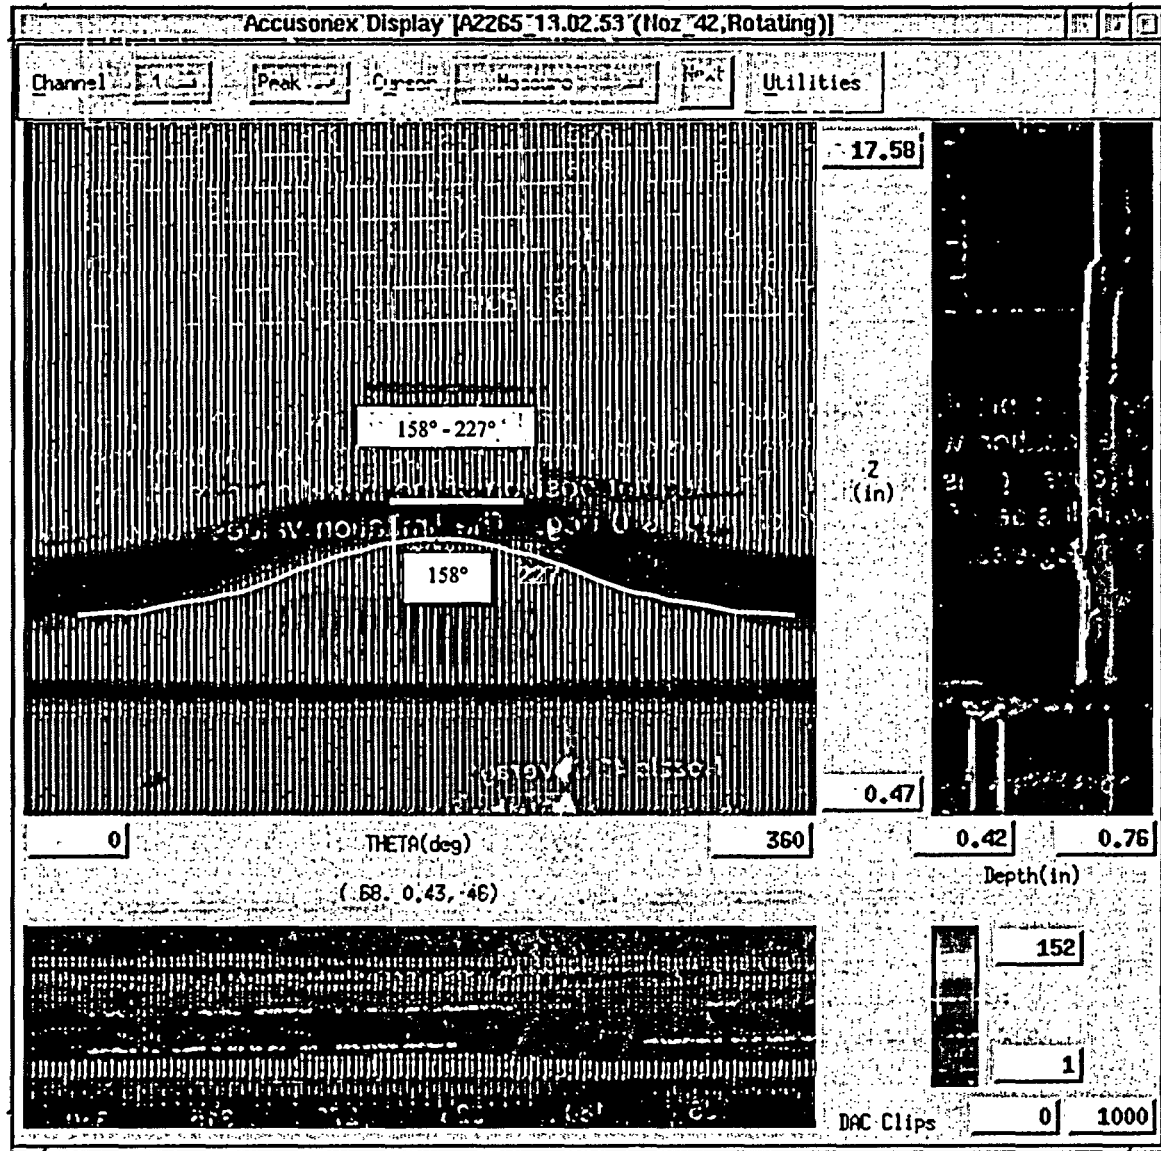
Nozzle 42	Area effected:		min:	max:	Total:		
			158	227	69		
			Beam	Probe	Limitation		
	Channel	Degree	Direction	Defects	Location	Start	End
	1	0	normal	vol	0	158	227
	2	30-L	axial	circ	338	136	205
	3	60-S	axial	circ	158	316	25
	4	45-LE	circ	axial	0	158	227
	5	60-SE	circ	axial	22	180	249
	6	60-SE	circ	axial	338	136	205
	7	0, 30L, 45LE	Leak Path		combined	158	205

Horizontal line denotes the stall area.

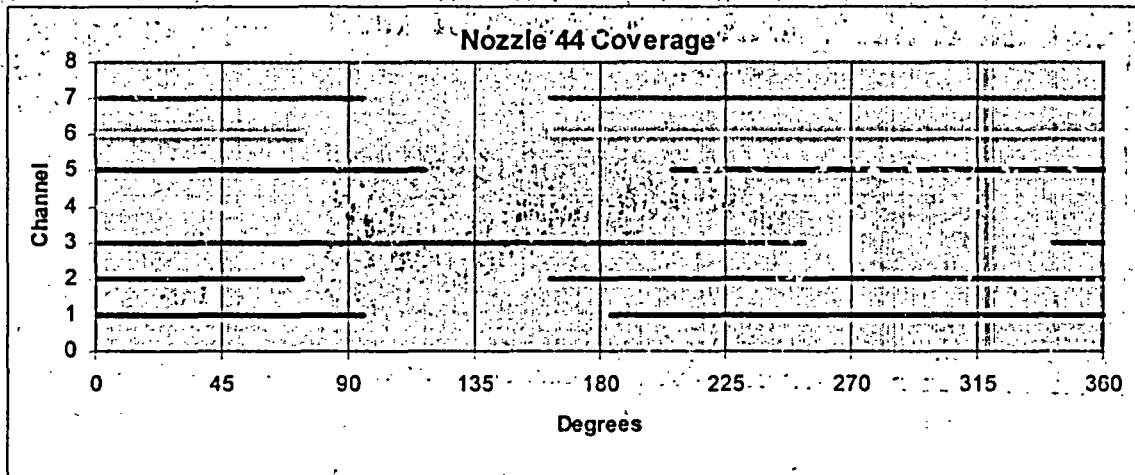
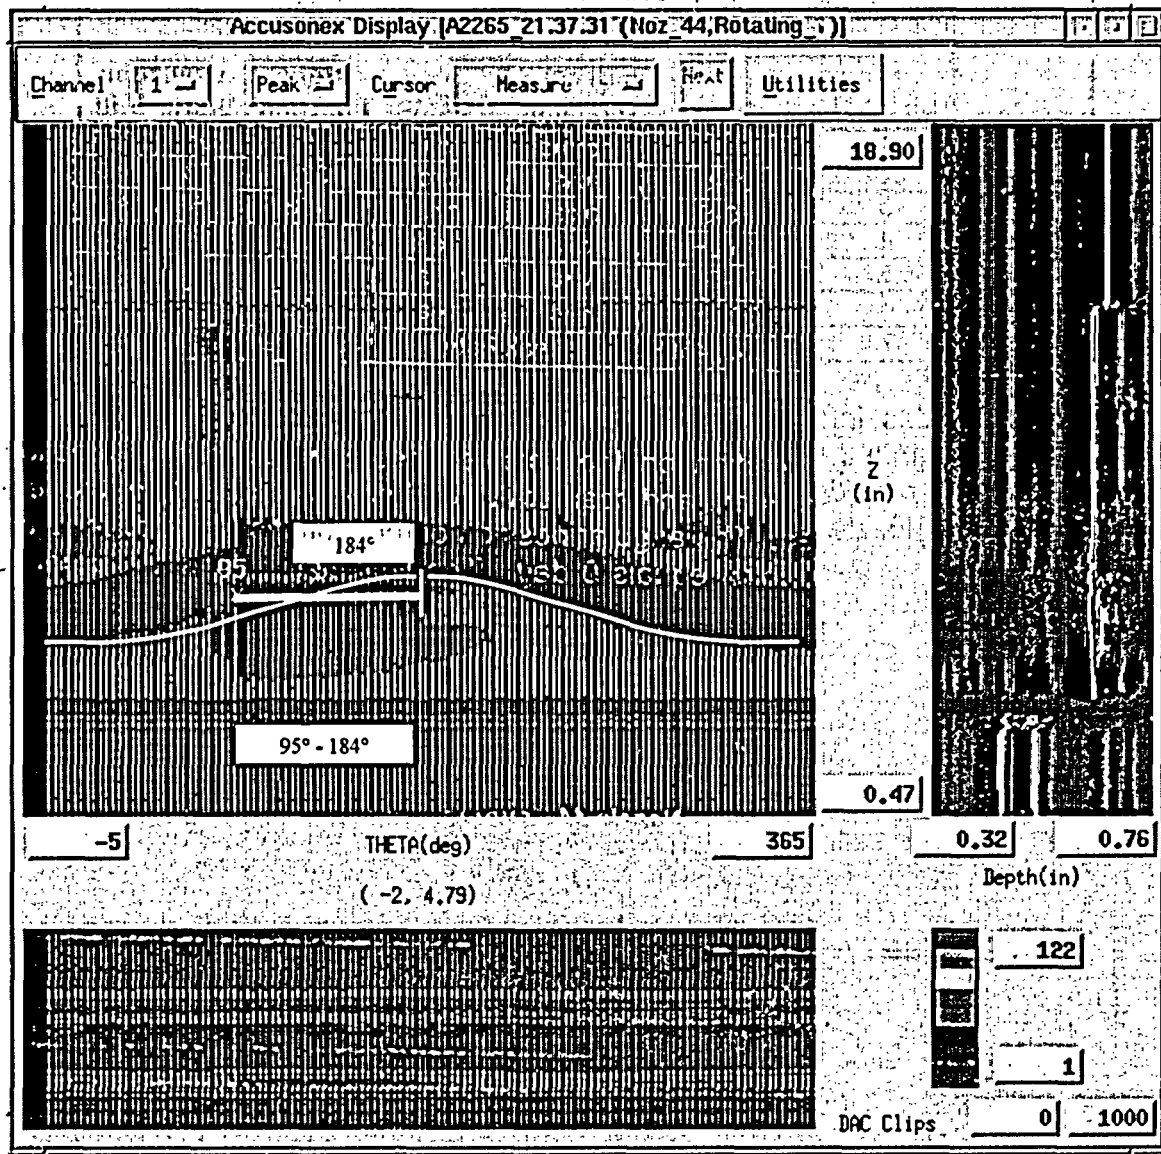
Nozzle 44	Area effected:		min:	max:	Total:		
			95	184	89		
			Beam		Probe	Limitation	
	Channel	Degree	Direction	Defects	Location	Start	End
	1	0	normal	vol	0	95	184
	2	30-L	axial	circ	338	73	162
	3	60-S	axial	circ	158	253	342
	4	45-LE	circ	axial	0	95	184
	5	60-SE	circ	axial	22	117	206
	6	60-SE	circ	axial	338	73	162
	7	0, 30L, 45LE	Leak Path		combined	95	162

Horizontal line denotes the stall area.

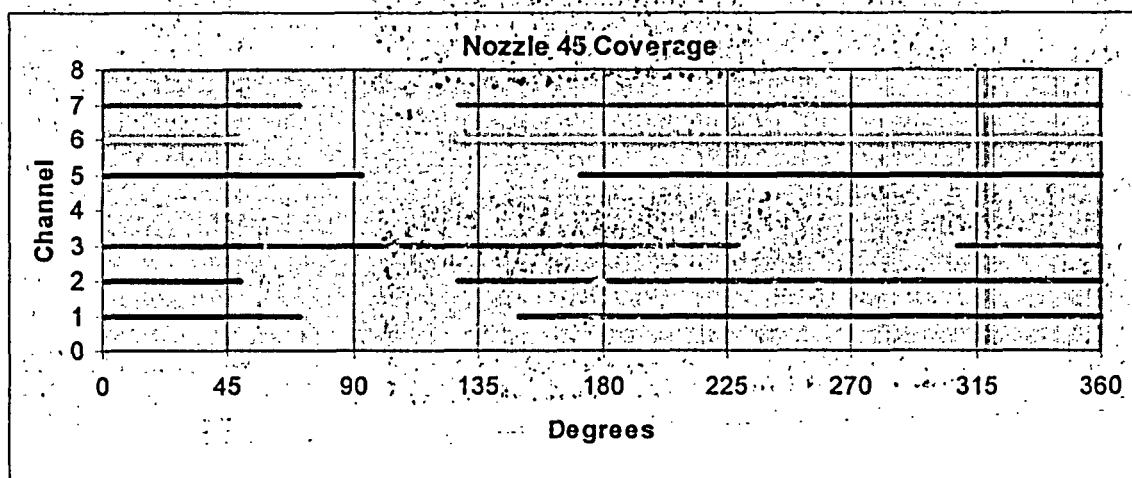
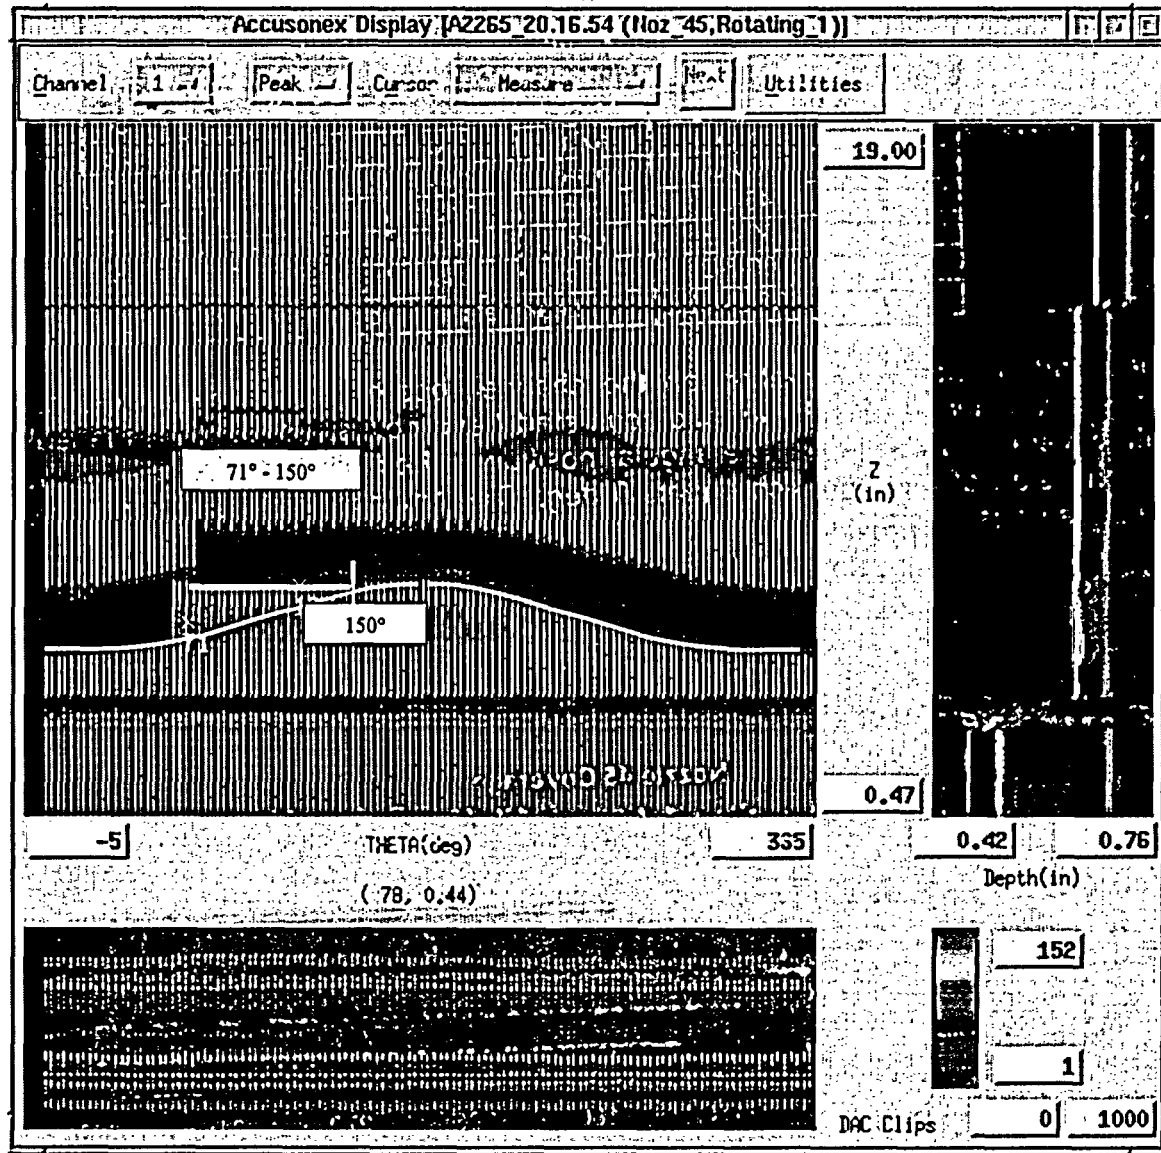
Nozzle 45	Area effected:		min:	max:	Total:		
			71	150	79		
			Beam		Probe	Limitation	
	Channel	Degree	Direction	Defects	Location	Start	End
	1	0	normal	vol	0	71	150
	2	30-L	axial	circ	338	49	128
	3	60-S	axial	circ	158	229	308
	4	45-LE	circ	axial	0	71	150
	5	60-SE	circ	axial	22	93	172
	6	60-SE	circ	axial	338	49	128
	7	0, 30L, 45LE	Leak Path		combined	71	128

Horizontal line denotes the stall area.

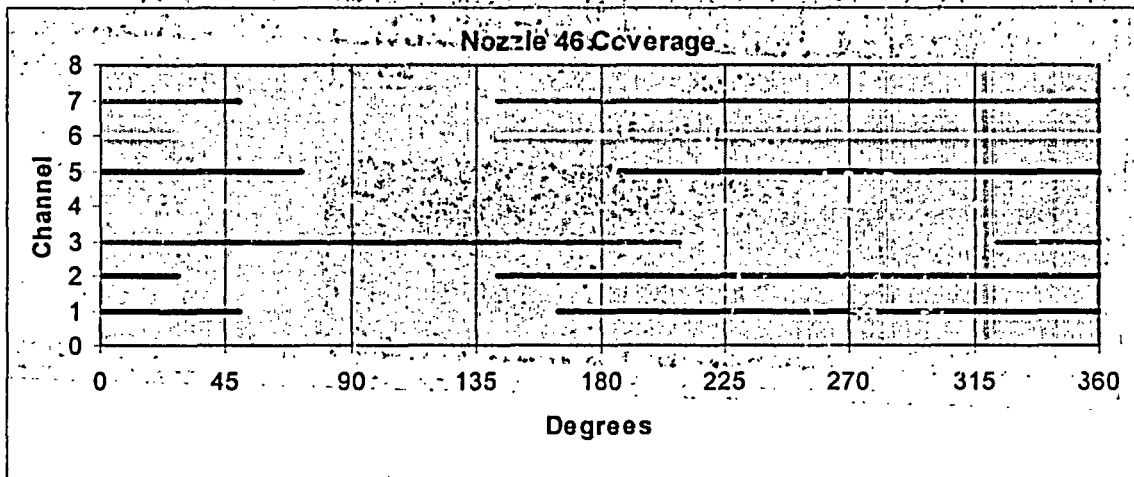
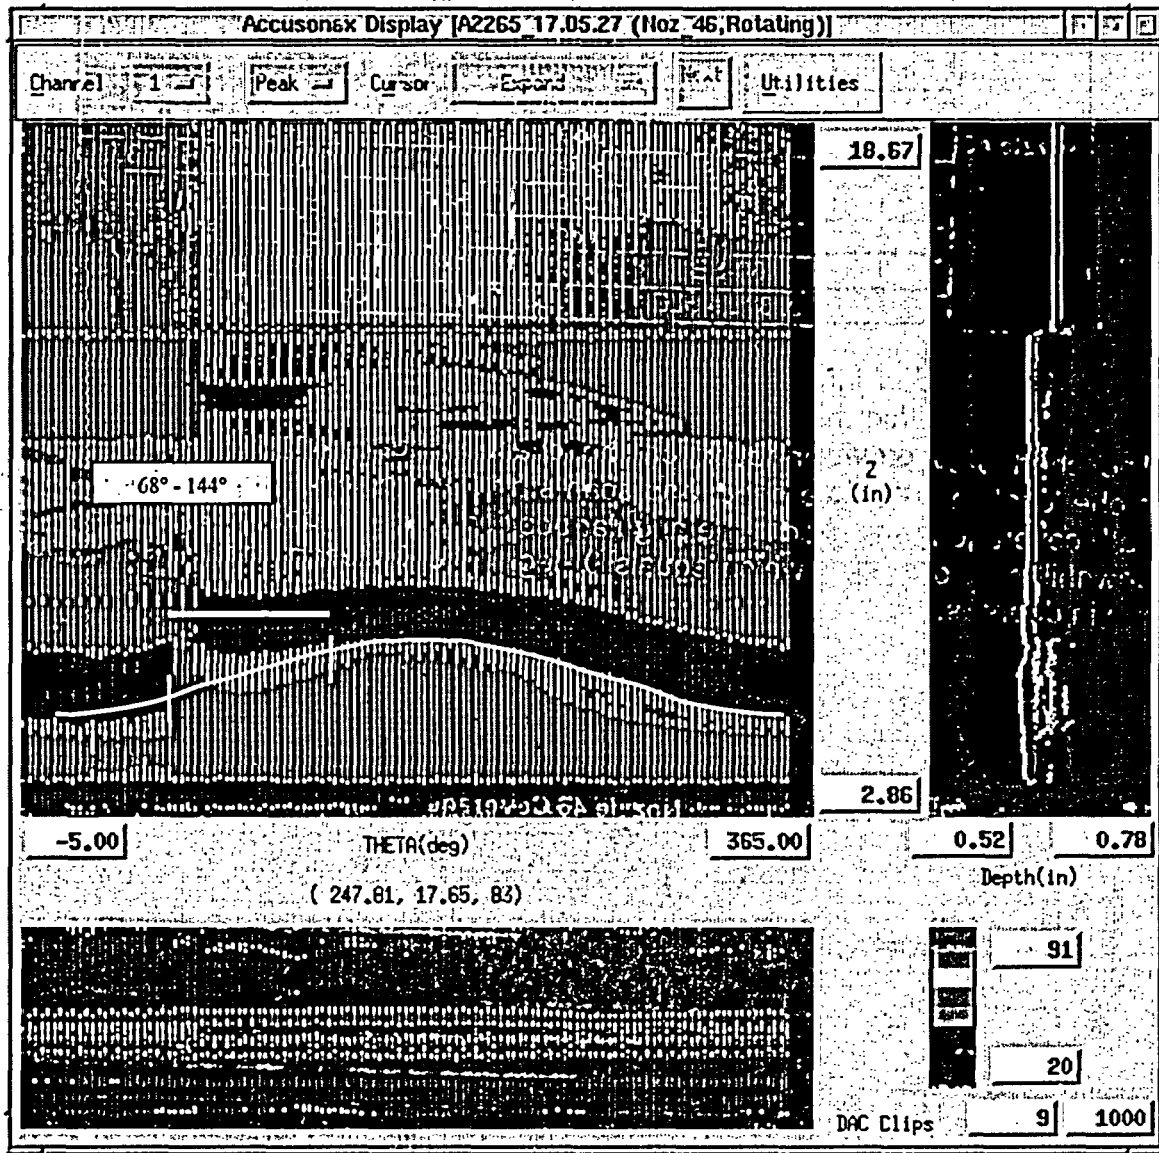
Nozzle 46	Area effected:		min:	max:	Total:		
			68	144	76		
	Channel	Degree	Beam Direction	Defects	Probe Location	Limitation Start	Limitation End
	1	0	normal	vol	0	68	144
	2	30-L	axial	circ	338	46	122
	3	60-S	axial	circ	158	226	302
	4	45-LE	circ	axial	0	68	144
	5	60-SE	circ	axial	22	90	166
	6	60-SE	circ	axial	338	46	122
	7	0, 30L, 45LE	Leak Path		combined	68	122

Horizontal line denotes the stall area.

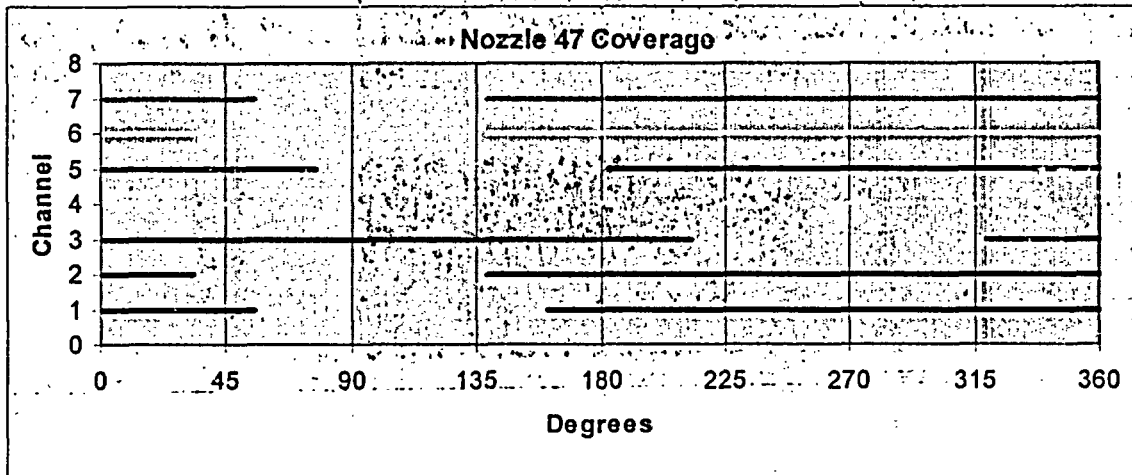
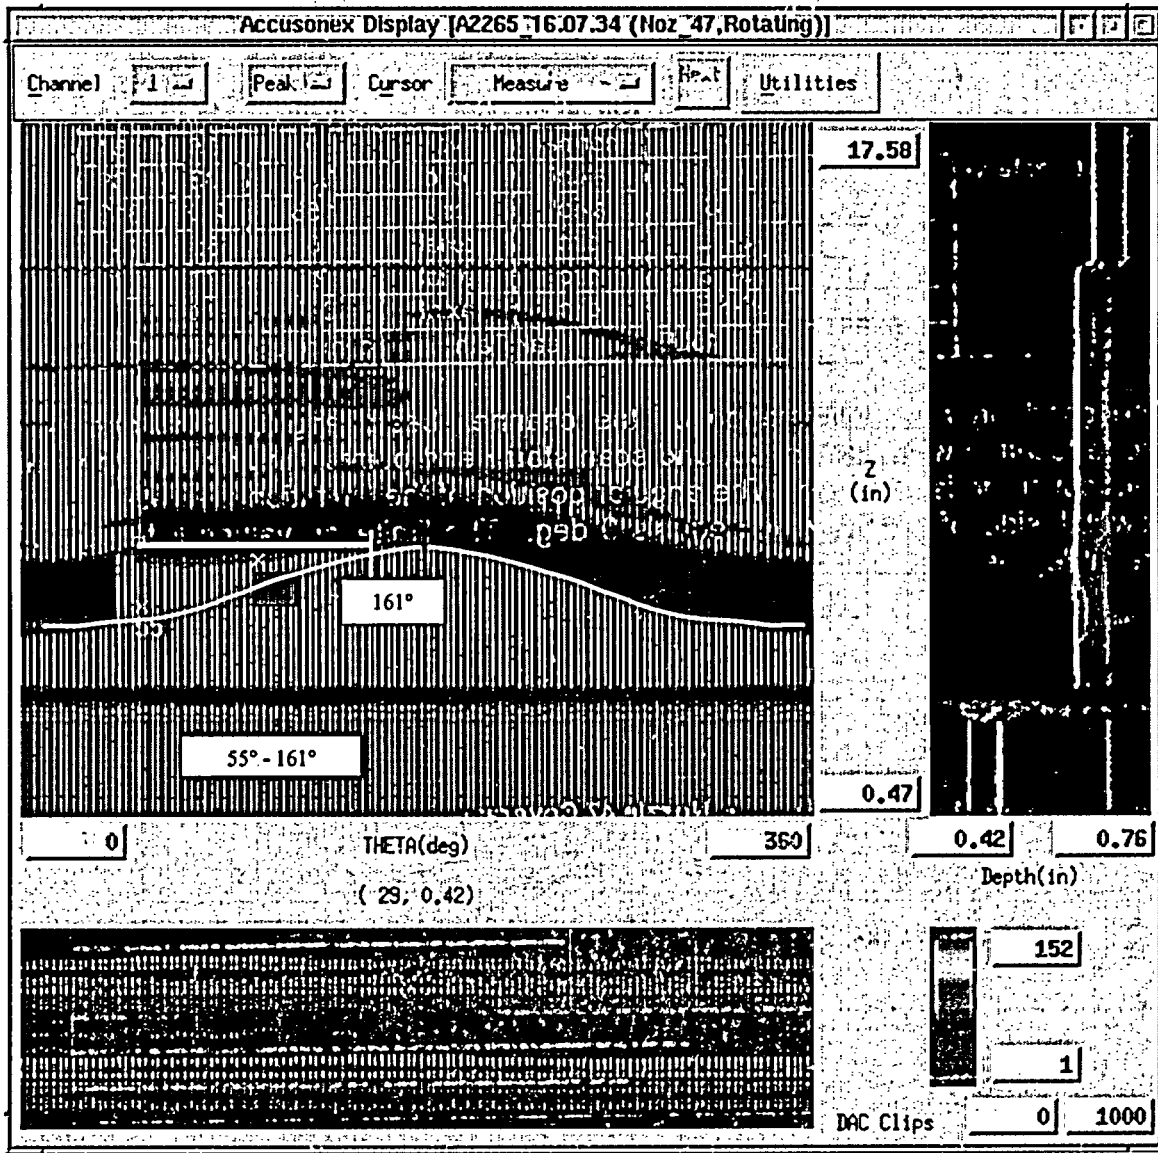
Nozzle 47	Area effected:		min:	max:	Total:		
			55	161	106		
			Beam		Probe	Limitation	
	Channel	Degree	Direction	Defects	Location	Start	End
	1	0	normal	vol	0	55	161
	2	30-L	axial	circ	338	33	139
	3	60-S	axial	circ	158	213	319
	4	45-LE	circ	axial	0	55	161
	5	60-SE	circ	axial	22	77	183
	6	60-SE	circ	axial	338	33	139
	7	0, 30L, 45LE	Leak Path		combined	55	139

Horizontal line denotes the stall area.
