## POST-IRRADIATION EXAMINATION RESULTS FROM THE BTF-105A LOCA/LOECC TEST

VALLIANT, P.J., IRISH, J.D. and CRAIG, S.T.

Fuel Safety Branch  
Reactor Safety Division  
AECL, Chalk River Laboratories  
Chalk River, Ontario, CANADA K0J 1J0

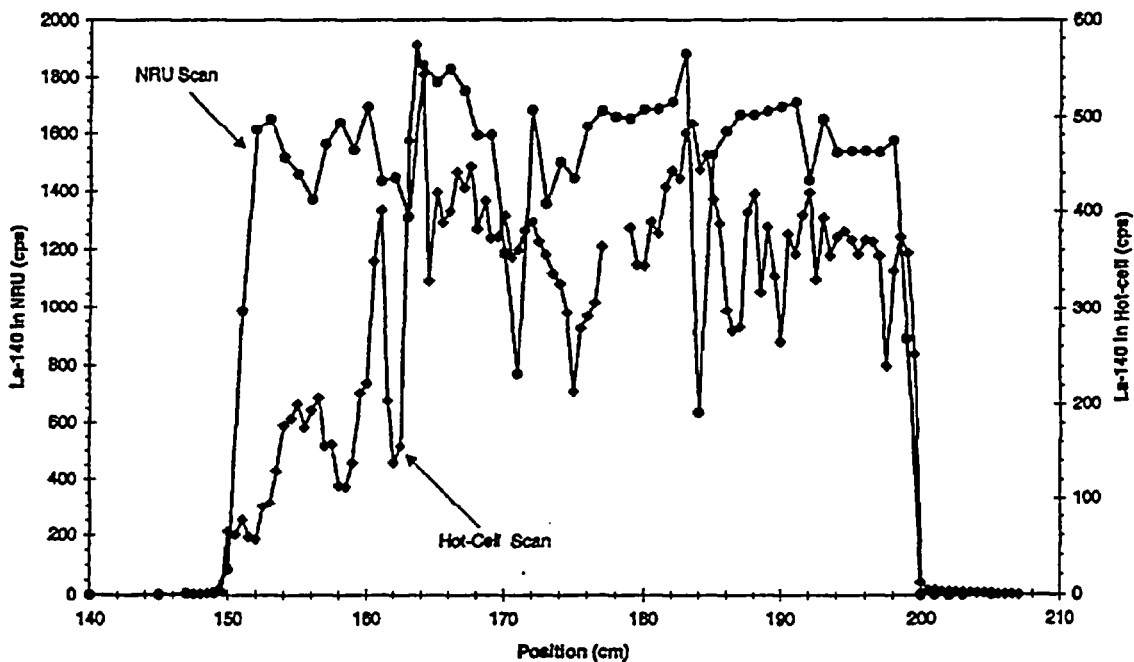
The fuel assembly was gamma scanned in a storage can in the NRU reactor building after the test. The scan revealed a relatively intact fuel element (Figure 5). A decision was made to transfer the assembly to the hot cells without epoxying the assembly. This allowed much more information to be gained about instrumentation and the condition of the thermal shroud than would have been possible if the stringer had been epoxied initially. The ZIRCAR thermal insulation was cut longitudinally and the upper and lower halves were separated to expose the inner Zircaloy wall of the thermal shroud. In Figure 6 it can be seen that the inner Zircaloy wall is heavily oxidized and broken up at the elevation of the lower bearing pad of the fuel element. Evidence of steam ingress into the ZIRCAR insulation can be seen in the mating half of the thermal shroud where this ingress has discoloured the initially white ZIRCAR insulation. The insulation is mainly intact except for a through-wall crack that appears to line up with the zone of heaviest damage on the inner Zircaloy wall. It is possible, that the rapid injection of steam into the shroud following failure of the inner wall caused the through-wall crack in the insulation to form, which in turn, provided a path for the hot steam to heat the outer wall of the shroud directly. This would explain the rapid rise in temperature following shroud failure observed by a thermocouple located on the outside of the shroud [1]. This outer shroud thermocouple was located axially within a few millimetres of the observed crack in the insulation. A second gamma scan done in the hot cell showed some fuel relocation (Figure 5). A comparison of the two gamma scans indicates that most of the damage to the fuel element occurred during handling after the element was removed from the reactor. "Fuel powder" consisting of loose  $\text{UO}_2$  fuel

Figure 5: Comparison of La-140 Gamma Scans Performed in the NRU Storage Block and in the Hot Cells

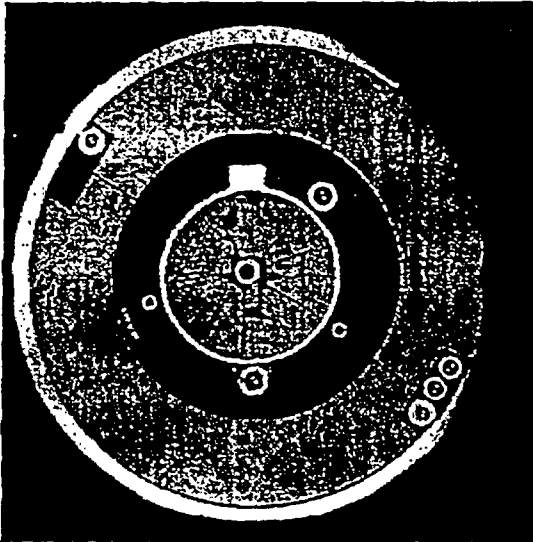
FS 30 2X  
Figure 8: Met 1 Upper Bearing Pad - TFC01

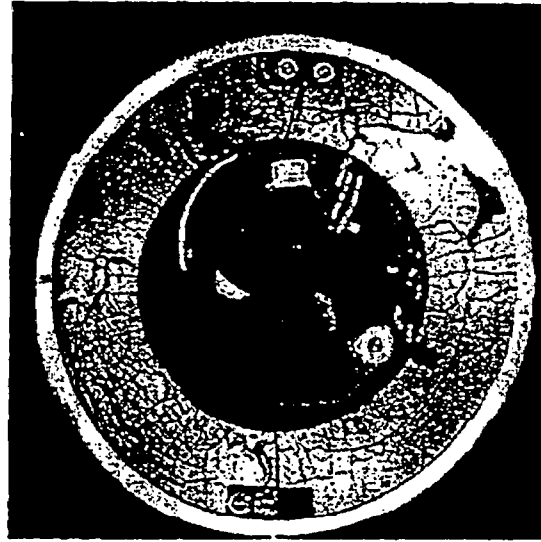
FS 25 2X  
Figure 9: Met 2 Middle Bearing Pad
