Re: Indian Point Unit No. 3
Docket No. 50-286
NL-03-182

Subject: Steam Generator Tube Inservice Examination
Results For 2003 Refueling Outage 12 (R12)

R12 STEAM GENERATOR TUBE INSERVICE EXAMINATION REPORT

Entergy Nuclear Operations, Inc
Indian Point Nuclear Generating Unit 3
Docket No. 50-286

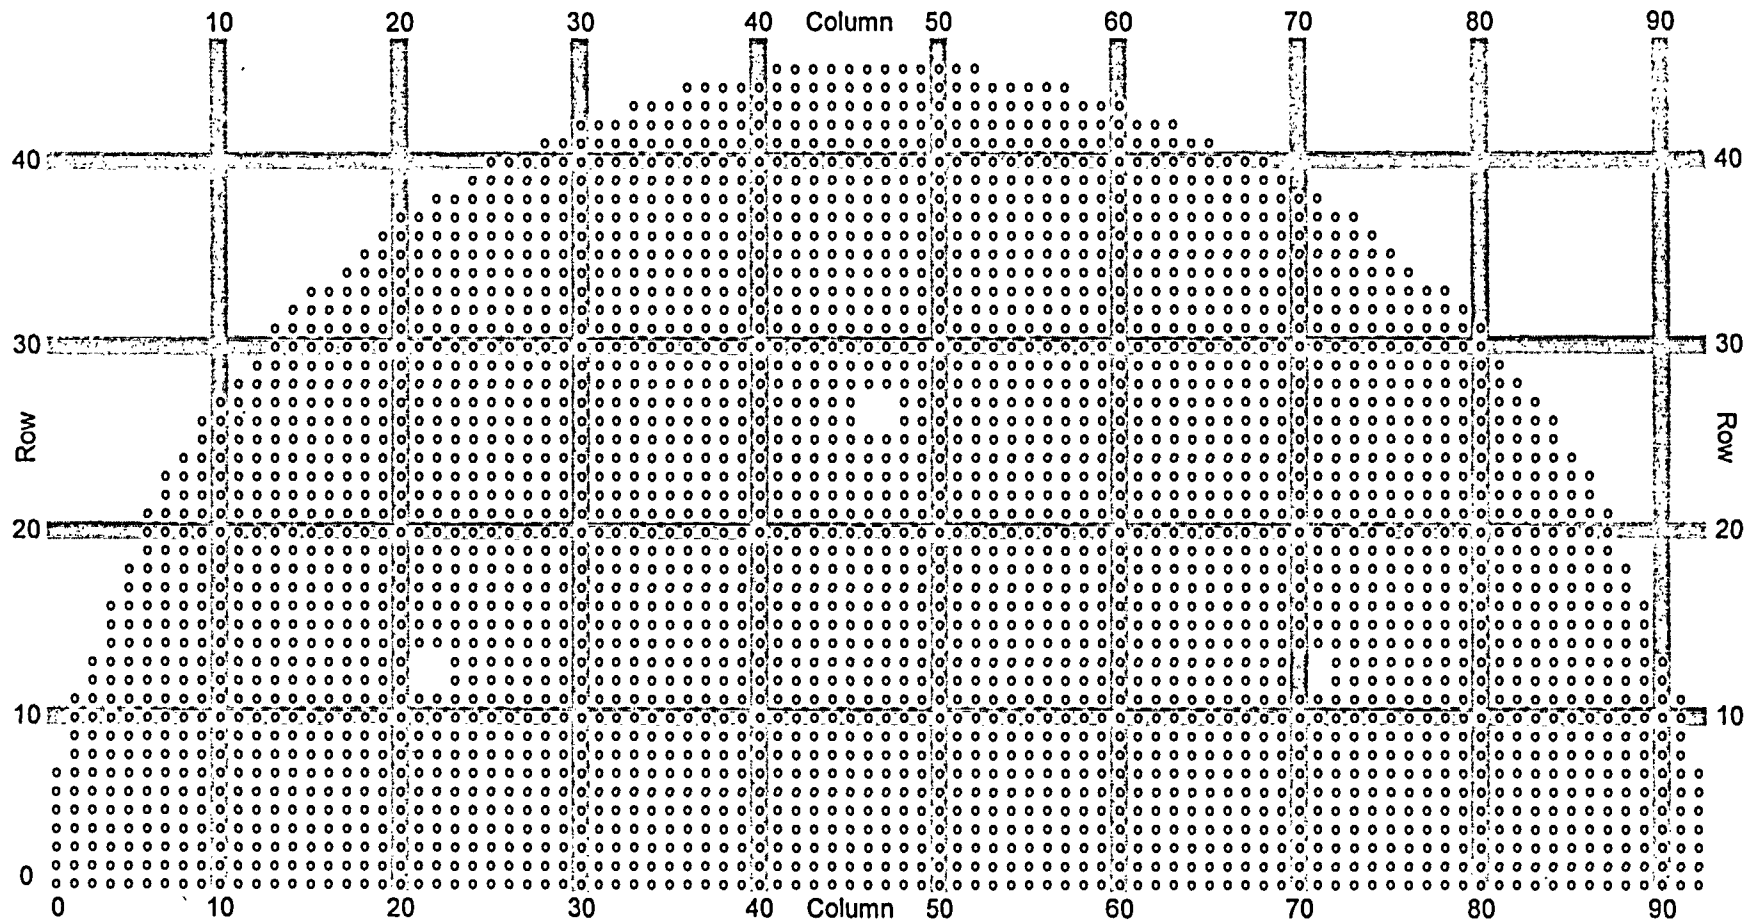
Figure 1

Steam Generator Tubesheet Map (one leg)
Westinghouse Model 44F (Indian Point 3)
Column 1 is the nozzle side of SG
