Augmented Inspection Team Inspection of Honeywell Uranium Hexafluoride (UF₆) Release

December 22, 2003

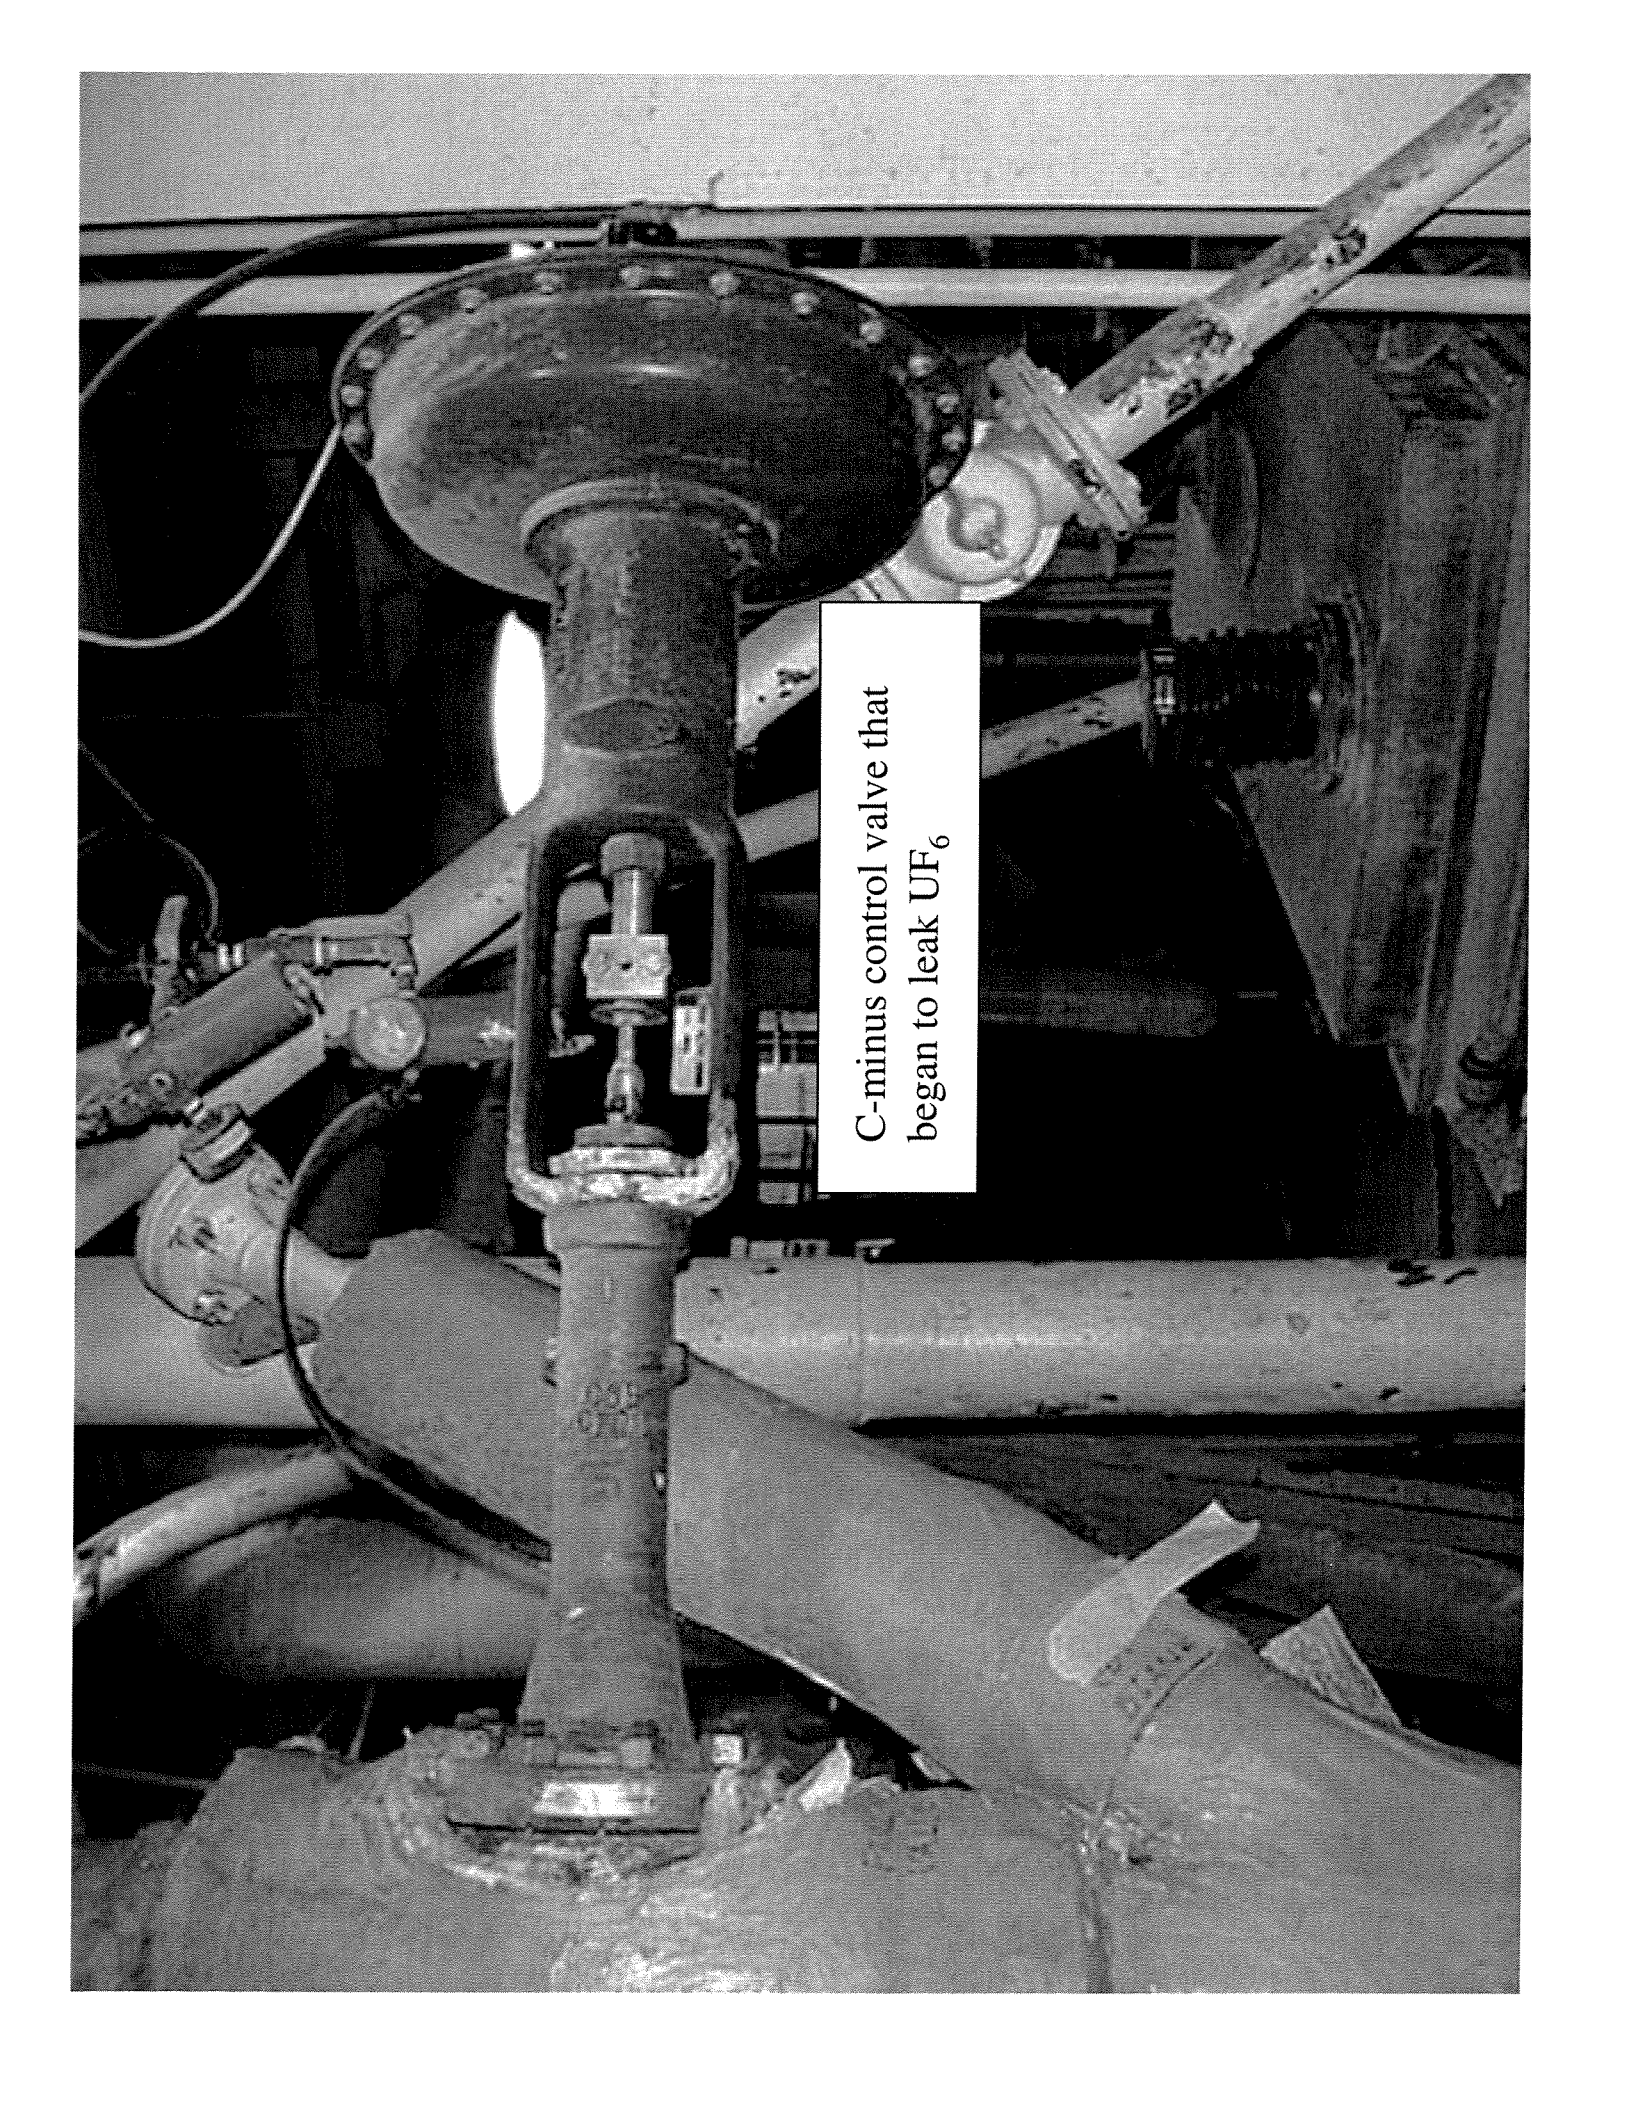
- The initial UF6 leak was from the C-minus control valve
- The release to the environment occurred when the dust collector valves were opened and the UF6 under pressure in the system exited through the dust collectors and out a horizontal exhaust stack on the southwest side of the Feed Materials Building (86 ft above ground level)

C-minus control valve that
began to leak UF₆

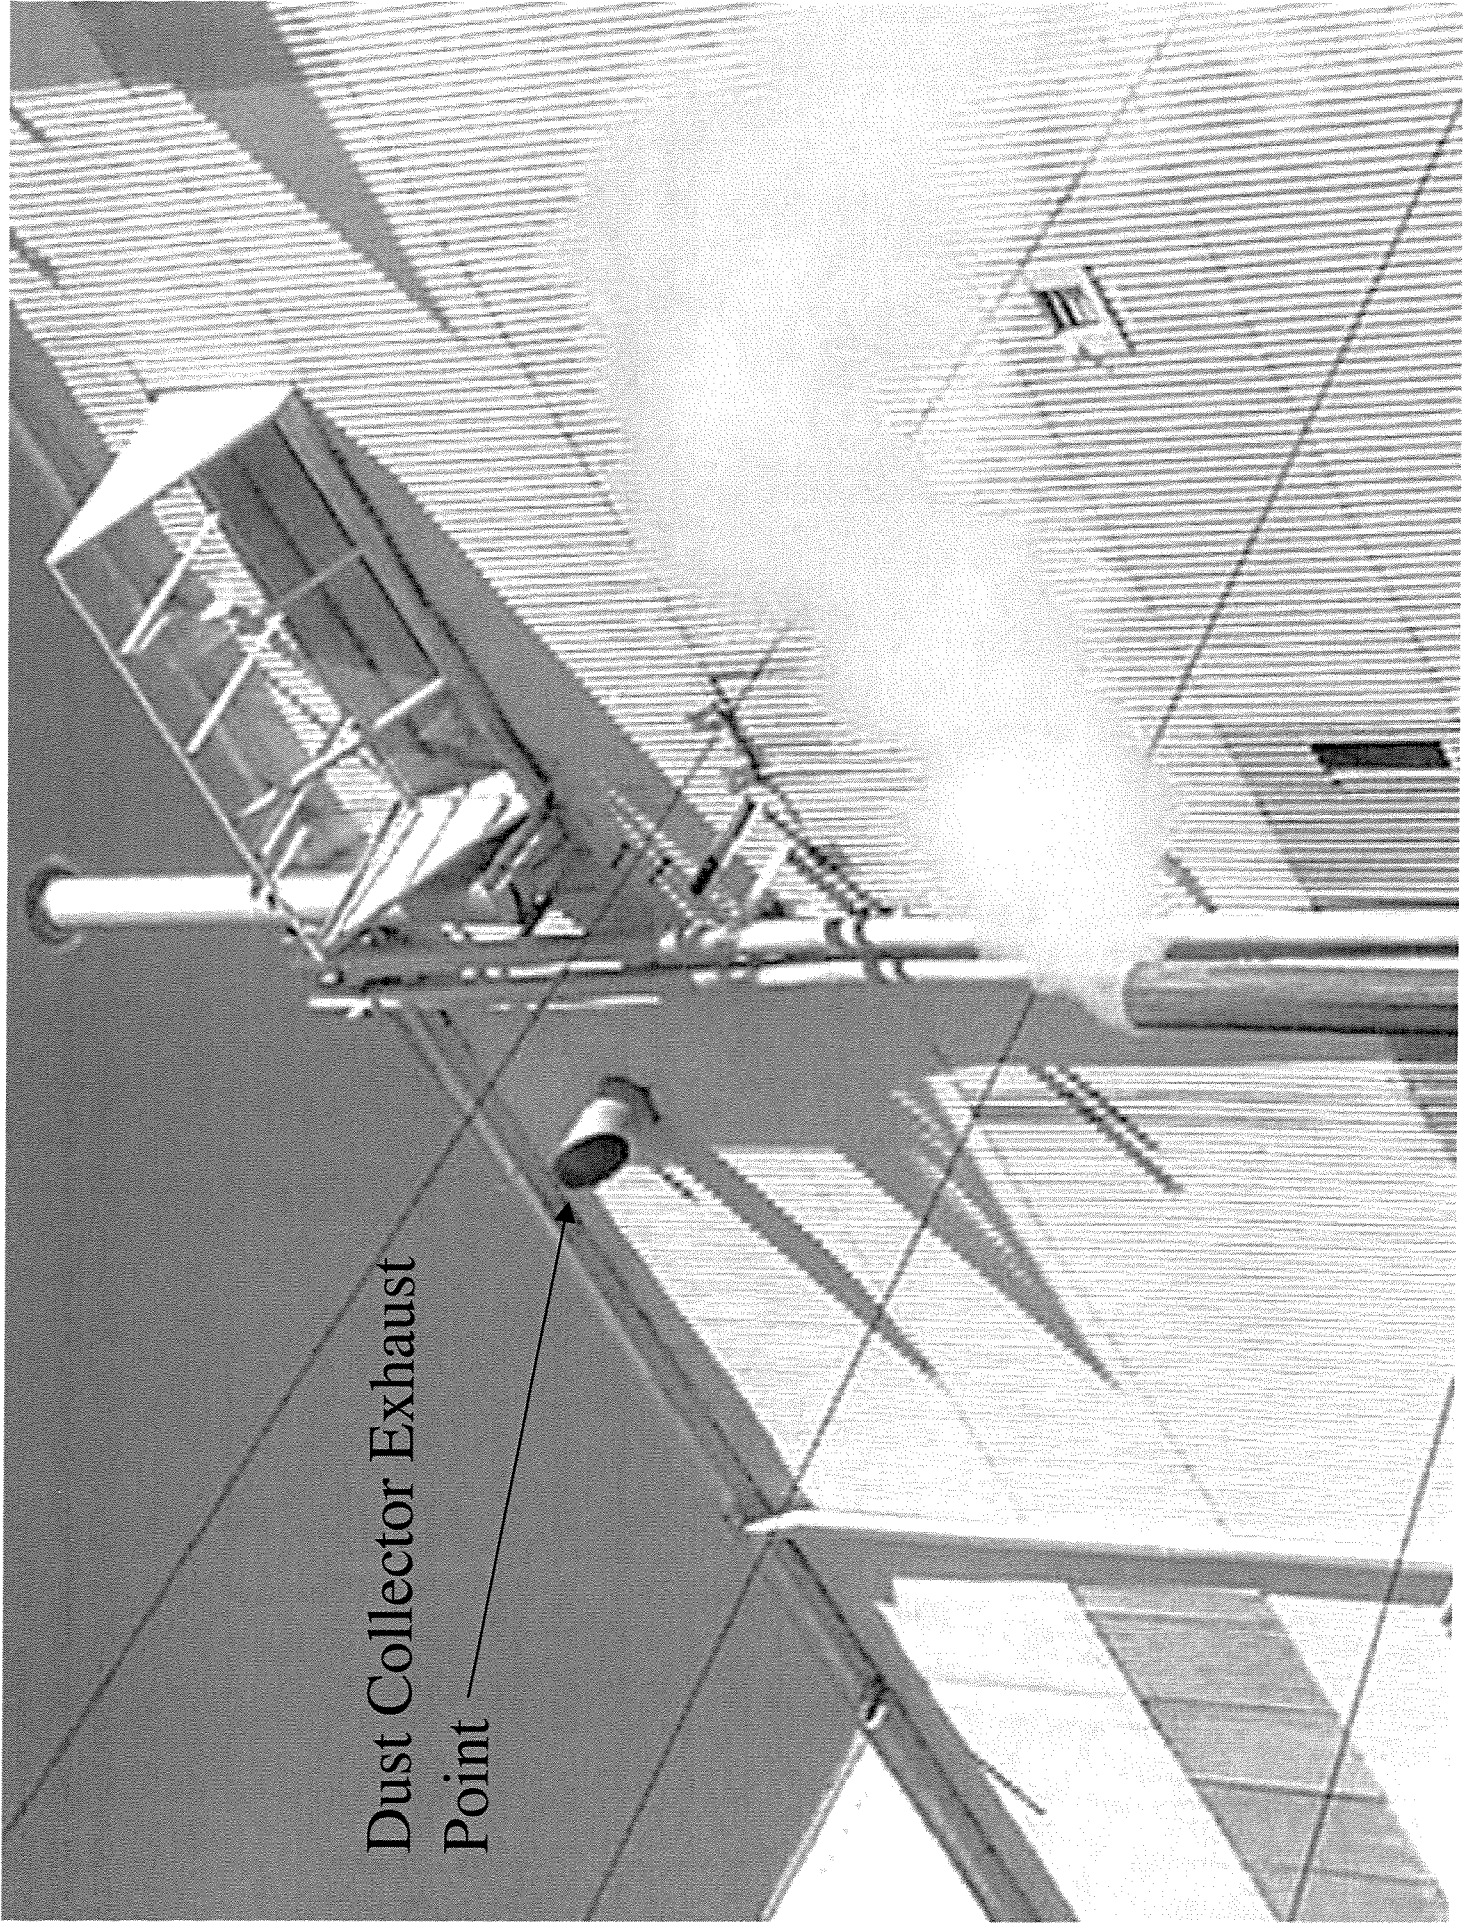
← Dust Collector Piping
(Valve on other side)

← C-minus Valve
Removed from here

← C-train System Valve

Dust Collector Exhaust
Point
