**Sequoyah Triennial Fire Protection Inspection**  
**IP 71111.05T (March 23, 2001)**

March 25-29, 2002

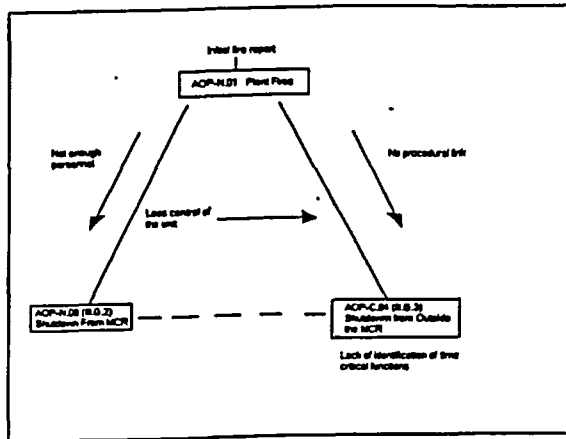
- RMSI noted errors; questioned whether transitions would occur due to identified deficiencies
- Severe Fire Mitigation - Three procedures
  - ▶ Initial Response (AOP-N.01)
  - ▶ Shutdown from Main Control Room (AOP-N.08)
  - ▶ Shutdown from outside the Main Control Room (AOP-C.04)
