SUBJECT: NRC INSPECTION REPORT 050-00312/04-001; 072-00011/04-001

Report Nos.: 050-00312/04-001; 072-00011/04-001

Facility: Rancho Seco Nuclear Generating Station

Dates: March 22-25, 2004

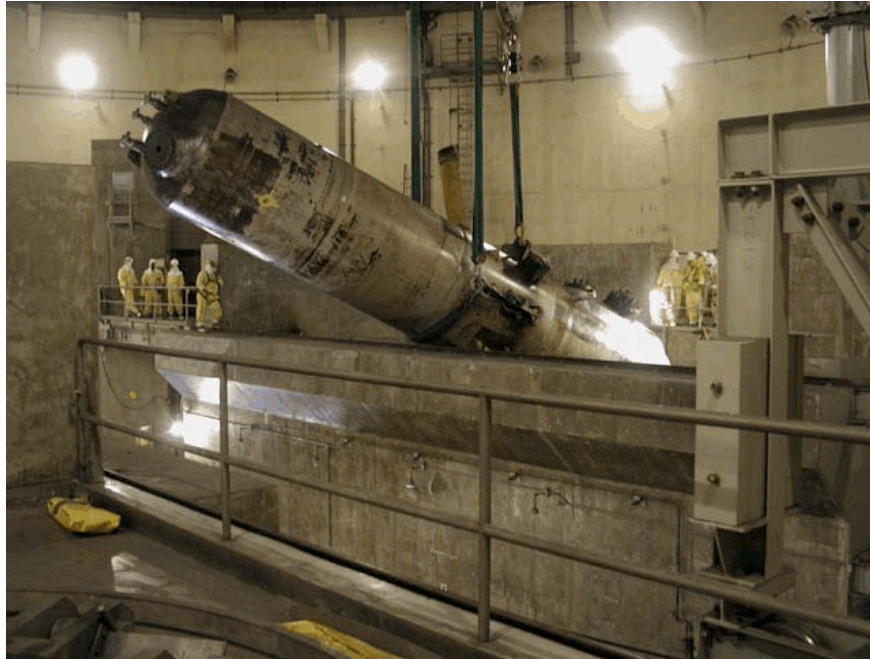
Figure 1
Rancho Seco Pressurizer
Lifted out of South Biological Shield “D” Ring

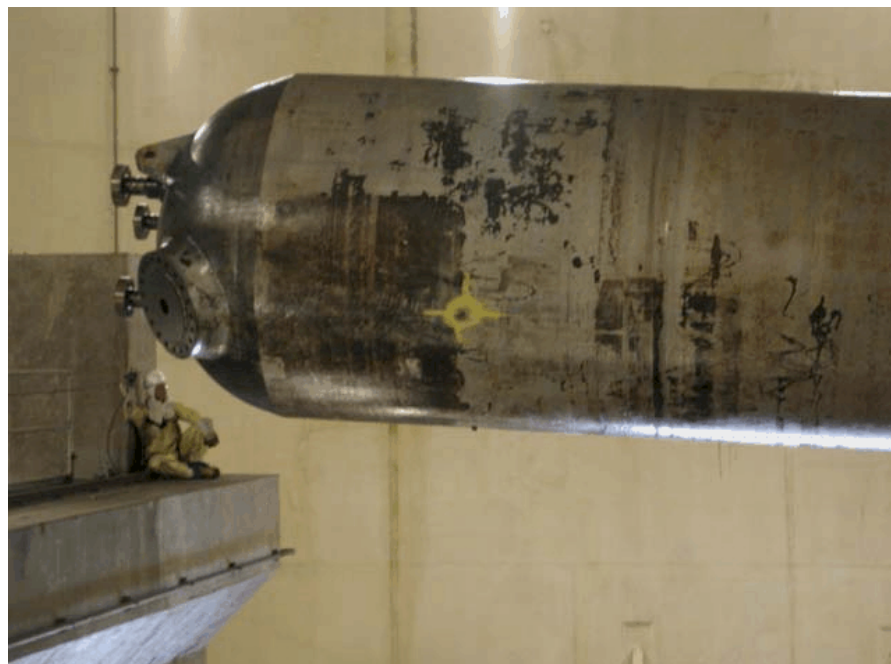
Figure 2
Rancho Seco Pressurizer
Approaching North Biological Shield “D” Ring

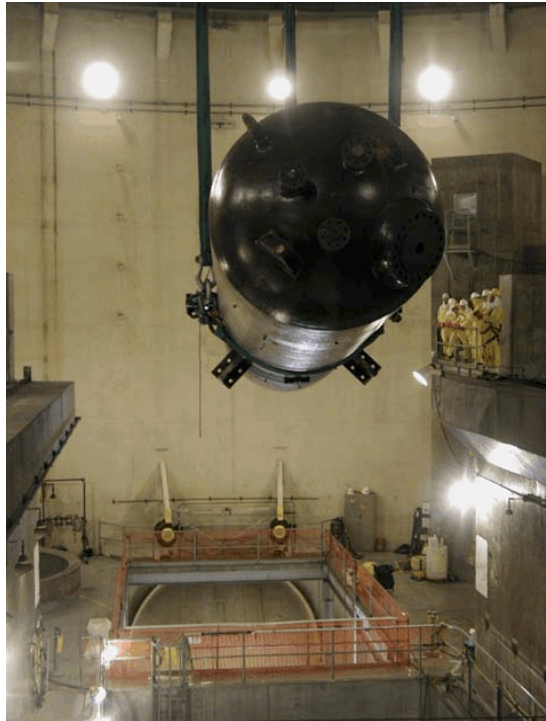
Figure 3
Rancho Seco Pressurizer
Moving toward Reactor Building Equipment Hatch

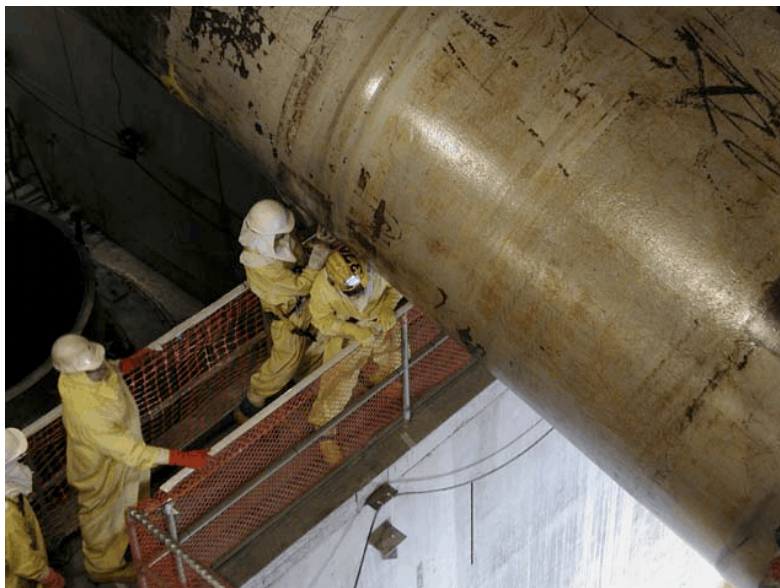
Figure 4
Rancho Seco Pressurizer
Tilted by Workers toward Equipment Hatch Bay

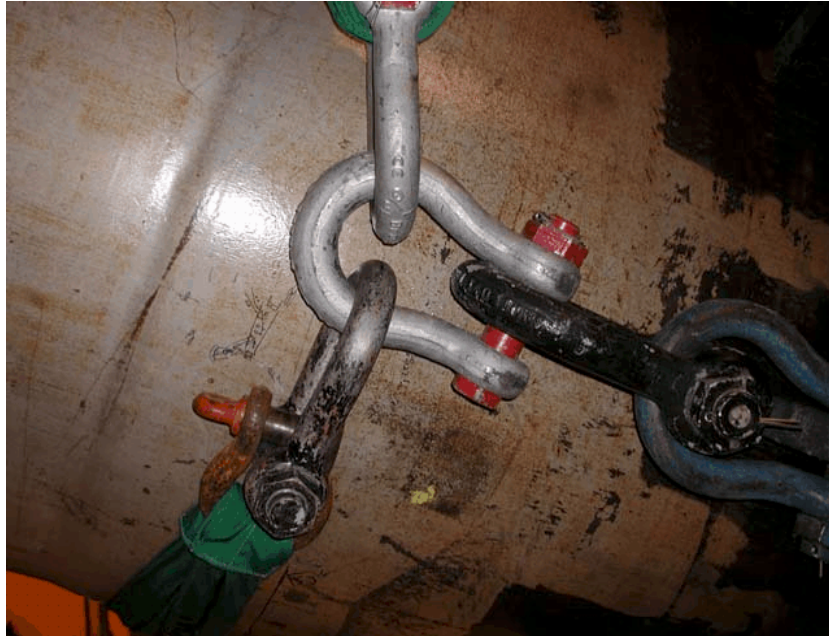
Figure 5
Rancho Seco Pressurizer
Rigging Shackle Details

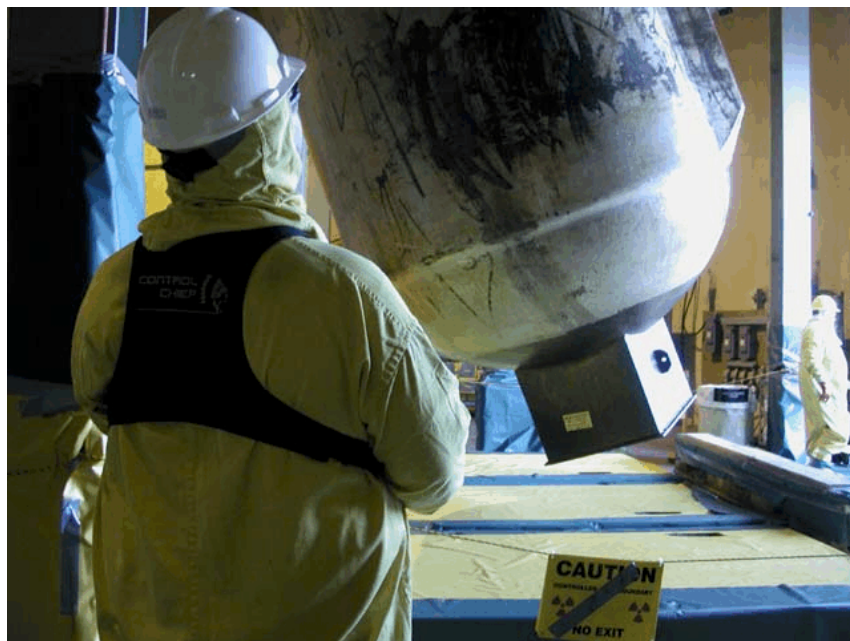
Figure 6
Rancho Seco Pressurizer
Crane Operator Using Remote Controls

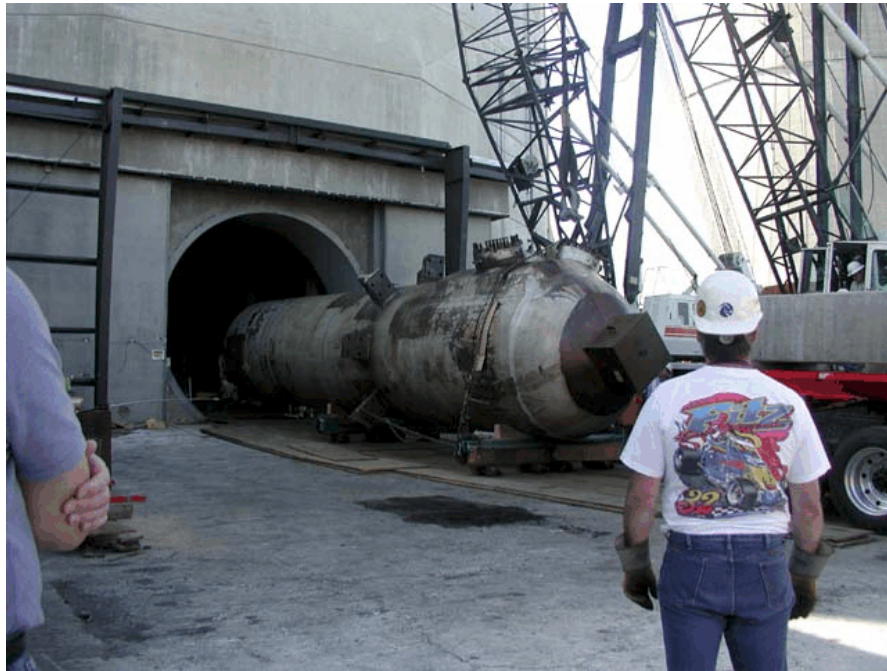
Figure 7
Rancho Seco Pressurizer
Pulled Outside Reactor Building Equipment Hatch

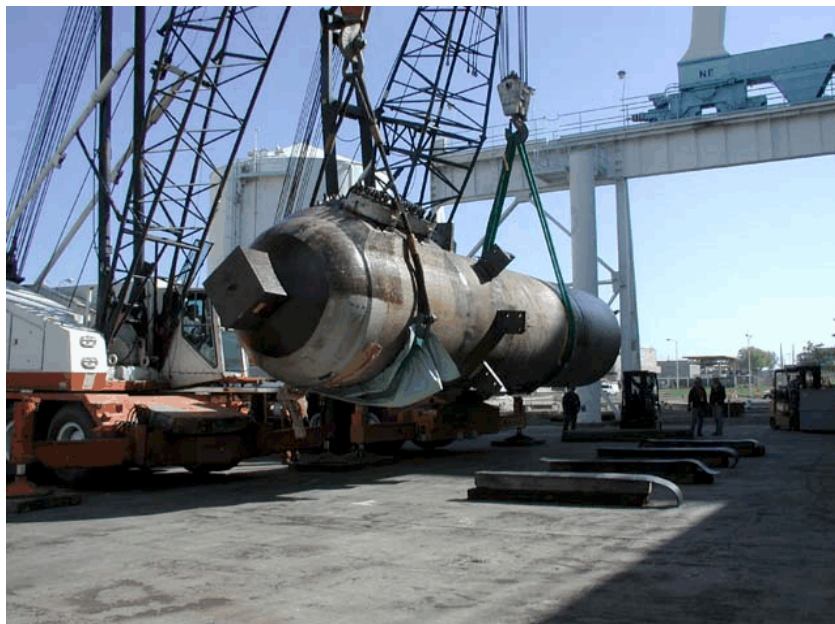
Figure 8
Rancho Seco Pressurizer
Lowered by Two Cranes at Shipping Staging Area
