Subject: Special Inspection No. 89-002

U.S. NUCLEAR REGULATORY COMMISSION
REGION I

Licensee: Safety Light Corporation
4150-A Old Berwick Road
Bloomsburg, Pennsylvania

Inspection Conducted: June 16, 1989

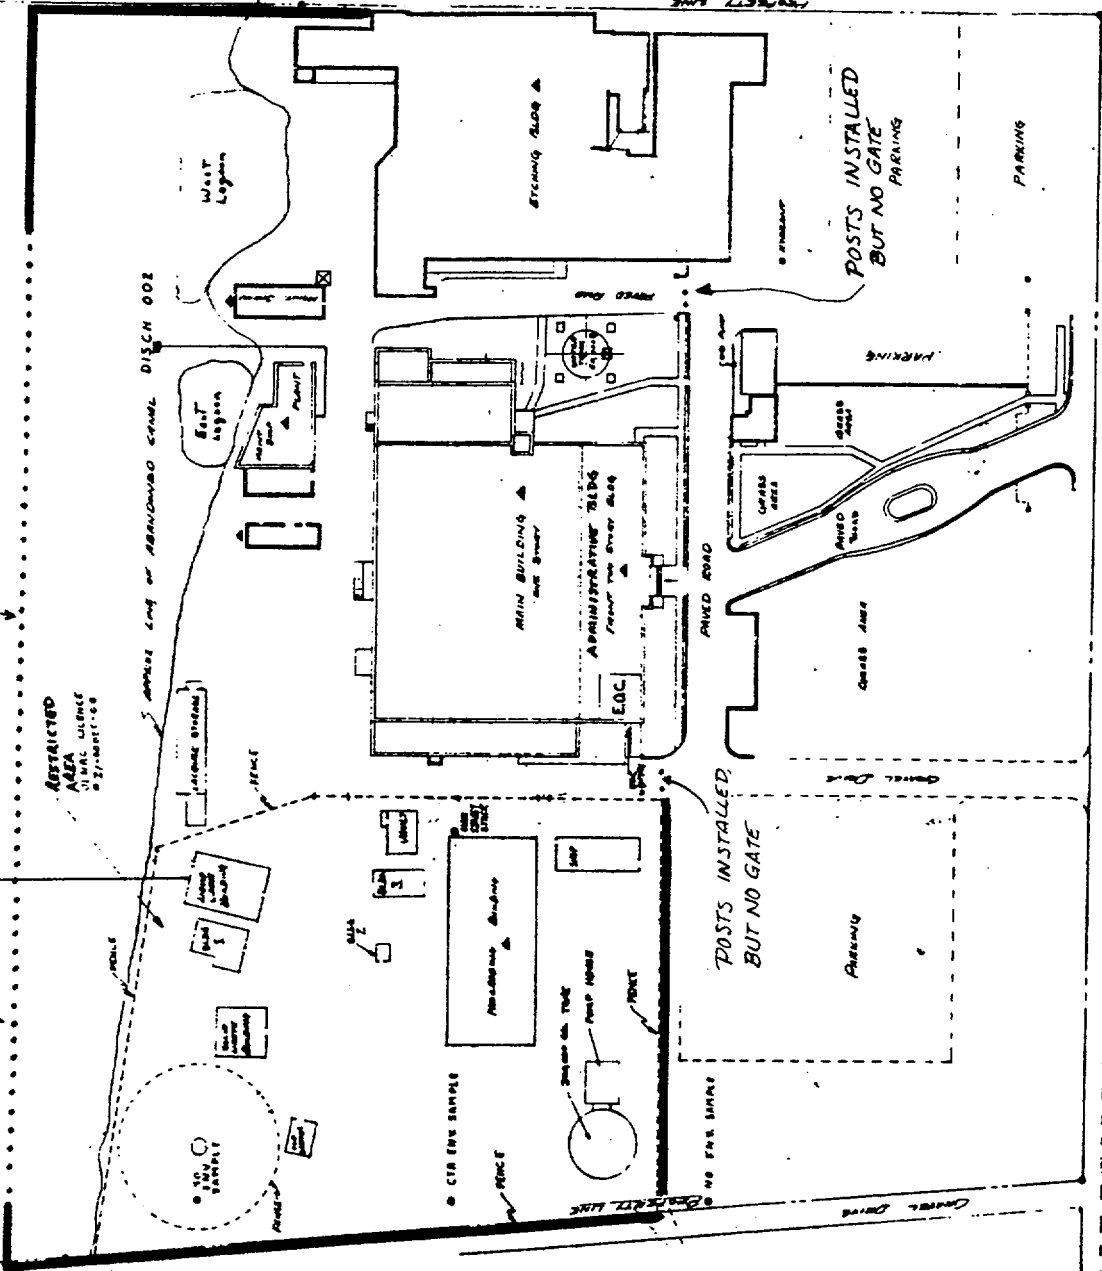
ATTACHMENT 1

The inspector toured the site on June 16 and noted that construction of the fence was underway (as shown in Attachment 1), but was incomplete and that access was not controlled to all contaminated areas. For example, gates planned to be installed across access roads at each end of the administration building had not been installed, and fence fabric had not been installed on posts on the side of the site facing the Susquehanna River. In addition, radiation safety training had not been initiated for employees of Multimetals and USR Metals, individuals who have access to contaminated areas of the licensee's site.

The failure to control access to all contaminated areas at the Bloomsburg facility by June 15, 1989 is an apparent violation of Section VII.A of the NRC's March 16, 1989 Order.

Bloomsburg Facility Depicted Status of Fence Completion

on June 16, 1989

POSTS INSTALLED,
BUT NO FENCE

POSTS INSTALLED
BUT NO GATE
PARKING

POSTS INSTALLED,
BUT NO GATE
PARKING
