Crystal River Nuclear Plant  
Docket No. 50-302  
Operating License No. DPR-72

Subject: LICENSEE EVENT REPORT 50-302/2004-003-00

4. TITLE  
Reactor Trip And Emergency Feedwater Actuation Caused By 230 Kilovolt Switchyard/Transmission Faults

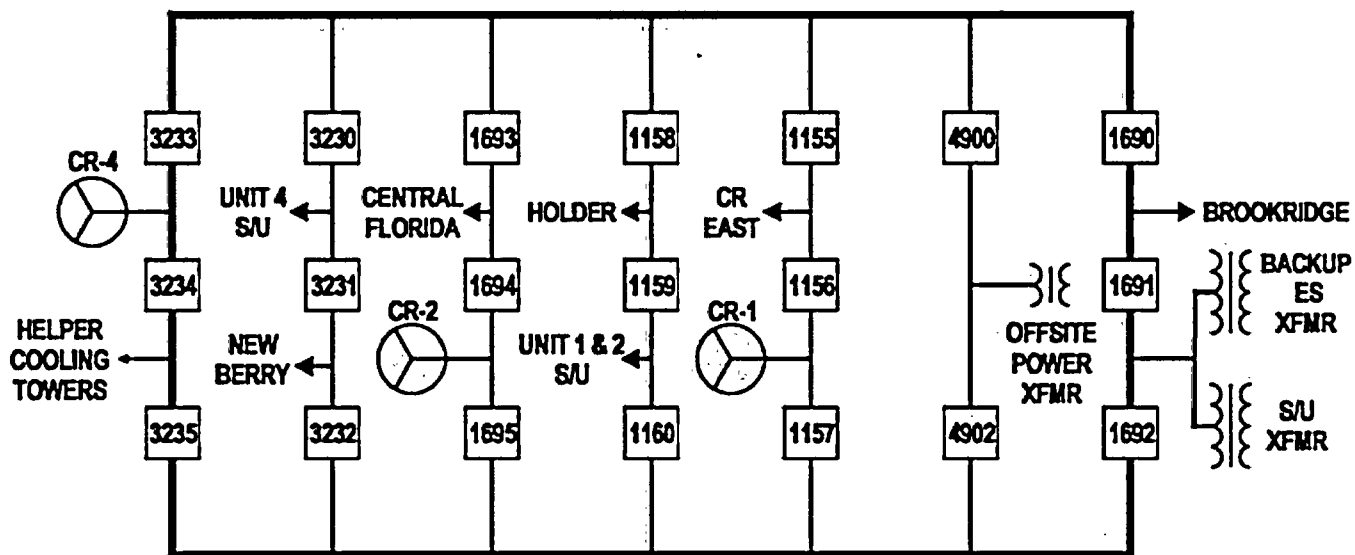
FIGURE 1

At 11:02 on September 6, 2004, a fault on the 230 kilovolt (kV) Brookridge transmission line [FK, CBL] resulted in the opening of Breakers 1690 and 1691 (see Figure 1) [FK, BKR]. Mechanical failure of an insulator string [FK, INS] resulted in a phase-to-ground fault when the transmission line dropped into the metal transmission tower [FK, TWR]. That transmission tower is located along the transmission corridor approximately two miles from the CR-3 switchyard. This removed one of the sources of power to the BEST and Startup transformer [EB, XFMR].

At 11:51, on September 6, 2004, a fault on the 230 kV switchyard south bus [FK, BU] resulted in the opening of Breaker 1692 (see Figure 1). A phase-to-ground fault on Breaker 3232 resulted in actuation of the primary and backup bus differential relaying schemes [FK, 87] resulting in the tripping of Breakers 3235, 3232, 3231, 1695, 1160, 1157, 4902 and 1692. This removed the remaining source of power to the BEST and Startup transformer. Improved Technical Specification (ITS) 3.8.1, Condition A, was entered for loss of the BEST.

The cause for loss of the 230 kV Brookridge transmission line was mechanical failure of a vertical string of insulators on the "A" phase due to diameter loss and consequent failure of one of the carbon steel pins connecting the insulators to one another. The porcelain "ball and socket" insulators were stamped "LAPP 20000 1968," indicating that they were manufactured by the Lapp Insulator Company and were 1968 vintage. The diameter loss was caused by possible leakage current which led to spark erosion and severe electrochemical corrosion of the carbon steel pin. Corrosion/erosion reduced the cross section of the carbon steel pin sufficiently to result in tensile overload. The passing of Tropical Storm Frances resulted in tropical storm force winds that placed additional stress on the carbon steel pin. A phase-to-ground fault occurred when the "A" phase transmission line dropped and came in contact with the metal transmission tower.

The tripping of the 230 kV switchyard south bus was due to a flashover ("B" phase-to-ground) on breaker 3232 due to contamination from wind and salt spray from the passing of Tropical Storm Frances. The bus differential relaying schemes functioned as designed based on the fault condition of the breaker and isolated the fault by opening breakers 3235, 3232, 3231, 1695, 1160, 1157, 4902 and 1692. Since the relaying functioned as designed to protect the adjacent equipment from the fault and the fault occurred as a result of Tropical Storm Frances, there were no inappropriate acts or equipment failures. Therefore, there is no corrective action to prevent recurrence of this condition.

1. CR-3 Administrative Instruction AI-704, "Reactor Trip Review and Analysis," was performed.
2. The failed vertical string of insulators was replaced. Vertical and "V" string insulators on the 230 kV Brookridge transmission line towers located along the transmission corridor adjacent to the CR-3 access road were inspected. Thirteen additional vertical strings of insulators were subsequently replaced on the 230 kV Brookridge transmission line.
3. A 230 kV switchyard south bus reenergization plan was created and implemented. The primary purpose of this plan was to reveal internal breaker faults prior to bus restoration. No internal breaker faults were identified. The 230 kV switchyard south bus breakers were closed and the 230 kV switchyard south bus was restored on September 7, 2004.

4. Breaker 3232 was evaluated. Physical evidence was found to confirm that a flashover had occurred from the "B" phase to ground. A series of tests were performed on the breaker with results being acceptable. In addition, an internal inspection was performed on the "B" phase of the breaker with results being acceptable. A complete hot wash was performed on insulators and breakers on the 230 kV switchyard south bus prior to CR-3 restart. A visual inspection of other sections of the 230 kV switchyard buses was also performed. The determination was made that additional hot washing was not required.
5. Other actions associated with this event are being addressed in the CR-3 Corrective Action Program in Nuclear Condition Report 136752.
