OCAN100403

October 28, 2004

SUBJECT: Response to Generic Letter 2004-01, Requirements for Steam Generator  
Tube Inspections  
Plant Name Arkansas Nuclear One, Units 1 and 2  
Docket Nos. 50-313 and 50-368  
License No. DPR-51 and NPF-6

**Response to Generic Letter 2004-01 for ANO-1 and ANO-2**

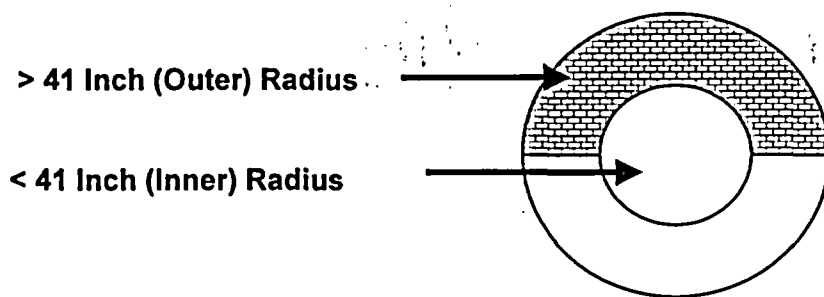
- 50% (100% of one half of the SG) of the tubes in the outer periphery (radius > 41 inches)
- 20% of the tubes in the inner section (radius < 41 inches)

No cracking was identified in the inner section (radius < 41 inches) but four circumferential indications were identified in the 50% sample in the "B" steam generator. The following table lists the indications:

Row	Tube	Arc	Depth (in.)	Radius	Assigned Leakage (gpm)
115	4	0.19	50	55.36	0.000823
125	2	0.24	72	56.39	0.00137
136	78	0.20	97	55.82	0.000823
137	75	0.21	97	55.69	0.000823
