YUCCA MOUNTAIN

April 1, 2004, Field Trip Report to Alcove 8 – Niche 3 Areas

By M. (Sam) Nalluswami and Jack Parrott

U. S. Nuclear Regulatory Commission
Washington, DC

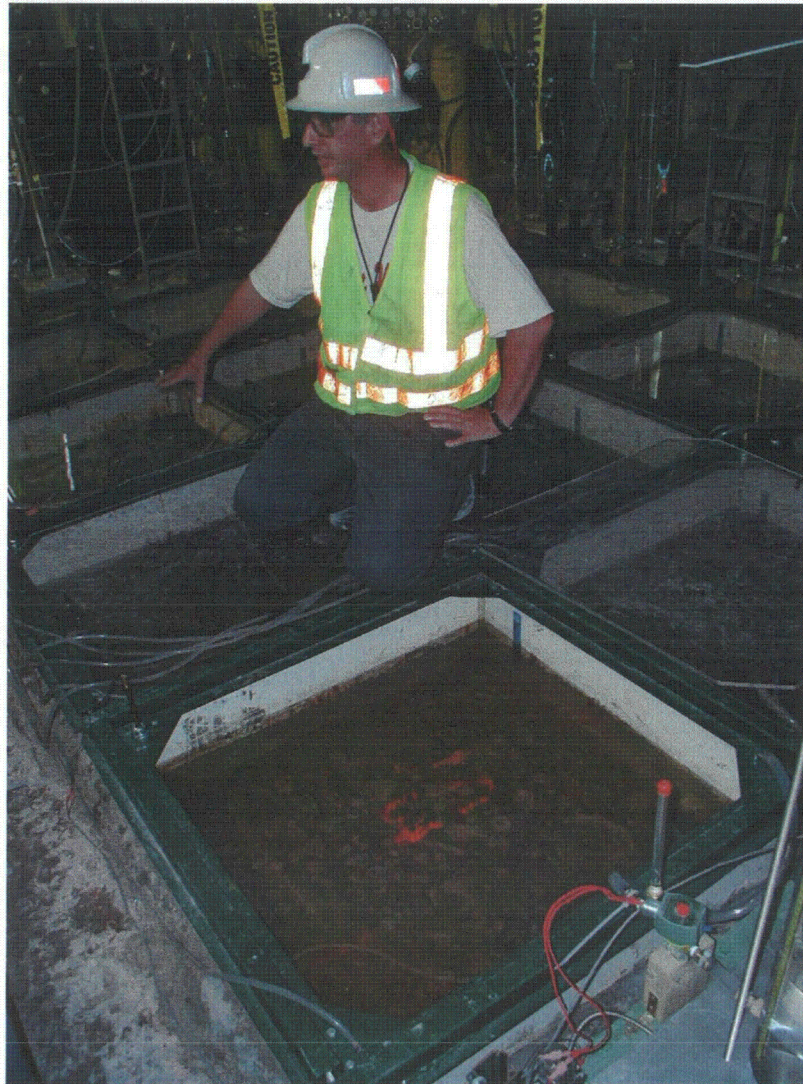
Seepage Plot in Alcove 8, Dave Hudson, USGS (P4010012.jpg)

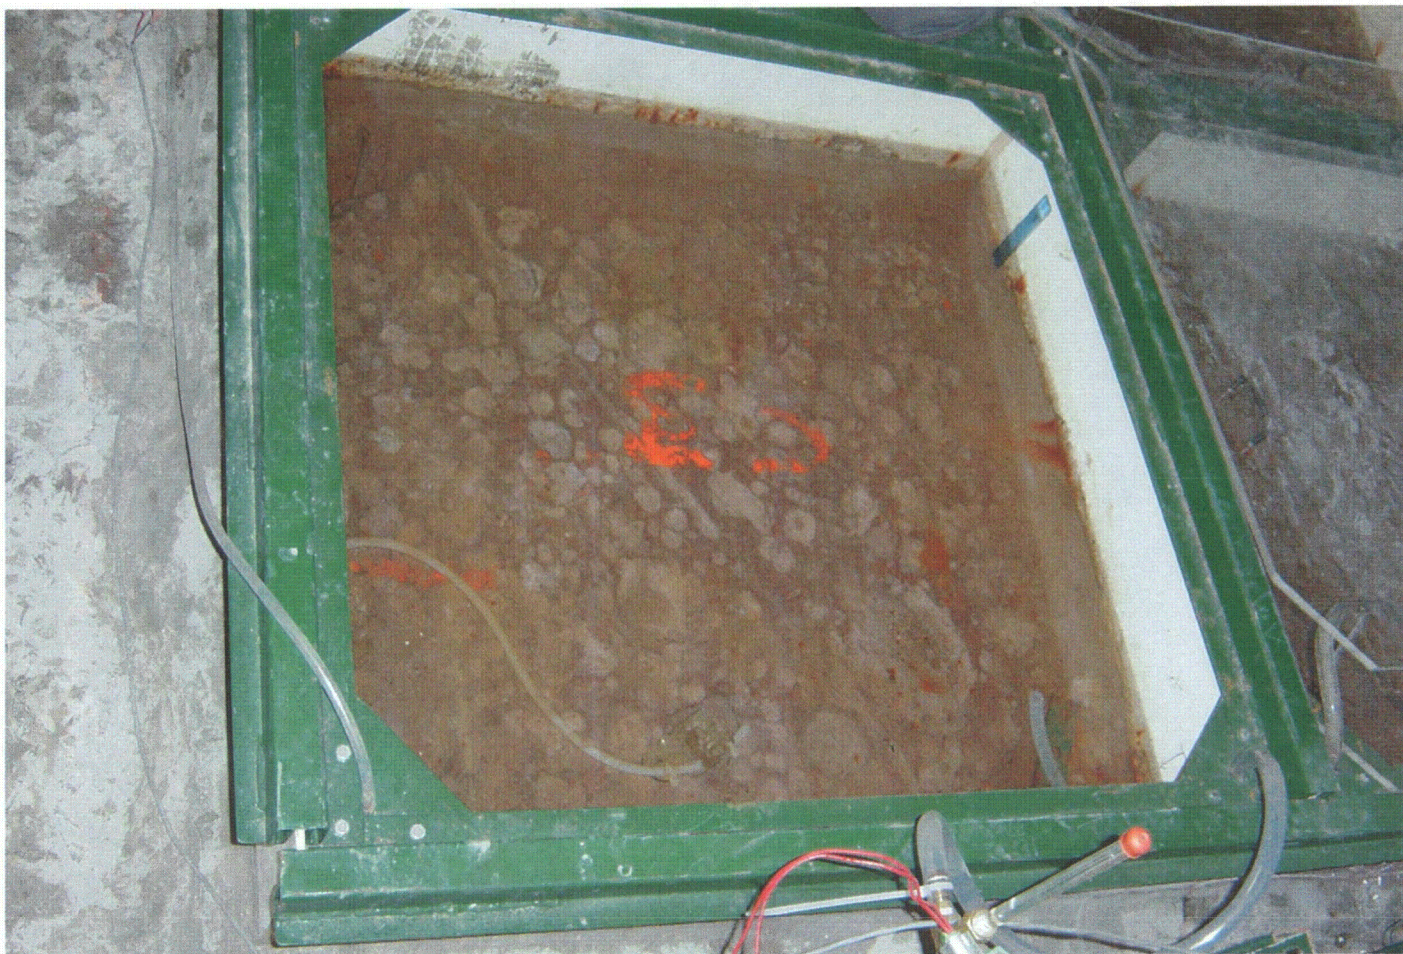
View of One Seepage Plot in Alcove 8 (4_5_04 021.jpg)

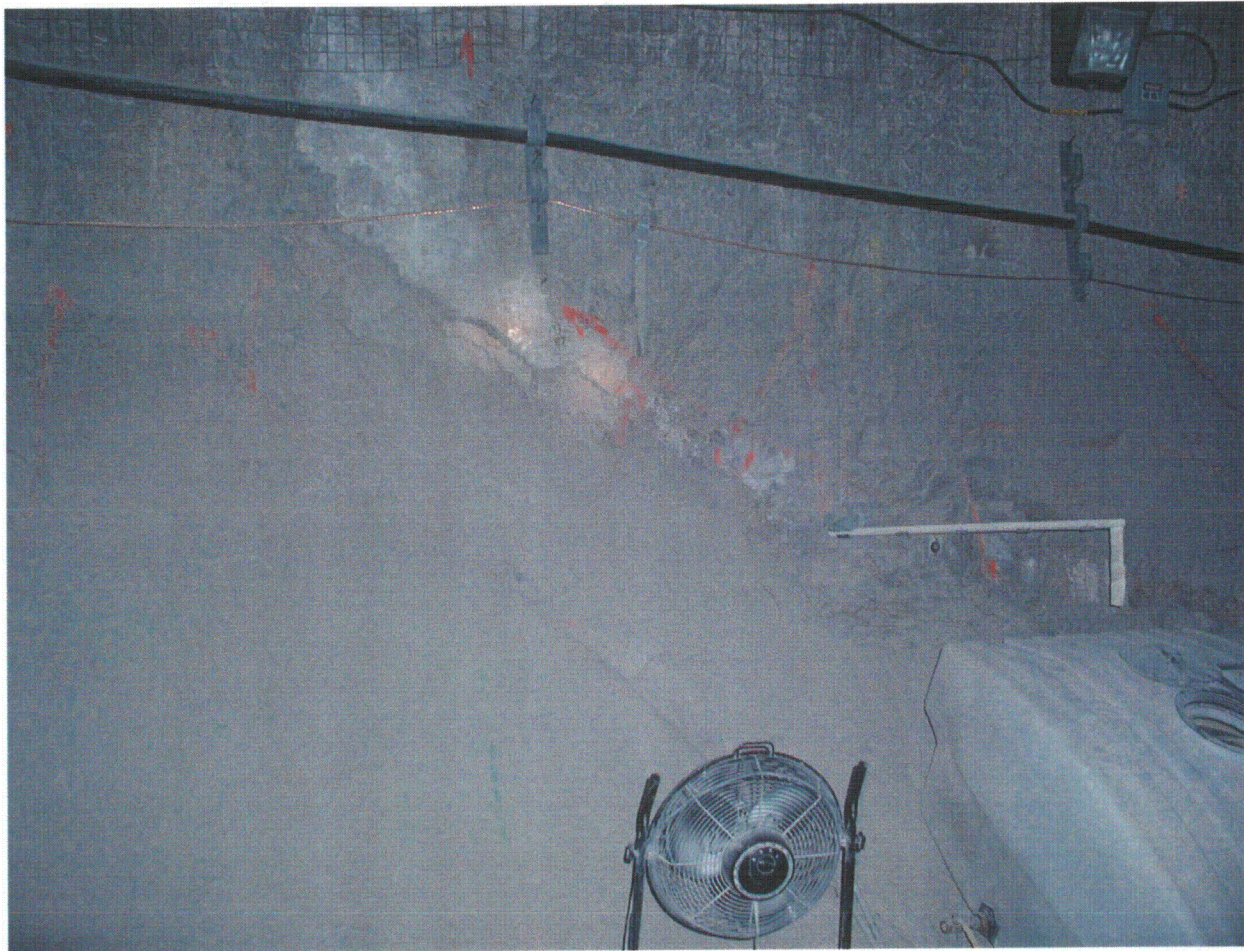
Fault Outside of Niche 3 in the ESF (P4010017.jpg)

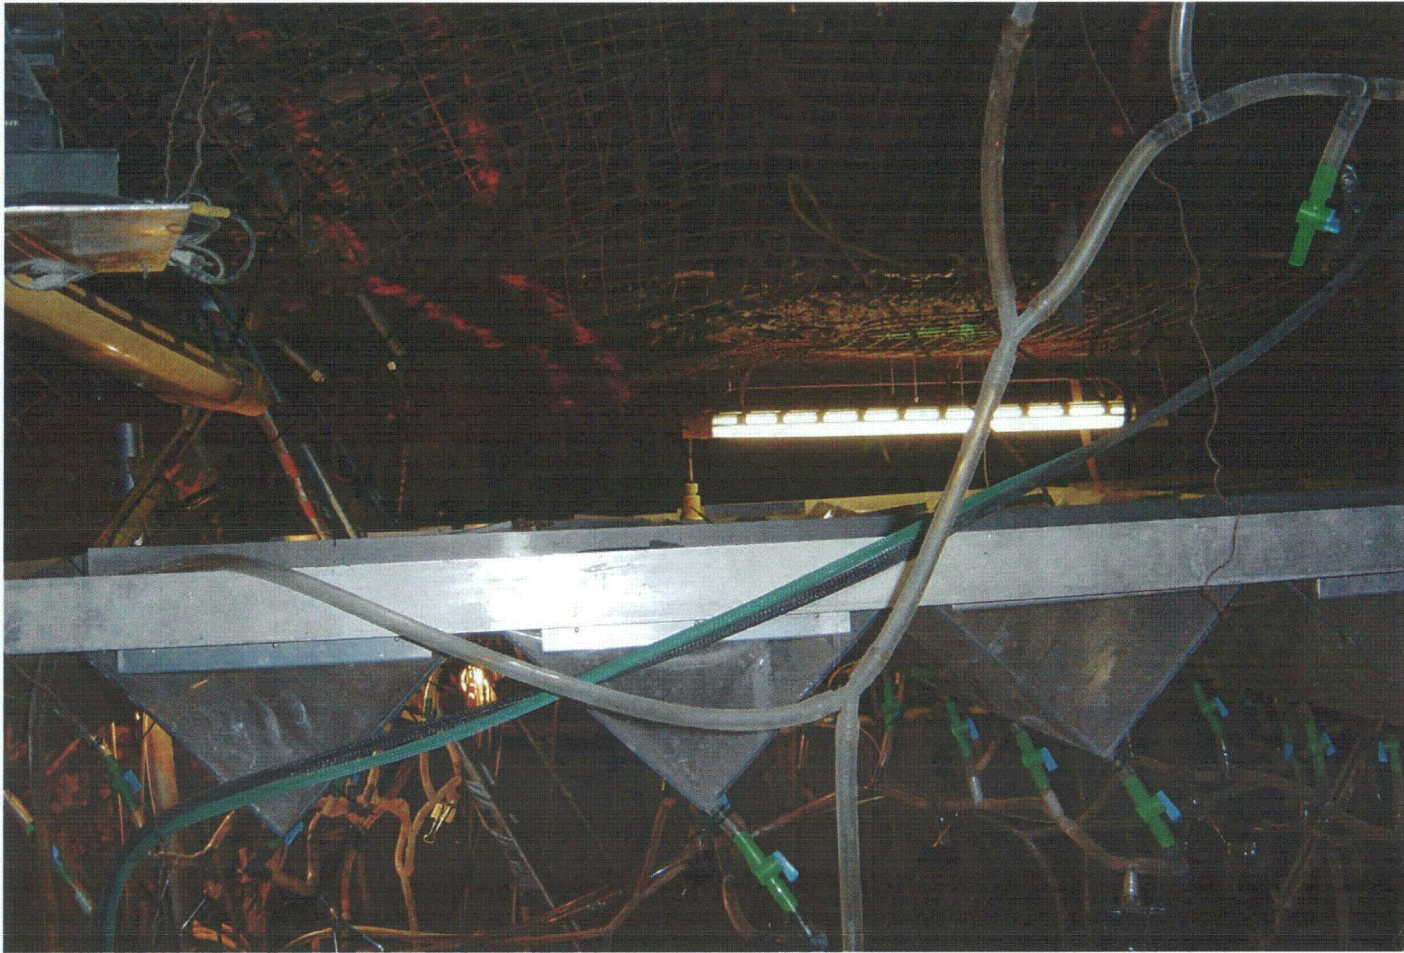
Roof of Niche 3 and Seepage Collection Trays (4_5_04 027.jpg)

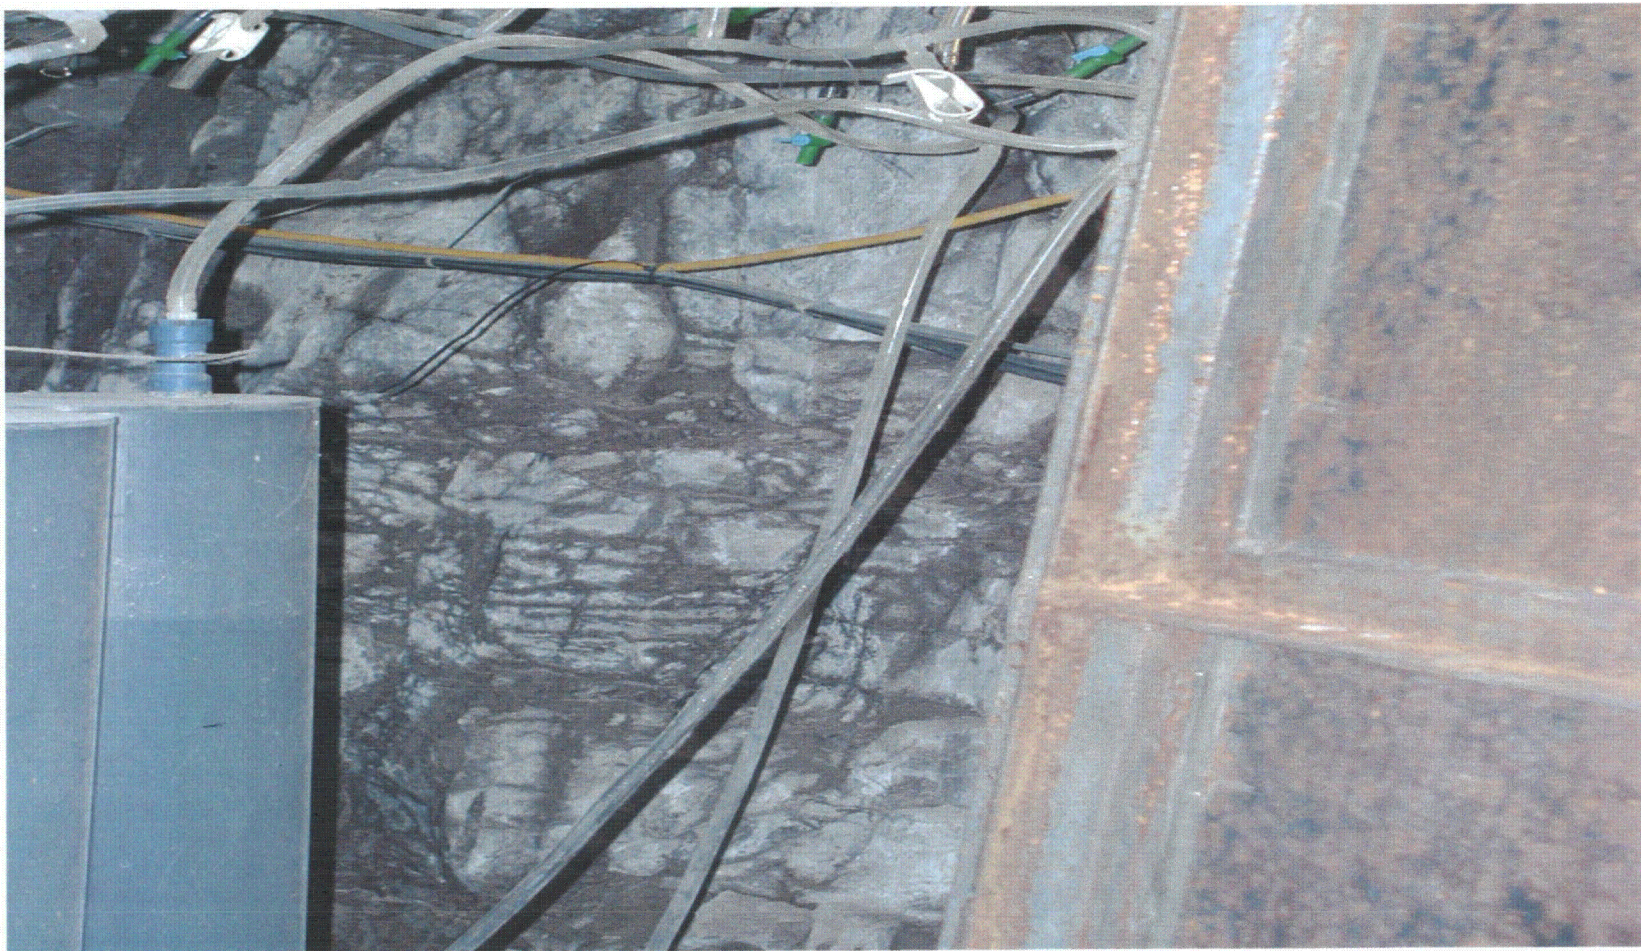
Wetting Pattern on the Wall of Niche 3 to Left of Door Opening (P4010018.jpg)

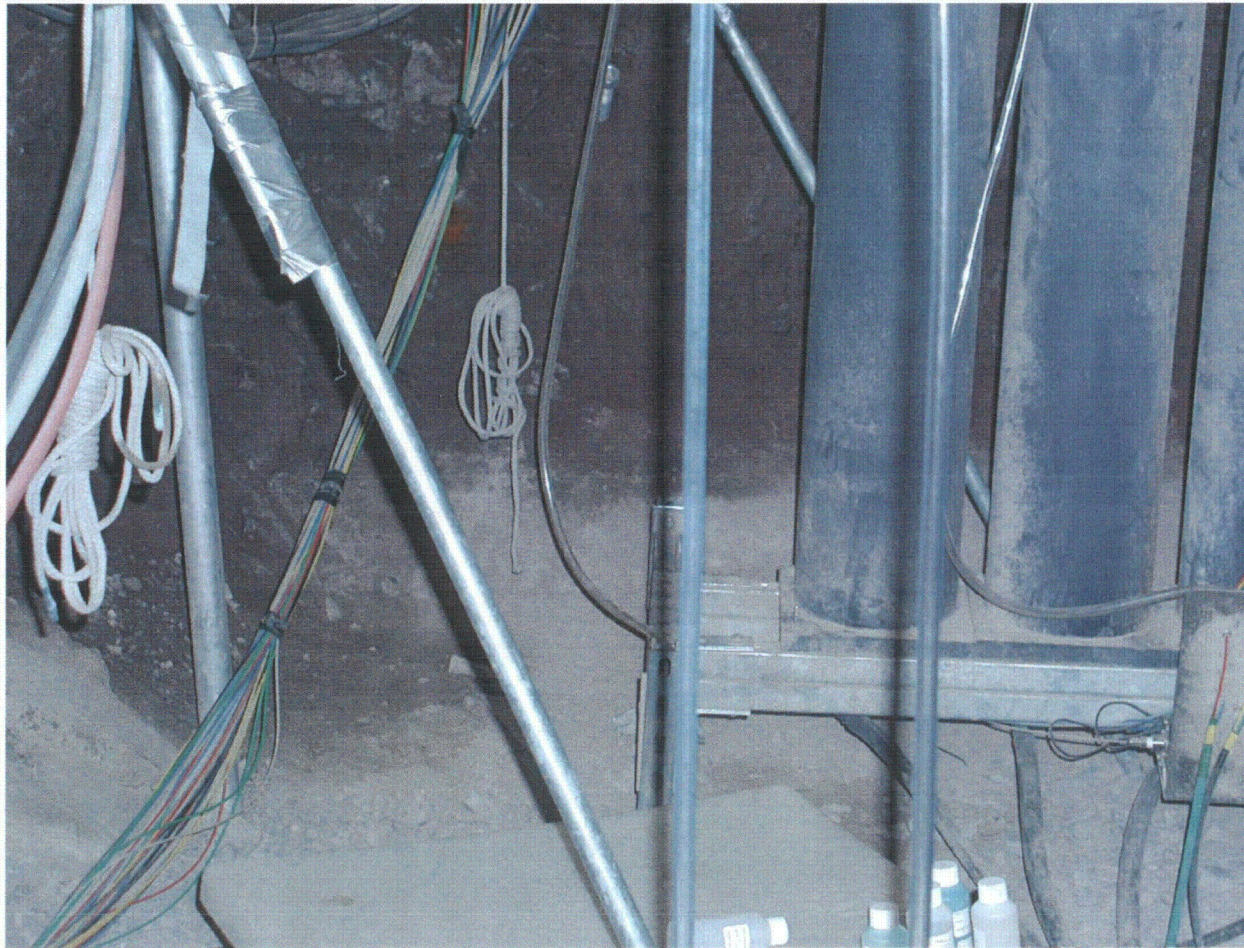
Seepage Collection Apparatus and Seepage Down the Wall in Niche 3 (P4010021.jpg)

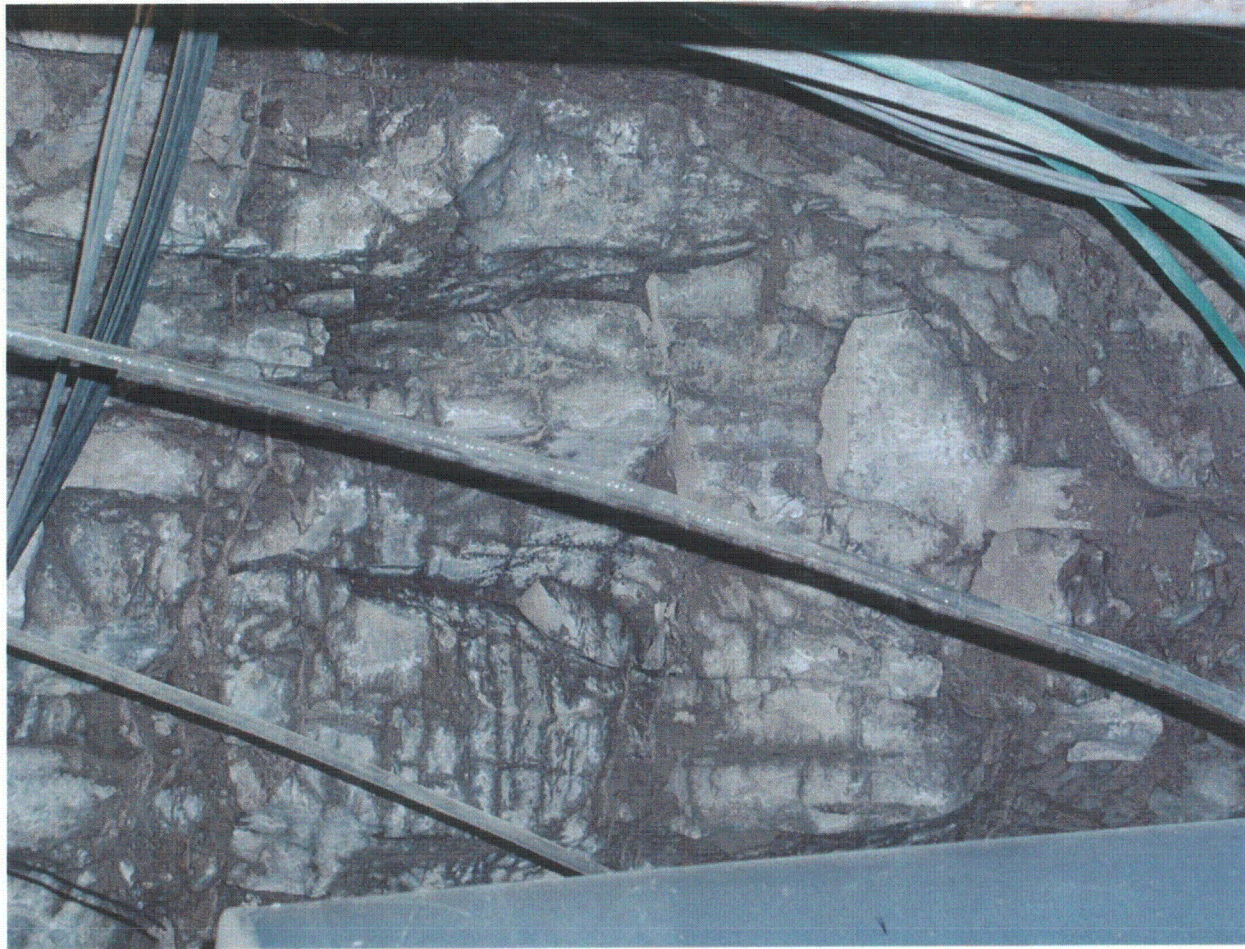
Seepage Pattern in the Wall of Niche 3 (P4010022.jpg)
