South Texas Project Electric Generating Station P.O. Box 289 Wadsworth, Texas 77483

South Texas Project  
Unit 2  
Docket No. STN 50-499  
Response to Request for Additional Information Regarding  
2RE10 Steam Generator Inspection

### **Response to Request for Additional Information**

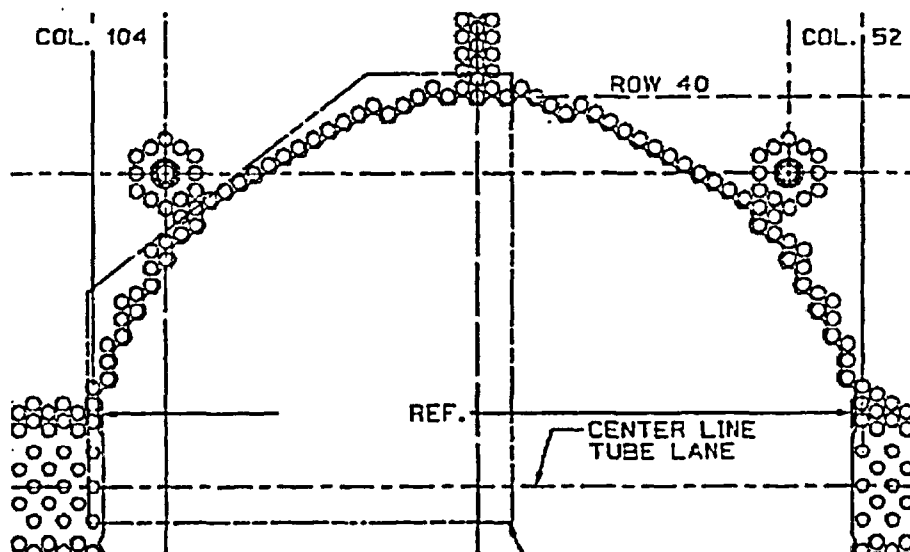
### Figure 1

The central cut out area is a circular symmetric cutout of ~ 43" diameter on the hot and cold leg central bundle position. Refer to Figure 1. No specific inspection of these areas were required or performed during 2RE10. The PSI of the baffle cut out region was performed only to obtain baseline rotating coil data for these areas should STP bobbin coil examinations encounter possible loose parts later in service.
