Re: St. Lucie Units 1 and 2
Docket Nos. 50-335 and 50-389
Reportable Event: 2004-004-00
Date of Event: September 25, 2004
Dual Unit Loss Of Offsite Power During Hurricane Jeanne

LICENSEE EVENT REPORT (LER)

Dual Unit Loss Of Offsite Power During Hurricane Jeanne

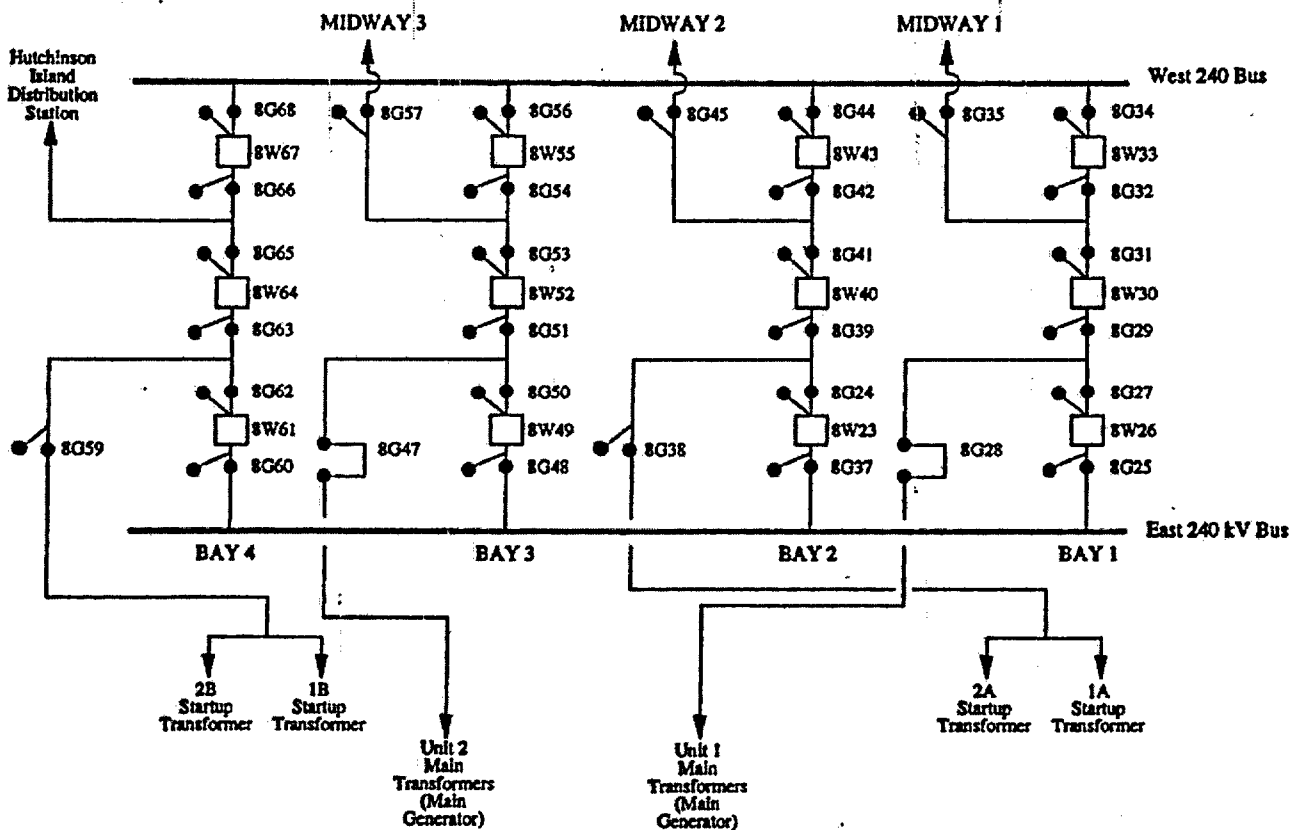
Figure 1 - St. Lucie Switchyard Arrangement

The arrangement of the St. Lucie switchyard [EIIS:FK] is presented in Figure 1. The four bay 230 kV (nominal) switchyard provides switching capability for two main generator outputs, four startup transformers, three outgoing transmission lines, and one distribution substation. The three outgoing transmission lines are identified as Midway 1, 2, and 3 and service switchyard Bays 1, 2, and 3, respectively. The Hutchinson Island distribution substation is serviced by Bay 4. The main generators for both St Lucie Units 1 and 2 produce power and that enters the switchyard in Bays 1 and 3, respectively.

Bay 2 (Midway 2) supplies power to startup transformers 1A and 2A, located in the St Lucie Unit 1 transformer yard. Bay 4 (Hutchinson Island distribution substation) supplies power to startup transformers 1B and 2B located in the St. Lucie Unit 2 transformer yard. During normal operation, either set of startup transformers can be fed from any one of the incoming transmission lines through all of the east-west switchyard bus cross-ties. However, when a unit is taken off-line, the switchyard design requires removal of the cross-tie between the east and west 230kV busses. To remove a unit from service, the generator breakers (8W30 and 8W26 in Bay 1 for Unit 1 or 8W52 and 8W49 in Bay 3 for Unit 2) must be opened and remain open to isolate the main transformer lines. Since both units are removed from service in anticipation of hurricane force winds, two bays between the east and west busses are lost such that the startup transformers are serviced by the two remaining east-west cross-ties in Bays 2 and 4.

At 1100 hours on September 25, 2004, Unit 1 was removed from service followed by Unit 2 at 1159 hours. Later the same day Unit 1 entered Mode 4 at 1840 hours followed by Unit 2 at 2036 hours. At 2221 hours, a fault in the Hutchinson Island distribution substation feed caused the west bus breaker 8W67 [EIIS:FK:BRK] and mid breaker 8W64 [EIIS:FK:BRK] to open in Bay 4. At this time, the 1A/2A startup transformers [EIIS:EA:XMFR] were still connected to the east and west switchyard busses in Bay 2, but in Bay 1 the 1B/2B startup transformers [EIIS:EA:XMFR] were only connected to the east switchyard bus. By 2349 hours, Unit 1 completed the transition to shutdown cooling as the decay heat removal mechanism, but Unit 2 was still removing decay heat by steaming to the steam generators. At 2356 hours, a fault on the Midway 2 feed to Bay 2 opened the west bus breaker 8W43 [EIIS:FK:BRK] and the mid breaker 8W40 [EIIS:FK:BRK], and power to the east switchyard bus was lost causing a complete loss of offsite power (LOOP) at both units (although Midway lines 1 and 3 remained energized, they were only capable of powering the west switchyard bus and the east-west cross-ties in Bays 2 and 4 were lost with the faults on the Hutchinson Island distribution substation and Midway 2 feeds). As described later, all four of the emergency diesel generators (EDGs) [EIIS:EK:DG] started in response the LOOP conditions and safe shutdown loads were sequenced onto each unit's safety busses. At 0004 hours on September 26, 2004, power to the Midway 2 line was restored. However, the decision was made to not restore power to the startup transformers until weather conditions improved enough to permit switchyard inspections.

An additional cause for the LOOP is that the switchyard design requires removal of each unit's east and west 230kV bus cross-tie when the unit is off-line. If the switchyard design had non-load interrupting disconnect switches (NLIDS) in the main transformer lines, Bays 1 and 3 would provide additional cross-ties between the east and west 230kV busses. This would allow re-closing the generator breakers (8W30 and 8W26 in Bay 1 for Unit 1 or 8W52 and 8W49 for Unit 2 in Bay 3) when a St. Lucie unit is off-line. This design would result in a more robust 230kV switchyard when challenged by extreme environmental conditions.

1. No immediate corrective action related to salt contamination was required since the post-storm testing demonstrated that the switchyard insulation was clean.
2. The 1B ICW pump load-sequencing relay was replaced under work order 34016797 and the 1B ICW pump control switch was replaced under work order 34016797.
3. The 2A EDG Day Tank RHH1 relay and the solid-state controller were replaced under work order 34016818.
4. St. Lucie is considering replacing the disconnect links between the switchyard and the main transformers of each St. Lucie unit with motor operated disconnect (MOD) switches or evaluate other means of improving switchyard reliability. This assessment will be completed by May 1, 2005.
