Generator Rotor and Steam Dryer Meeting

Dresden Nuclear Power Station
December 2, 2004

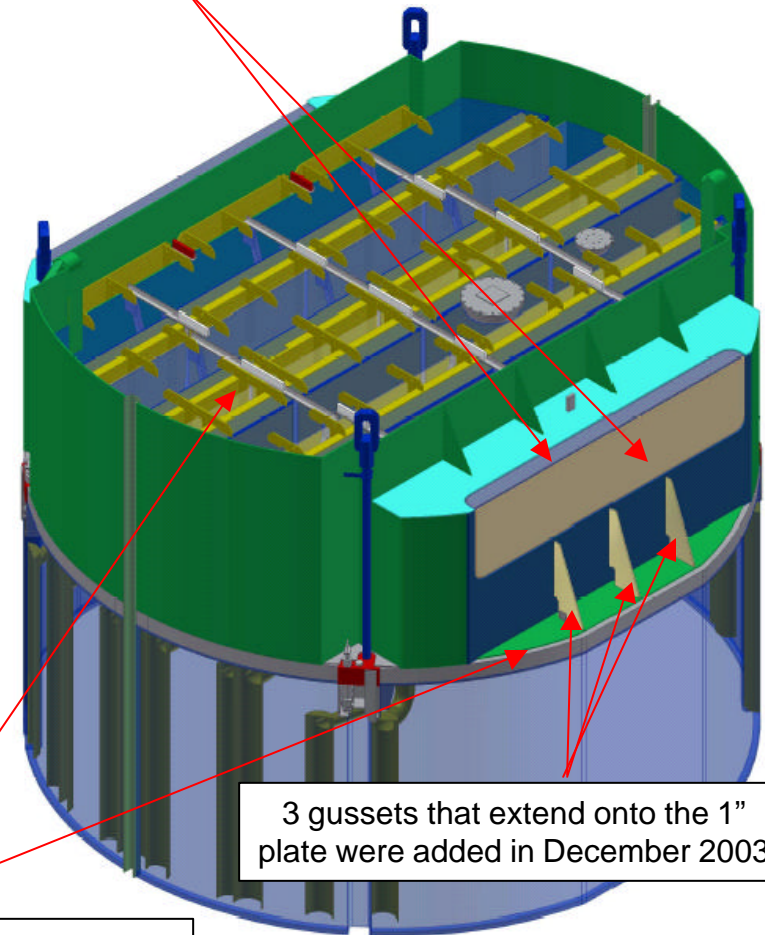
1" inserts added December 2003

3 gussets that extend onto the 1" plate were added in December 2003

Insert/cover plate size increased to 1/2" in Fall 2002

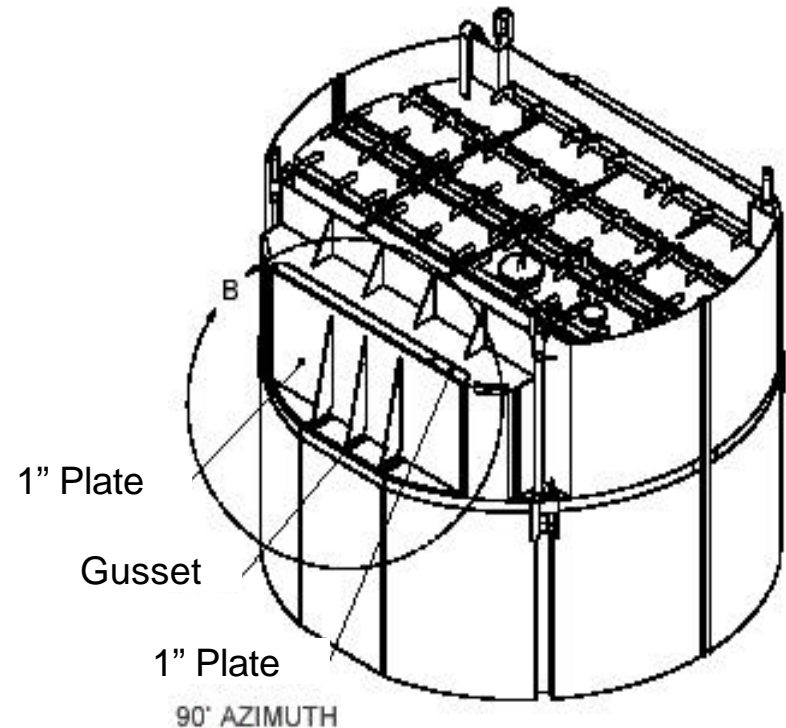
- Replace front vertical plate and corresponding section of horizontal plate with 1" plate on both outer hoods
 - Retain section on each end for attachment weld
 - Vertical welds are ½" groove welds
 - Top and bottom horizontal welds are ½" fillet welds
- Install ½" thick gusset to ~6" from top of vertical plate
 - Taper to 1" at tip
 - Groove welded to vertical plate in shop
 - Weld continues around tip
 - Round extension piece to connect gusset to lower cover plate
- Increase the cover plate to ring weld (R2) to ½"
- Dryer stresses reduced by approximately 2.5 times through modifications

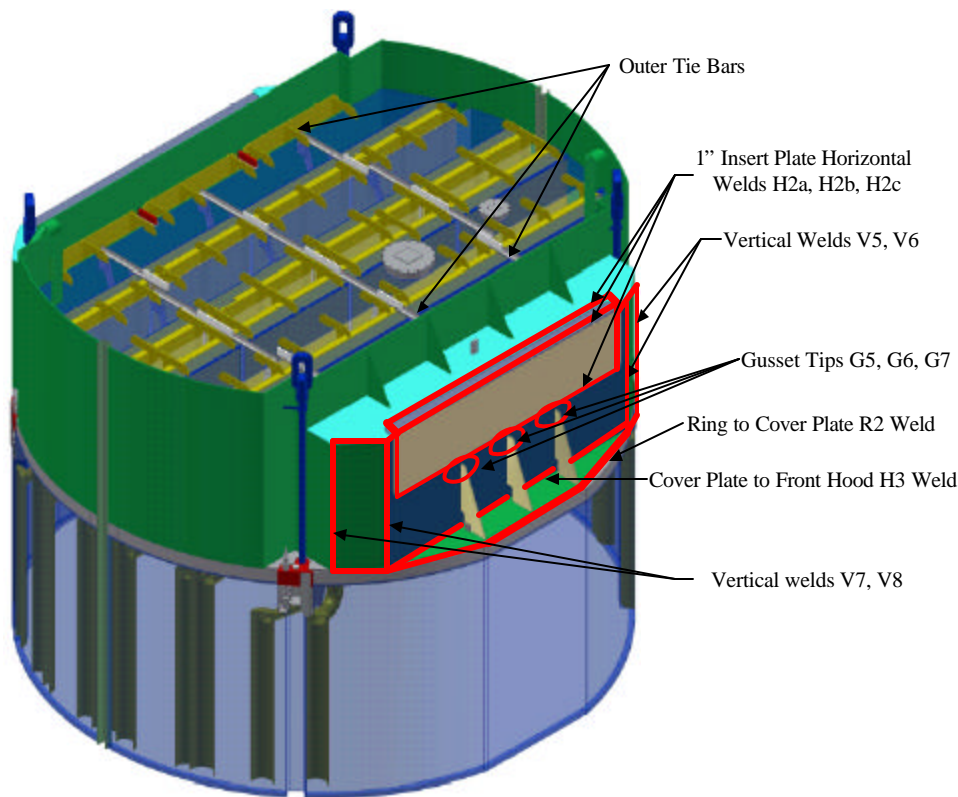
2004 D2 Inspection Scope/Results

- Based on D3 inspection results, an inspection of D2 was performed
- Inspected areas where loose parts could be generated or the structural integrity of the dryer could be threatened
 - All high stress welds identified in GE SIL 644, Revision 1
 - Welds in areas modified in 2003
 - Outer tie bars
 - Startup instrumentation piping
 - Interior inspections of the illustrated welds
- One INR identified – cover plate to dryer support ring crack
