December 28, 2004
LIC-04-0132

SUBJECT: Response to Request For Additional Information Concerning the 2003 Steam Generator Inservice Inspection Reports

Response to Request For Additional Information Concerning the 2003 Steam Generator Inservice Inspection Reports

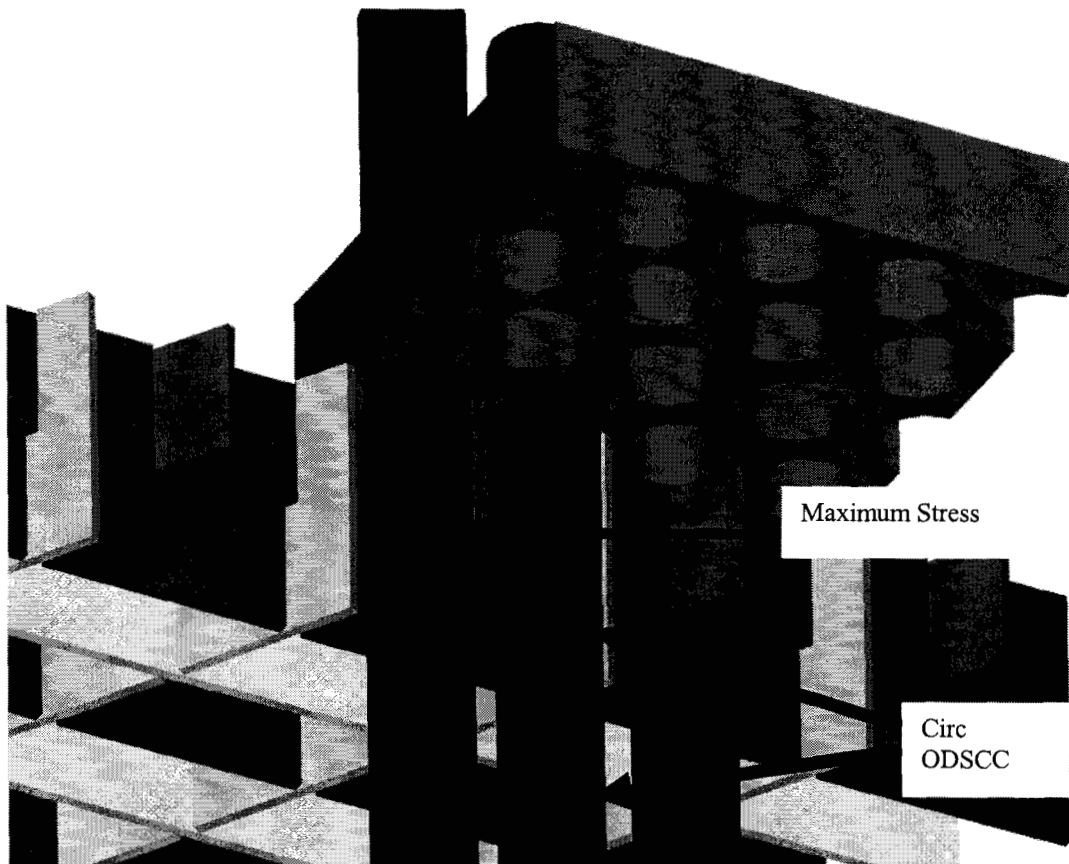
A root cause analysis was conducted after the inspection. The indication identified at the eggcrate support is at the chord region (edge) of the partial drilled support plate (see UT results for SG B Row 84 Line 73 listed above in question #1). A second tube (also in the chord region) with a circumferential indication at an eggcrate location was detected in SG B (R87/L52) at support H4 – 1.10". This support structure is also a combination eggcrate / drilled plate assembly. The indication is 0.27 volts with an estimated depth of 33% and an arc length of 21 degrees. The three coil delta probe confirms the presence and orientation of the flaw. The low frequency pancake coil data shows that the flaw is located below the tube support plate and the azimuthal orientation of the flaw is about 120 degrees relative to the eggcrate lattice. Only one lattice bar is evident in the ECT data. This intersection was not included in those tested by UT.

At the top of these eggcrates along the chord the edge of the drilled plate is scalloped and has the shape of a series of semi circles when viewed from the top. Growth of the drilled plate from denting results in a bending strain at and below the eggcrate where the tube is restrained from movement in the lateral plane. This configuration is unique to the chord region and these locations have been identified as a critical area in accordance with EPRI guidelines. The February 2005 examination will include plus point coil testing of 100% of this critical area.

Eggcrate and Tube Support Plate Intersection –
Bottom View with Maximum Stress and Crack Locations
