BWR steam dryer integrity

SIL No. 644
Revision 1

November 9, 2004

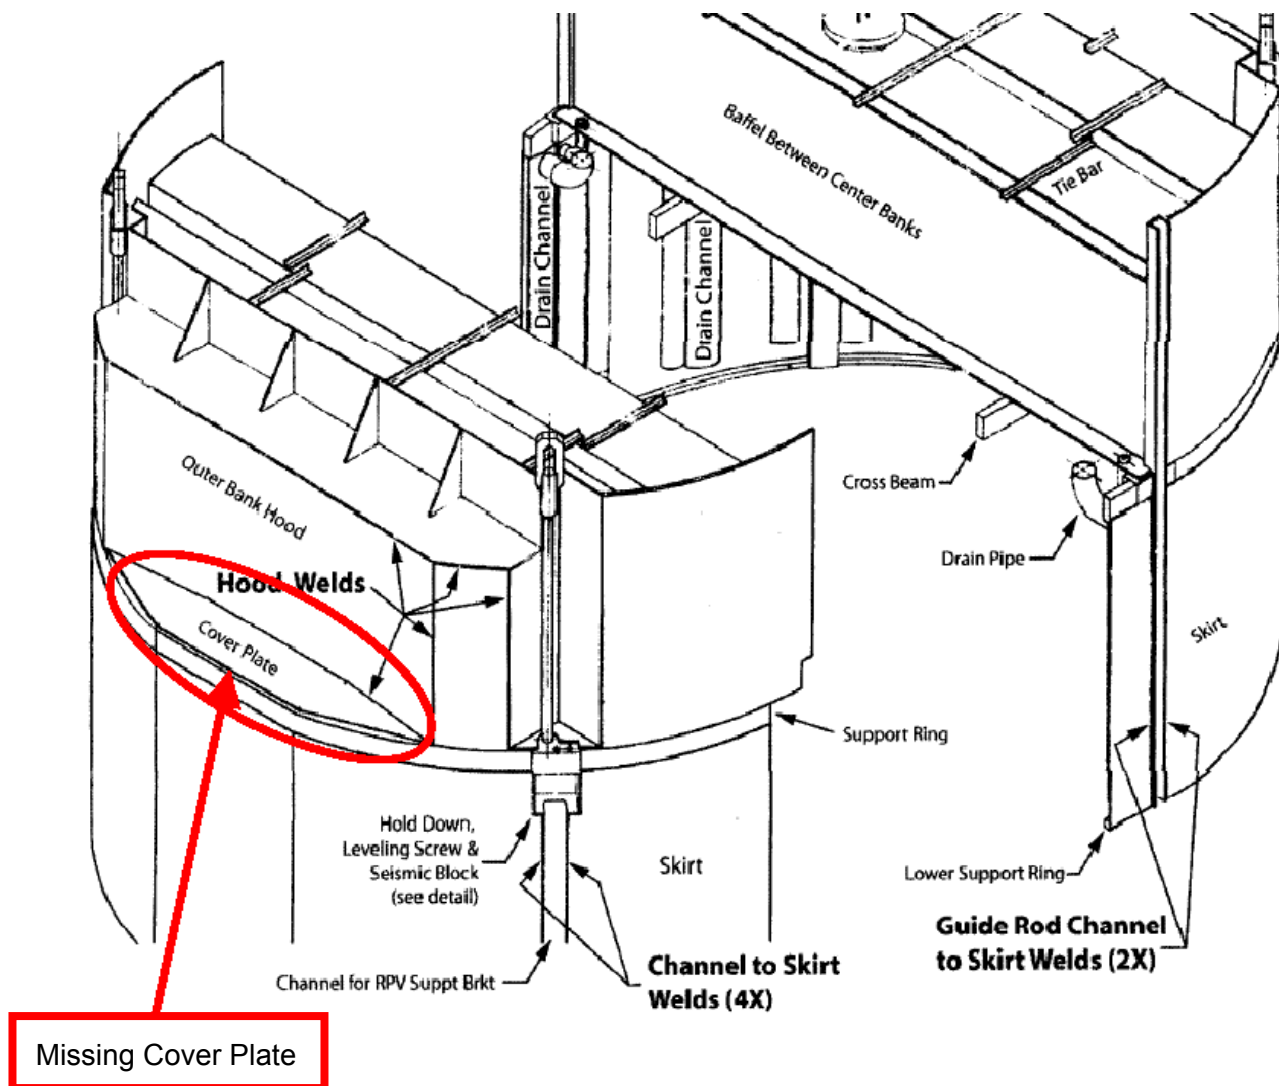
Figure A-1: Location of the 2002 Lower Cover Plate Failure

Inspection of the steam dryer revealed that a ¼-inch stainless steel cover plate measuring approximately 120” x 15” had failed near the MSL “A” and “B” nozzles (Figure A-1). The failure of this cover plate allowed steam to bypass the dryer banks and exit through the reactor MSL nozzles, causing the observed increase in moisture content. The majority of the cover plate was found as a single piece on top of steam separators. However, a piece of the cover plate (approximately 16”x 6”) had failed and was found lodged in and partially blocking the MSL “A” flow venturi contributing to the MSL flow imbalance and water level perturbations. Several smaller loose pieces (believed to have come from a startup pressure sensor bracket which may have been knocked off by the cover plate) were located at the turbine stop valve strainer basket. Minor gouges and scratches from the transport of foreign material were noted in the “A” steam nozzle cladding, the main steam piping and the MSL “A” flow venturi. All loose pieces were recovered. No collateral damage to other reactor vessel components was observed.

Preliminary laboratory analysis has been completed. The main crack originated from the bottom side of the cover plate and propagated upward through both the plate base metal and weld metal. The transgranular, as opposed to intergranular, nature of the fracture surface and the relative lack of crack branching indicated that the failure was not caused by stress-corrosion cracking. The lack of macro and micro ductility features in and near the fracture indicated the cracking occurred over a period of time and not due to a mechanical overload. Additionally, there was no evidence that the failure was a result of an original manufacturing defect. Based on the available evidence, the most probable cause of the cover plate cracking was mechanical, high cycle fatigue.

The results of the metallurgical analysis confirmed that the failure mechanism is high cycle fatigue. The cause of this high cycle fatigue is believed to be flow induced vibration. At this time there are two probable root causes of the cover plate failure:

1. Increased pressure oscillations on the steam dryer due to the increased steam flows at extended power uprate conditions, aggravated by the potential presence of a pre-existing crack in the cover plate.
2. A flow regime instability that results in localized, high cycle pressure loadings near the MSL nozzles. When the natural frequency of the installed cover plate coincides or nearly coincides with the frequency of the cyclic pressure forcing function, and the acoustic natural frequency of the steam zone, the resulting resonance or resonances can lead to high vibratory stresses and eventual high cycle fatigue failure of the cover plate.

The cover plates on both sides of the dryer have been replaced with ½-inch continuous plates (this eliminates two intermediate welds on the original plates). The fillet weld connecting the plate to the support ring was increased to ¾-inch and the weld to the vertical face of the dryer hood was increased to ½-inch. The plant has been returned to service with interim, enhanced monitoring of moisture content, reactor steam dome pressure, MSL flow rates and reactor water level. As an additional measure, the plant has implemented dynamic response monitoring of the MSLs to determine if higher flow induced vibration occurs as the steam flow is increased.

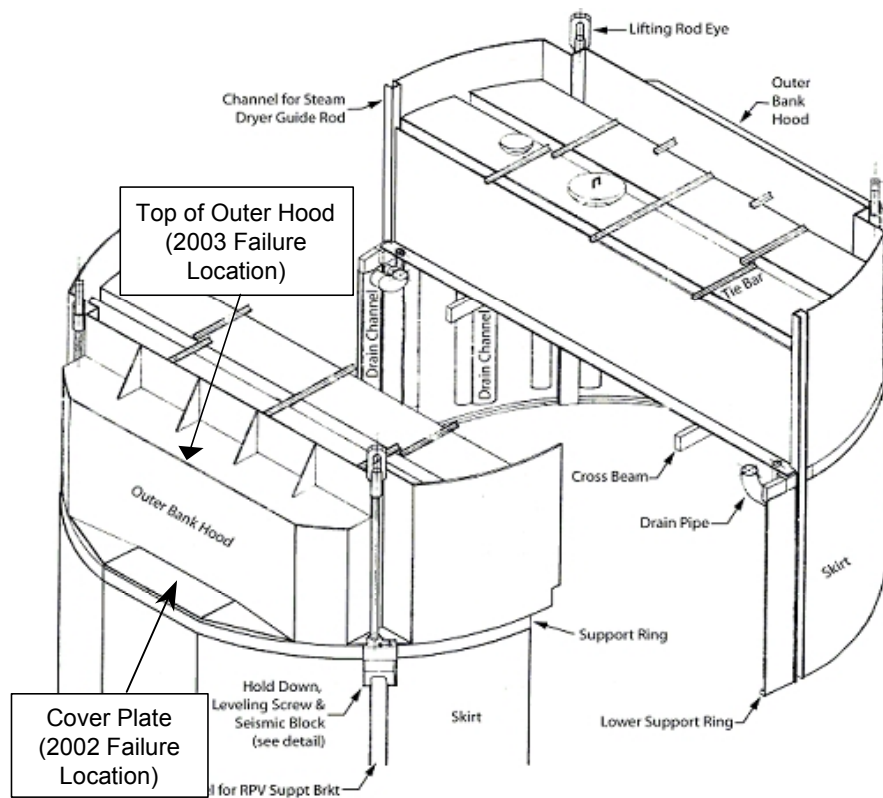
Figure B-1: Location of the 2003 Outer Hood Failure

A detailed visual inspection of the accessible external and internal areas of the steam dryer revealed significant steam dryer damage. The damage was most severe on the 90-degree side of the steam dryer, the side that was closest to the PORV that had opened. On the 90-degree side, a through-wall crack approximately 90 inches long and up to three inches wide was observed in the top of the outer hood cover plate and the top of the vertical hood plate (refer to Figures B-1 and B-2). Three internal braces in the outer hood were detached and one internal brace in the outer hood was severed. The detached braces were found on top of the steam separator. All detached parts were accounted for and retrieved. On the opposite side of the steam dryer (270-degree side), incipient cracking was observed on the inside of the outer hood cover plate and one vertical brace in the outer hood was cracked. No damage was found in the cover plates that had been replaced following the first steam dryer failure in 2002.

Extensive metallurgical and analytical evaluations (e.g., detailed finite element analyses, flow induced vibration analyses, computational fluids dynamics analyses, 1/16th scale model testing and acoustic circuit analyses) concluded that the root cause of the steam dryer failure was high cycle fatigue resulting from low frequency pressure loading. There are two potential contributing factors to the failure:

1. Continued operation for approximately 1 month following the failed cover plate in 2002 which resulted in additional stress loading on the vertical hood plate, and
2. Inadvertent opening of the PORV resulting in a decompression wave, which subjected the steam dryer to two to three times the normal pressure loading. (It is believed that there was incipient cracking in the steam dryer and the PORV event caused the cracks to open up).

1. replaced damaged ½ inch outer hood plates with 1 inch plates
2. removed the internal brackets that attached the internal braces to the outer hood
3. added gussets at the outer vertical hood plate and cover plate junction
4. added stiffeners to the vertical welds and horizontal welds on the outer hood
