Palo Verde Nuclear Generating Station Cracked Reactor Coolant Pump Shaft Event

by
Howard Maxwell
Consulting Engineer
Arizona Public Service
Phoenix, AZ

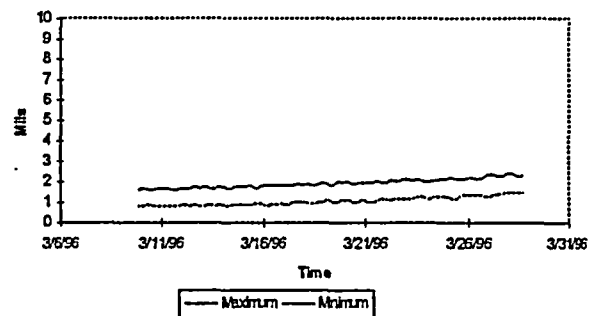
Figure 1. RCP Y-Probe 1xRPM Vibration

On Friday 3/28/96, the Unit 1 RCP 2B came into alarm on the 1xRPM acceptance region at 1.5-2.4 mils. The Vibration Technicians responded to the alarm, and about 2 hours before quitting time showed me trend graphs from the installed monitoring system similar to Figures 1 and 2. These graphs do not give a very clear picture of the pump condition for several reasons. First, the graphs are on a fixed scale much larger than the actual values. Second, the time scale is only 3 weeks because the system only stores that much data. As described below, this event had started earlier. In spite of this, there is clearly something going on in the 1xRPM, and perhaps in the 2xRPM. Note that the increase from 3/13/96 was about 0.6

mils on a signal with a noise band of about 0.8 mils. The overall level at this time was 2.69-3.56 mils and had not shown the trend yet. The manufacturer's limits are 8 and 10 mils, so this level of vibration is in the excellent range. The Vibration Technicians began monitoring the pump daily over the weekend.

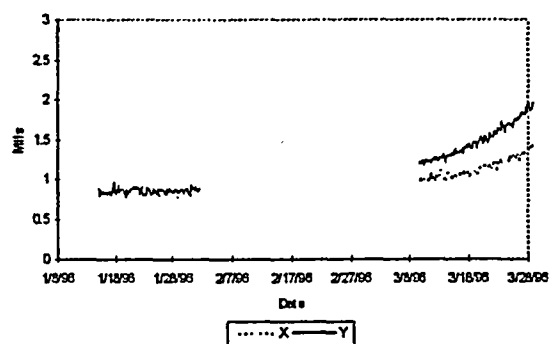
Figure 3. X&Y Probes - 1xRPM Average Vibration

We have a long-term trending system, where we take the data from the installed system and enter it into a database. Over the weekend we updated the database with the current data and produced the graphs shown in Figures 3,4,5 and 6. Note that the two curves in Figures 3 and 4 are now the averaged values of both probes, rather than the maximum and minimum of only one probe. Figure 5 shows the polar graph of the Y probe 1xRPM vector; the X probe was identical except for a 90 degree shift. The gap in the data on the four graphs is because we missed collecting data from the installed system for input into the long term-trending system. Note that during this gap something happened. Naturally, Murphy's Law says that any interesting data will somehow go missing. For a couple of days

we thought the pump had been tripped during this period. We usually see 1xRPM changes during a trip, so that change could have been because of a trip, but we had never seen a 2xRPM shift caused by a trip. We found out that the plant had tripped due to a lightning strike, but the pump had not tripped. Clearly something is going on in the pump. The symptoms, except for the lack of a clear 2xRPM phase change, indicate a possible cracked shaft.

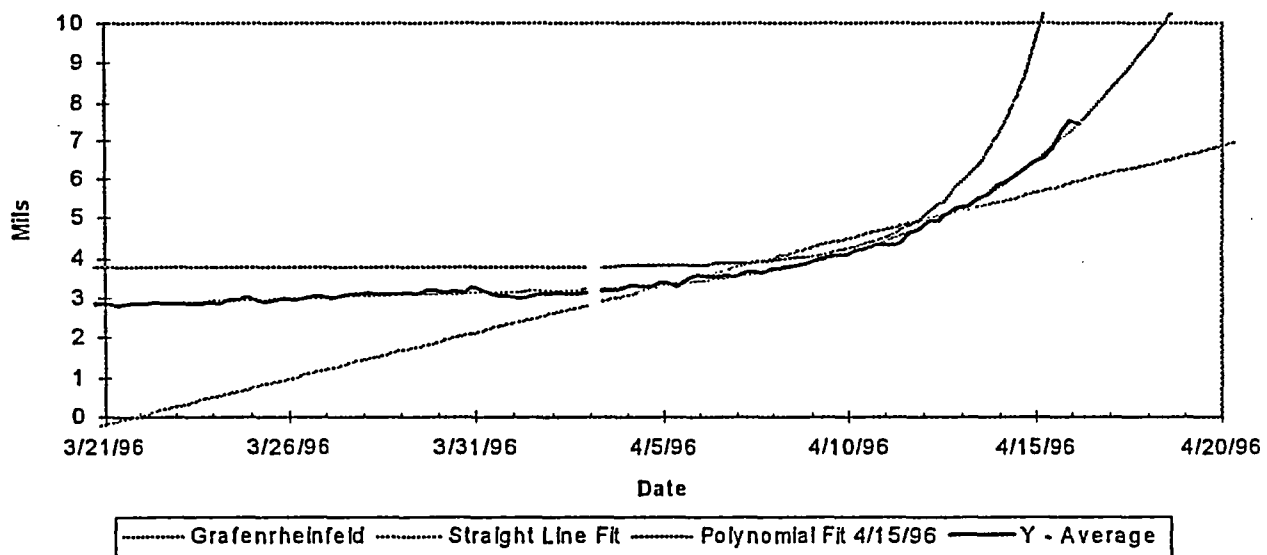
Figure 7. Overall Vibration with Projections

During the period from 4/4/96 to 4/15/96, maintenance had made considerable progress toward preparing for the pump outage. A plan had been developed, specialized tools were located which were difficult to find because they hadn't been used for 8 years, crews were identified and scheduled, a spare seal housing had been obtained and a new seal pack had been assembled. Maintenance was essentially ready, so on 4/16/96 the pump was shutdown at a level of about 7.5 mils. Figure 7 shows the final trend graph with extrapolations.

There are three extrapolations shown in Figure 7. The first is a straight line fit, which in the early stages matched the trend pretty well. The second is the European failure, adjusted for a different operating speed and shaft size. The third is a fifth order polynomial fit. As the failure progressed, the order of the fit required to match the data increased from third order curve to a fifth order curve. I think that the theoretical curve is a 4.5 order curve. Figures 8, 9, 10, and 11 show the other parameters.

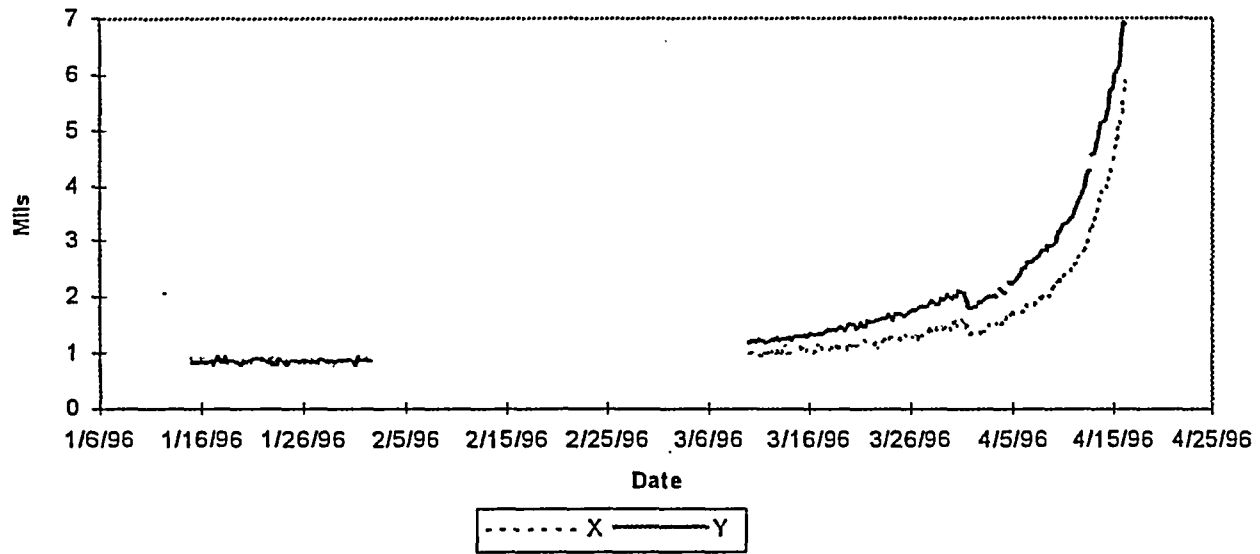
Figure 8. X & Y Probe 1xRPM Vibration

Several features of the data are of interest. First is the drop in vibration on 3/30/96. An inspection of the curve in Figure 8 before and after the drop, shows that the slope of the curve seems to be more linear after the drop than before, and this continues till about 4/12/96. This could be explained by the center bore hole. As the crack encounters the first wall of the hole, the asymmetry of the shaft is changed as the bore hole diameter is added to the crack. Secondly, as the crack progresses around the hole, the change in asymmetry is less than before or after the crack has encountered the bore hole.

The change in slope on 4/12/96 could be when the crack encountered the second wall of the bore hole.

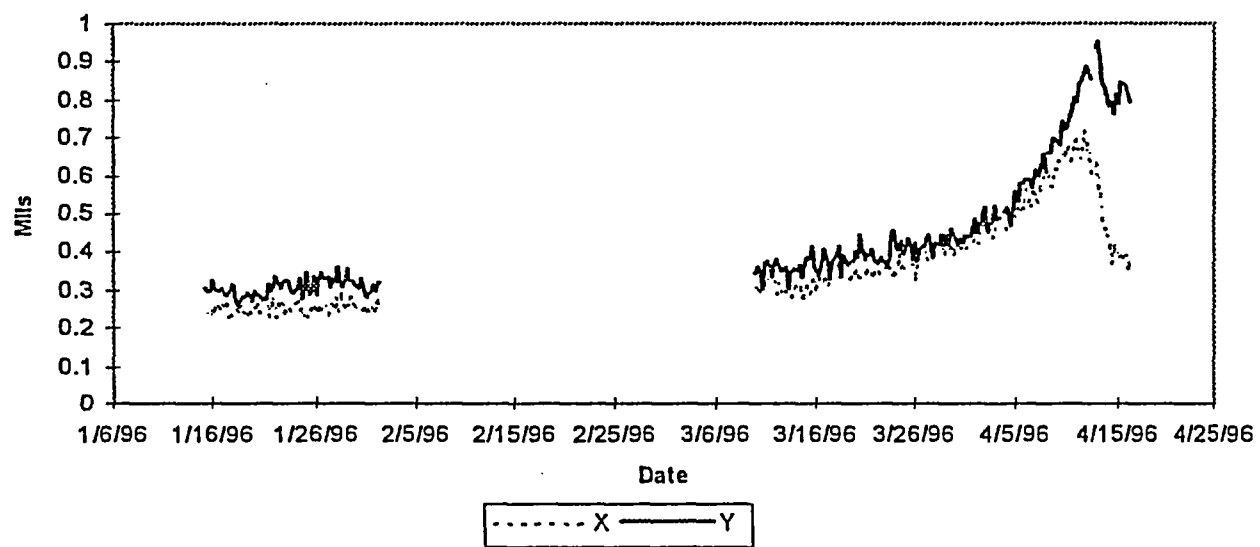
Figure 9. X&Y Probes 2xRPM Vibration

The second interesting feature is that the 2xRPM amplitude never exceeded 1 mil, while the 1xRPM went to near 8 mils. This is contrary to many expectations. Also the 2xRPM vector made almost a complete circle in the polar plane.
