National Transportation Safety Board
Washington, D.C. 20594

Railroad Accident Brief

Accident Number: DCA-01-MR-004
Location: Baltimore, Maryland
Date and Time: July 18, 2001, 3:08 p.m.
Accident Type: Derailment and fire
Companies: CSX Transportation
Injuries: 5 (minor)
Fatalities: None
Cost: \$12 million

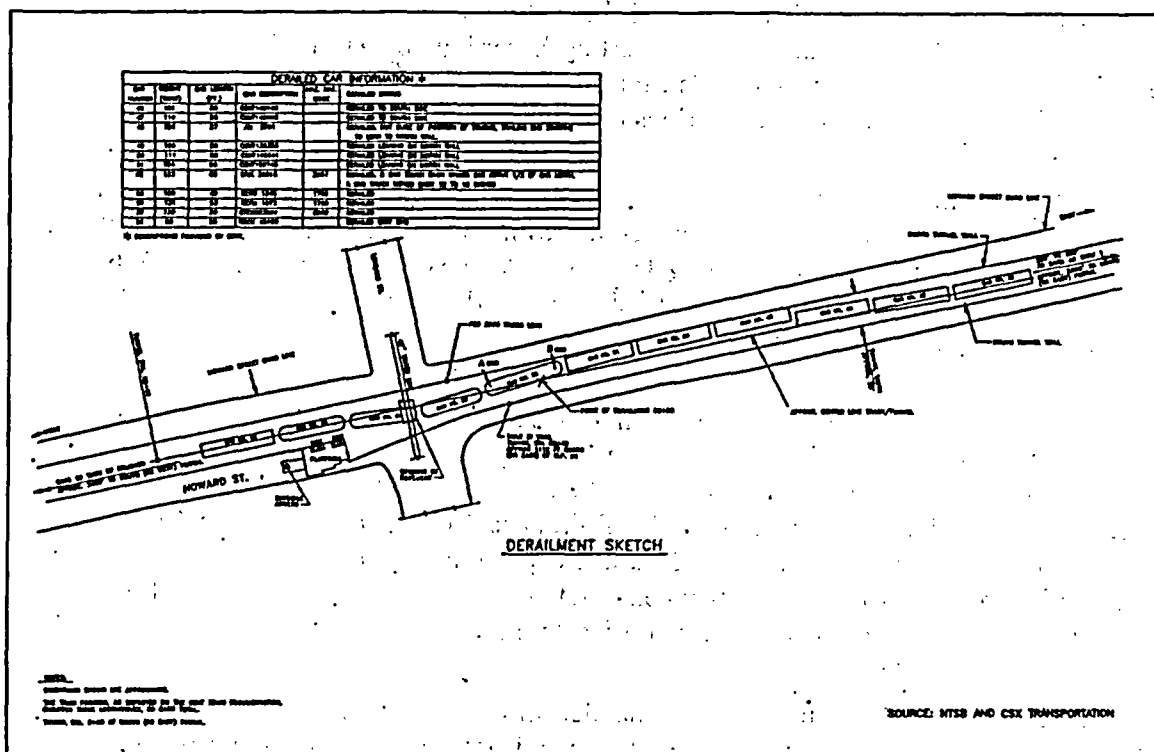
Figure 1. Positions of derailed cars.

The 47th car in the consist showed the most rib wear, indicating that this car had spent the most time derailed, so it was probably the first car to derail. The trucks of the 46th car had the next most rib wear. There was less wear to the B-end (leading end) spring seat ribs of the 48th car and only scrapes to the A-end (trailing end) ribs. Therefore, it appears that the 46th car was the second car to derail (pulled off the track by the 47th car) and that its derailment was followed by the derailment of the 48th and subsequent cars.

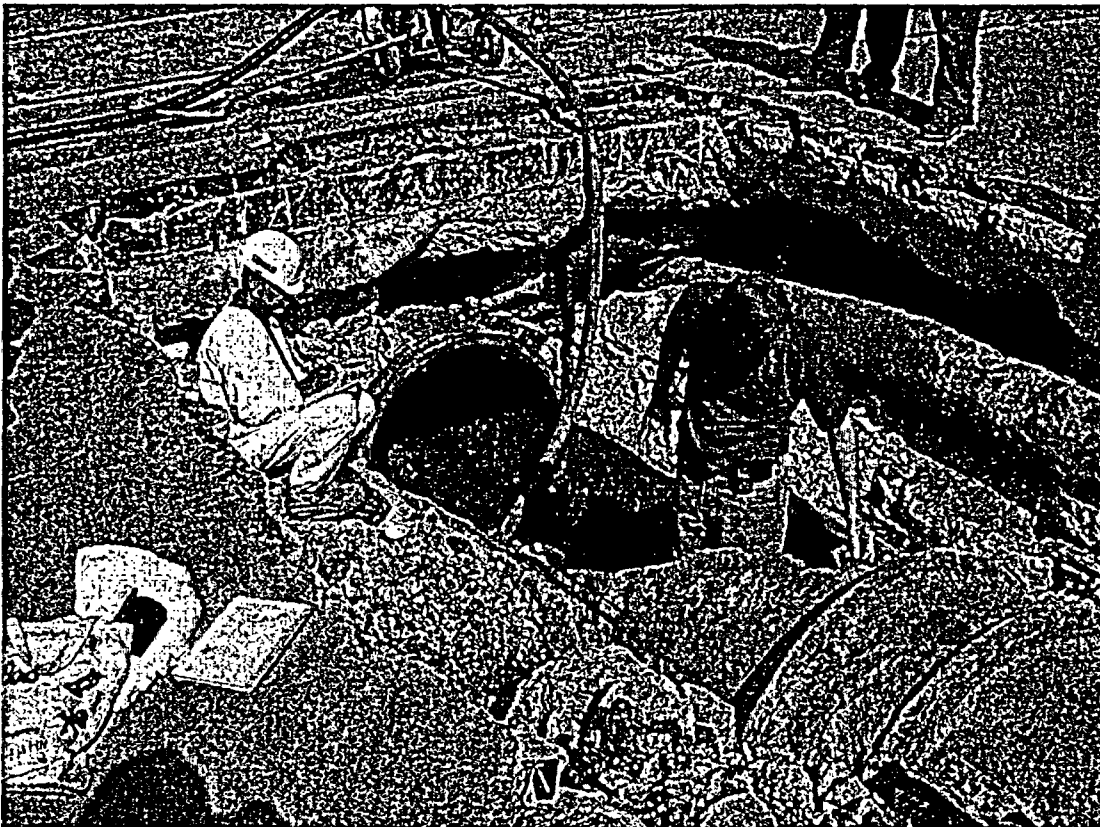
Figure 2. Broken 40-inch-diameter water main.

The 40-inch-diameter cast iron water main that ran directly above the Howard Street Tunnel, which ruptured and introduced a large volume of water into the tunnel, was considered as a possible causal factor in the accident. When postaccident examination was made of the ruptured pipe, no indication of third-party damage or significant corrosion damage was found at or near the point of rupture. Metallurgical examination of the fractured pieces of the water main showed that the fractures in the pipe section were brittle, with no evidence of crack arrest positions or slow growth regions, which indicates that a sudden overstress fracture of the cast iron pipe occurred.

A photo from a time-stamped security camera at the intersection of Howard and Lombard Streets indicated that water from the broken main appeared at the street surface at 6:19:38 p.m., about 3 1/4 hours after the derailment. In addition, water elevations at several nearby water treatment plants declined between about 6:15 p.m. and 6:30 p.m. This timing information suggests that the water main broke as a result of the postaccident events, including the fire within the tunnel, rather than prior to the accident.

A finite element analysis¹⁰ of the tunnel and surrounding area in the vicinity of the water main was performed using the ABAQUS¹¹ code to determine whether the fire within the tunnel could have caused the water main to fracture. The analysis concluded that the postaccident fire was responsible for thermal expansion of the tunnel and that the expansion caused the tunnel walls to heave upwards, displacing the surrounding materials and imparting significant loads upon the water pipe. Further, the unique construction

details of the tunnel, the pipe, and the light rail foundation¹² combined to generate discontinuities in resistance to the thermal heaving, generating significant concentrations of stress within the water pipe. The location of the high stress concentrations predicted by the analysis was consistent with the location of the initiation of the fracture in the pipe, as determined through metallurgical examination. Therefore, the 40-inch water main that ran directly above the Howard Street Tunnel broke after the train had derailed, as a result of the thermal expansion of the tunnel caused by the postaccident fire within the tunnel.
