South Texas Project Electric Generating Station P.O. Box 289 Wadsworth, Texas 77483

South Texas Project
Unit 1
Docket No. STN 50-498
Request for Relief from ASME Boiler and Pressure Vessel Code,
Section XI Requirements for the Essential Cooling Water System (ECW Train 1A)
(Relief Request RR-ENG-2-41)

**SOUTH TEXAS PROJECT
REQUEST FOR RELIEF FROM ASME BOILER AND PRESSURE VESSEL CODE,
SECTION XI REQUIREMENTS FOR THE ESSENTIAL COOLING WATER SYSTEM
(ECW TRAIN 1A) (RELIEF REQUEST RR-ENG-2-41)**

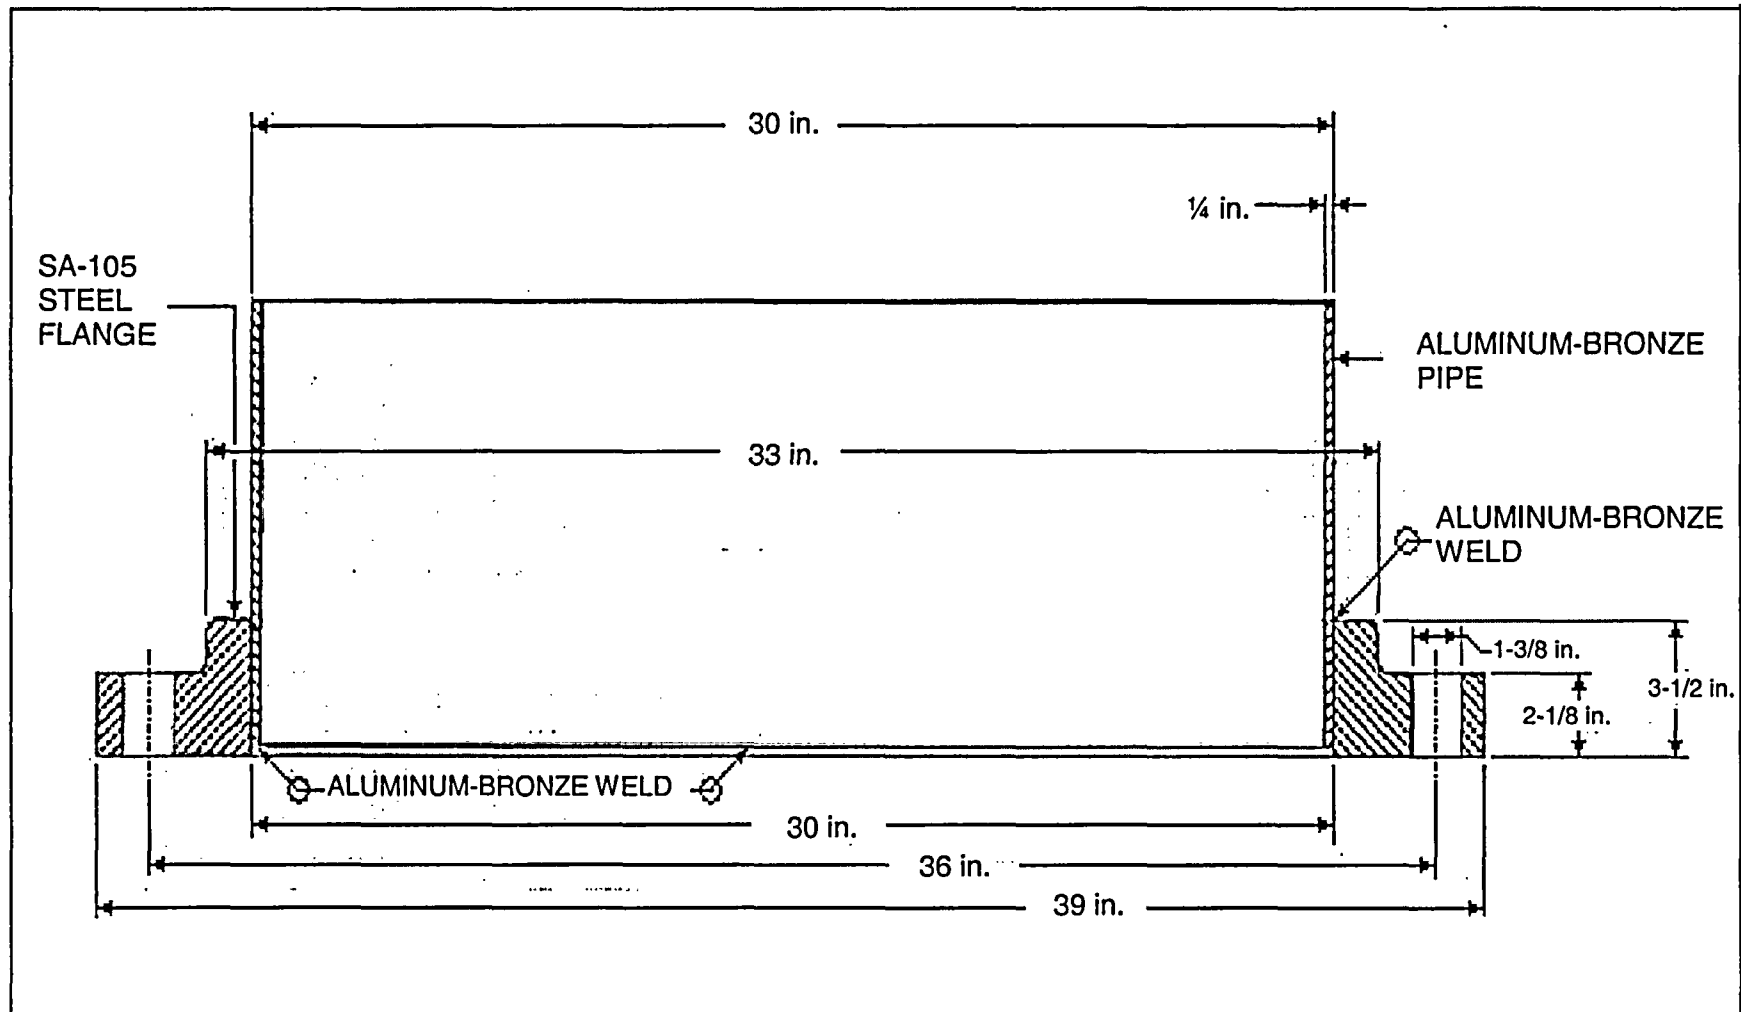
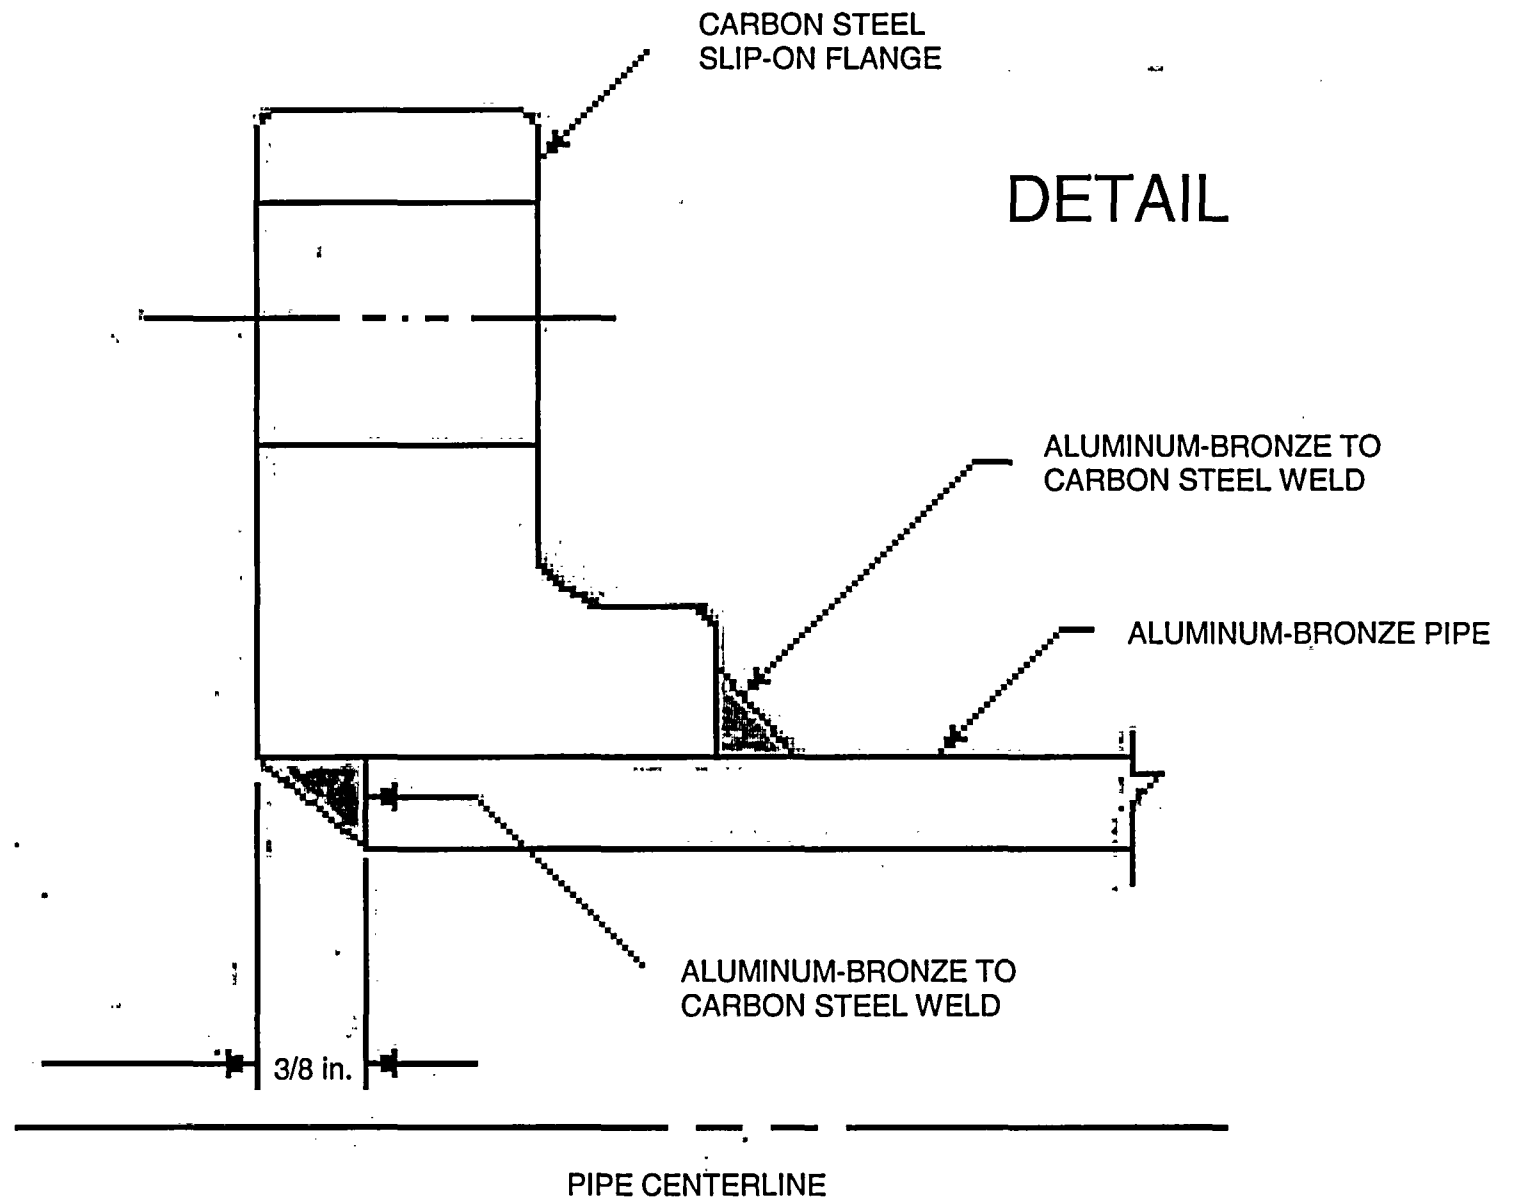
SLIP-ON FLANGE

Through-wall indications have been identified on the 30-inch pipe of ECW Train A downstream of ECW valve EW-0027. Damage consists of pitting located immediately downstream of throttle valve EW-0027 on the inside wall of the pipe in an area covered outside the pipe by a slip-on flange. Some pitting extends through the 1/4-inch thick wall into the flange material for an approximate total depth of 1.145 inch. While there is some damage to the slip-on flange, the slip-on flange and the attendant welds prevent leakage from the ECW system. The root cause of the pitting is apparent cavitation resulting from required throttling of the EW-0027.

In addition, a linear flaw indication was found in the pipe end-to-flange fillet weld. The flaw is approximately 11.25 inches long along the pipe circumference and extends through the pipe wall but not through the flange. There was no active leak because of the carbon steel slip-on flange. The lower fillet weld acts as a pressure-retaining boundary. The linear indication is the result of high residual stress initiated during assembly combined with stresses due to high cycle fatigue.

The aluminum-bronze pipe has a nominal diameter of 30 inches and a nominal thickness of 0.25 inch. The pipe material is SB 169 CA-614 rolled and welded plate (6-8 percent aluminum) fabricated to SA-155 tolerances. The slip-on flange material is SA-105 carbon steel. The slip-on flange is welded to the 30-inch aluminum bronze pipe with fillet welds at both ends. The configuration is depicted in the attached figures.

Contrary to ASME Section XI IWA-4310, defects were not removed prior to returning the affected train to service. Non-code repairs using seal welds have been completed in areas where pitting is excessive and where separation had occurred at the inside diameter fillet weld.

Voids and imperfections on wetted surfaces of the 30" ECW return line from CCW Heat Exchanger 1A (Line Number 30" EW 1105-WT3) downstream of Valve 1-EW0027 were filled with Belzona 1111 to minimize further degradation. The Belzona application is not
