Honeywell Metropolis Works

**Investigation Report of
Uranium Hexafluoride Release
on December 22, 2003**

Date of Report
February 6, 2004

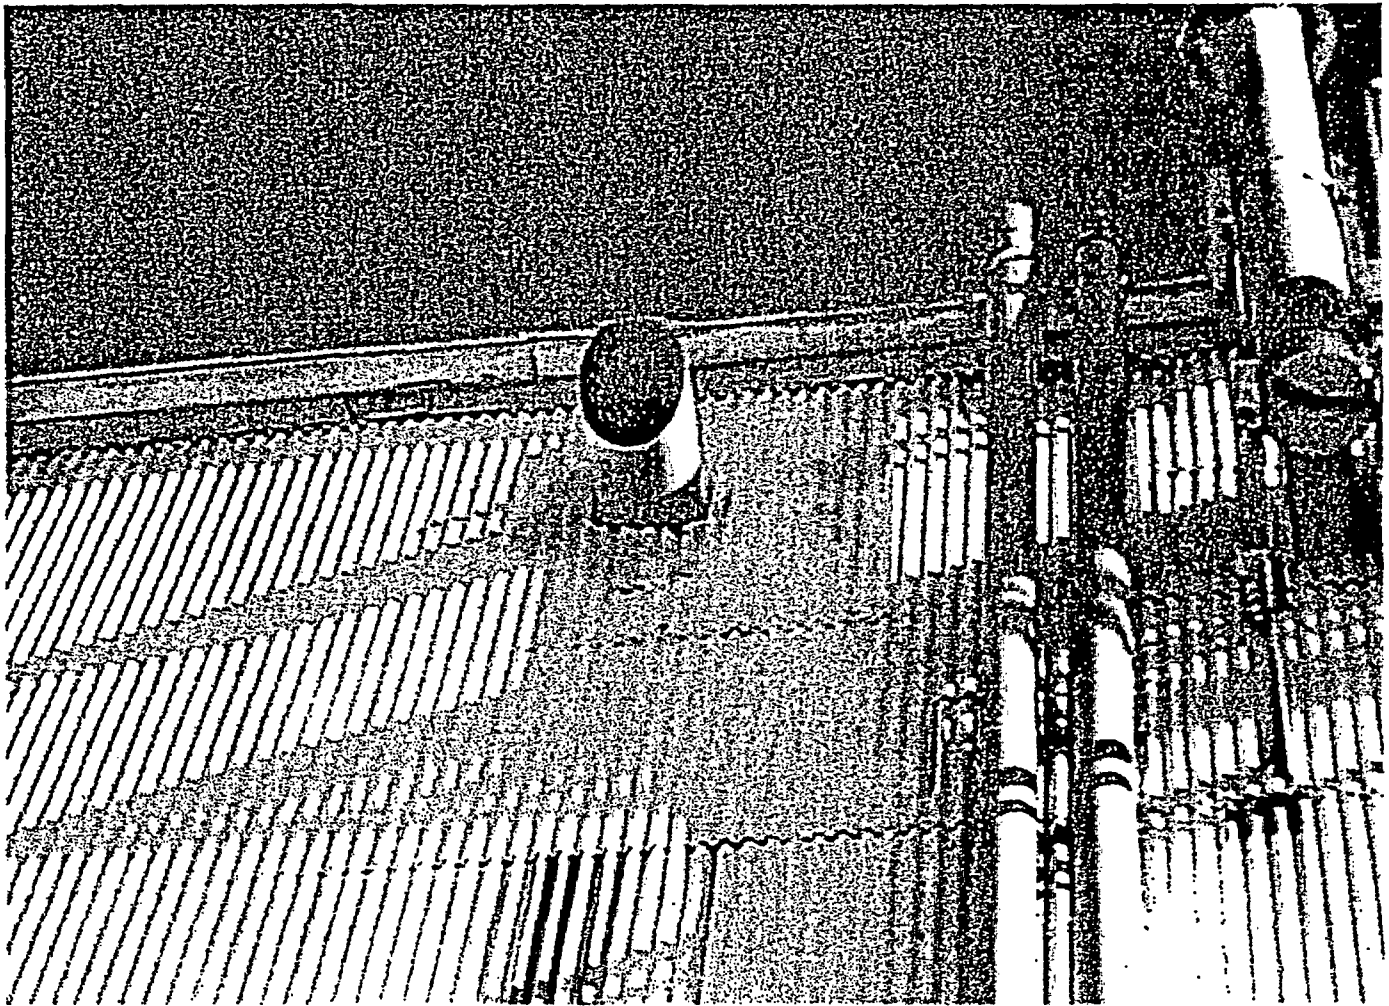
Figure 4 Ash Dust Collector Exhaust (Horizontal Stack)

The actions taken by the HAZMAT Response Team at 0228 hours had the effect of venting the gas mixture to the ash dust collector system's horizontal exhaust stack, hence to the environment. (See Appendix 2, Figure 4.) This initiated the second release pathway. At 0231 hours, a remote security camera showed a release from the ash dust collector system. At 0234 hours, the ERT leader advised security personnel to notify the sheriff's office of the offsite release. This notification was promptly made. NRC was notified at approximately 0300 hours.

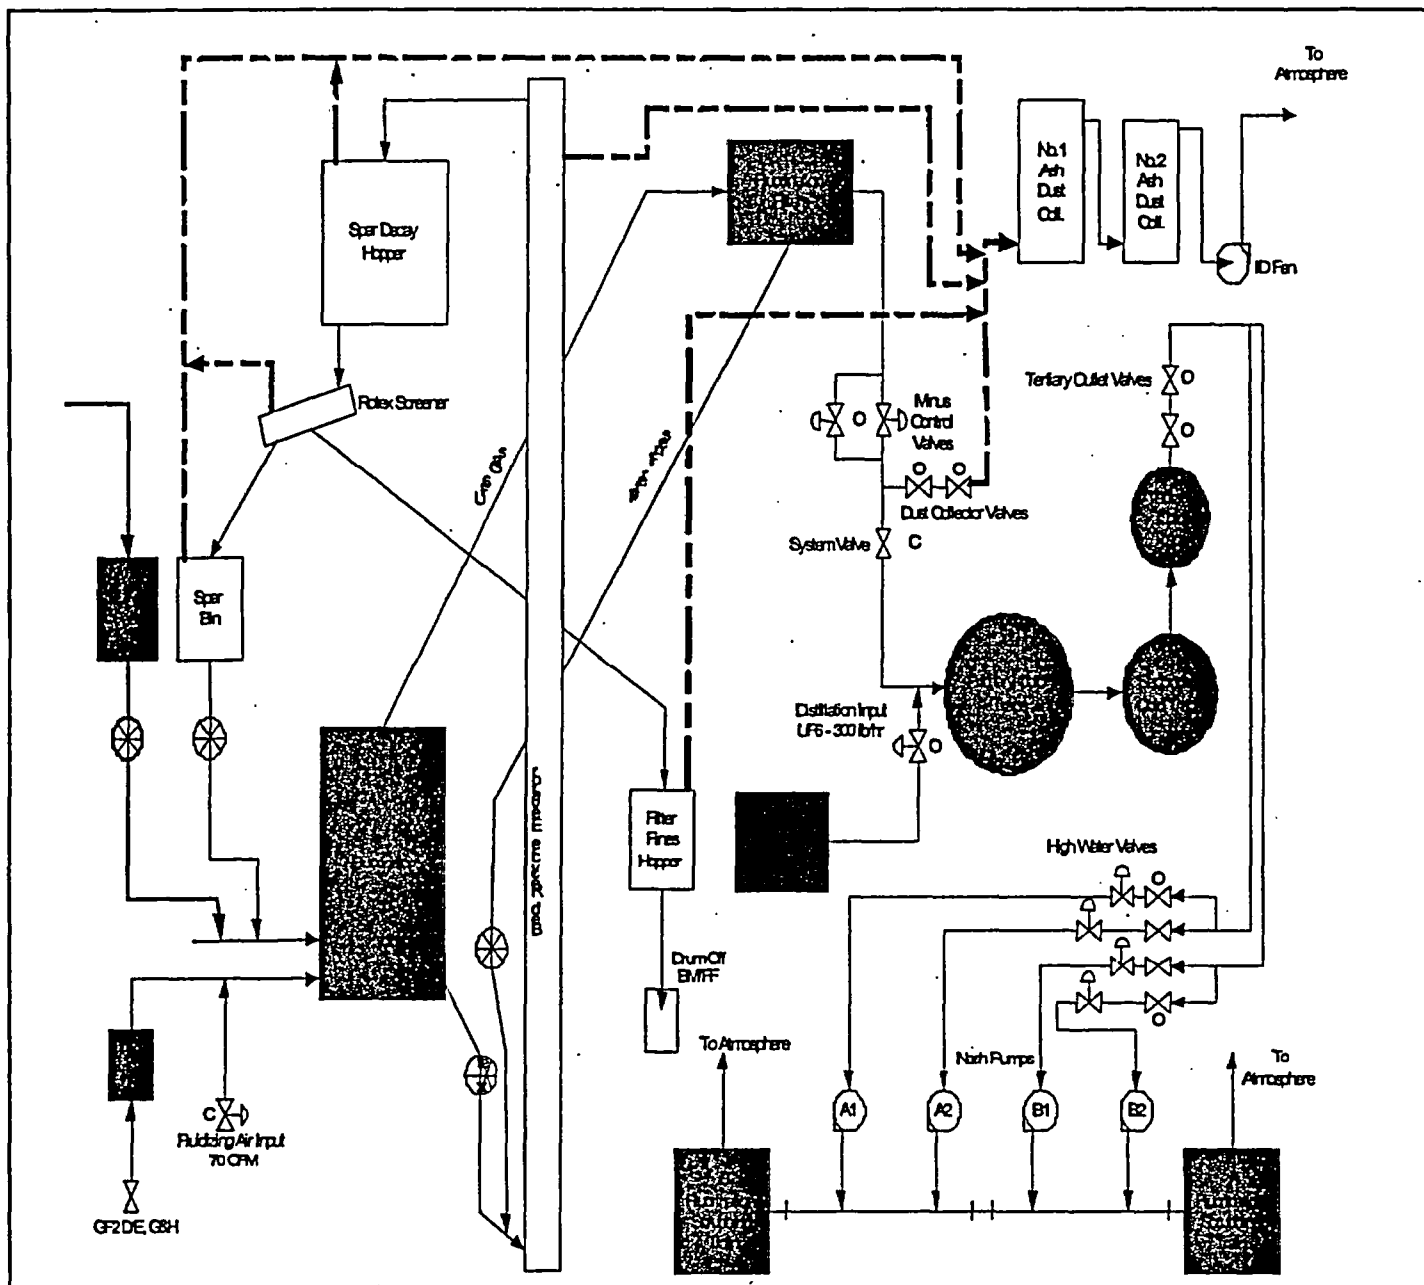
Figure 5 Process When Release Terminated

At 0305 hours, the Nash vacuum pump was restarted and sub-atmospheric pressure was established at 0313 hours. The time to restore sub-atmospheric pressure and thereby terminate the release was extended by the complexity of the lockout, the high level of personal protection necessary for the HAZMAT Response Team, and by the unexpected equipment failure in the Nash vacuum pumps. (See Appendix 2, Figure 5 for valving configuration.)
