ENGINE SYSTEMS, INC.

Report No. 10CFR21-0090
Rev. 0: 09/16/05

10CFR21 REPORTING OF DEFECTS AND NON-COMPLIANCE

COMPONENT: Governor Drive Coupling Element
P/N AK-007-001

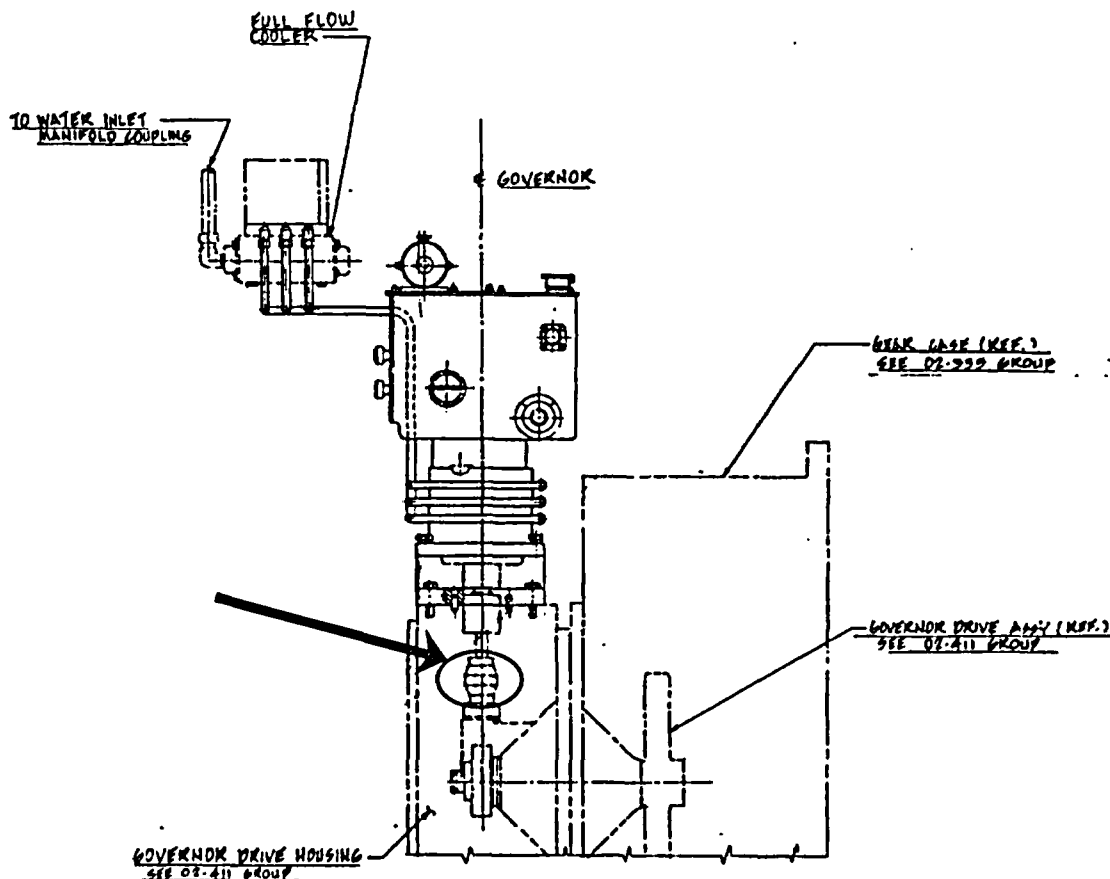
The coupling assembly is used on a vertical drive shaft to transmit power from the engine gear train to the governor in order to allow engine speed sensing and regulating capability (see Figure 1 below). The element resides in compression within the coupling and serves to transmit torque, isolate vibration, and compensate for minor misalignment between the associated coupling halves (see Figure 2). Failure of the element would cause the coupling assembly to fail which would result in inoperability of the governor.

Figure 1: Location of coupling installed in system

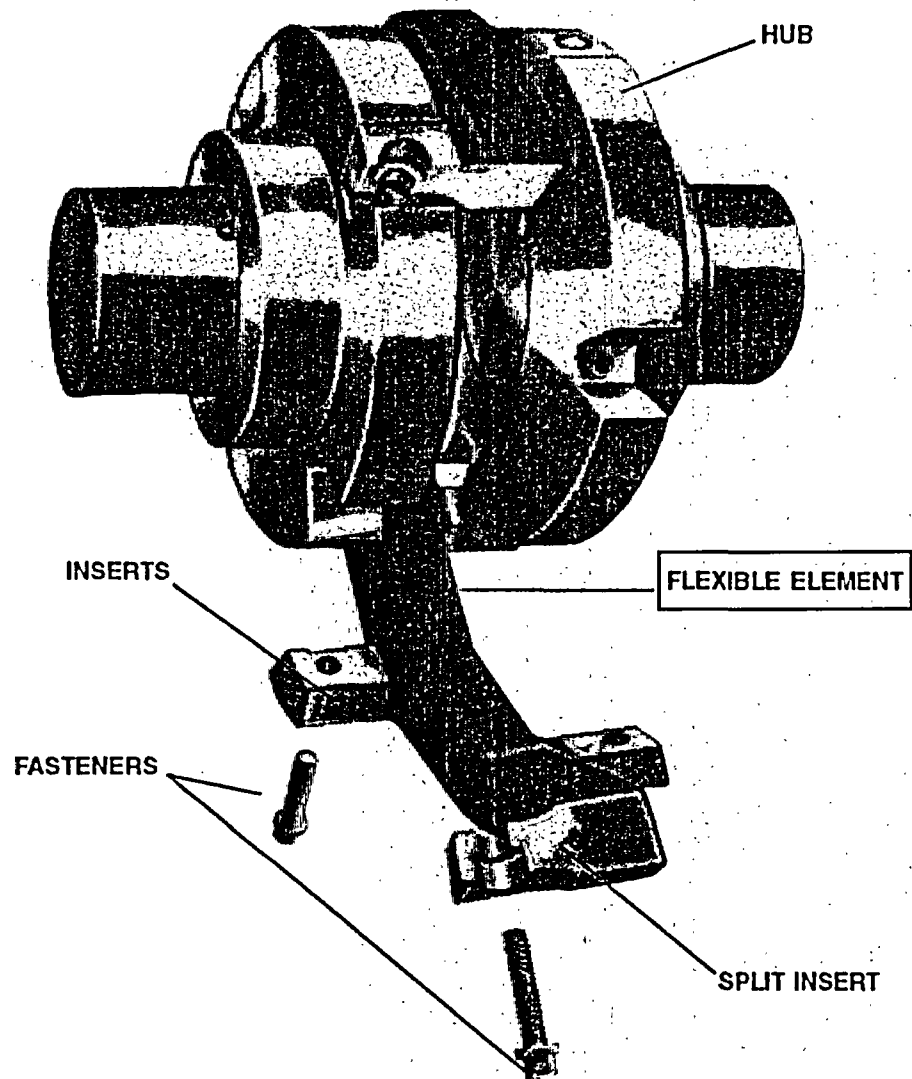
Figure 2: View of coupling assembly

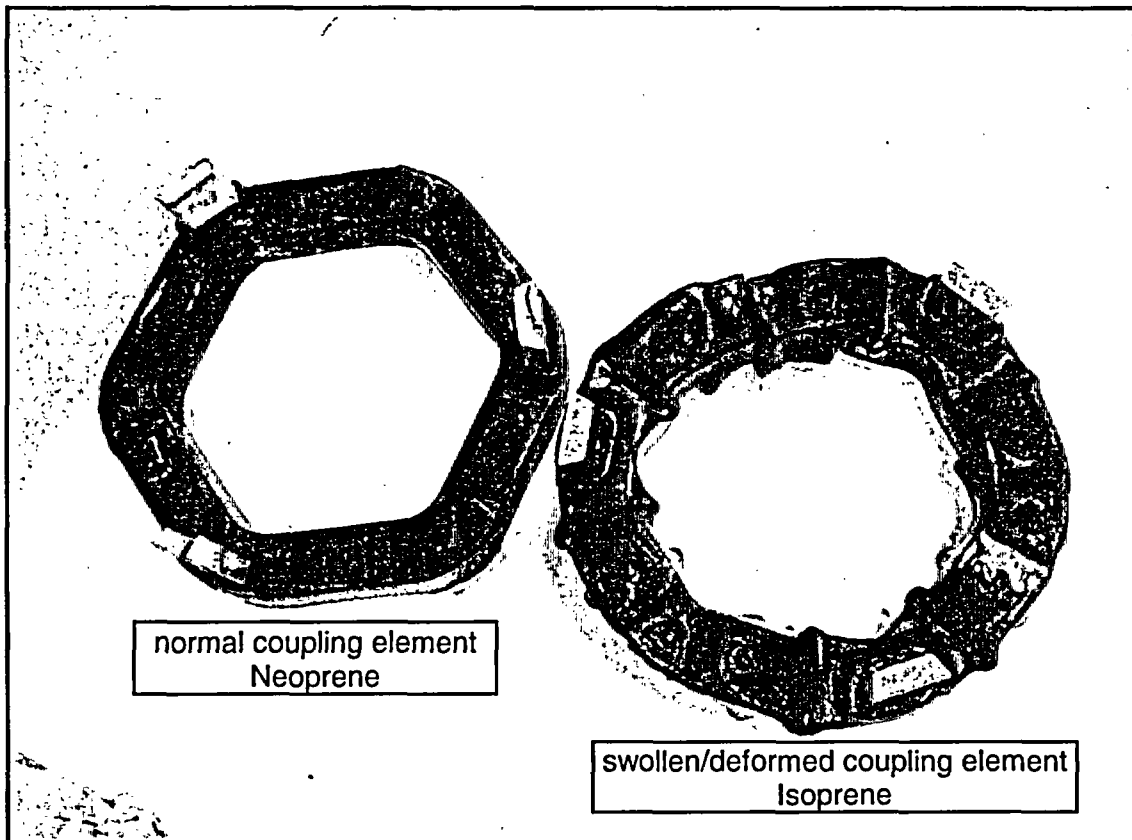
In June 2005, the Shearon Harris plant had reportedly removed a coupling element from their diesel engine and observed the material to be swollen and deformed (see Figure 1 below). A subsequent technical report provided by the site's Materials Services Section found the material composition of the element to be isoprene (natural rubber). The current design of the coupling specifies the material to be polychloroprene (neoprene).

FIGURE 1 A photograph of two governor couplings removed from an emergency diesel generator at the Harris Nuclear Plant. There are supposedly identical components that have been exposed to the same service environment. Note that the coupling on the right is swollen and deformed compared to the one on the left.

The results of ESI's internal investigation revealed that several utilities have been supplied coupling elements made from isoprene. The isoprene material is not suitable for the high temperature, oil rich environment of the engine gear case and is susceptible to failure after prolonged exposure (the condition reported at Shearon Harris was noted after being installed on the engine for 16 months).

1. Review their inventory for suspect elements listed in Table 1. Any suspect elements should be removed from inventory and replaced.
2. Determine if suspect elements listed in Table 1 have been installed on the engine. ESI has not been able to determine an expected service life of isoprene coupling elements when exposed to the high temperature, oil rich environment of the engine gear case. Therefore, our recommendation is to replace any installed suspect elements as soon as possible.
