Appendix C2

SEM/EDS Data for Unused and Test-2 Day-30 Copper Coupons

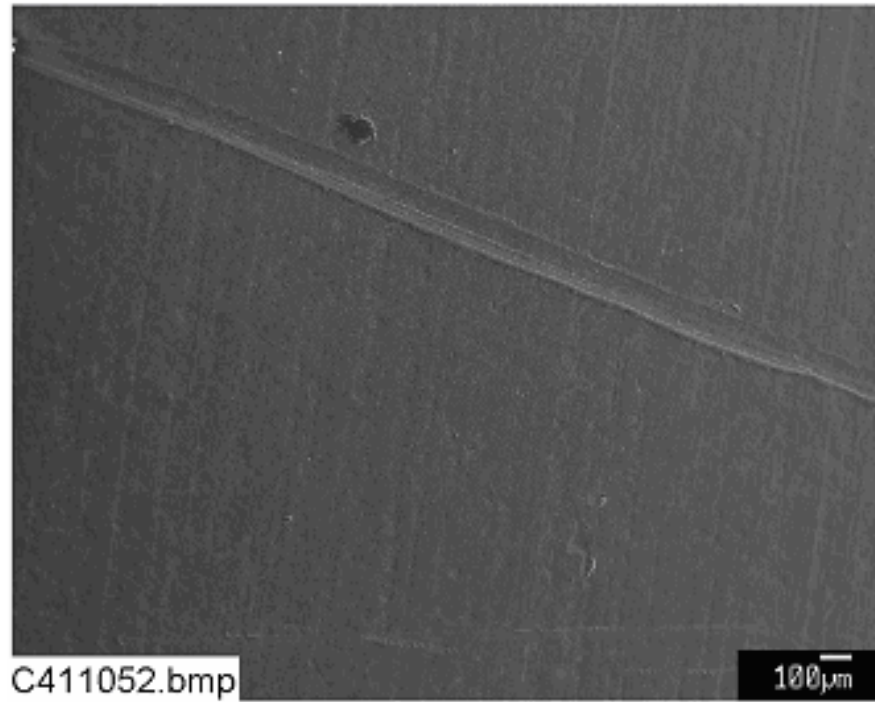
Figure C2-1. SEM image for an unused copper coupon (C411052).

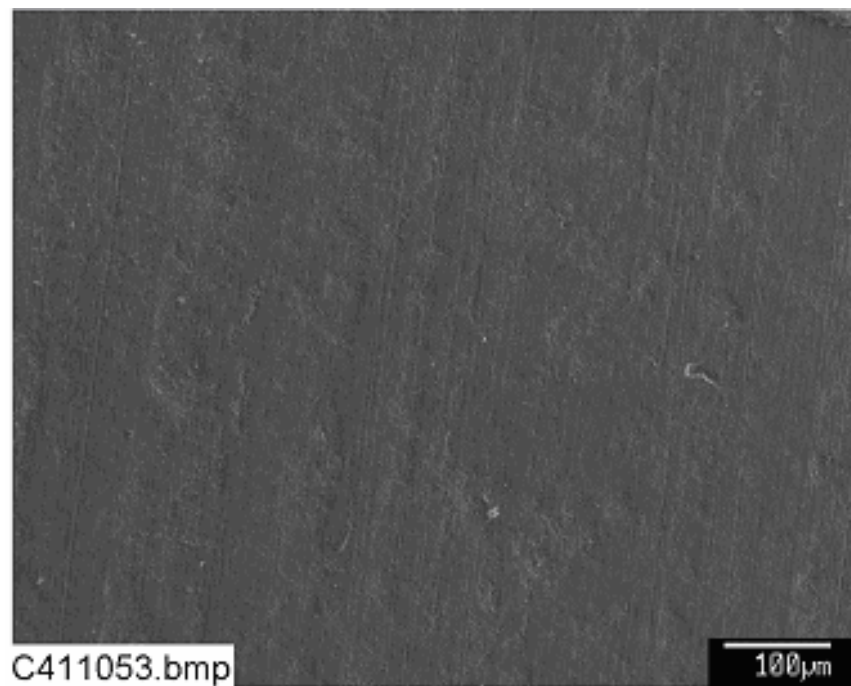
Figure C2-2. SEM image for an unused copper coupon (C411053).

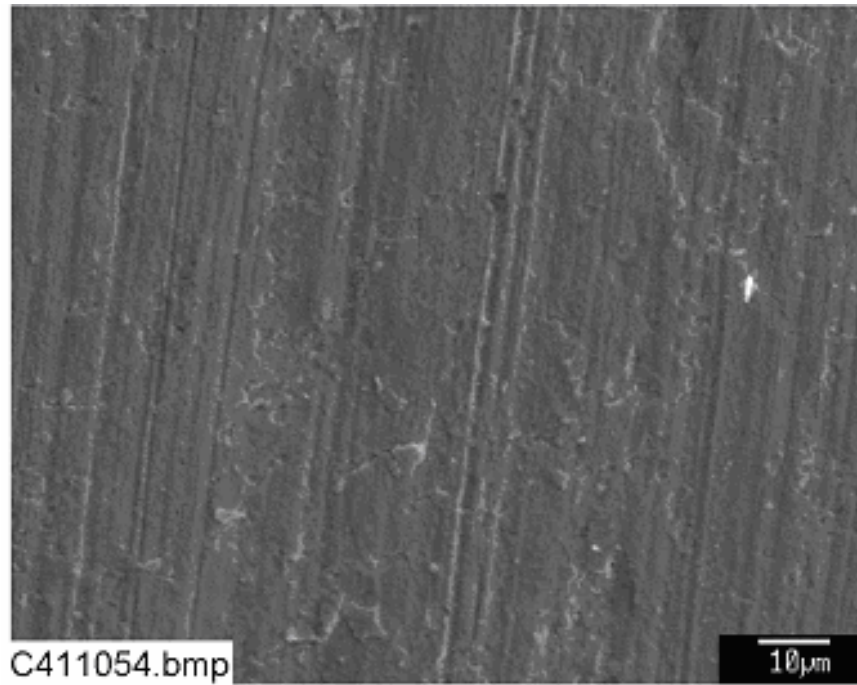
Figure C2-3. SEM image for an unused copper coupon (C411054).

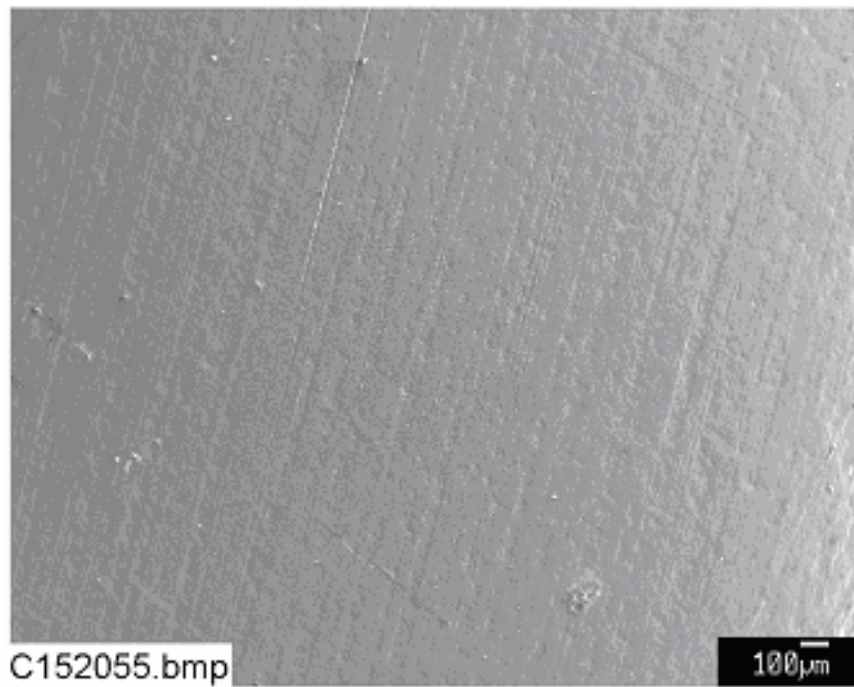
Figure C2-4. SEM image for a Test-2 Day-30 unsubmerged copper coupon (C152055).

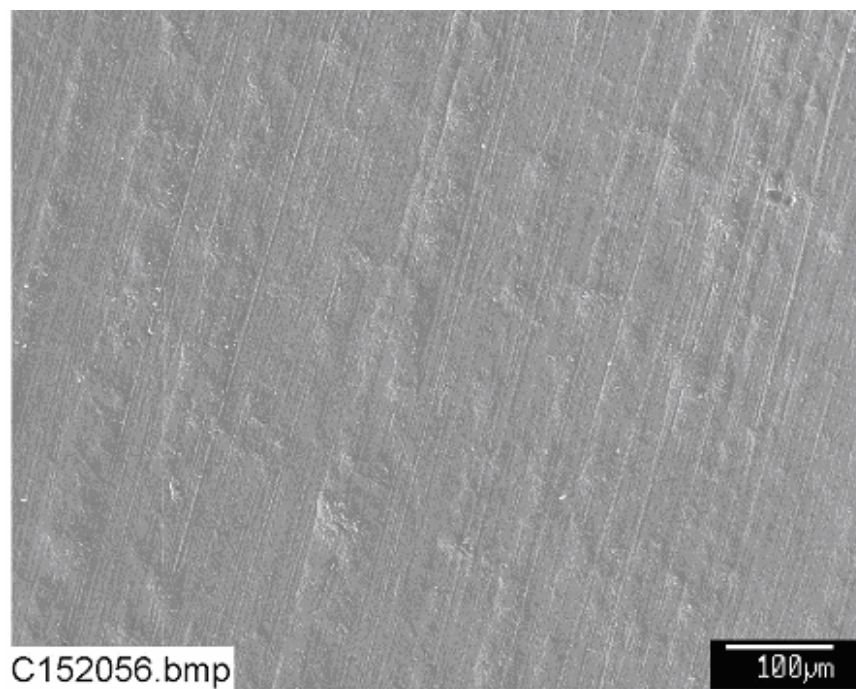
Figure C2-5. SEM image for a Test-2 Day-30 unsubmerged copper coupon (C152056).

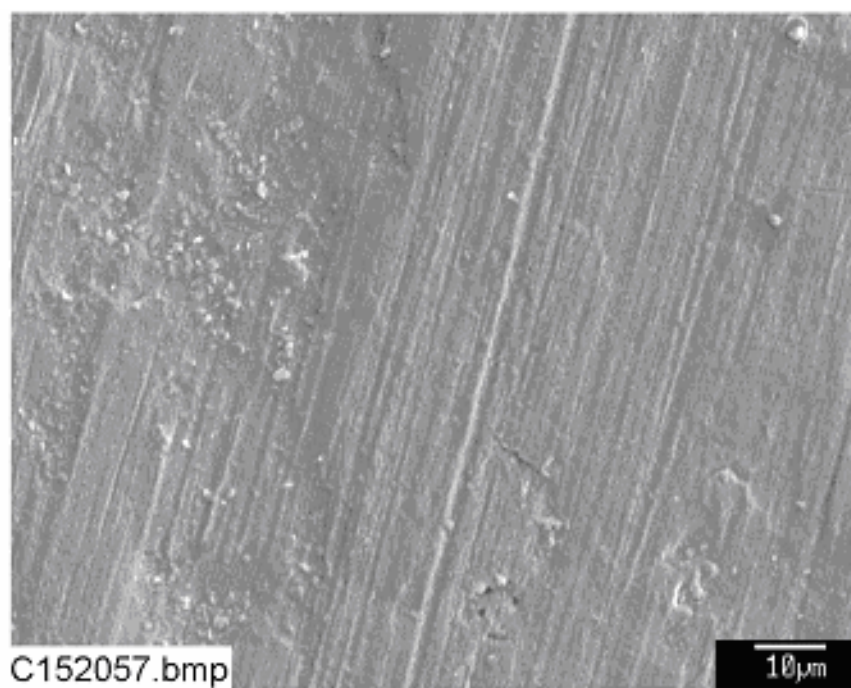
Figure C2-6. SEM image for a Test-2 Day-30 unsubmerged copper coupon (C152057).

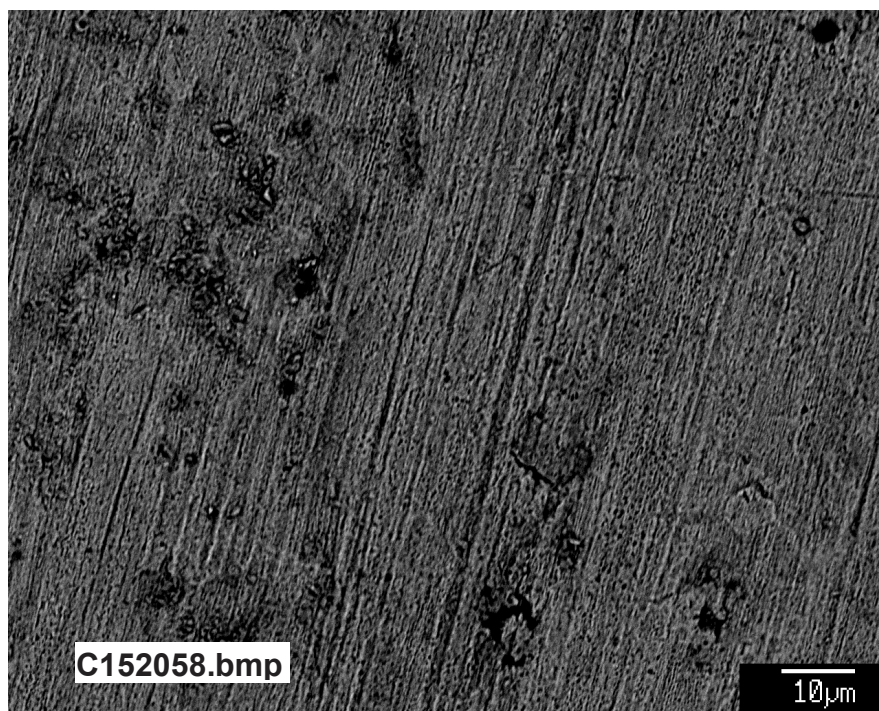
Figure C2-7. Backscattered SEM image for a Test-2 Day-30 unsubmerged copper coupon (C152058).

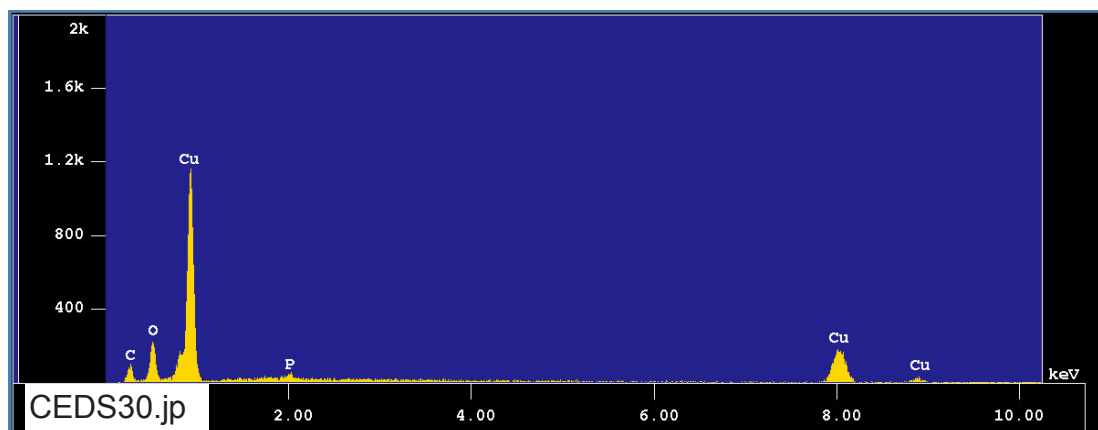
Figure C2-8. EDS counting spectrum for one of the dark spots shown in Figure C2-7 (CEDS30).

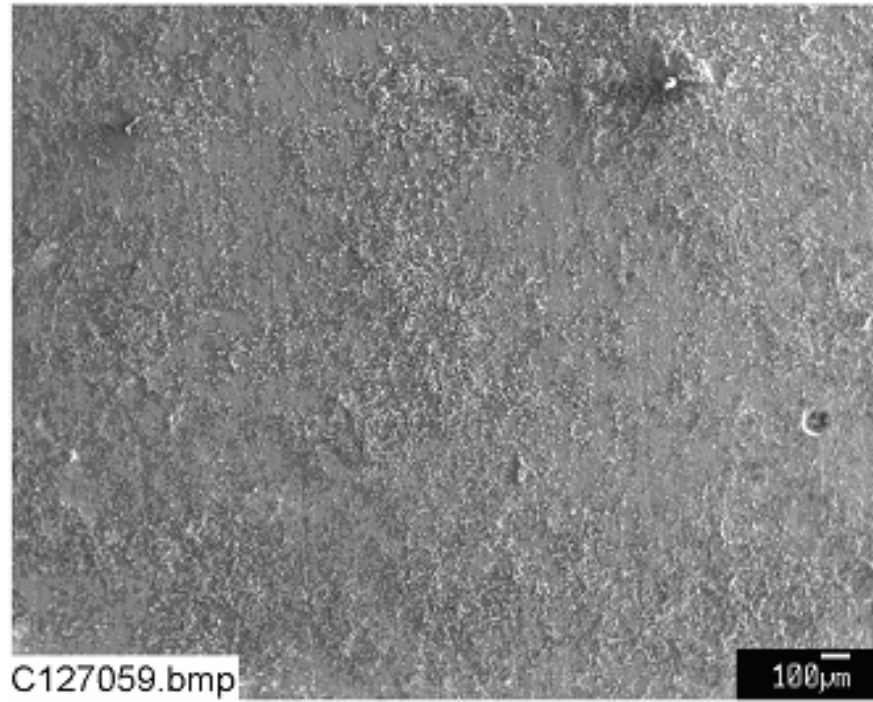
Figure C2-9. SEM image for a Test-2 Day-30 submerged copper coupon (C127059).

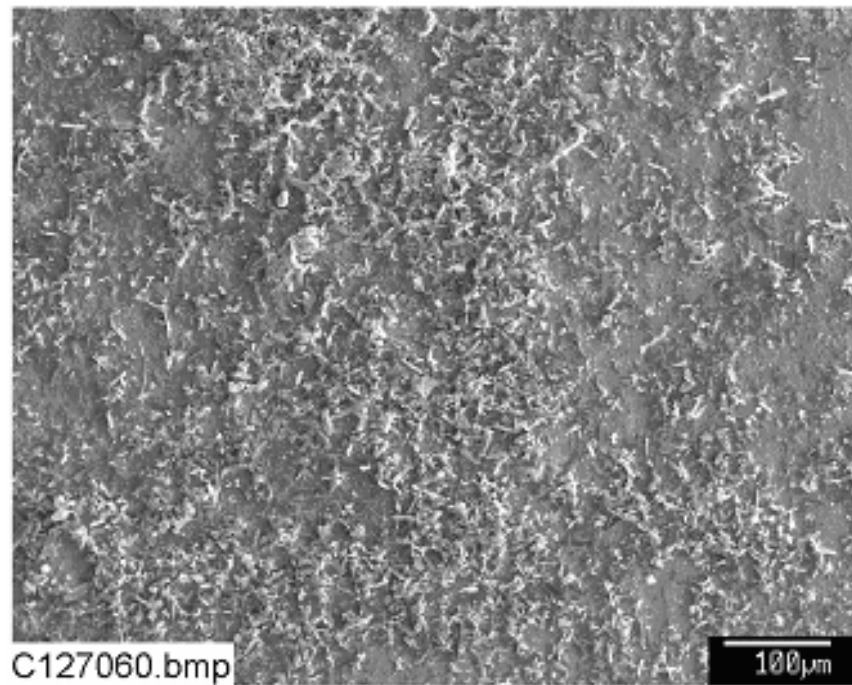
Figure C2-10. SEM image for a Test-2 Day-30 submerged copper coupon (C127060).

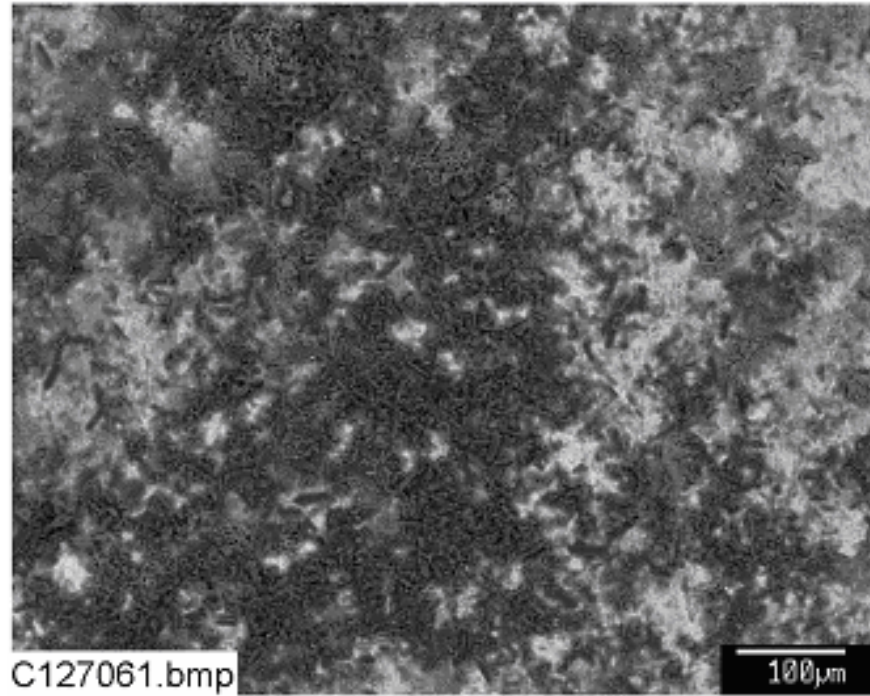
Figure C2-11. Backscattered SEM image for a Test-2 Day-30 submerged copper coupon (C127061).

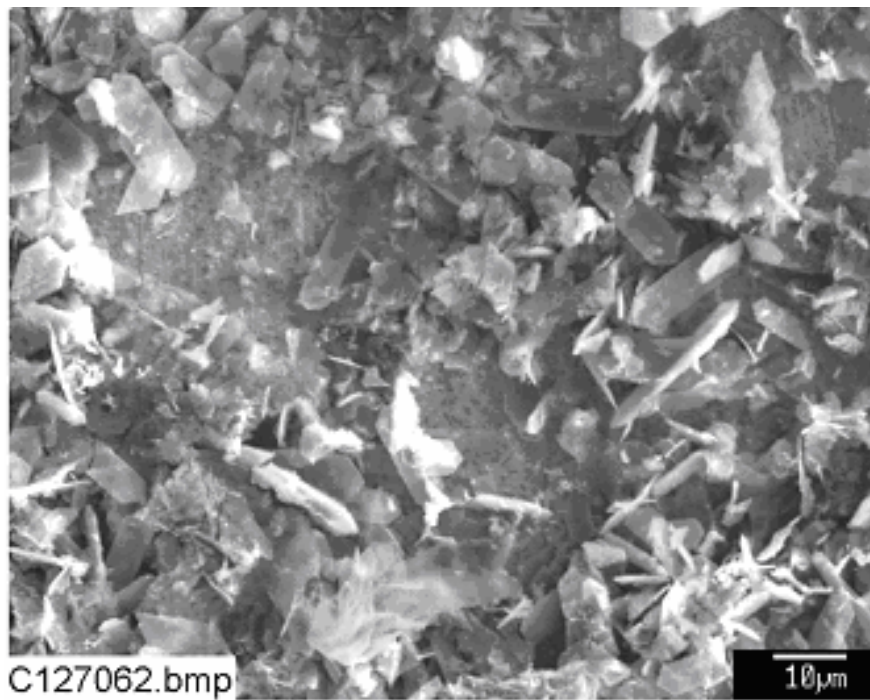
Figure C2-12. SEM image for a Test-2 Day-30 submerged copper coupon (C127062).

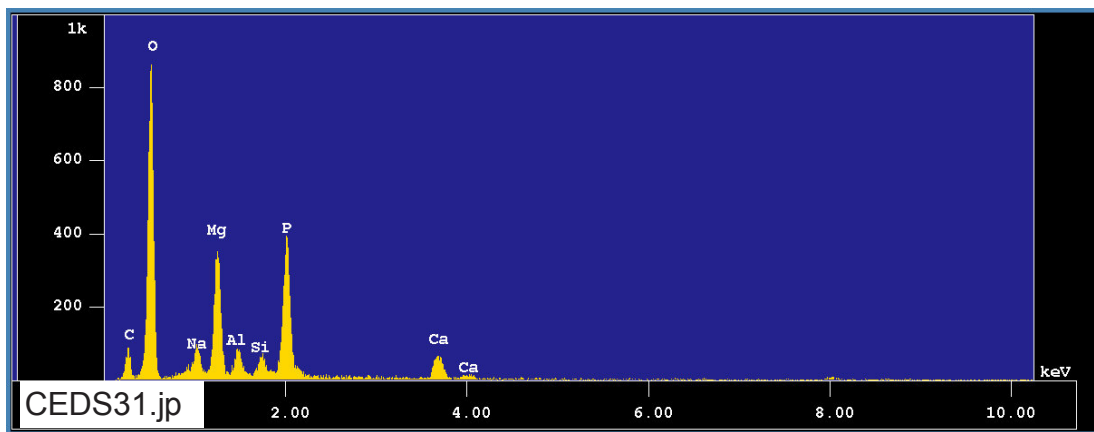
Figure C2-13. EDS counting spectrum for the dark patches shown in Figure C2-11 (CEDS31).

Element	Mass%	Atomic%	ZAF	Z	A	F
O	59.978	72.8049	0.9785	0.9908	0.9877	1.0000
Na	2.826	2.3873	1.3800	1.0457	1.3215	0.9986
Mg	11.431	9.1315	1.4595	0.9845	1.4842	0.9988
Al	1.789	1.2876	1.4515	1.0179	1.4298	0.9974
Si	1.887	1.3046	1.2557	0.9952	1.2690	0.9943
P	16.716	10.4809	0.9027	1.1946	0.7558	0.9997
Ca	5.372	2.6032	1.0249	1.0161	1.0086	1.0000

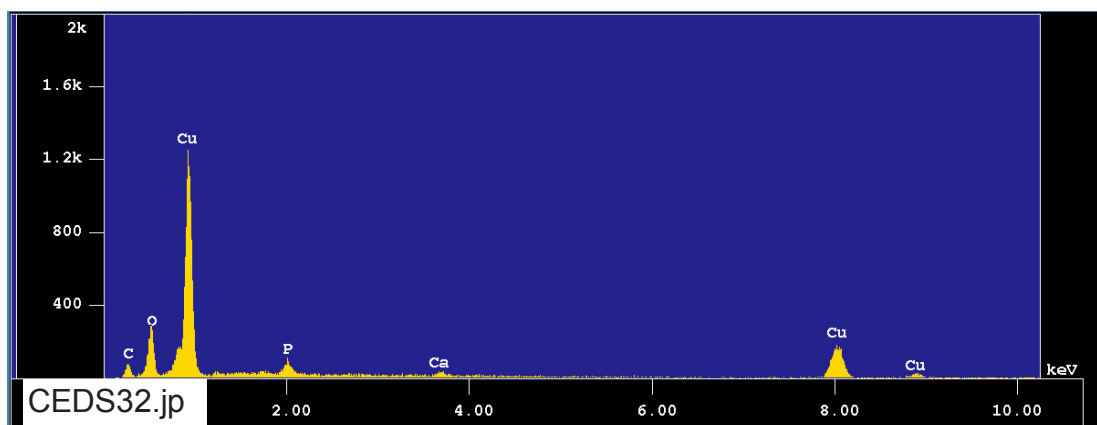
Figure C2-14. EDS counting spectrum for the light patches shown in Figure C2-11 (CEDS32).

Element	Mass%	Atomic%	ZAF	Z	A	F
O	16.042	42.1700	0.8549	0.8436	1.0136	0.9998
P	2.528	3.4327	1.0005	1.0112	0.9894	1.0000
Ca	1.293	1.3565	0.8912	0.8542	1.0459	0.9975
Cu	80.137	53.0408	1.0634	1.0641	0.9994	1.0000

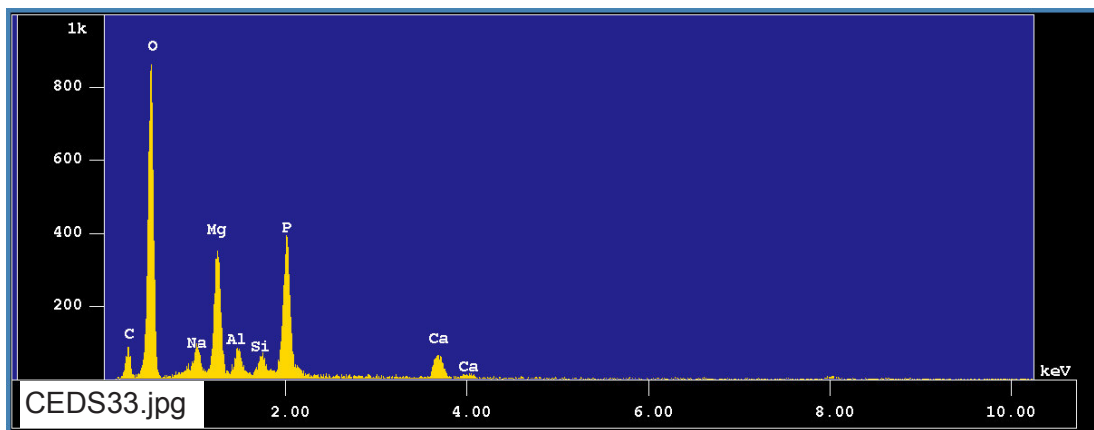
Figure C2-15. EDS counting spectrum for the lathlike crystals shown in Figure C2-12 (CEDs33).
